**Re: Upper 1/2-Mile Reach of Housatonic River Removal Action  
Monthly Report – April 2000**

EXHIBIT A  
UPPER 1/2 MILE REACH REMOVAL ACTION

**½ MILE RIVER REMOVAL ACTION  
MONTHLY PROGRESS REPORT  
APRIL, 2000  
FIGURE 1 PHOTO DOCUMENTATION**

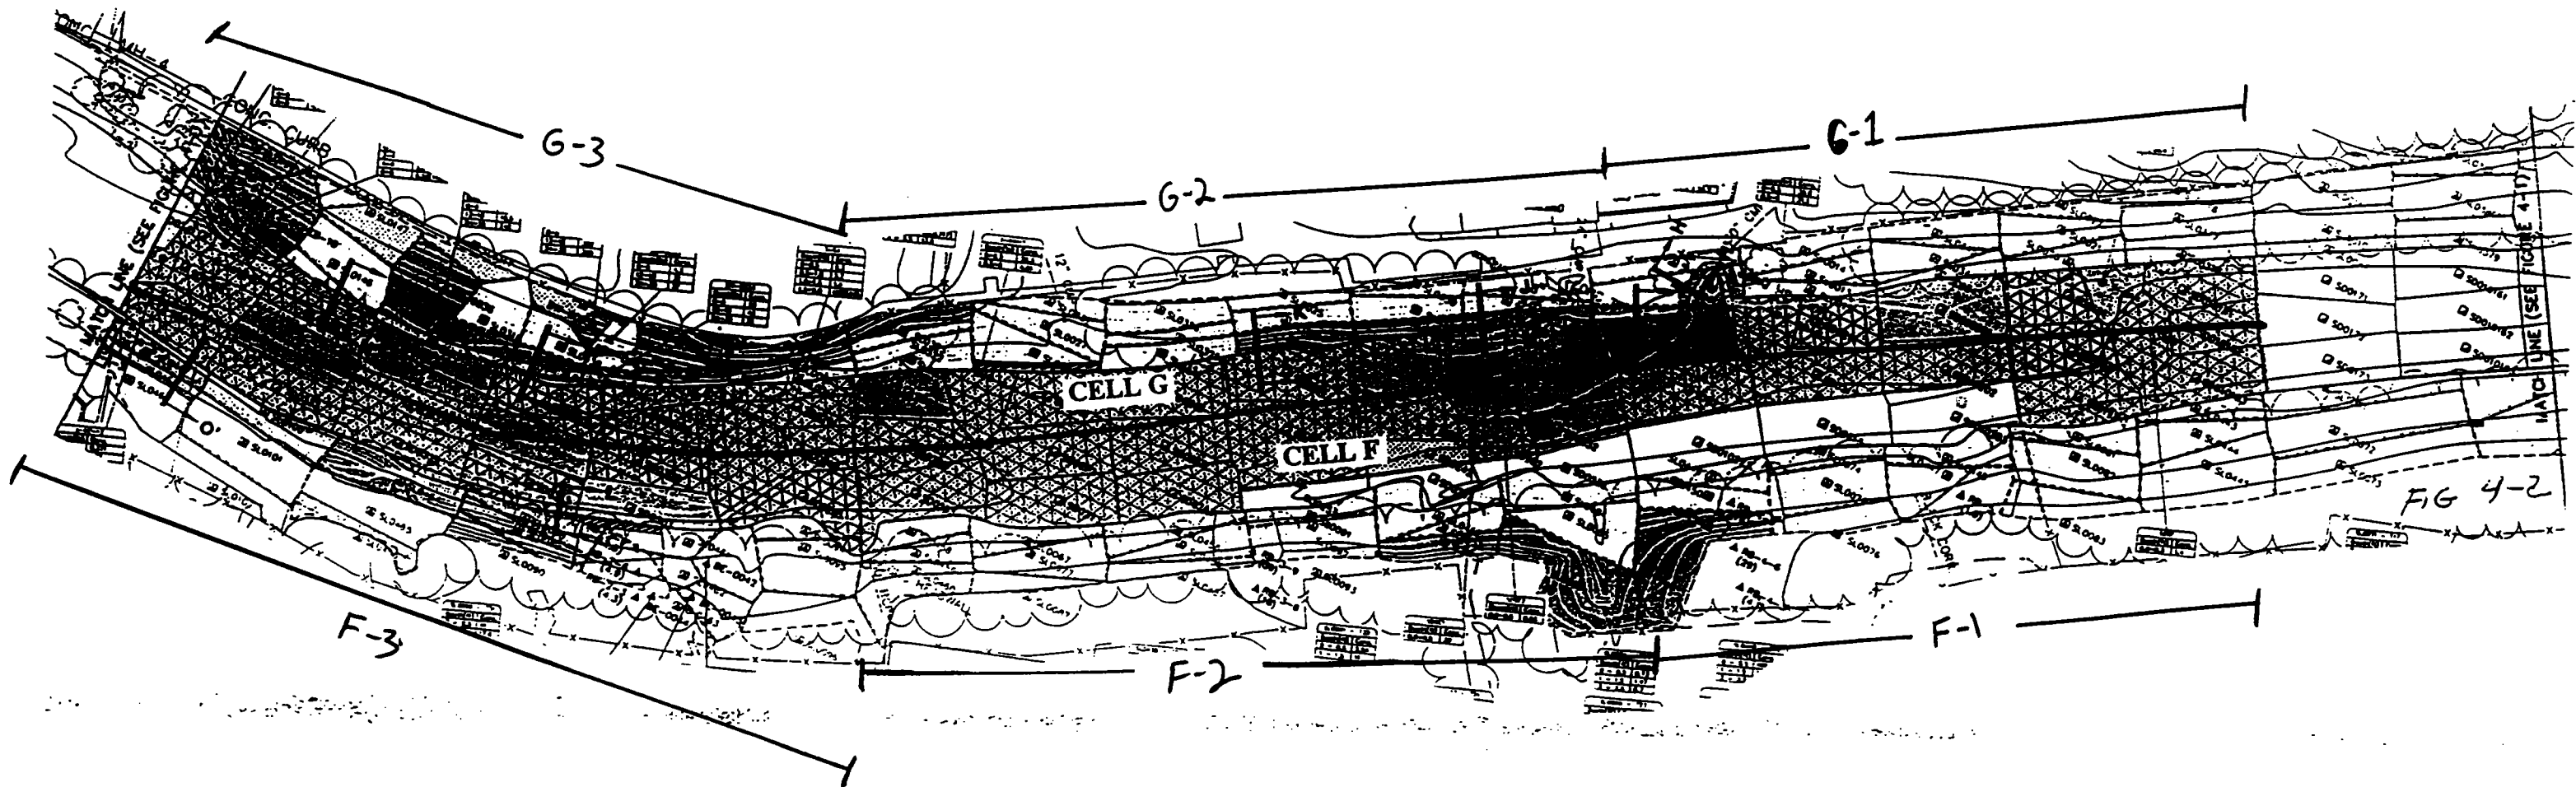
A diagram labeled as Exhibit A shows the location of the Cells (A, B, C, D, E, F, and G) and is attached to this report for reference. Additionally, Exhibit B shows the area of DNAPL based on the results of the DNAPL investigation conducted by GE.

Refer to the diagram (Exhibit A) referenced in Section 4.0 and attached to this report for an orientation of the sheetpile cells and their respective locations. In the month of April, GE Buildings 33X and 65 were used as temporary storage facilities for TSCA and non-TSCA material. The DNAPL-impacted sediments were stored in a separate area in Bldg. 33X for a short period of time. All DNAPL impacted sediments were disposed of off-site.

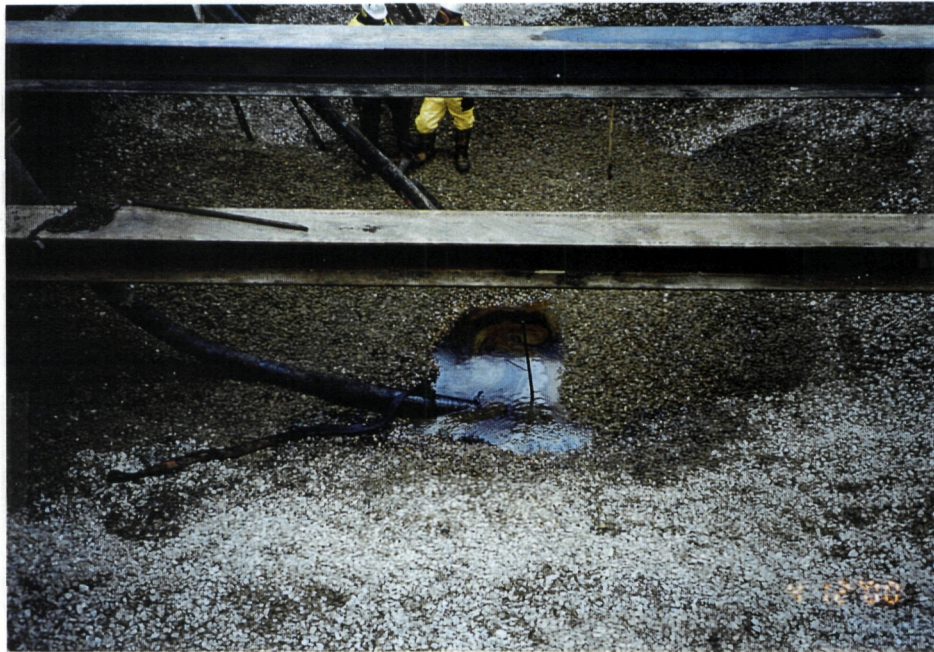
**PHOTO NUMBER: 1**

**PHOTO LOCATION:**  
DNAPL cell looking upstream (east).

**PHOTO DESCRIPTION:**  
DNAPL observed in the DNAPL cell.  
6" recovery well installed in the middle section

After removing 250-300 cy of sediment to an elevation between 961 to 962(AMSL) DNAPL was still present. On April 11, GE in consultation with EPA decided to install a DNAPL recovery well at an elevation of 959.6. The 24 inch long well screen of this well ranged from elevations 960.6 to 962.6. Two to four feet of 1 ½ inch stone were placed throughout the entire DNAPL Cell, sloping down to the location where the recovery well was installed. Filter fabric covered all the stone and 6 inches of washed sand was placed underneath the HDPE liner. This liner installed from elevation 964.5 sloped up to elevation 965.5 along the source control sheetpile. The liner was sealed along the source control sheetpile and around the recovery pipe. A 12-inch steel protective casing was installed around the 6-inch recovery well. This recovery well system was installed at a 40-degree angle and was eventually covered by the 12-inch stone placed at a 1H : 1V slope along the source control sheetpile. Following the placement of 3 to 4 feet of isolation material the normal restoration sequence was followed. The grouting subcontractor was re-mobilized to grout the source control sheetpile and the restoration in the DNAPL Cell was completed on April 27.

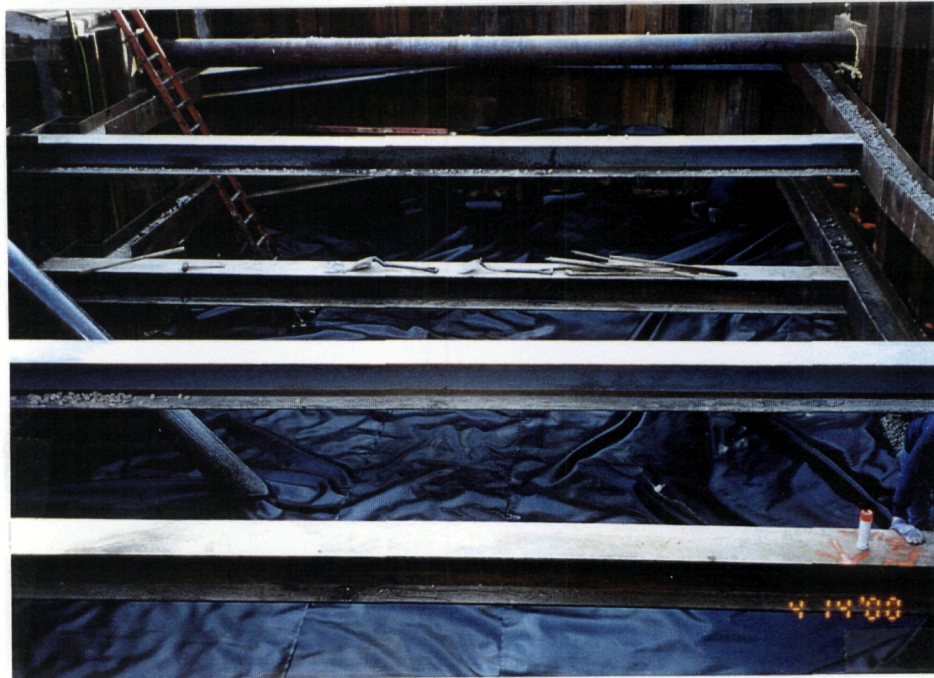
**PHOTO NUMBER: 2**

**PHOTO LOCATION:**  
DNAPL Cell looking upstream (east).

**PHOTO DESCRIPTION**  
Restoration: filter fabric placed over the cell  
followed by 6" sand layer and HDPE liner.

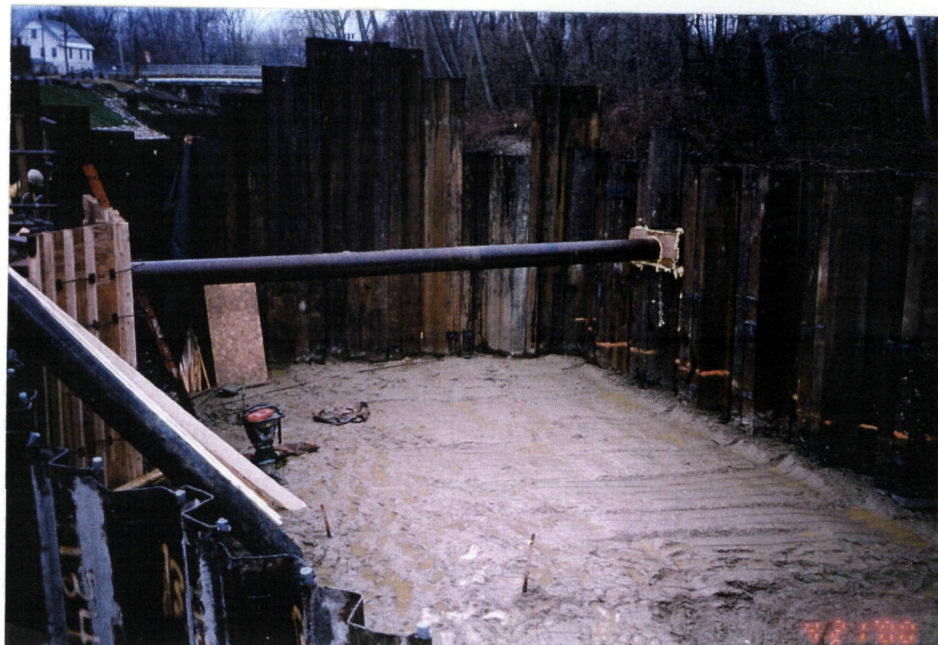
**PHOTO NUMBER: 3**

**PHOTO LOCATION:**  
DNAPL Cell, looking upstream (east)

**PHOTO DESCRIPTION**  
Restoration upto design removal depths.  
Perimeter bracing removed.

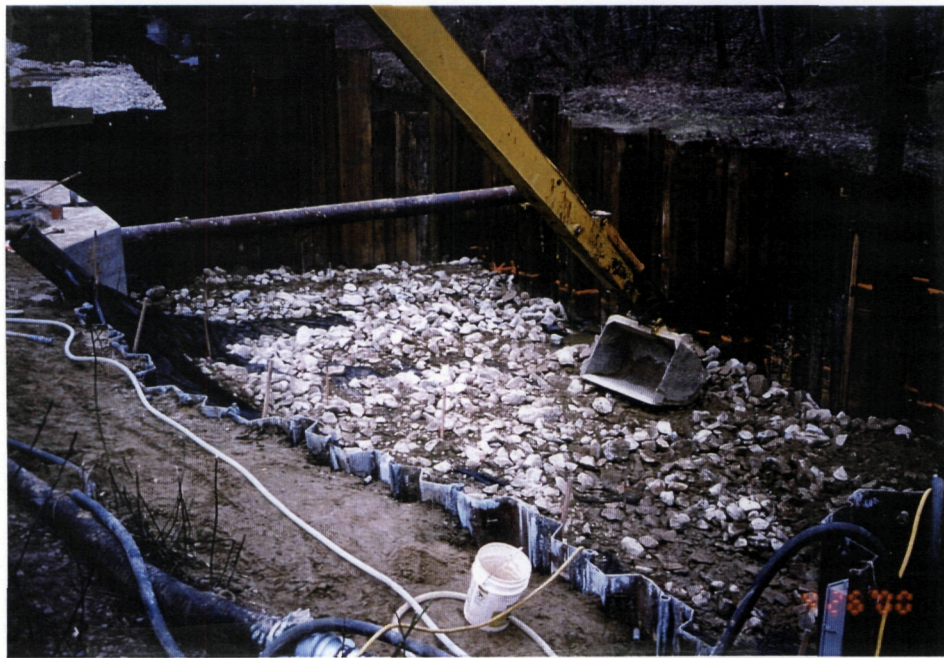
**PHOTO NUMBER:** 4

**PHOTO LOCATION:**  
DNAPL cell looking upstream (east).

**PHOTO DESCRIPTION:**  
Restoration: placement of final layer of rock.  
(Note new concrete headwall and 12' protective pipe casing for recovery well at left side of photo)

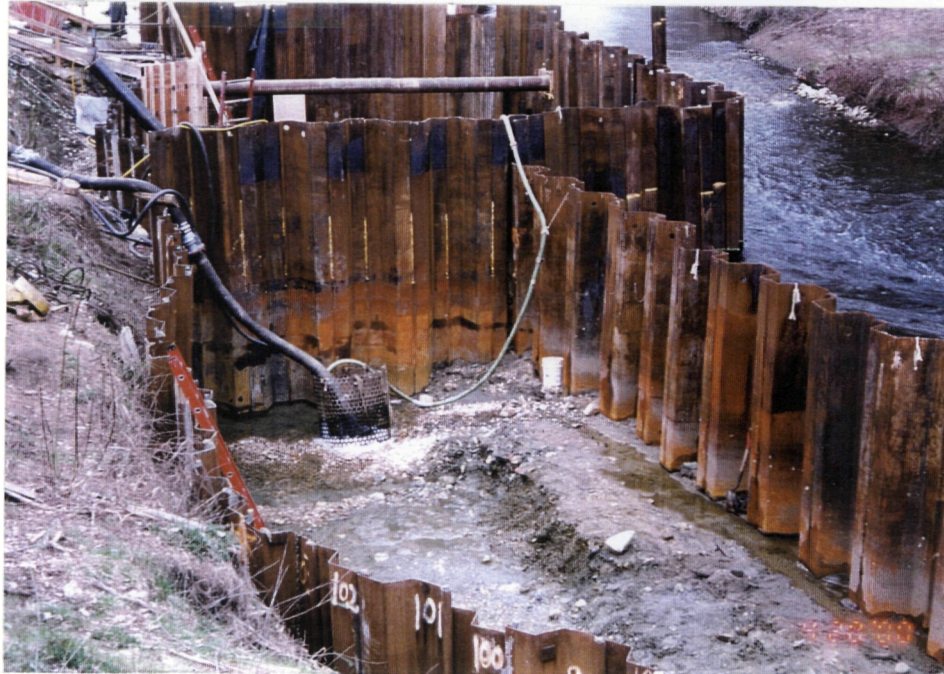
**PHOTO NUMBER:** 5

**PHOTO LOCATION:**  
Cell D looking upstream (east).

**PHOTO DESCRIPTION:** Sediment removal.  
Additional 1-2 foot of sediment removal  
in the upstream 30 feet of Cell D

Removal activities in Cell D began on April 18, and no DNAPL was observed in this area. One to two feet of additional sediment excavation in the upstream part of Cell D was completed over the first 30 feet of the cell, at which point the original removal depth was achieved (section between area B and C at elevation 969). April ended with approximately 4 more days required to complete restoration in Cell D.

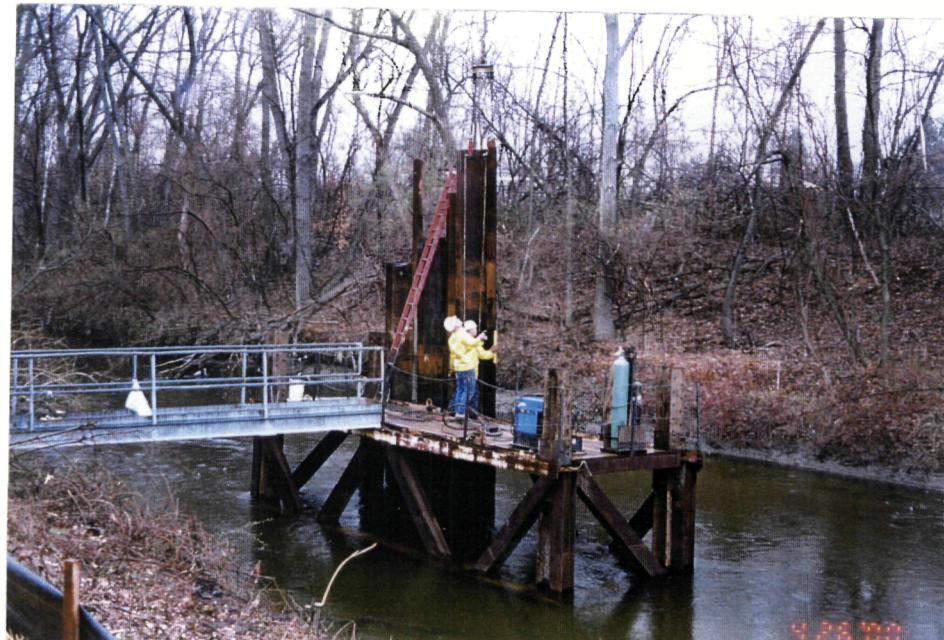
**PHOTO NUMBER:** 6

**PHOTO LOCATION:** Cell F and G  
Next section of the river.

**PHOTO DESCRIPTION:**  
Installation of sheetpile (center of the river)

Site preparation activities were initiated in the next downstream section of the river (Cell F south side and Cell G north side). Clearing of trees and brush began on April 3 and lasted through April 28, temporary access roads were constructed along the north bank starting April 21, and sheetpiling installation began on April 26. Cells F and G will be subdivided into 3 smaller section approximately 200 to 300 feet long. Cell F-1 (upstream section along the south side of the river) will be de-watered first followed by Cell G-1 (upstream section along the north side of the river)
