Re: Upper 1/2-Mile Reach of Housatonic River Removal Action

Monthly Report - December 1999

# EXHIBIT A UPPER ½ MILE REACH REMOVAL ACTION LOCATION OF CELLS A, B, C, D and E FOR THE UPSREAM SECTION

1/2 MILE RIVER REMOVAL ACTION MONTHLY PROGRESS REPORT DECEMBER, 1999 FIGURE 1 PHOTO DOCUMENTATION

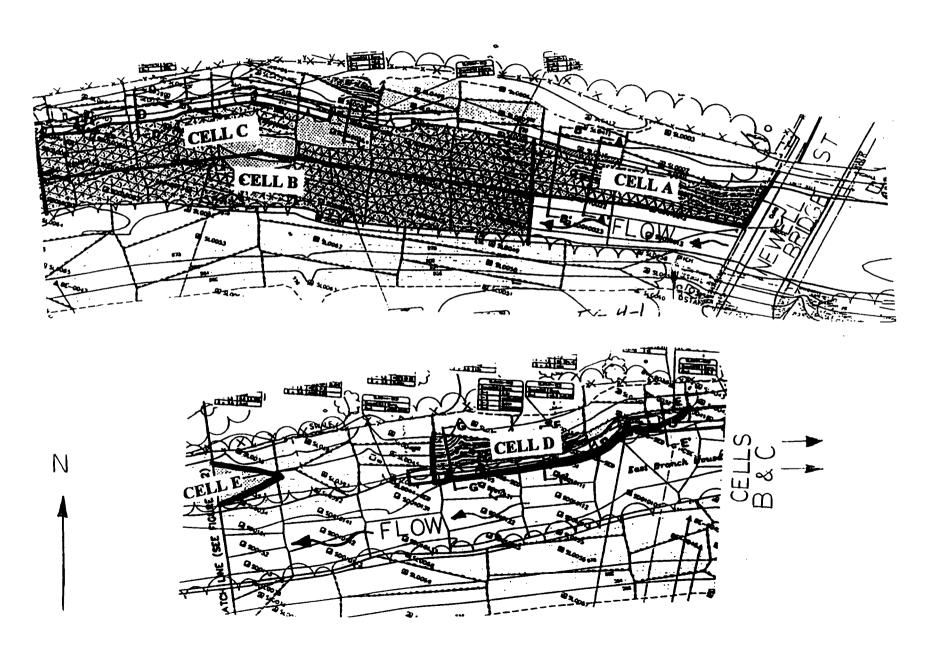
Refer to the diagram (Exhibit A) referenced in section 4.0 and attached to this report for an orientation of the sheetpile cells and their respective locations progressing downstream along the river. In the month of December, removal/restoration activities in cells A and B were completed. These activities included the following general sequence of events:

A diagram labeled as **Exhibit A** shows the location of the cells (A, B, C, D and E) and is attached to this report for reference.

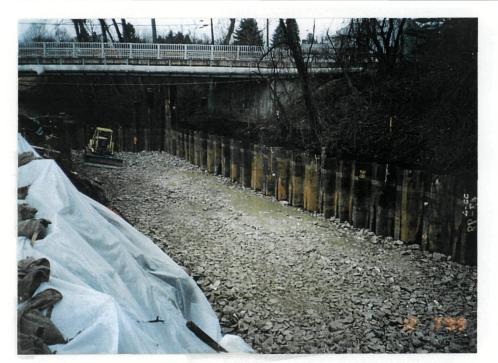
PHOTO NUMBER: 1

PHOTO LOCATION: Cell A

Looking east towards Newell Street Bridge.

Restoration in cell A complete.

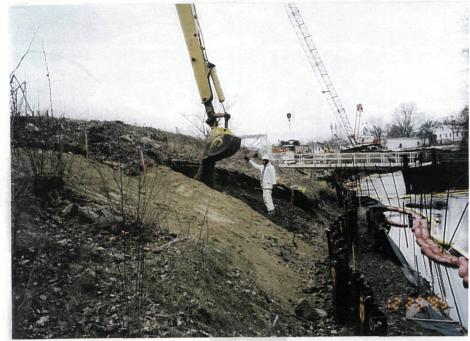
Looking east along north bank (upstream)

**PHOTO DESCRIPTION:** Back-filling the bank area adjacent to cell D, behind the source control (permanent) sheetpiling.

Work in cell E (bank area), which involved soil removal to a 1 foot depth and restoration activities were completed. Excavation of an additional bank area adjacent to cell D was also completed and the area was backfilled, except adjacent to the permanent source control sheetpiling. Backfill and restoration of this area will be completed after the sheetpile wall is grouted.

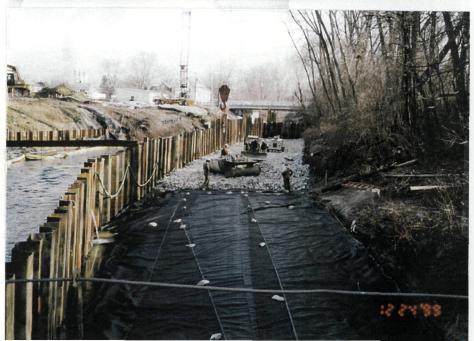
PHOTO NUMBER: 3

Looking east (upstream) at cell B.

**PHOTO DESCRIPTION:** Cell B Restoration activities, stone placement

on top of filter fabric and geogrid

In cell B the first habitat restoration structure was completed and accepted by the EOEA representative (on behalf of the Trustees). One single wing triangular deflector was constructed with a combination of larger 24" stones along the perimeter and 12" size rip-rap in the core of this structure. The final elevation was at the normal water surface elevation of the river, which is approximately 972 feet above mean sea level.
