**Re: Upper 1/2-Mile Reach of Housatonic River Removal Action  
Monthly Report - January 2000**

**6.0 Photo documentation of activities performed:** See attached Figure 1

**½ MILE RIVER REMOVAL ACTION  
MONTHLY PROGRESS REPORT  
JANUARY, 2000  
FIGURE 1 PHOTO DOCUMENTATION**

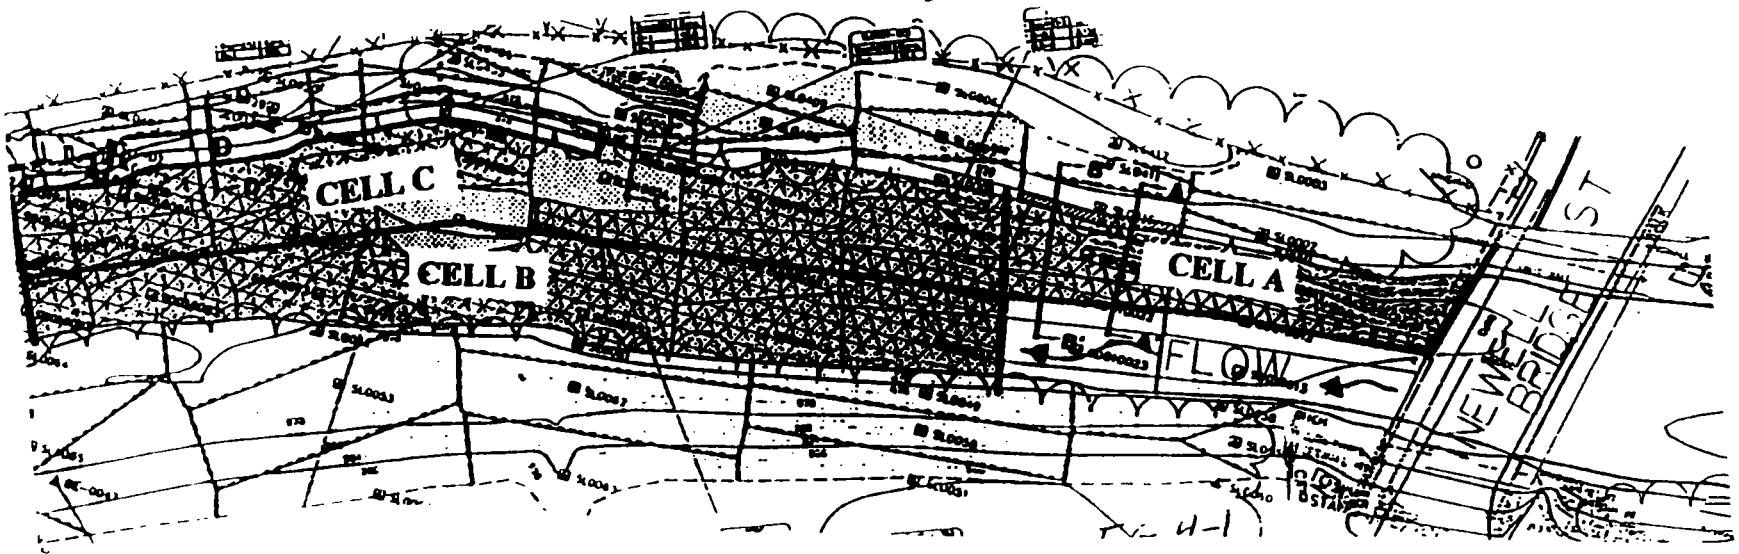
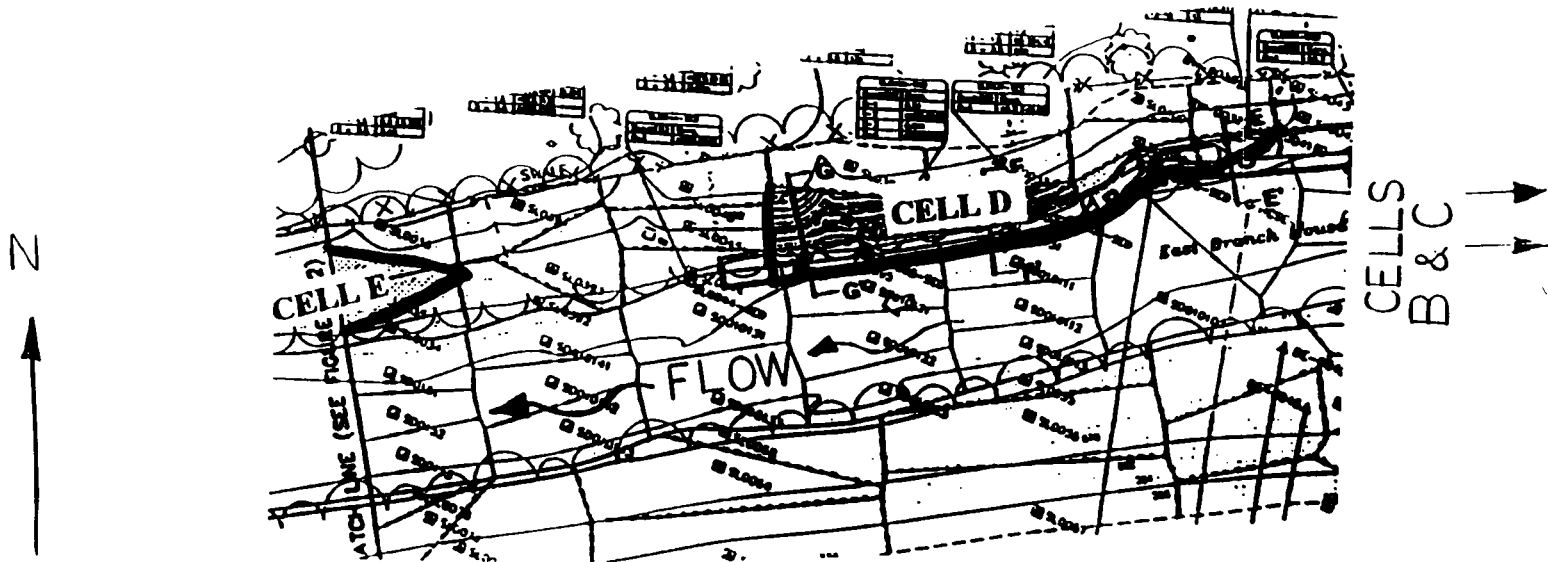
EXHIBIT A  
UPPER 1/2 MILE REACH REMOVAL ACTION  
LOCATION OF CELLS A, B, C, D and E FOR THE UPSTREAM SECTION

A diagram labeled as Exhibit A shows the location of the Cells (A, B, C, D and E) and is attached to this report for reference. Additionally, Exhibit B shows the area where the DNAPL was observed and the location of containment barriers/berms that were constructed.

Refer to the diagram (Exhibit A) referenced in Section 4.0 and attached to this report for an orientation of the sheetpile cells and their respective locations. In the month of January, GE's Bldg. 33X was approved by EPA to be used as a temporary storage facility for TSCA and non-TSCA material (in addition to Bldg. 65).

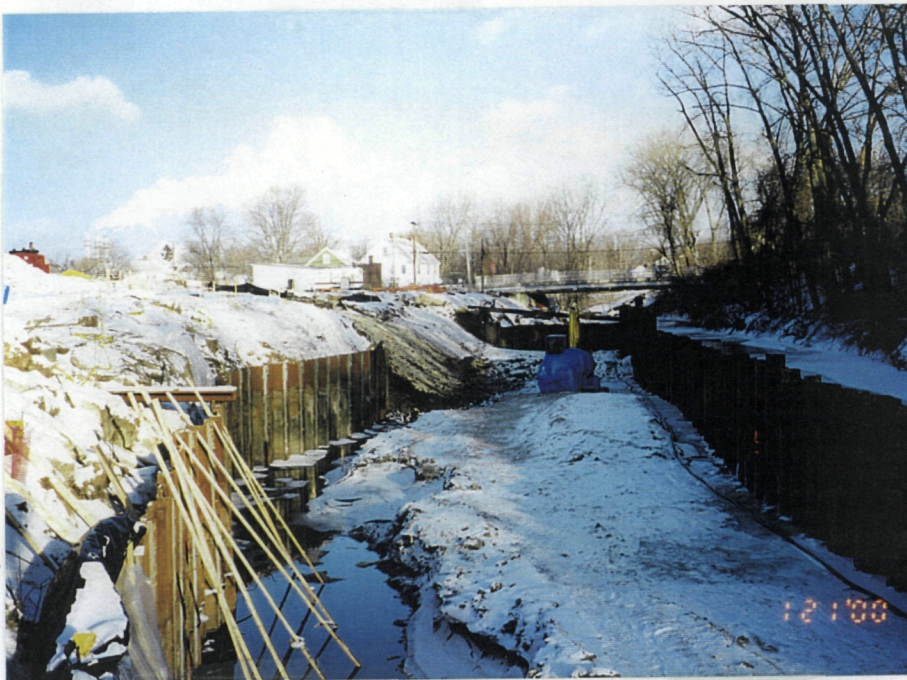
**PHOTO NUMBER: 1**

**PHOTO LOCATION:** Cell C  
Looking east towards Newell Street Bridge.

**PHOTO DESCRIPTION:**  
Excavation in cell C. Bank removal at the east end.  
Additional excavation completed along the source  
control sheetpile.

In Cell C, adjacent to the source control sheetpiling, an estimated additional 150 cubic yards (cy) of river sediment was removed at GE's discretion due to the appearance of the material at the removal depth specified in the Work Plan. In a 200 foot by 10 foot area, approximately 2 feet of sediment was removed (as discussed on site with EPA). In the upstream part of the same cell, saturated fine sands and silts were visibly "boiling" from the bottom of the excavation and laterally out of the sloughing north bank in this area, thereby creating an unsafe, "quick" condition. An evaluation of this area determined that over-excavation of the sediments and decreasing the slope of the adjacent north bank would likely correct the unstable condition. This approach was attempted and was successful. This resulted in an additional 300 cy of sediment and bank soil material being removed in order to control water in the unstable excavation.

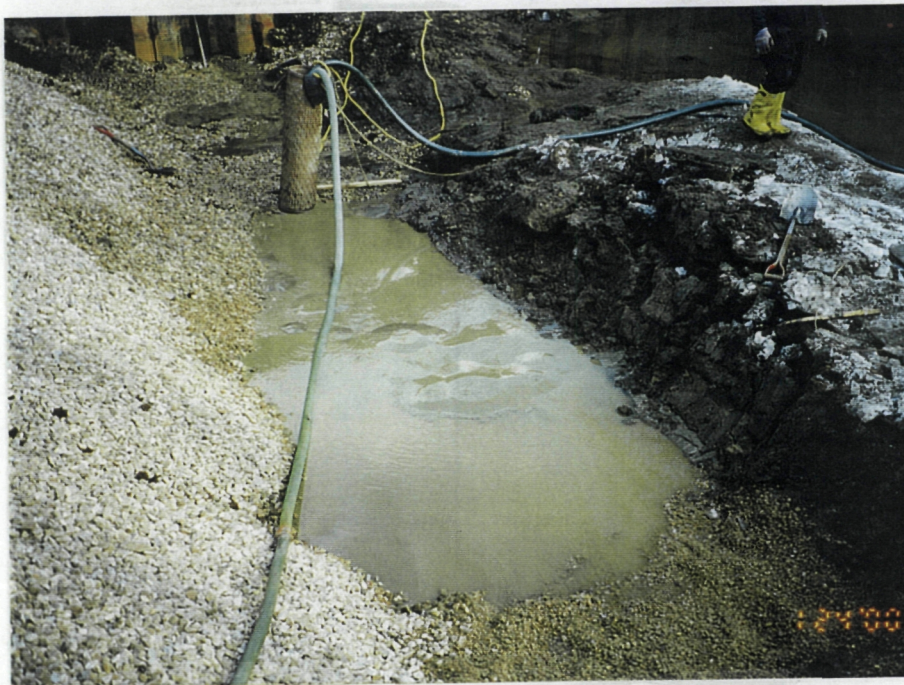
**PHOTO NUMBER: 2**

**PHOTO LOCATION:**  
Looking at the north bank, upstream end of cell C

**PHOTO DESCRIPTION:** Unstable conditions  
where saturated fine sand, silt, and ground water  
are "boiling" up from the sediment excavation

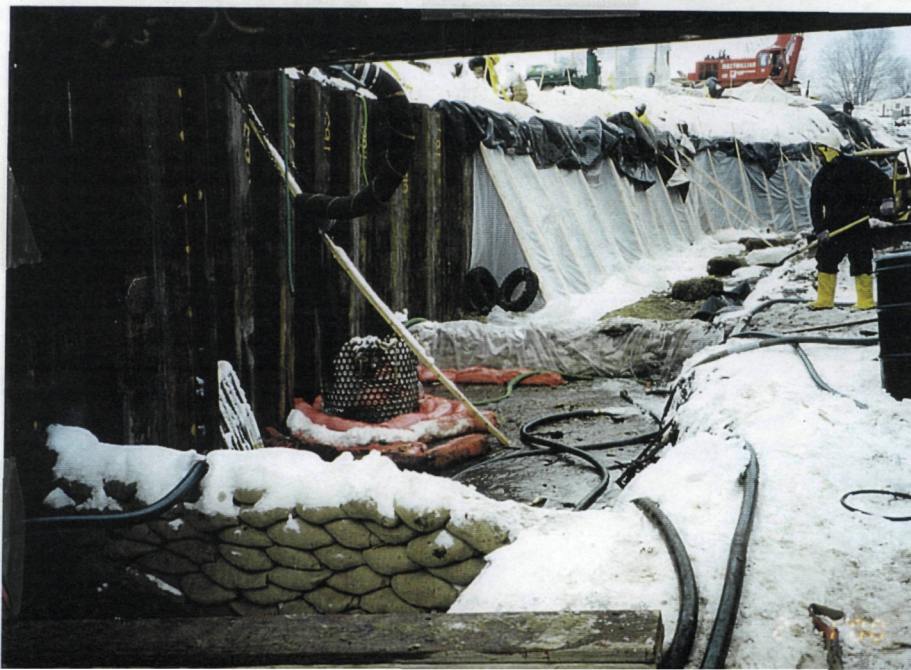
**PHOTO NUMBER: 3**

**PHOTO LOCATION:**  
Looking east (upstream) along the  
source control sheetpiles in cell C

**PHOTO DESCRIPTION:** Sandbag barriers/  
berms isolating the DNAPL area from others  
areas in cell C.

On January 24, 2000 when DNAPL was observed in the downstream (west) end of Cell C, a second notification was made to MDEP, EPA, EPA Region 1 Spill Response, and the NRC. A release tracking number (517665) was issued from the NRC. MDEP did not issue a new release notification number. GE immediately deployed a number of oil absorbent booms/pads and began constructing sandbag berms/barriers to isolate and contain the DNAPL from other areas of the excavation to the extent practicable.

As previously discussed, DNAPL was observed on January 24, 2000 in a small area of the downstream (west) end of Cell C. The area is within the sheetpile cell and isolated from the river. After the Agency notification process was complete and the area was contained and isolated to the extent practicable from the ongoing restoration activities, the oil was sampled. Analytical testing indicated that it is made up of coal tar constituents. No PCBs were detected. The test results are attached to this report. Manual DNAPL recovery has been conducted on a daily basis and as of January 31, 2000 approximately 66 gallons of oil had been recovered (note as of February 7, 2000 approximately 210 gallons of oil had been recovered).
