The World Trade Center Bombing: Report and Analysis

New York City, New York

USFA-TR-076/February 1993

U.S. Fire Administration Fire Investigations Program

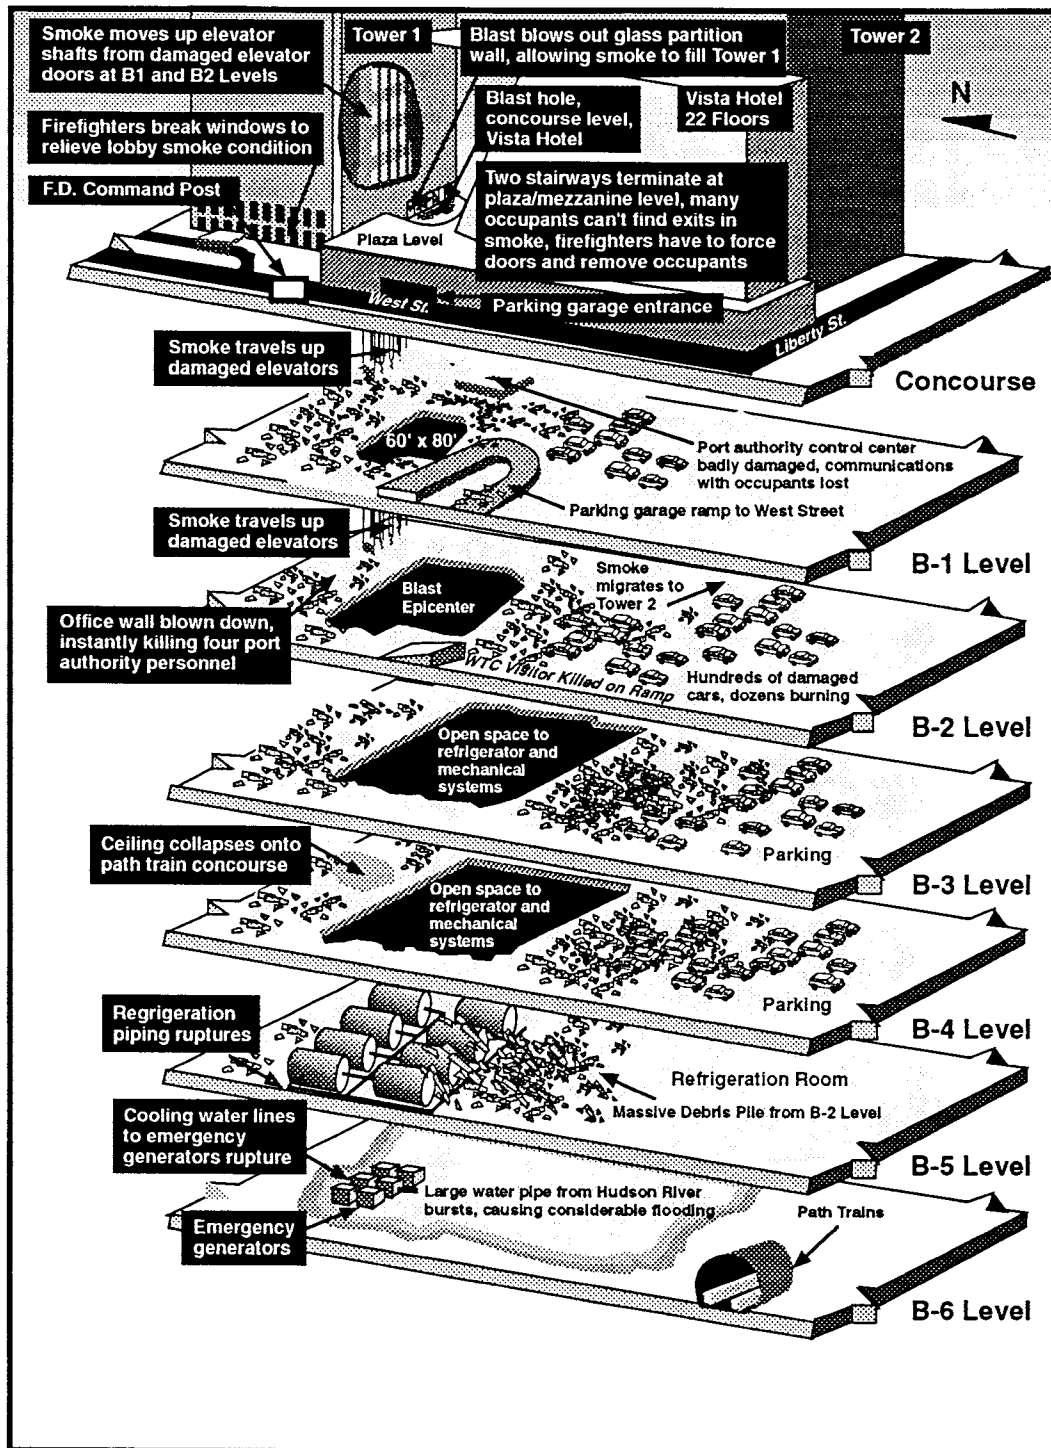
772-2-28-94-7

Blast Damage

- A 5,000-square-foot hole was opened on the ramp leading to the parking garage below.
- The Port Authority command/communications center was heavily damaged and rendered inoperable.
- Walls and ceilings were heavily damaged.
- Elevators were damaged.
- Seven steel columns were damaged and left without lateral support.

- An L-shaped crater, approximately 130 by 150 feet at its maximum points, was opened, collapsing reinforced concrete and debris onto levels below.
- At least nine steel columns were heavily damaged and left without lateral support.
- Many walls collapsed, including a concrete block wall adjacent to the blast area that collapsed onto and killed five WTC personnel.
- Doors/enclosure walls of Tower 1 elevator shafts were heavily damaged.

- Some 200 vehicles were fully or partially destroyed, and many were on fire.
- Primary electrical power feeder lines were damaged.
- Stairway doors and shaft walls were heavily damaged.
- Some standpipes were damaged.
- The sprinkler system in the immediate blast area was destroyed.

- Debris from the blast traveled through a three-level architectural opening (spanning B 3 through B 5) and crashed down on refrigeration equipment on B 5.
- A ceiling of the PATH train station on the B-5 level collapsed.
- A 24-inch-diameter water supply pipe from the Hudson River to the air-conditioning chillers, as well as other smaller refrigeration/air-conditioning and domestic water pipes, were ruptured.
- Domestic water lines to the emergency generators were damaged on the B-6 level.

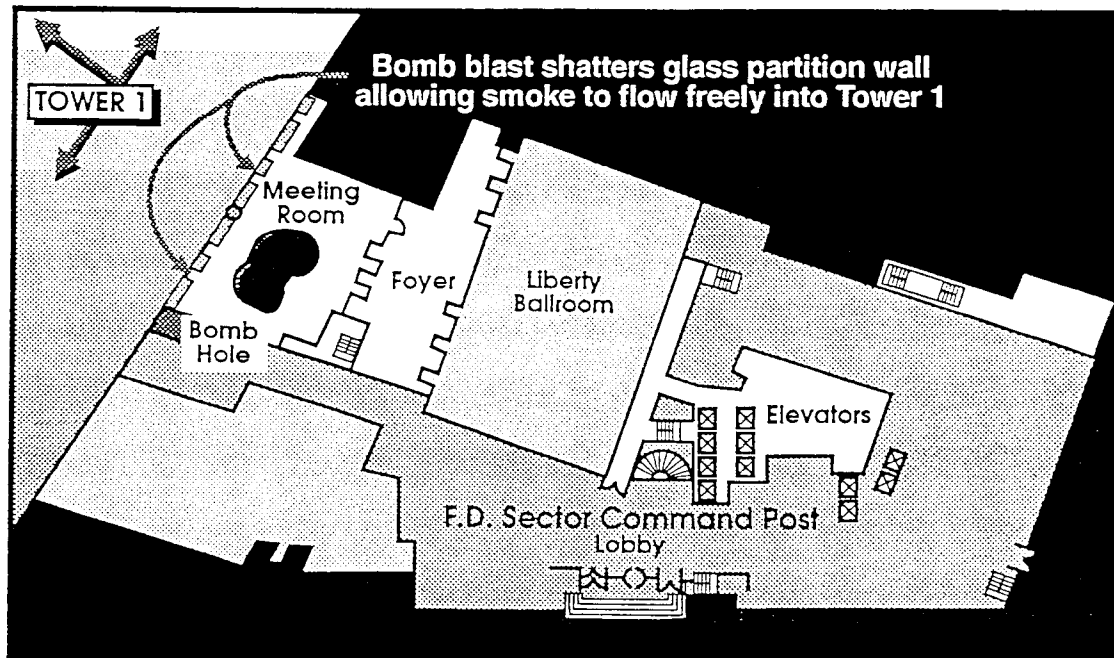
772-2-28-94-4

Vista Hotel — Lobby/Concourse

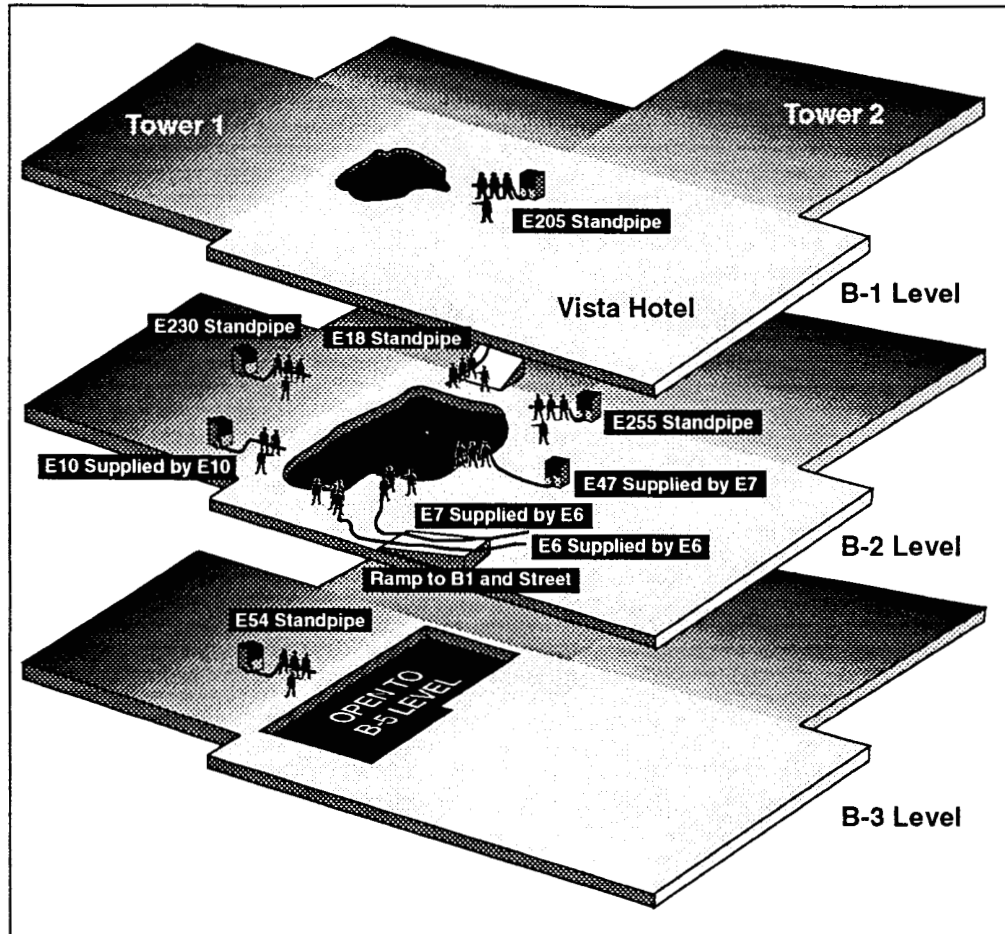
772-2-28-94-6

Handlines Deployed in Fire Extinguishment

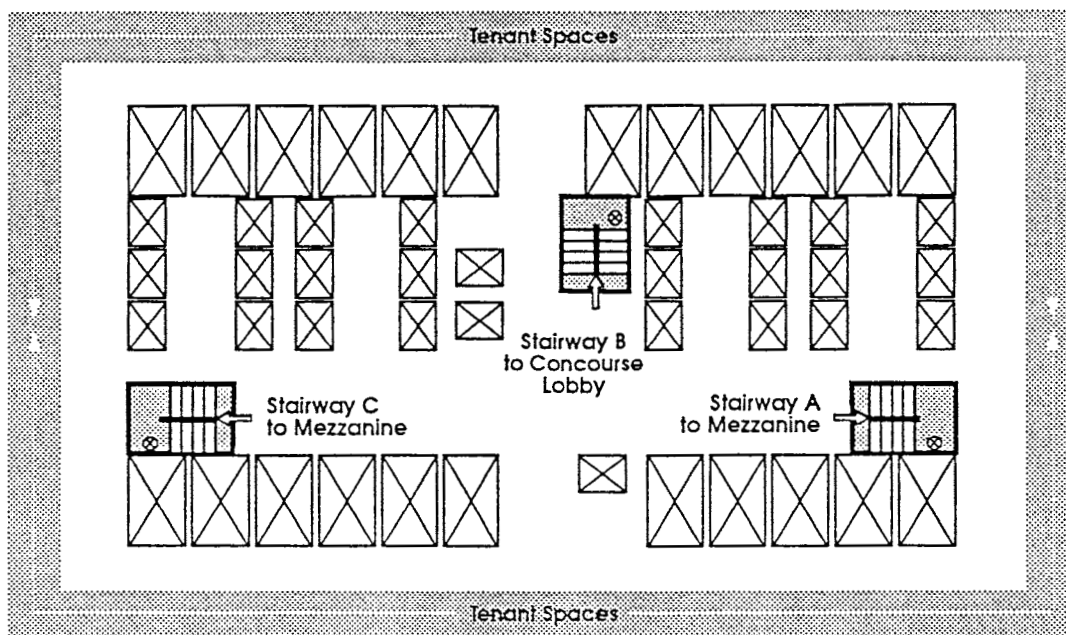
772-2-28-94-1

Elevator and Stairway Configuration, Towers

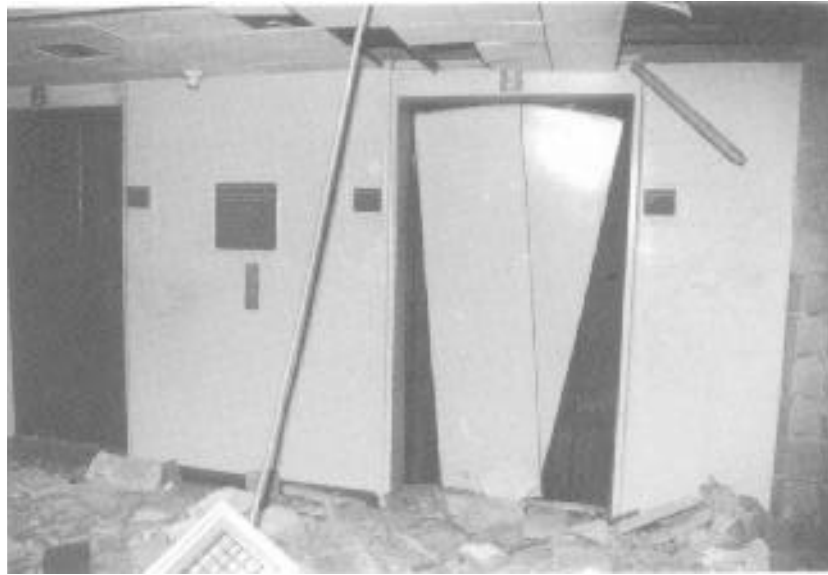
Damaged elevator doors and enclosures on the B-2 level presented a vertical channel for smoke spread into Tower 1.

Above grade. The large quantities of smoke that had been generated prior to the fire's knockdown became a major operational factor. Due to the destroyed elevator shaft doors at the B-2 level, the hole in the Vista Hotel meeting room with the blown-out glass partition wall between the Vista Hotel and Tower 1, and doors being opened on all floors by people evacuating — and with the stack effect working — most floors and all stairways of Tower 1 and the Vista Hotel became charged with smoke. Tower 2 had a smoke condition but to a lesser degree. The smoke condition in Tower 1 was the worst of the three buildings above grade.

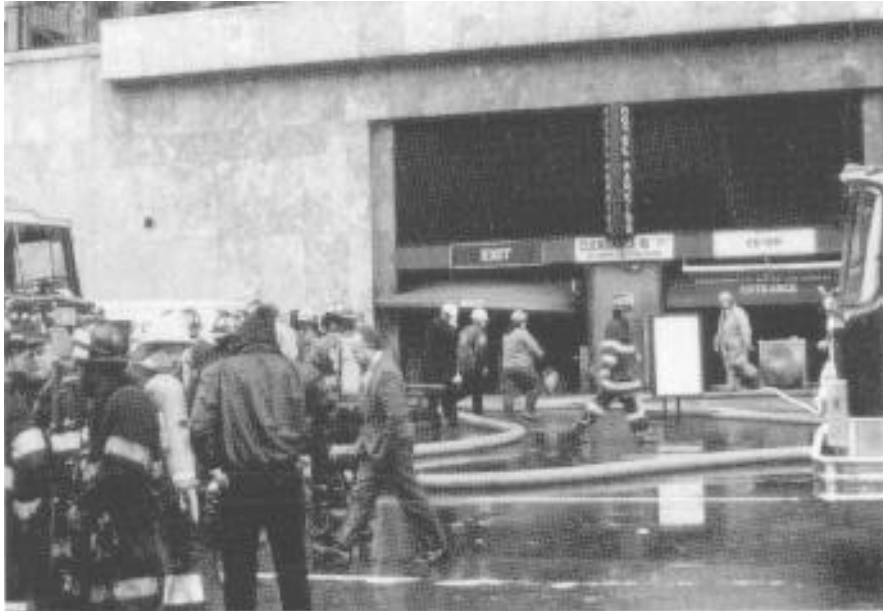
A view of the parking garage entrance on West Street, through which first fire companies launched the initial fire attack.

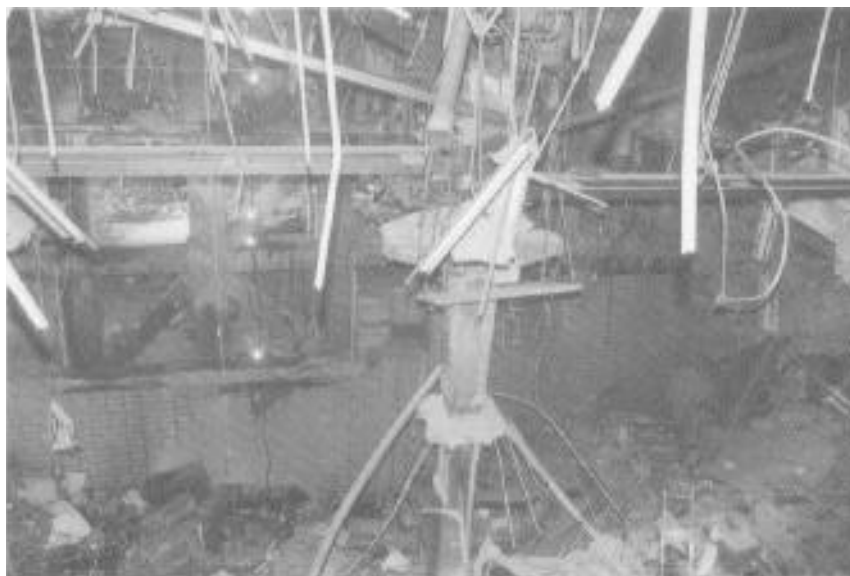
A view of the crater from the B-1 to B-5 levels. Note the steel column. Horizontal supports were destroyed in some cases, but the columns did not give.

Damage/hazard assessment. Lights were brought into the below-grade areas. Damage from the blast was extensive. The B-2 level surrounding ground zero was completely destroyed. Piping and conduit were snapped like twigs. Masonry walls and steel-reinforced concrete flooring were blown apart. Cars were strewn about like toys. Steel columns were shocked but held.

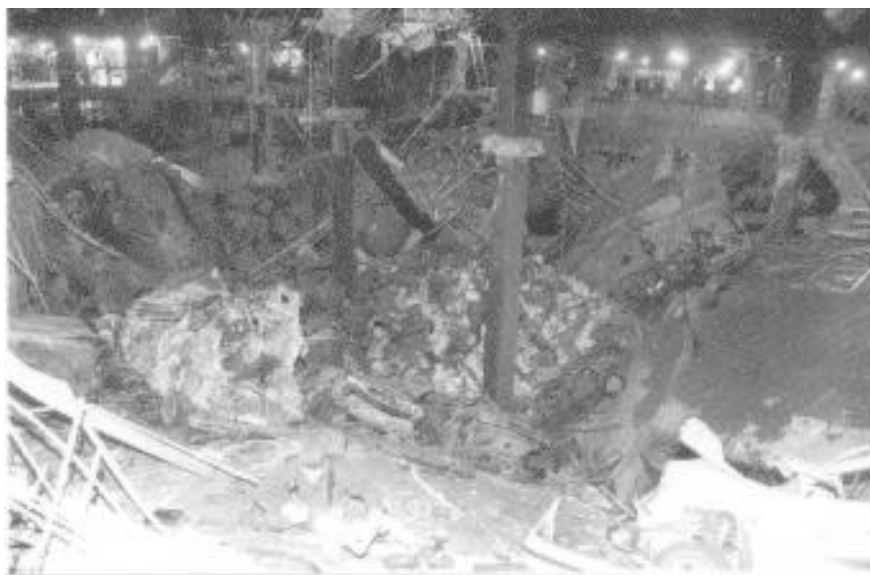
The crater, looking from the B-2 level down to B-5, taken during the investigation/restoration phase.

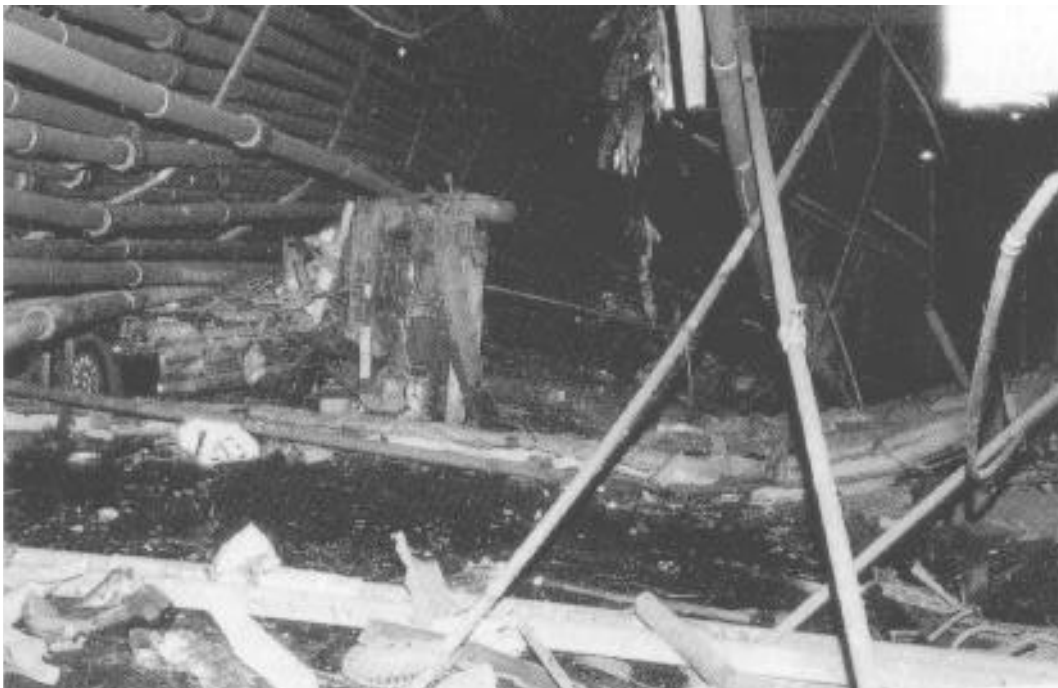
Building systems in the vicinity of the blast were destroyed. Here, twisted electrical conduit has landed on top of what was once a car.

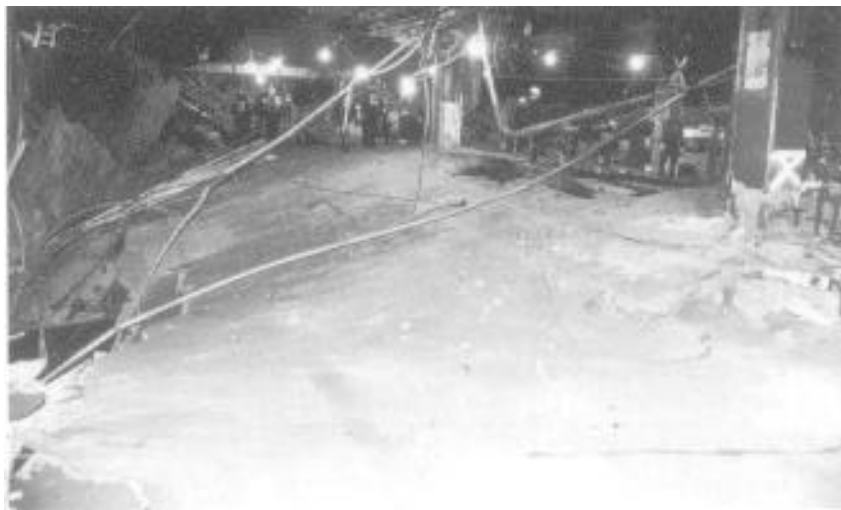
The sloping, hanging steel-reinforced concrete floor at the perimeter of the crater was a major hazard for units operating on the crater fire, particularly in the heavy smoke condition.

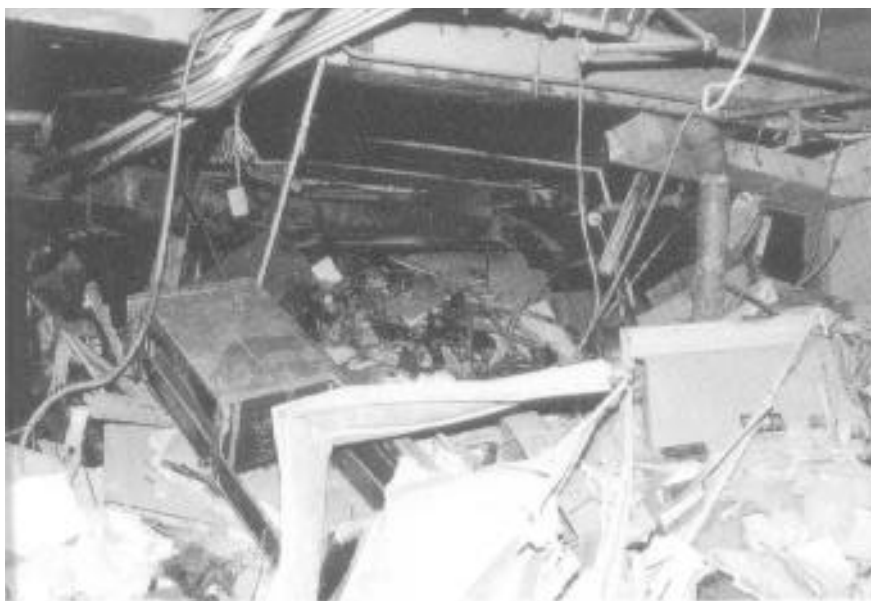
This destroyed office area on the B-2 level is typical of the debris piles faced by searching firefighters.

Port Authority personnel assisted by establishing a probable victim location in occupied work areas on the B-2 level under the Vista Hotel and Tower 1. The blast destroyed a dividing wall between the garage and this work area (demolished, it was later found, by a steel support beam hurled through it with the unimaginable force created by the blast). A search first was concentrated in this area, and four fatalities were located and removed by FDNY to a temporary morgue established in the Vista Hotel. Five of the six fatalities in this incident were removed within the first two hours. (One victim was found by FDNY on a driveway ramp early in the incident.) The sixth victim was located in rubble by police personnel during their investigation 17 days later.

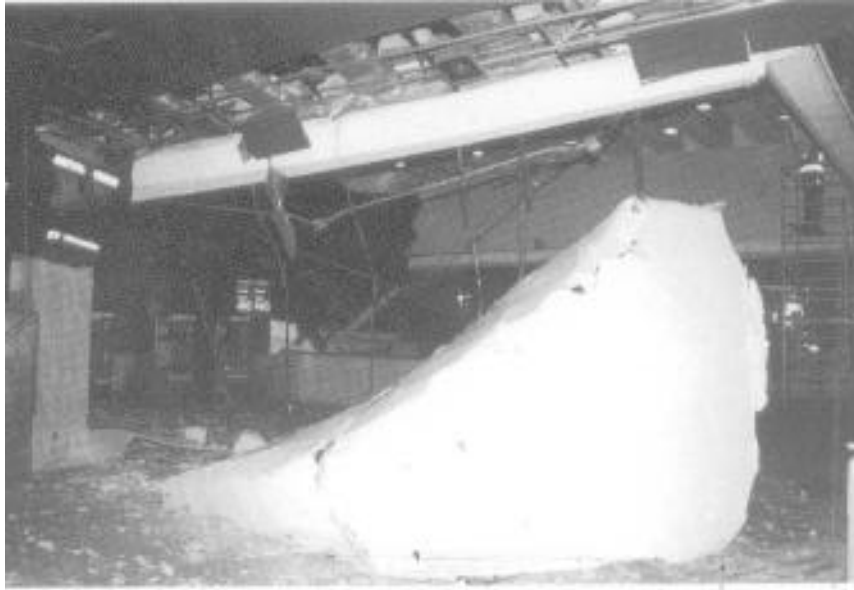
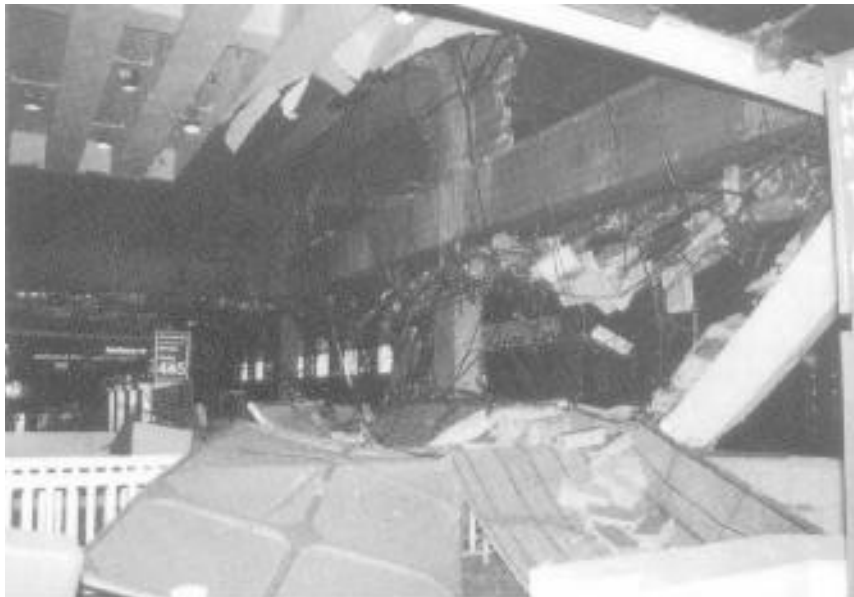
The explosion collapsed a portion of ceiling on the B-5 level onto a PATH train concourse.

- a plaster ceiling of the PATH train station on the B-5 level had collapsed due to the explosion;
- smoke was moving into many areas of the Vista Hotel, Tower 1, and Tower 2;
- rescuers were removing numerous injured from both above and below in the complex;
- a major evacuation had to be accomplished — once 50,000 people decided to self-evacuate, there was no turning back, not without a working communication system; and
- the potential number of people trapped in elevators was great, and my suspicion was substantiated by the number of elevator rescues that already had been achieved.

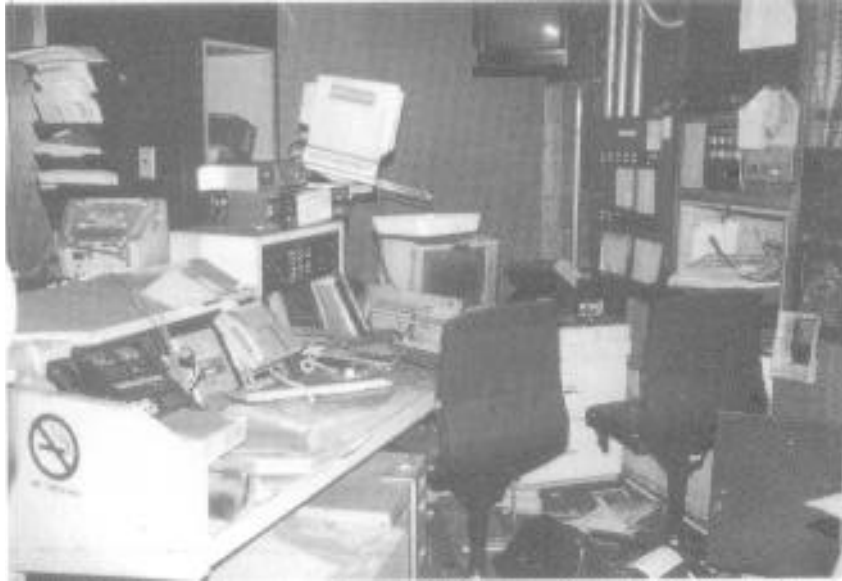
The Port Authority Command/Communications Center on the B-1 level, approximately 50 feet from the blast hole on that level, was damaged and communication with occupants in the towers was lost.

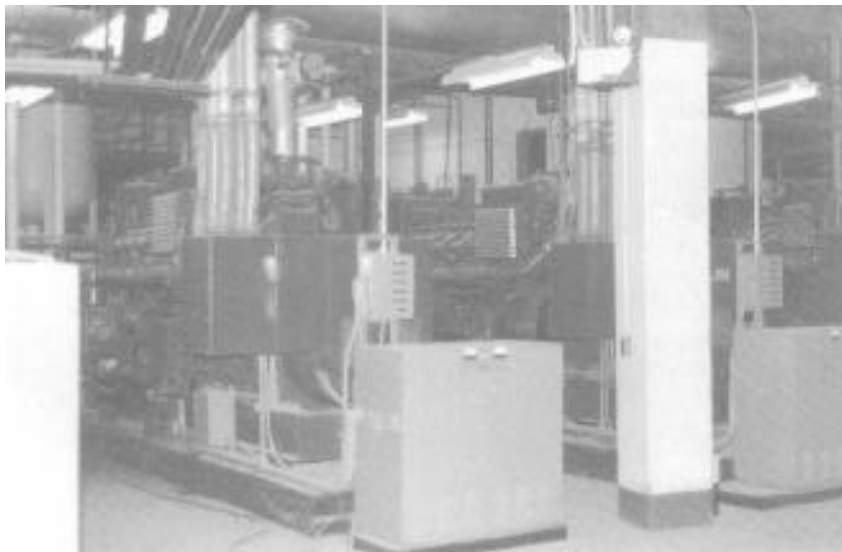
Emergency generators on the B-6 level. Cooling water lines for these unit were ruptured by the blast, shutting down all emergency power.

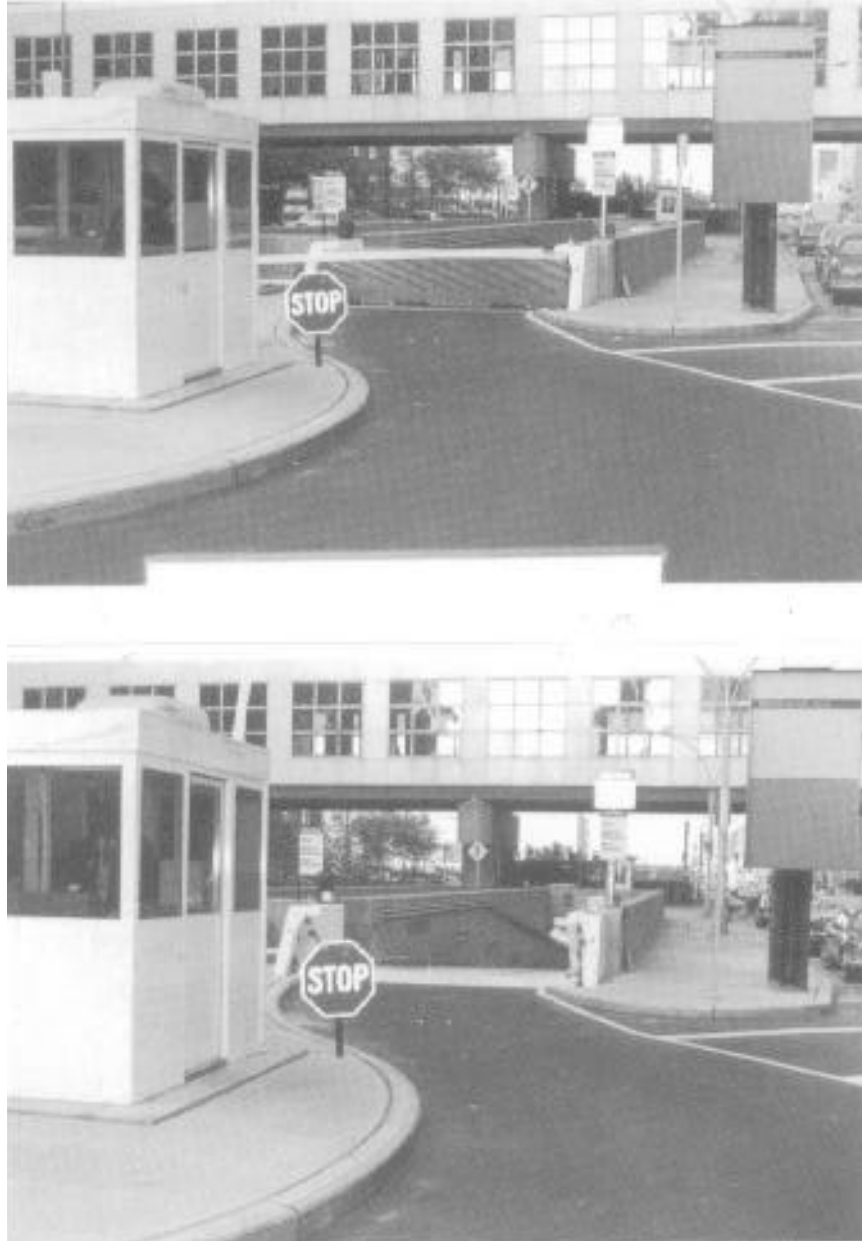
Controlling access to public buildings is a major concern for building management. After the incident, Port Authority, in addition to many security changes, installed substantial barriers to unauthorized vehicle access. The barrier, controlled by security personnel in the booth, folds down when the driver has been cleared to enter.
