Surface-Water Hydrology and Quality at the Pike Hill Superfund Site, Corinth, Vermont, October 2004 to December 2005

Scientific Investigations Report 2007–5003

By Richard G. Kiah, Jeffrey R. Deacon, Nadine M. Piatak, Robert R. Seal II,
James F. Coles, and Jane M. Hammarstrom

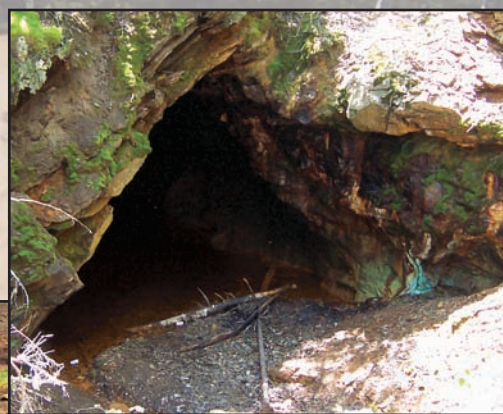
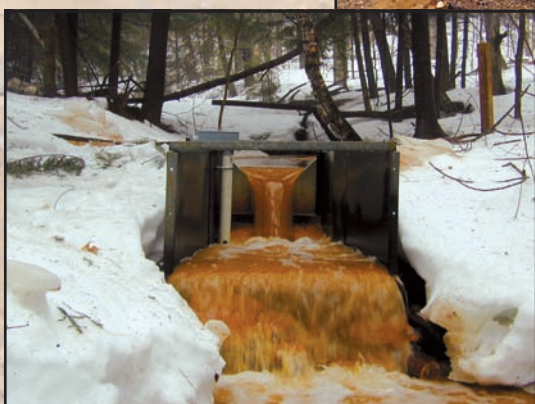
Cover. *Top right*, photograph of mine workings at the Pike Hill Superfund site, Corinth, Vermont. *Middle*, photograph of mine waste at the Pike Hill Superfund site, Corinth, Vermont. *Lower left*, photograph of Pike Hill Brook above Richardson Road near Corinth, Vermont.

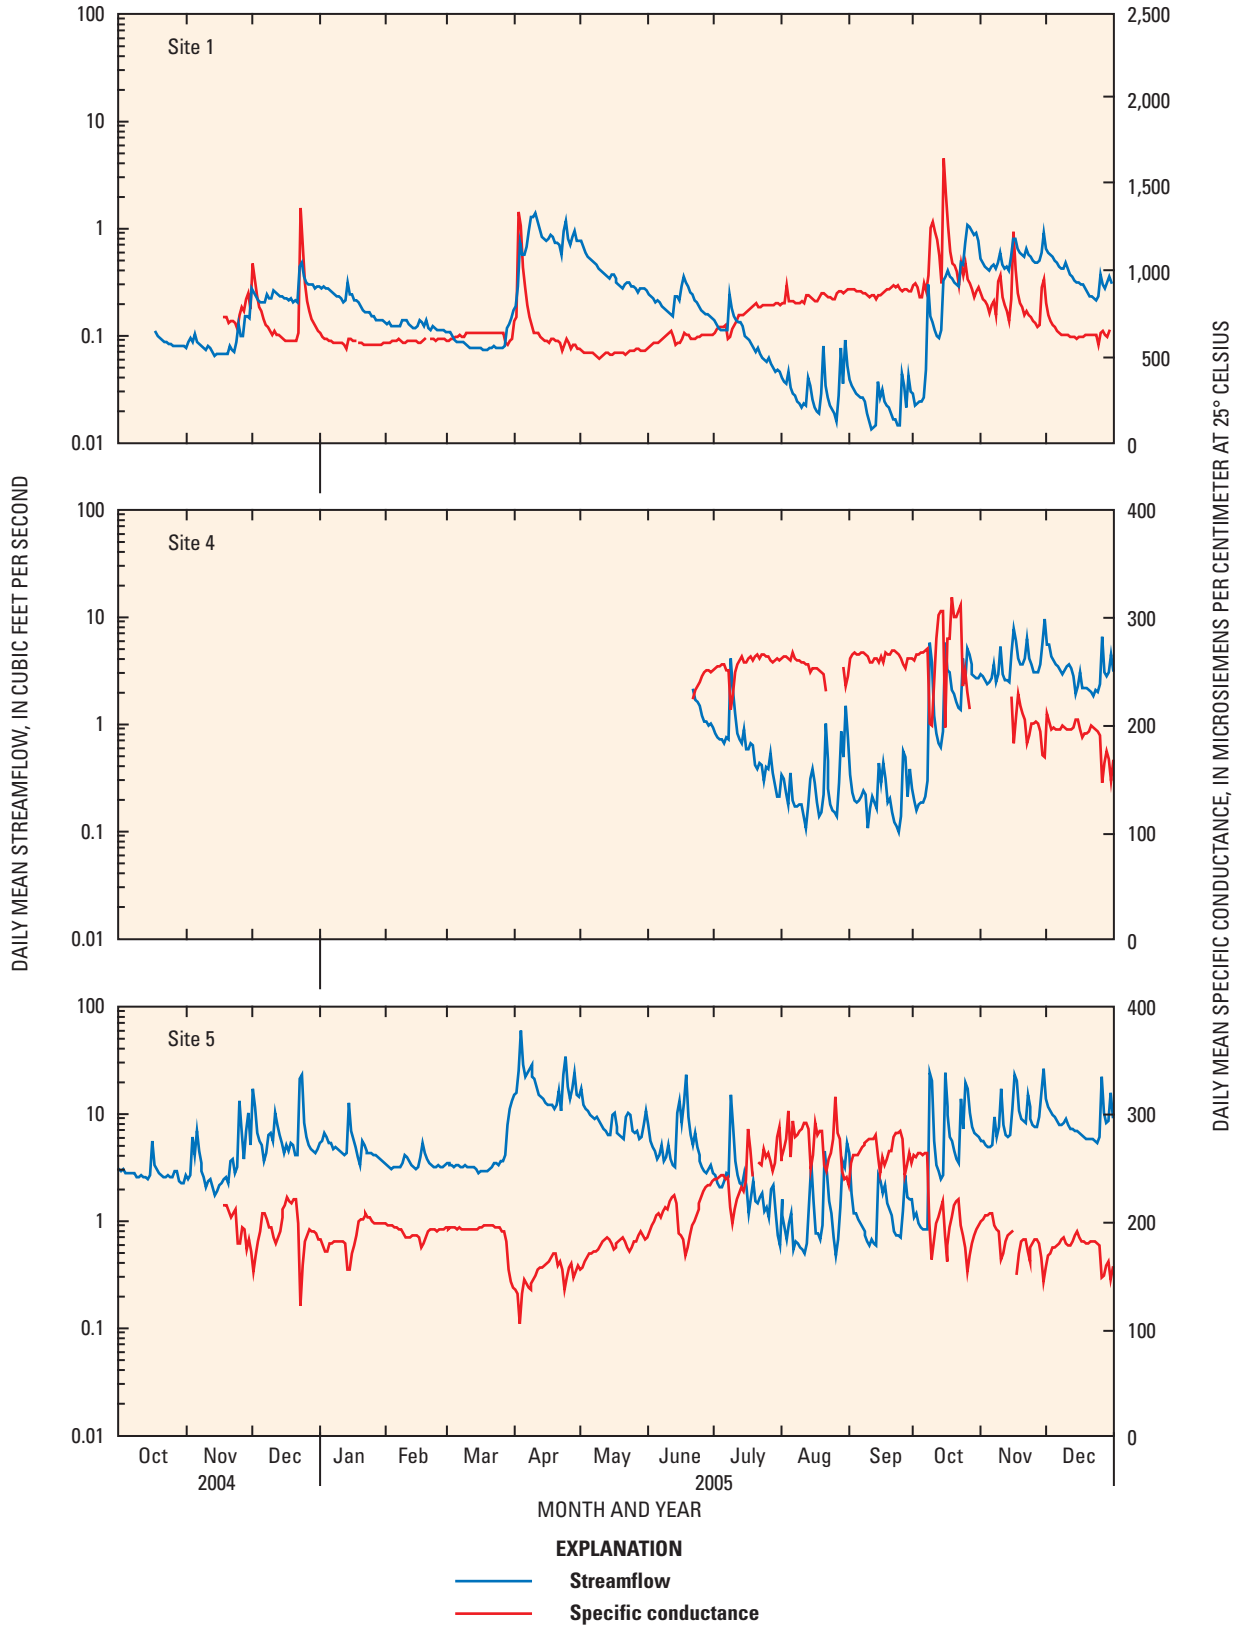
Figure 2. The relation of daily mean streamflow to daily mean specific conductance at the three continuously monitored sites in the Pike Hill, VT, study area.

Specific conductance and pH values among the three continuously monitored sites were tested to determine if there were statistically significant differences in the data. Specific conductance and pH values were significantly different among the three continuously monitored sites ($p < 0.05$) (fig. 5). Changes in specific conductance and pH values at sites 1, 4, and 5 are likely the result of rapid dilution from rain and inflows (ground- and surface water). Specific conductance and pH can be affected by a flushing of efflorescent sulfate salts, which form on waste sulfide materials (Alpers and others, 1992). Efflorescent sulfate salts were found during a geochemical characterization of the Pike Hill mine waste (Piatak and others, 2006a). During a typical rain event, there is an initial dilution of waters in Pike Hill

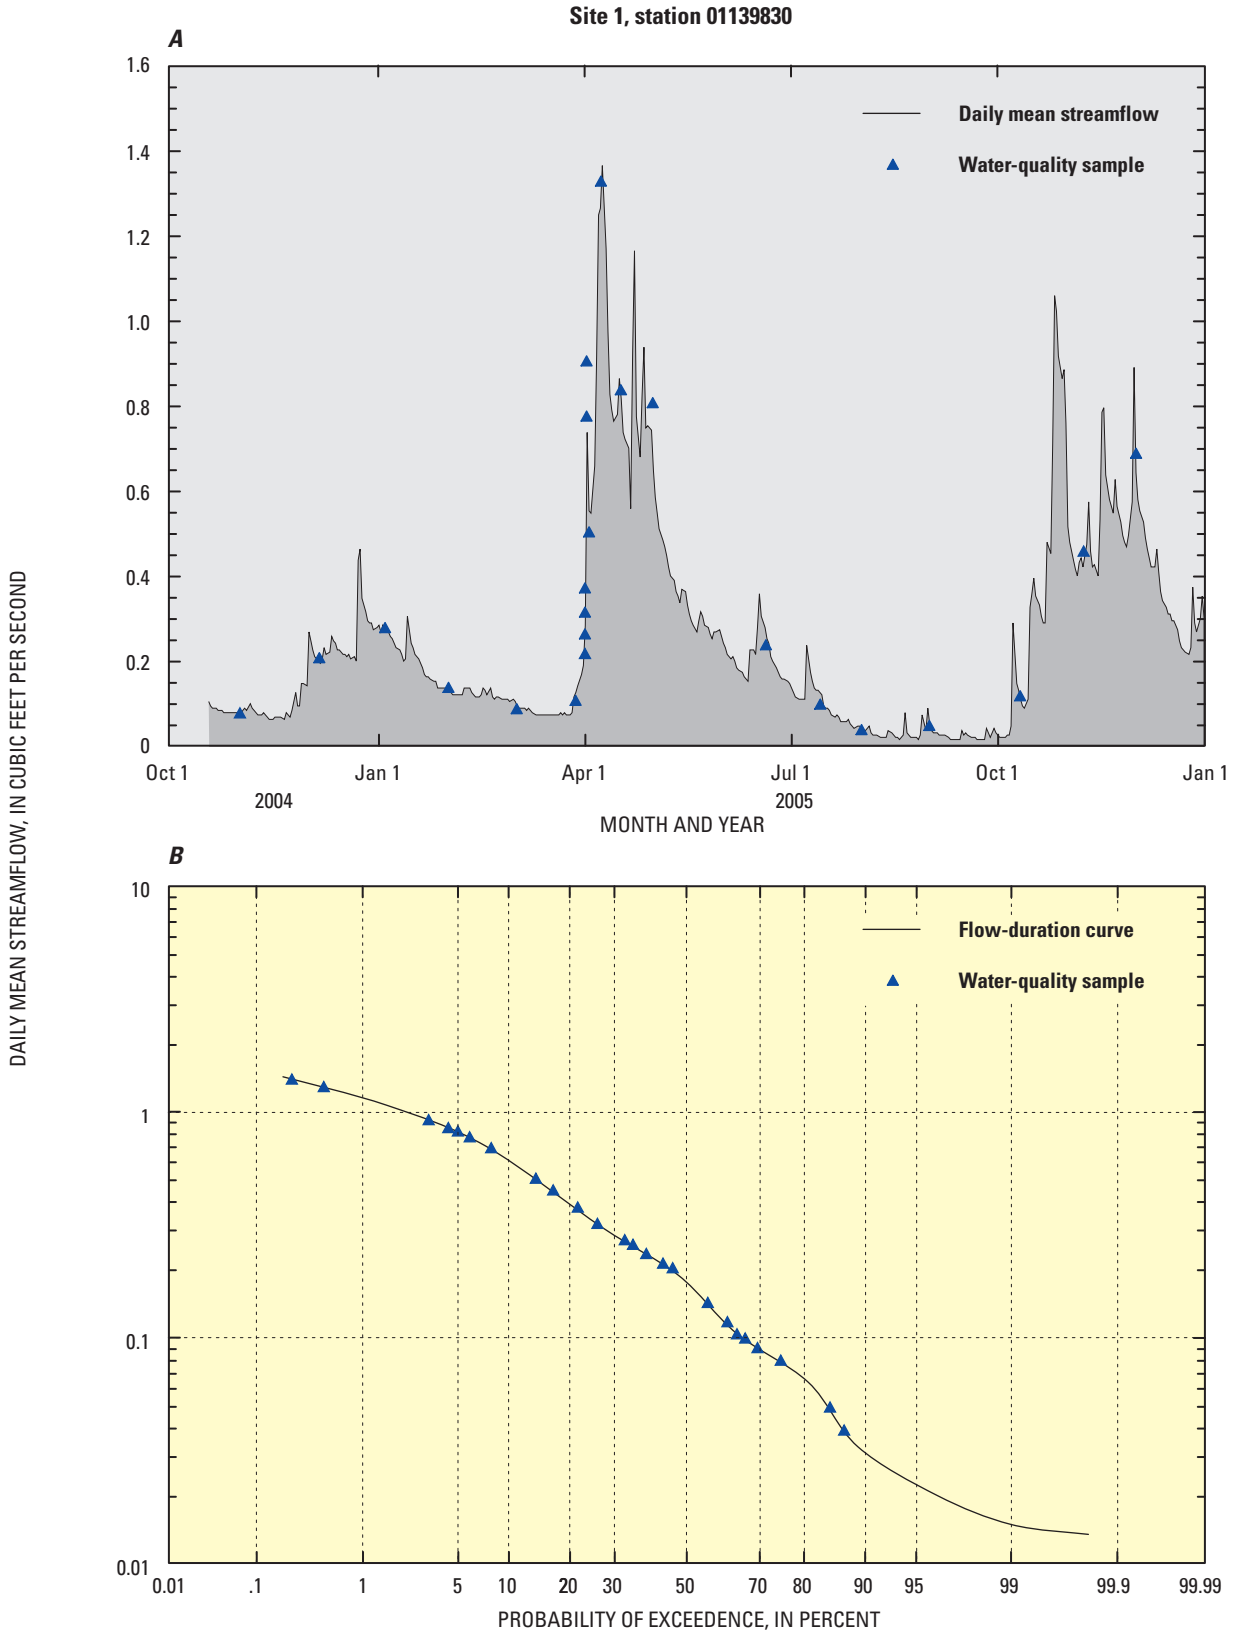
Figure 7. (A) Daily mean streamflow and time distribution of water-quality samples, and (B) flow-duration curve with streamflow distribution of water-quality samples for Pike Hill Brook above Richardson Road near Bradford, VT, station 01139830, site 1.

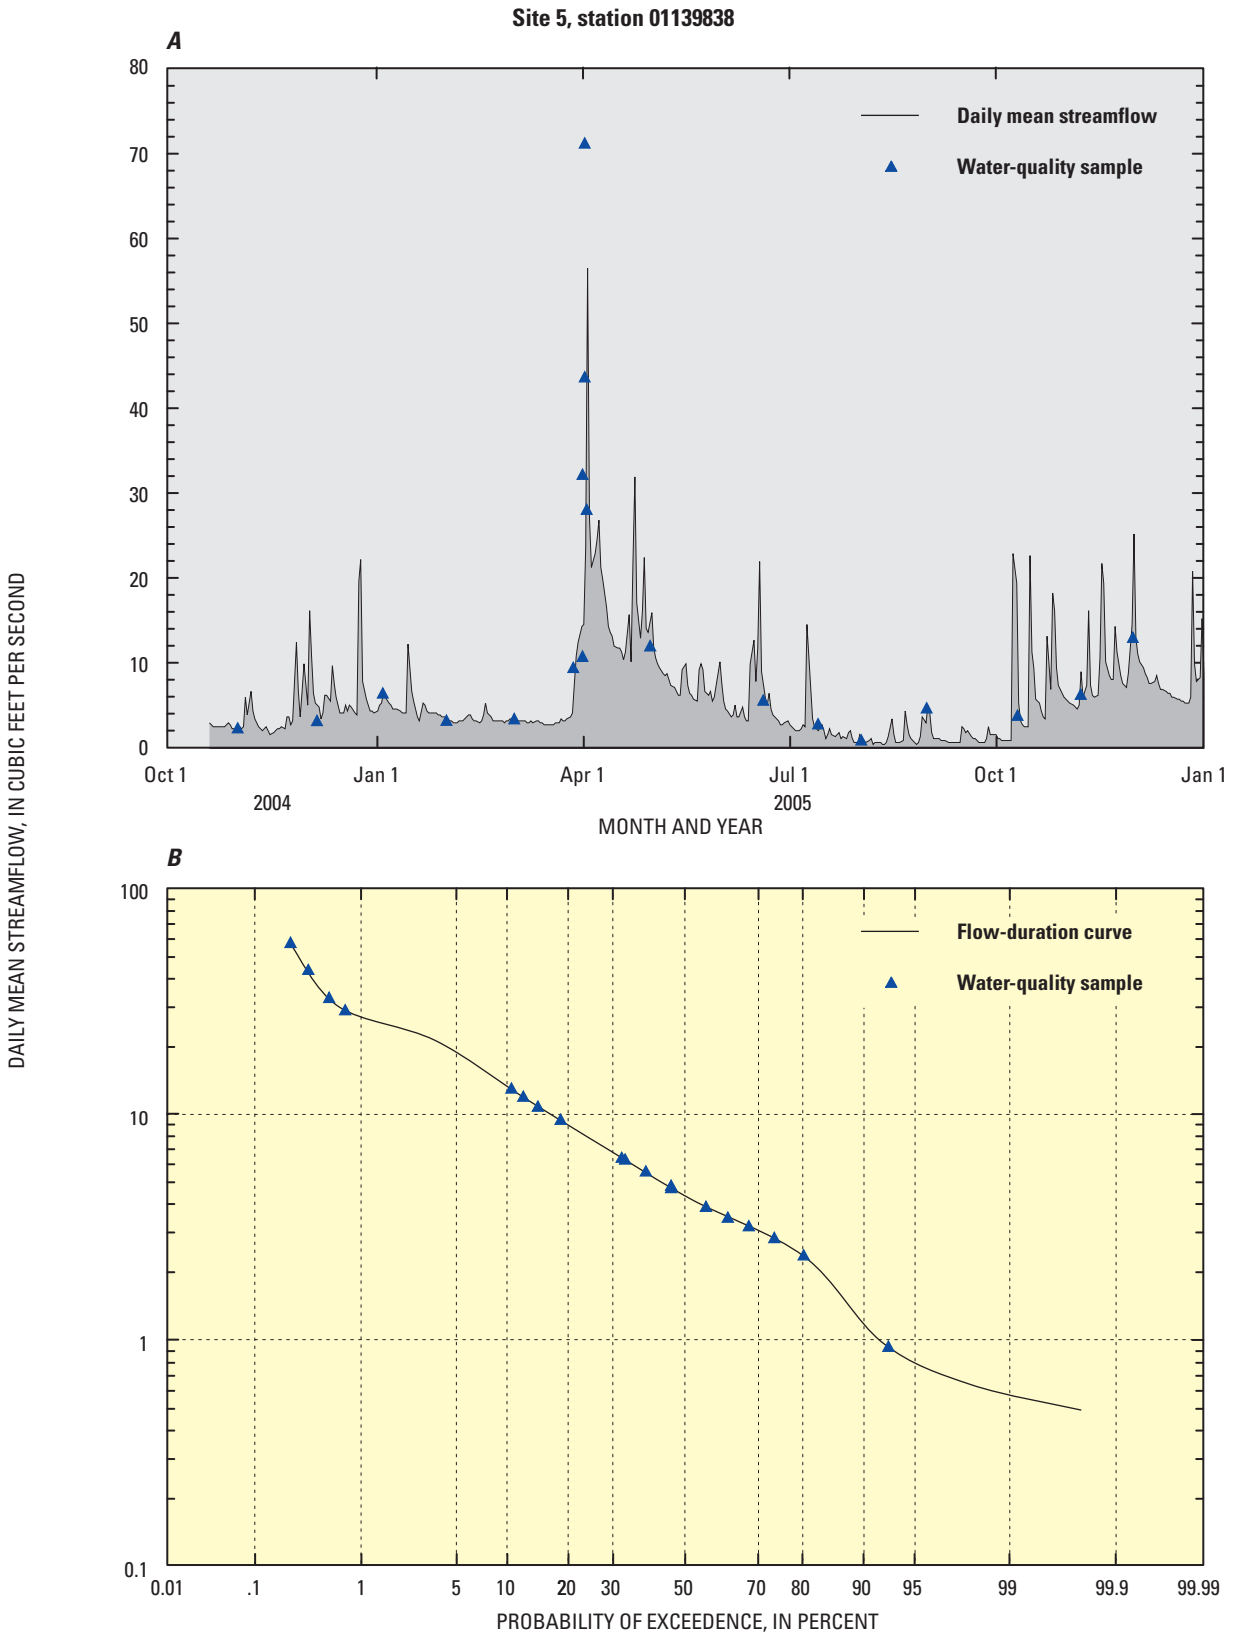
Figure 9. (A) Daily mean streamflow and time distribution of water-quality samples, and (B) flow-duration curve with streamflow distribution of water-quality samples for Pike Hill Brook at Pike Hill Road near Bradford, VT, station 01139838, site 5.

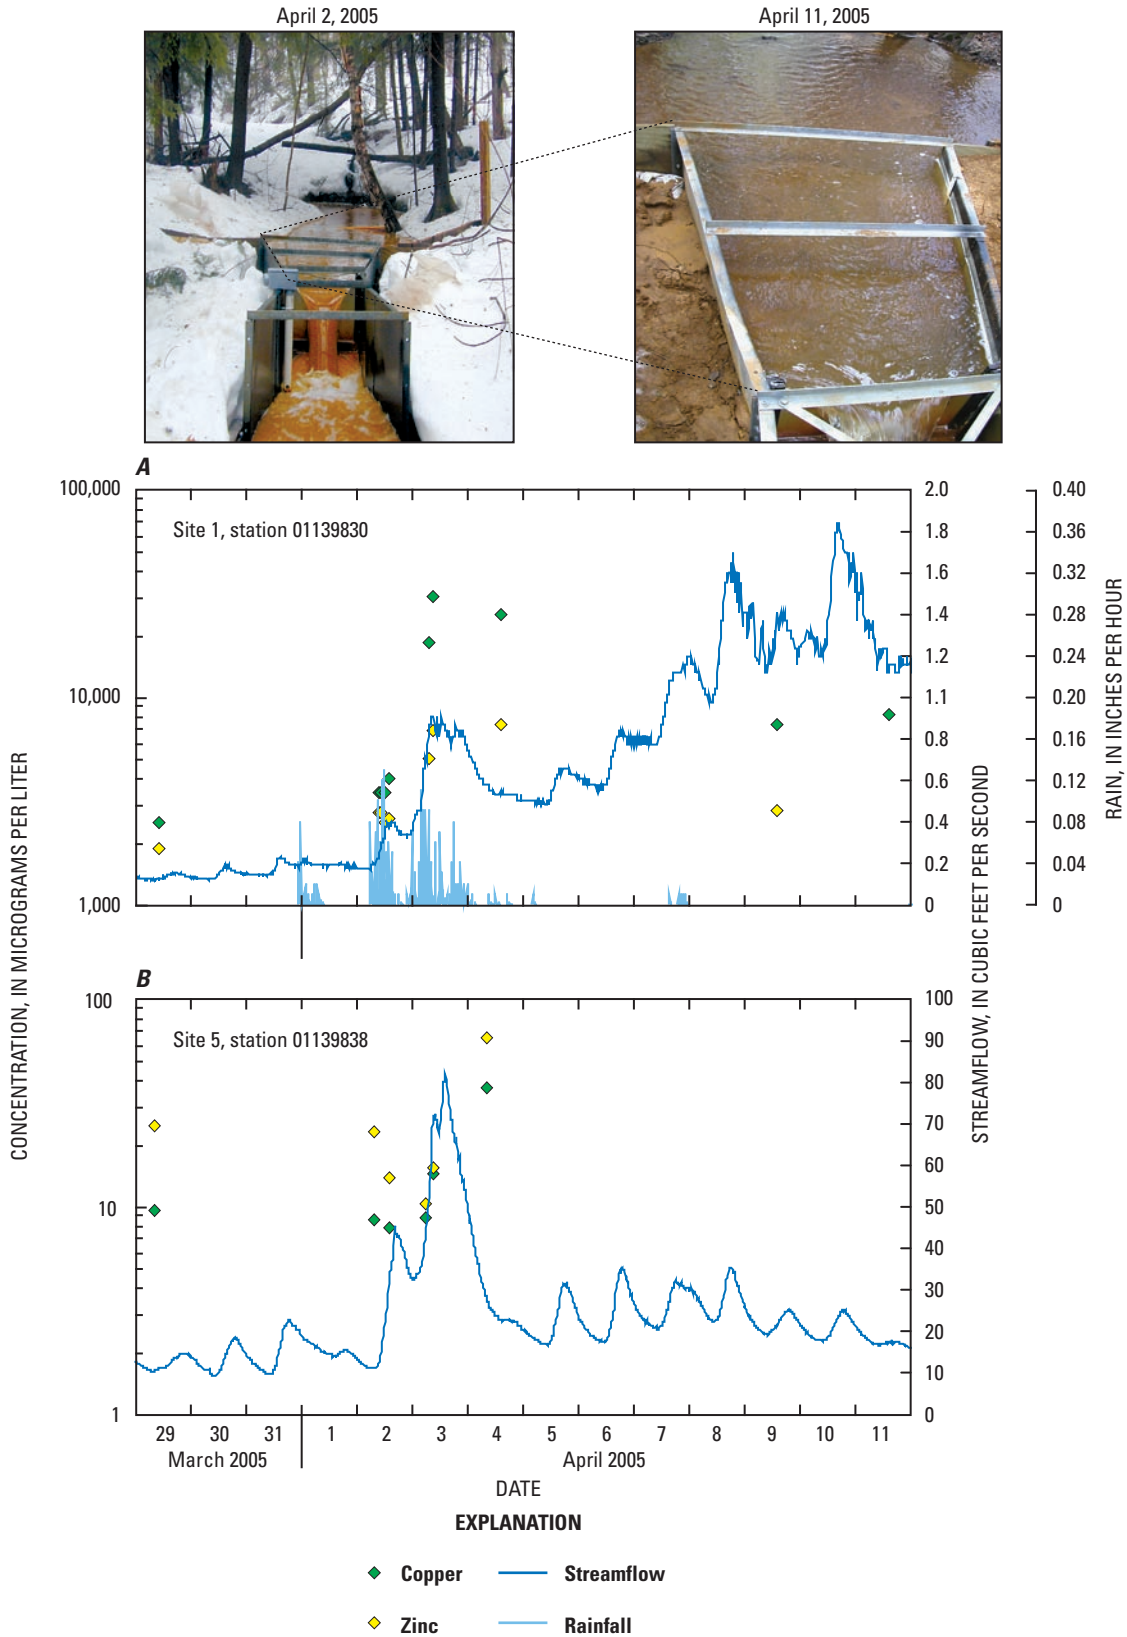
Figure 18. Streamflow conditions at site 1 during early snowmelt and rain (April 2, 2005) and snowmelt (April 11, 2005), and graphs showing the distribution of concentrations of copper and zinc in relation to maximum streamflows resulting from early snowmelt and rain (April 2 to 4, 2005), and from snowmelt (April 5 to 11, 2005) at (A) Pike Hill Brook above Richardson Road near Bradford, VT, station 01139830, site 1; and (B) Pike Hill Brook at Pike Hill Road near Bradford, VT, station 01139838, site 5.

Concentrations of Cu and Zn in relation to the instantaneous streamflow at site 1 from March 29, 2005 to April 11, 2005 are graphically shown in figure 18A. Hourly rain totals recorded at USGS streamflow-gaging station 01139800 East Orange Branch at East Orange, VT, are also shown in figure 18A. Concentrations of Cu and Zn in relation to the instantaneous streamflow at site 5 from March 29, 2005 to April 11, 2005 are graphically shown in figure 18B.

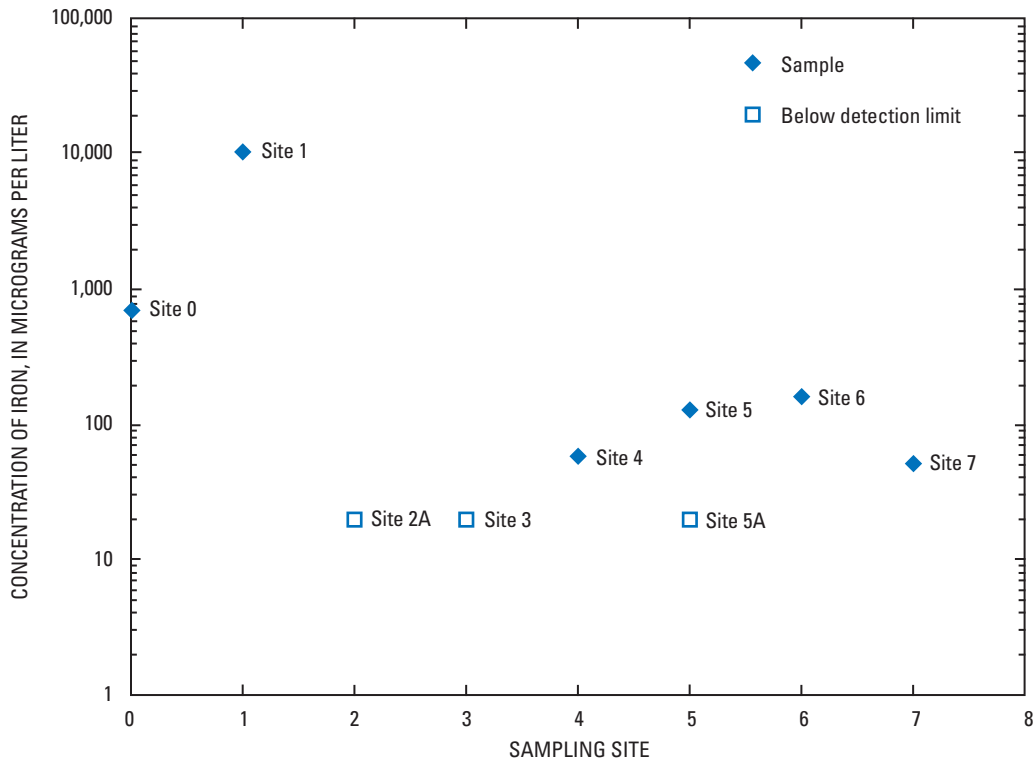
Figure 22. Concentrations of dissolved iron at synoptic sampling sites in the Pike Hill, VT, study area, August 3, 2005.

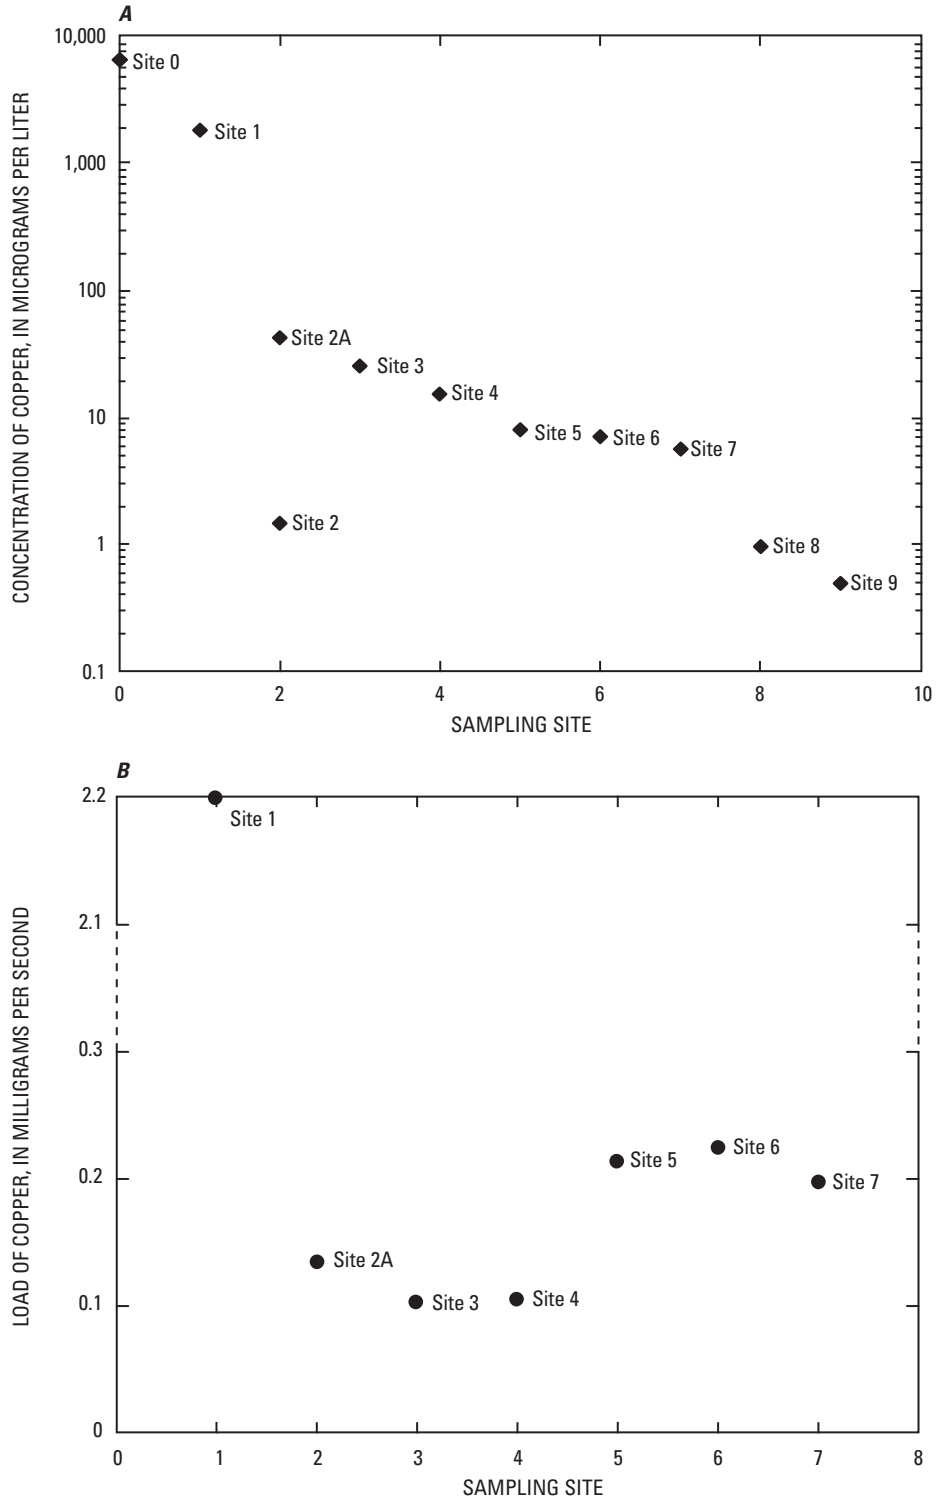
Figure 24. (A) Concentrations of dissolved copper, and (B) instantaneous loads of copper at sampling sites in the Pike Hill, VT, study area, August 3, 2005.

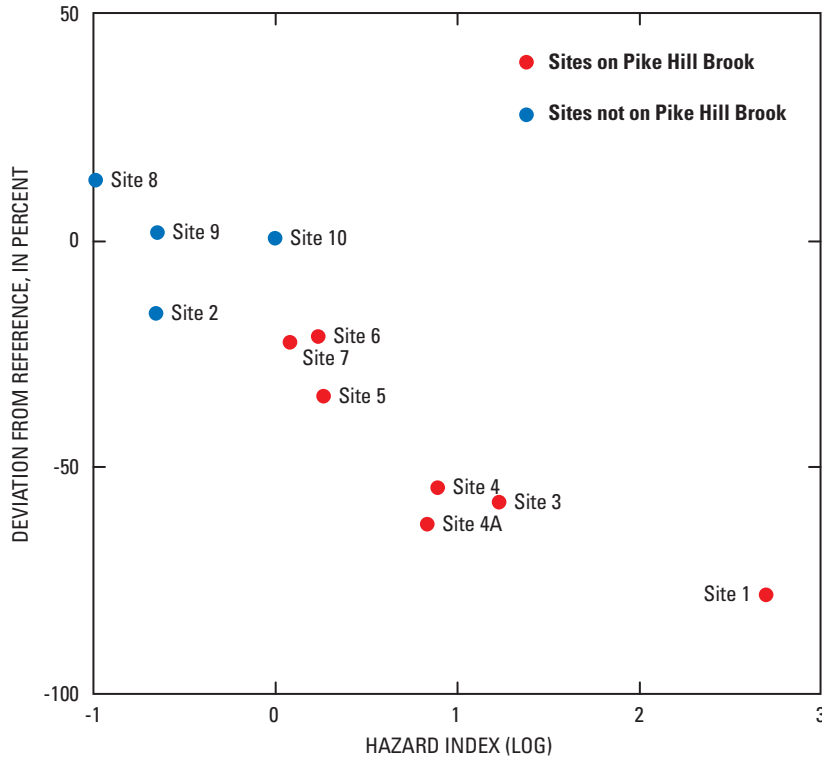
Figure 27. The relation between values of site deviation from reference and the Hazard Index values (log) at sampling sites in the Pike Hill, VT, study area.

The results of this analysis from the 11 sampling sites indicated that site deviation from reference values were highly correlated with the Hazard Index values ($\rho = -0.936$) (fig. 27). This relation indicated a trend of gradually improving conditions in Pike Hill Brook along the continuum of sites from the waste-rock headwaters (site 2) to the end of the brook (site 7) before it enters the Waits River (fig. 28). Additionally, the wetland between sites 4A and 5 may have a mitigating effect on the water quality of Pike Hill Brook, possibly because it traps much of the sediment that was transported from the waste rock. A comparison between the qualitative assessment categories provided by VT-DEC and values of site deviation from reference indicates relative agreement among all sites. These results help confirm consistency in the evaluations of the sites, which increases the confidence in recognizing the level of ecological risk associated with each site.

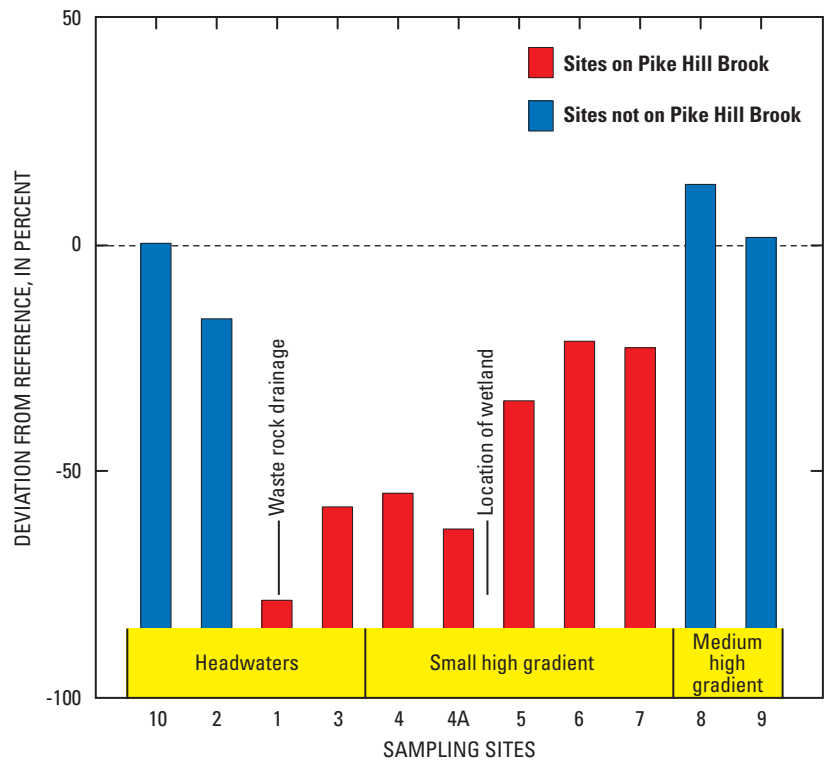
Figure 28. The relation of macroinvertebrate data at the Pike Hill, VT, study area to data from Vermont reference streams.
