Research  
Note  
FPL-RN-0301

# Two-Year Wisconsin Thermal Loads for Roof Assemblies and Wood, Wood-Plastic Composite, and Fiberglass Shingles

November 2005

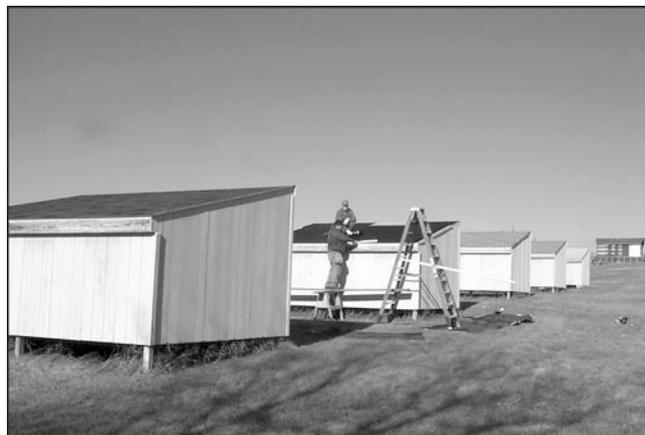
**Figure 1—Exposure structures located at Forest Products Laboratory test site near Madison, Wisconsin. All five units were similar except for roofing materials and were instrumented for long-term temperature monitoring of roof assemblies. Shown, from the foreground, are black fiberglass shingles, western redcedar shingles (being installed), wood–thermoplastic composite shingles (two structures—closer with lath and further without lath), and white fiberglass shingles.**

In the summer of 1991, five field exposure structures (Fig. 1) were constructed near Madison, Wisconsin (43° latitude). In Madison, the average incidence angle of sunlight is 19.5° from the southern horizon on the winter solstice (December 21) and 43° on the summer solstice (June 21). The annual average declination angle is 31.25°. The Wisconsin exposure structures (WI structures) were constructed to face south in a shadeless area open to direct sunlight. The structures were spaced far enough apart to prevent any one structure from shading the next structure. Winandy and Beaumont (1995) described the construction of the WI structures in detail and reported 3-year annualized data.
