NTIA Technical Memorandum TM-03-405

Digital Television (DTV) Field Strength and Video Quality Study

DIGITAL TELEVISION (DTV) FIELD STRENGTH AND VIDEO QUALITY STUDY

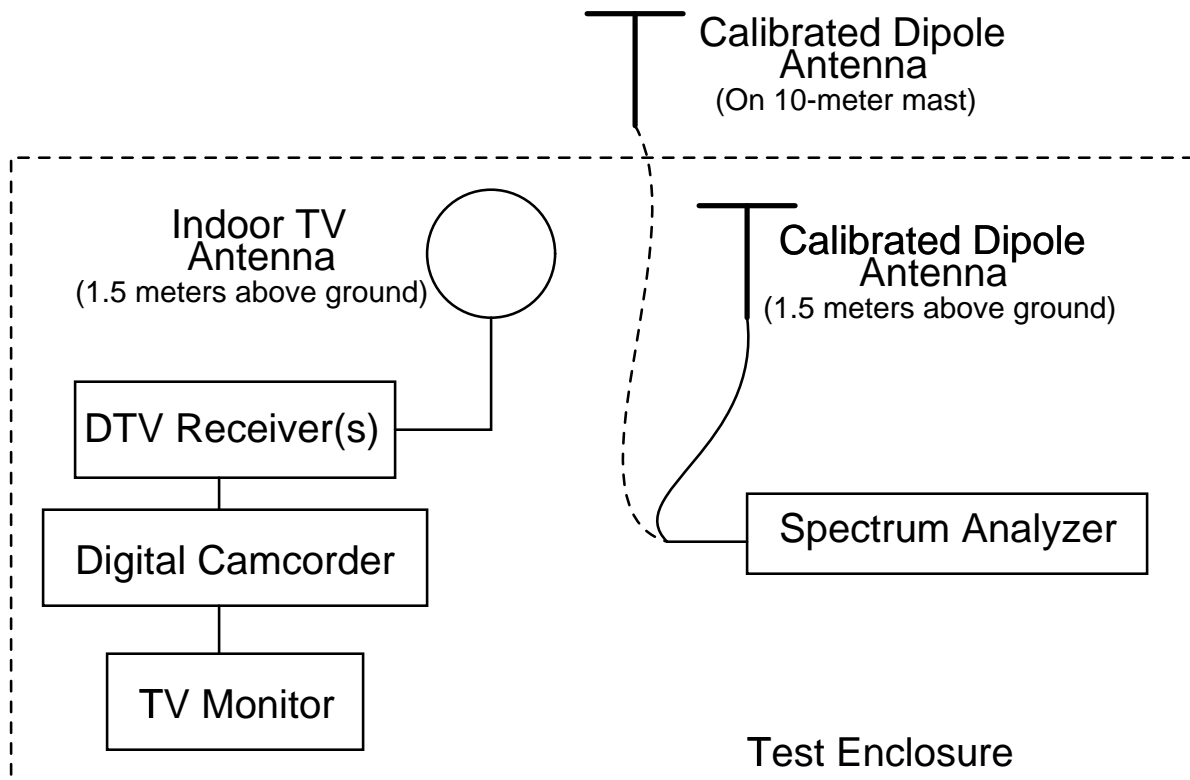
Figure 1: Measurement system configuration.

To improve the approximation of the enclosure to a typical house, the structure included a window in the broad wall, was insulated with fiberglass, and was paneled with 1/4 inch plywood. All of the equipment was assembled as diagrammed in Figure 1.

Both the indoor TV antenna and the calibrated dipole antenna could be mounted inside the test enclosure at the same location. This allowed ITS to position the indoor TV antenna for recording the DTV receiver's video signal, or to measure the field strength at this location using the calibrated dipole and spectrum analyzer. Additionally, mounting the same dipole antenna on a 10-meter mast allowed ITS to position it outside the enclosure at a height of 10 meters above ground for an external field strength measurement. This height approximates the location of an external antenna located on a representative home.

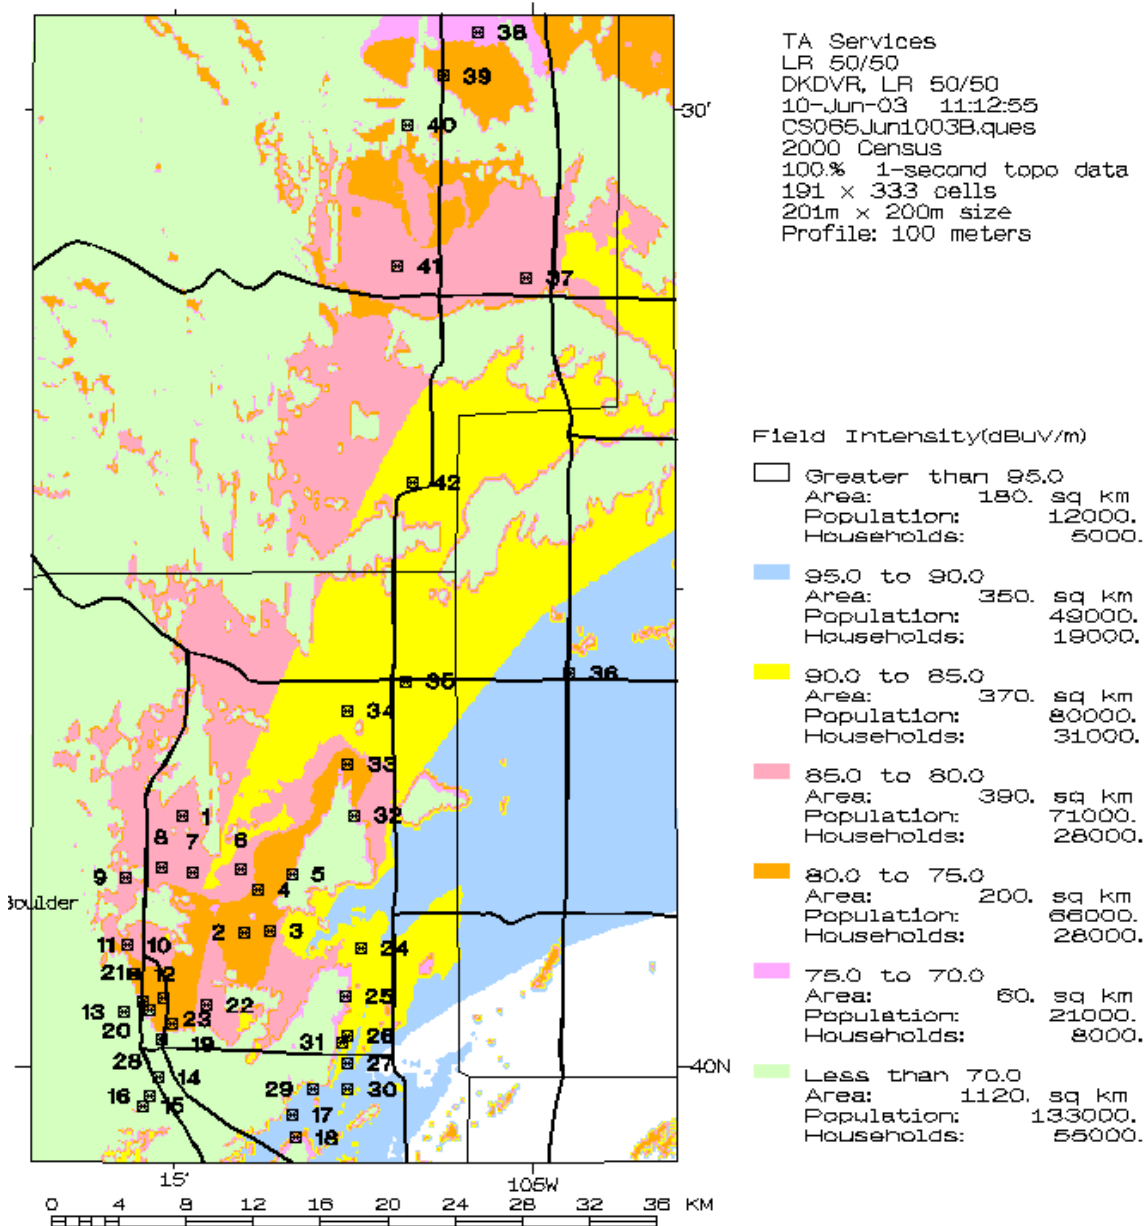
Figure 2: Map showing test locations.

The test locations have also been overlayed on top of a field strength prediction map in Figure 2. Here it is important to note that peak field strengths were measured in order to understand the upper bound on the received signal. In contrast, the computer models compute average field strengths, and will indicate a lower predicted field strength. One should also recognize that the computer models assume that the station’s transmit power and antenna pattern exactly match what is on record. Confirmation of this would require testing at the transmitter, which for this study was not possible.

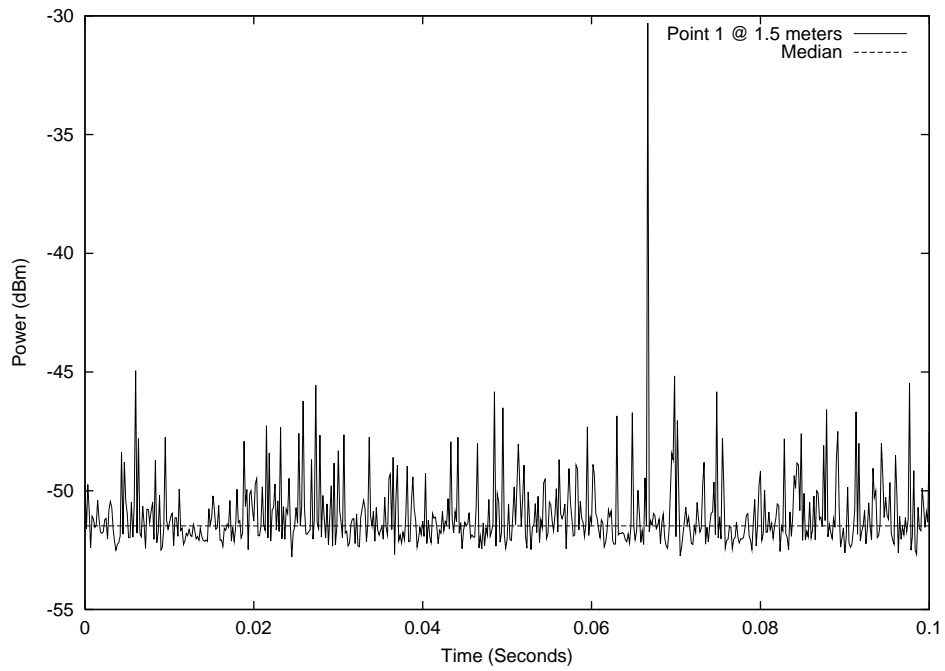
Figure 3: Power at 1.5 meters in location 1.

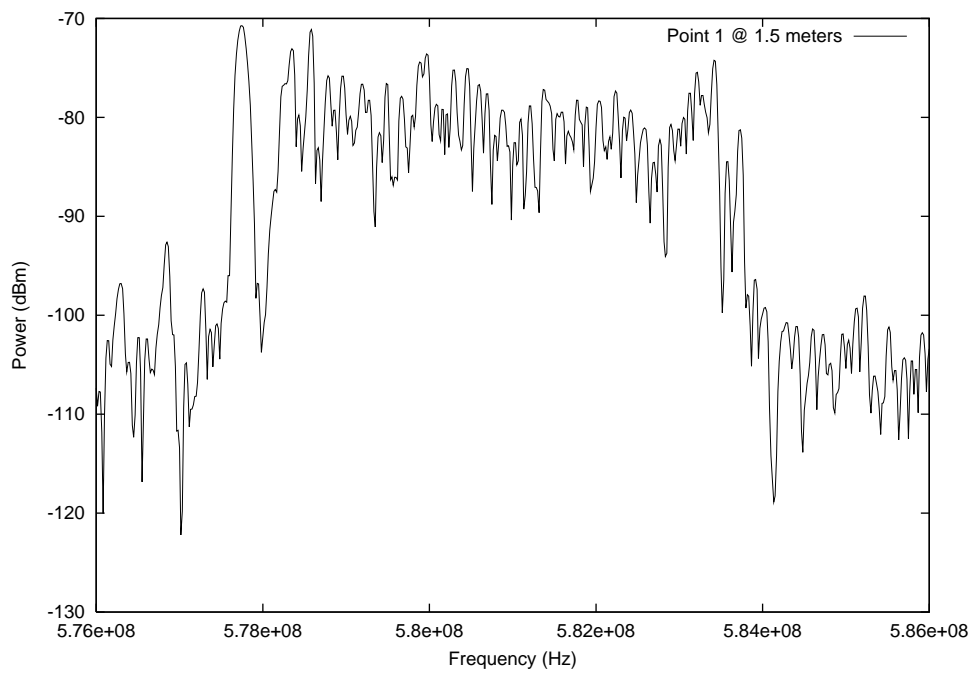
Figure 4: DTV envelope at 1.5 meters in location 1.

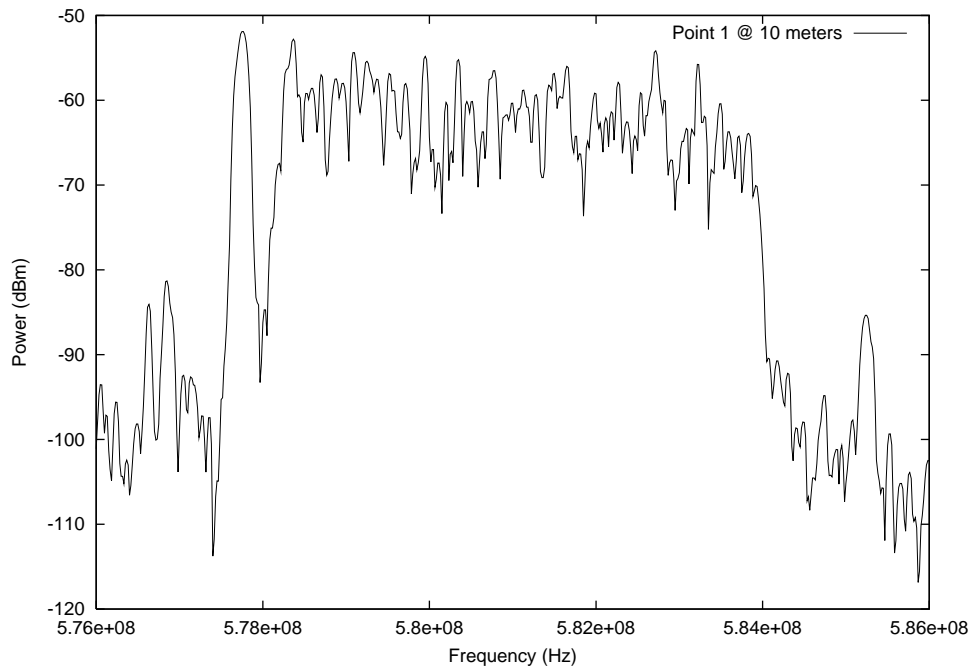
Figure 6: DTV envelope at 10 meters in location 1.

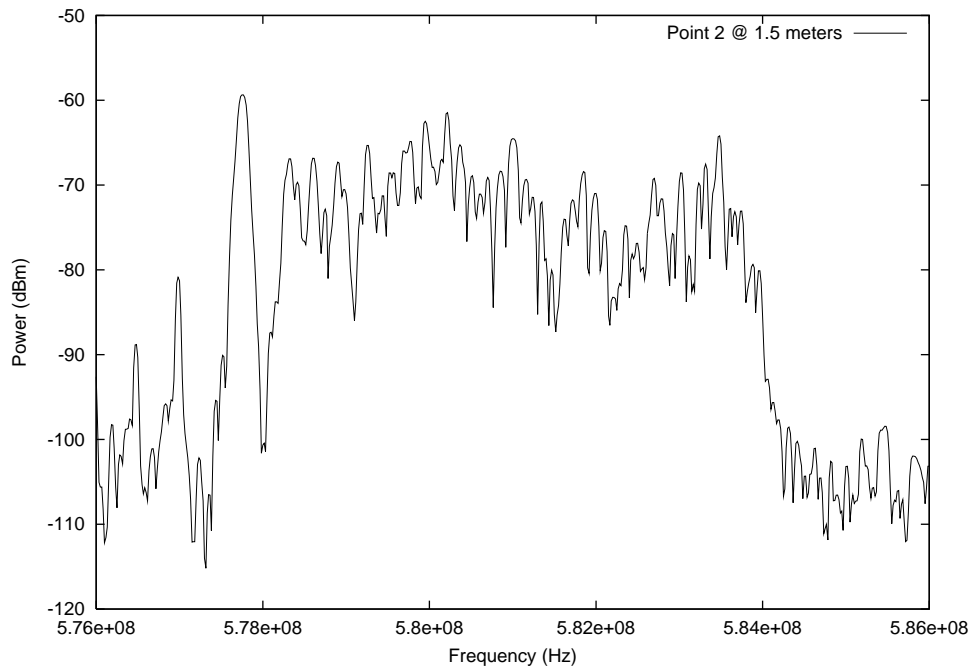
Figure 8: DTV envelope at 1.5 meters in location 2.

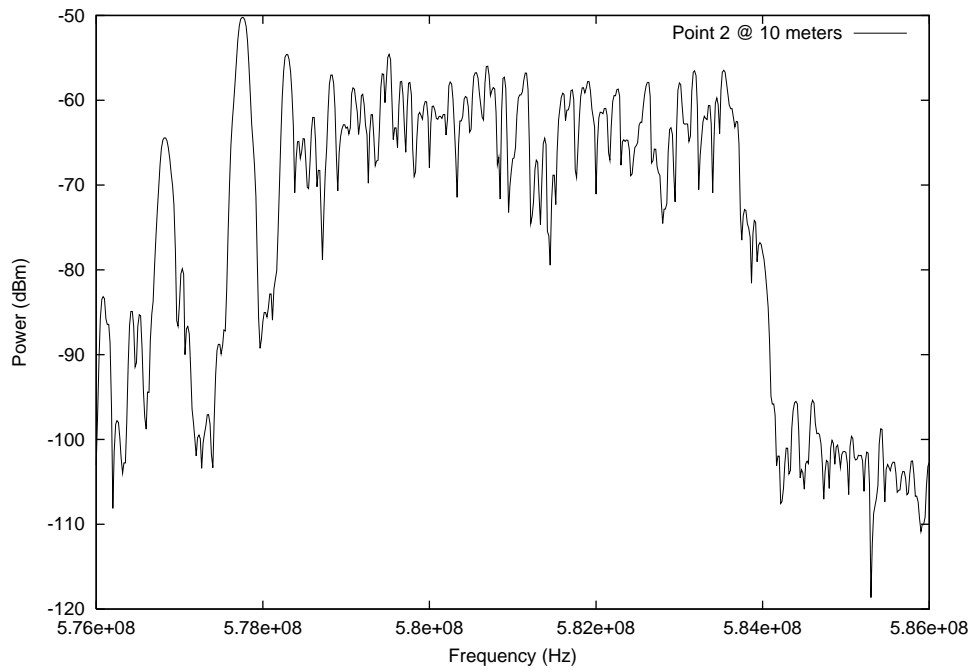
Figure 10: DTV envelope at 10 meters in location 2.

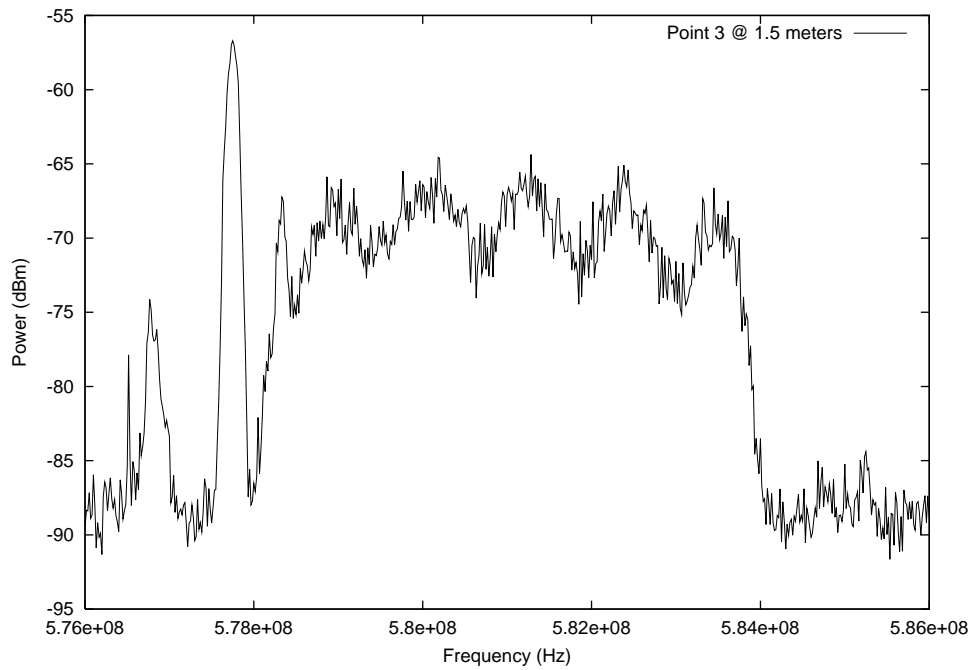
Figure 12: DTV envelope at 1.5 meters in location 3.

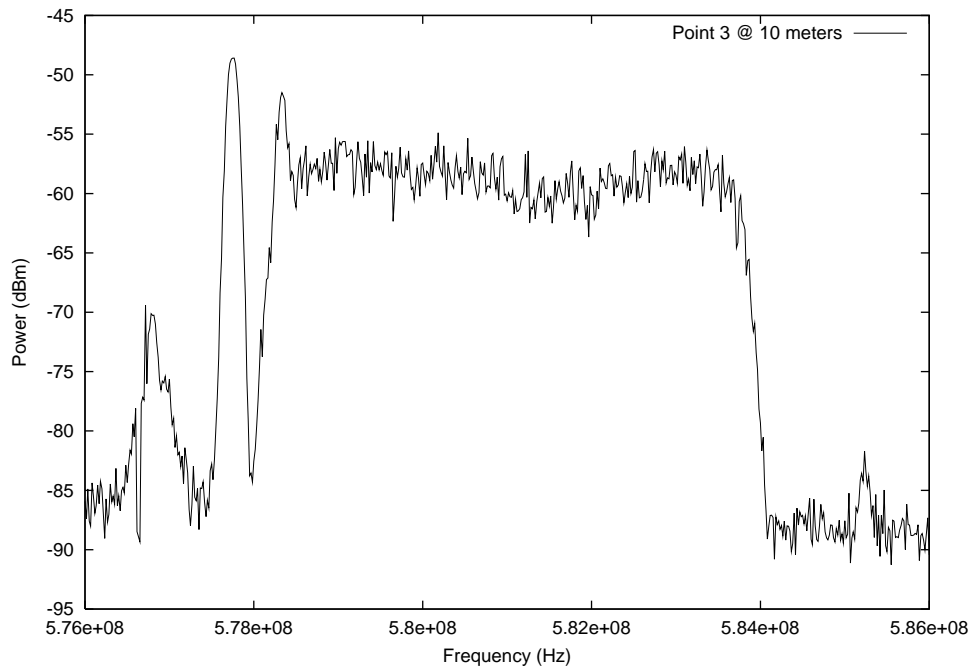
Figure 14: DTV envelope at 10 meters in location 3.

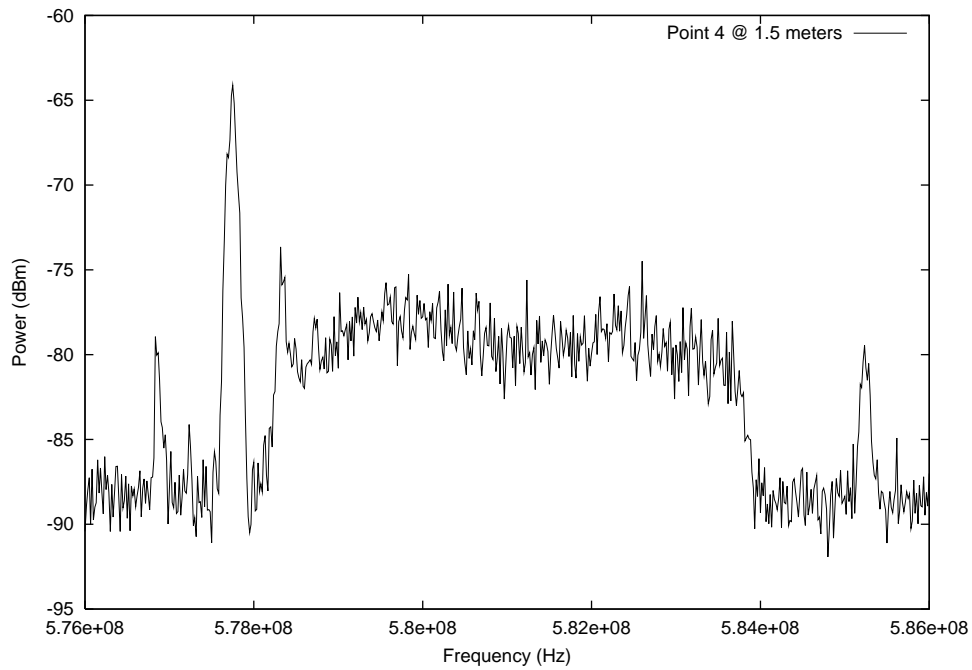
Figure 16: DTV envelope at 1.5 meters in location 4.

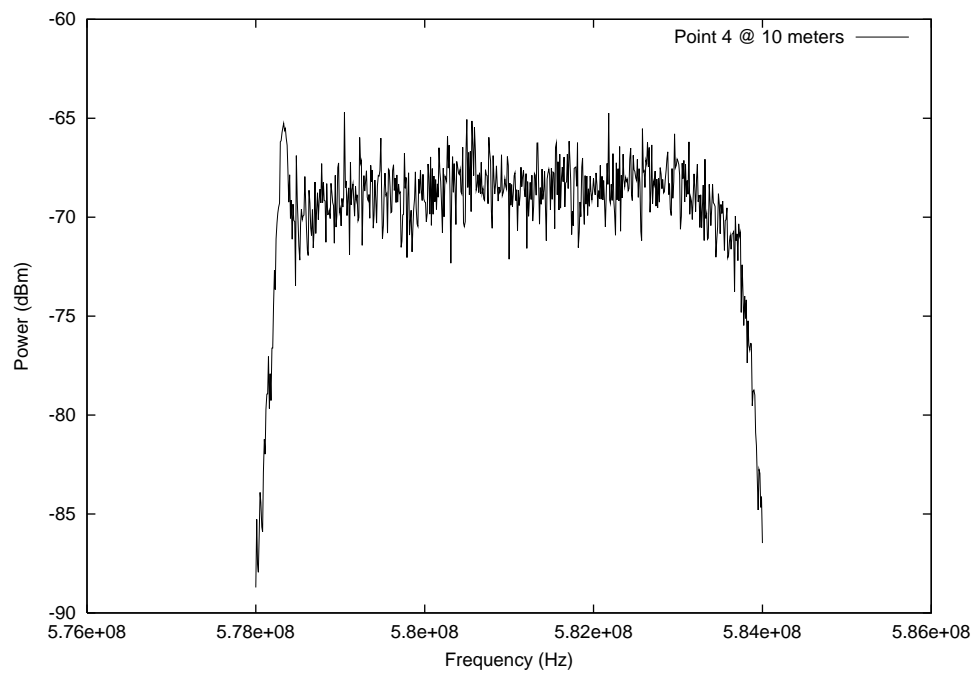
Figure 17: DTV envelope at 10 meters in location 4.

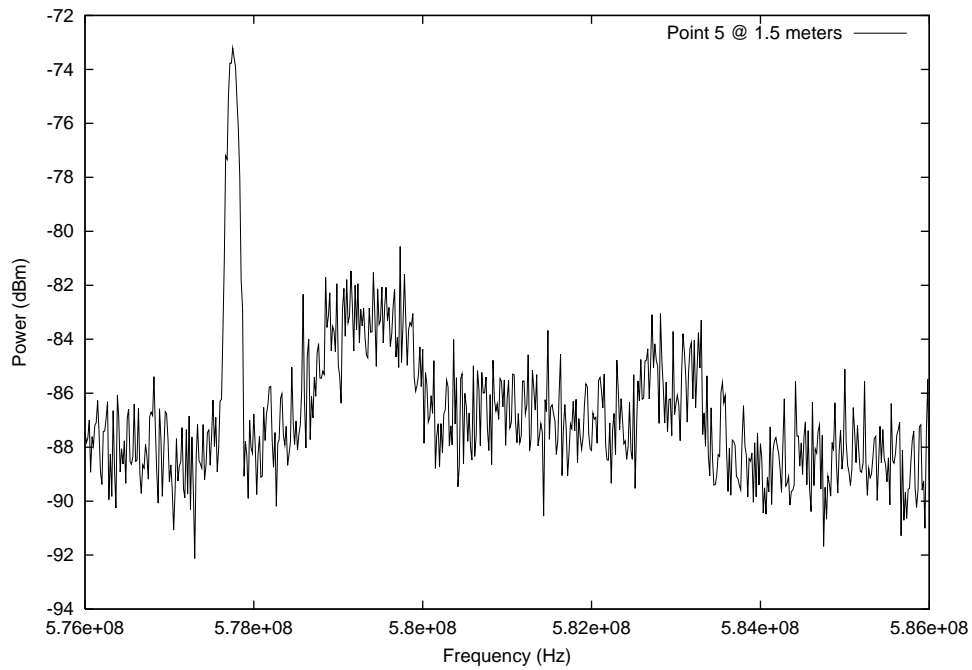
Figure 19: DTV envelope at 1.5 meters in location 5.

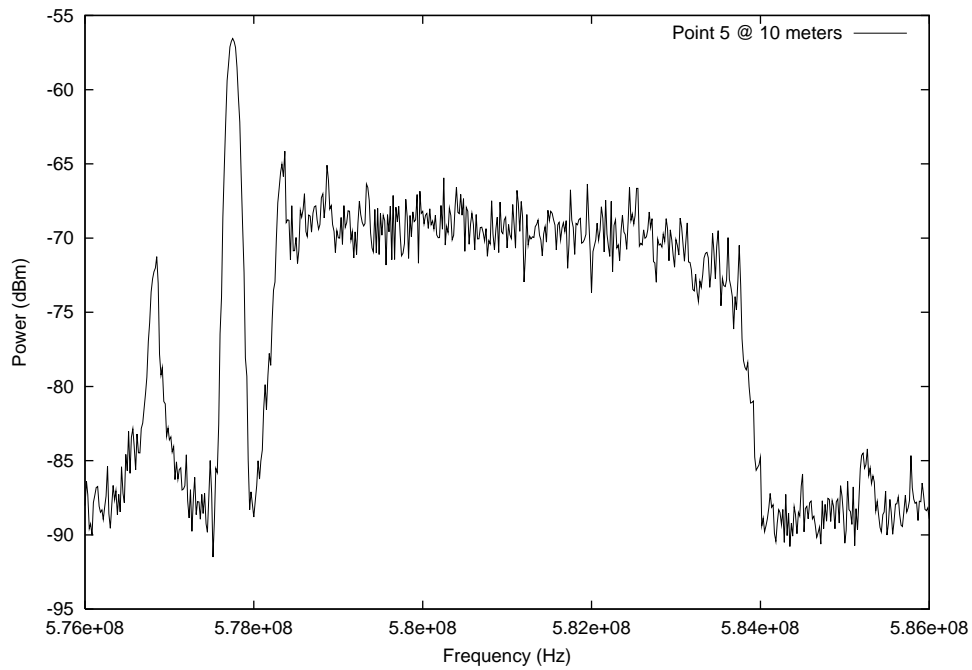
Figure 21: DTV envelope at 10 meters in location 5.

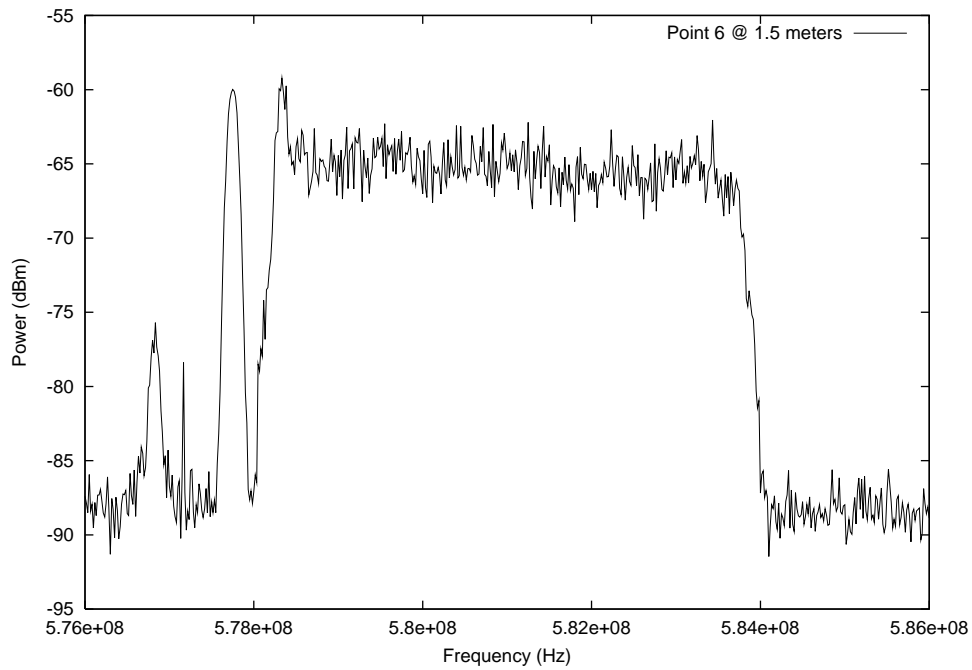
Figure 23: DTV envelope at 1.5 meters in location 6.

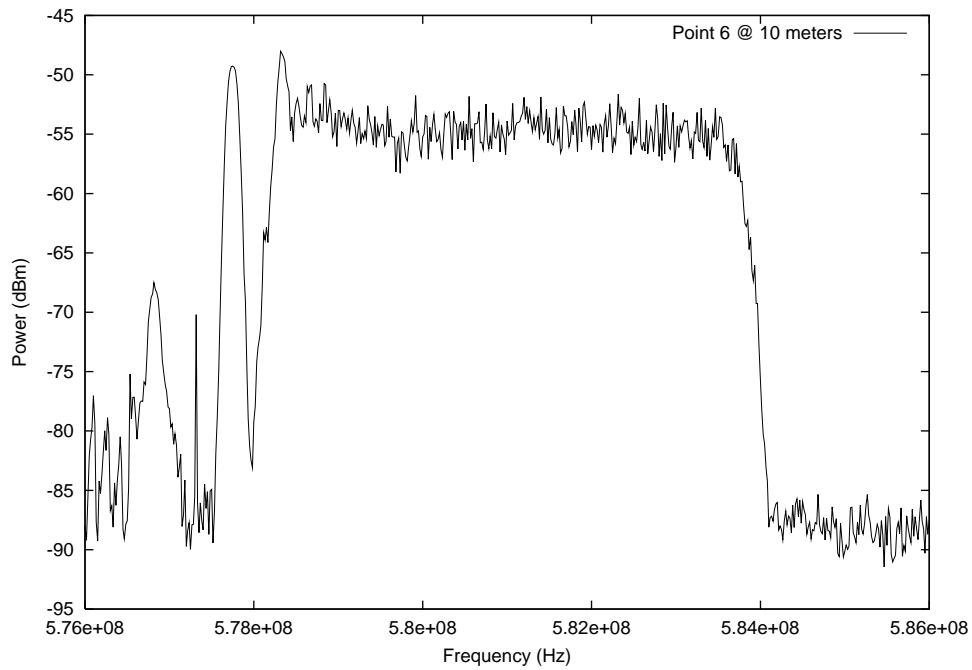
Figure 25: DTV envelope at 10 meters in location 6.

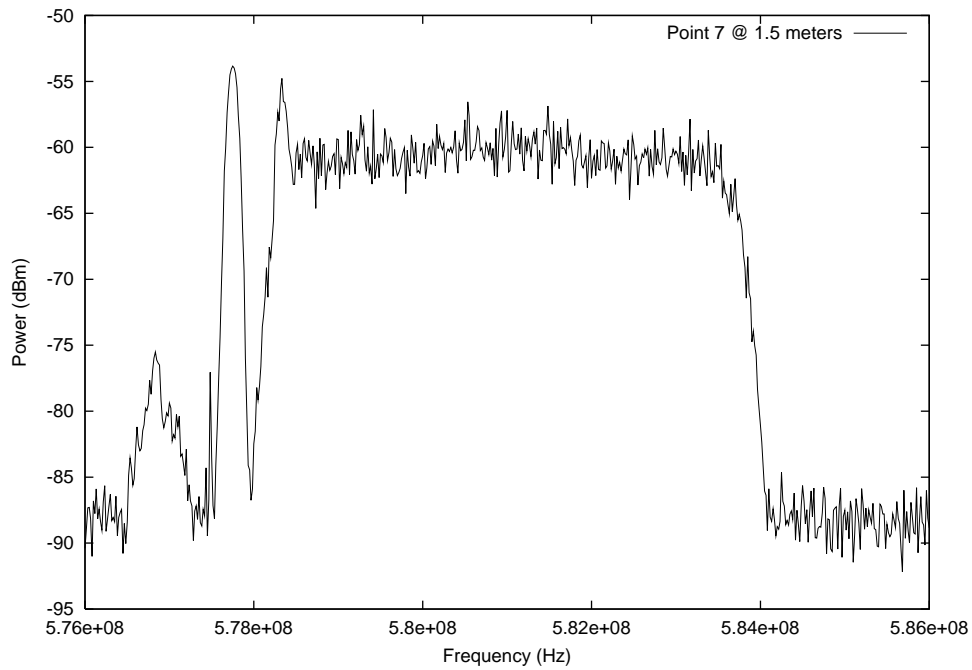
Figure 27: DTV envelope at 1.5 meters in location 7.

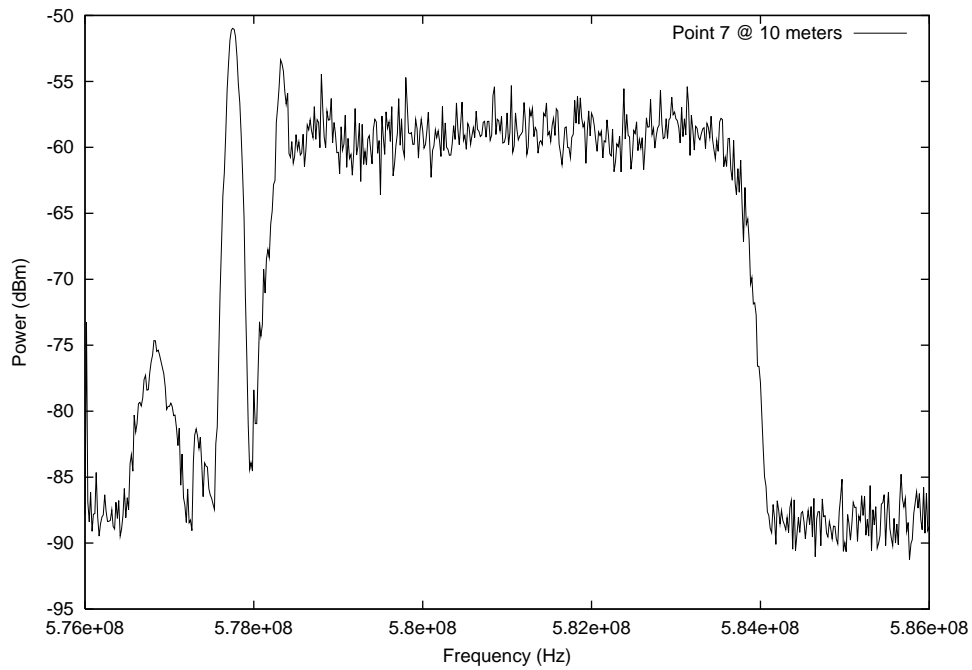
Figure 29: DTV envelope at 10 meters in location 7.

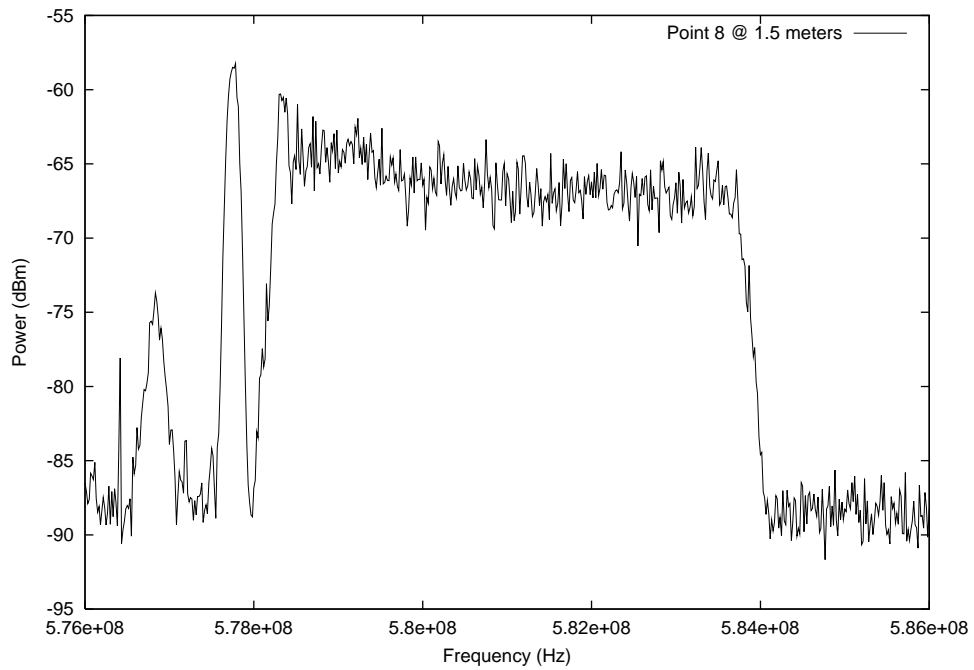
Figure 31: DTV envelope at 1.5 meters in location 8.

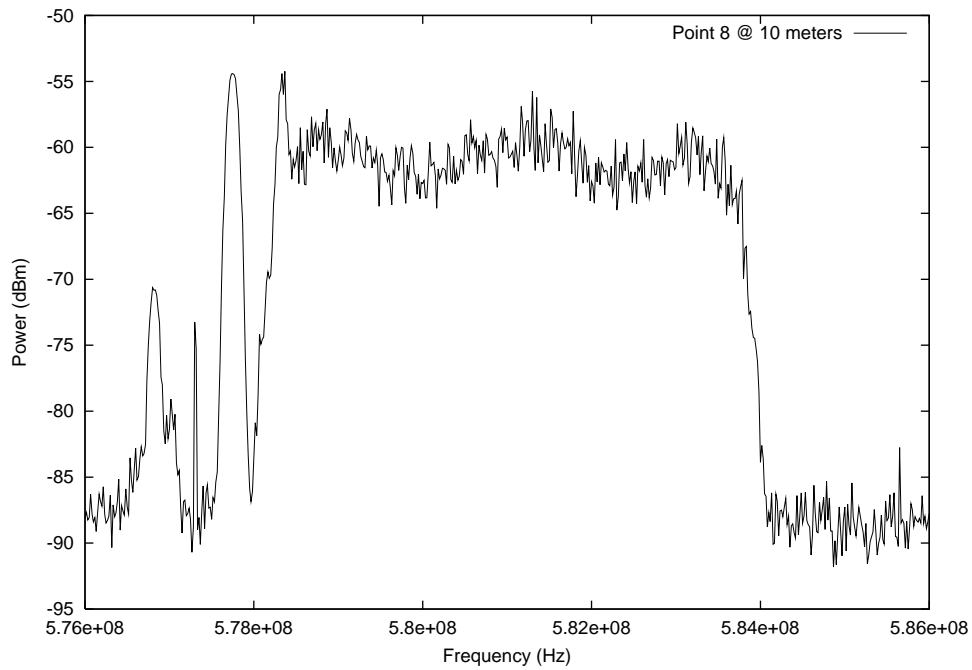
Figure 33: DTV envelope at 10 meters in location 8.

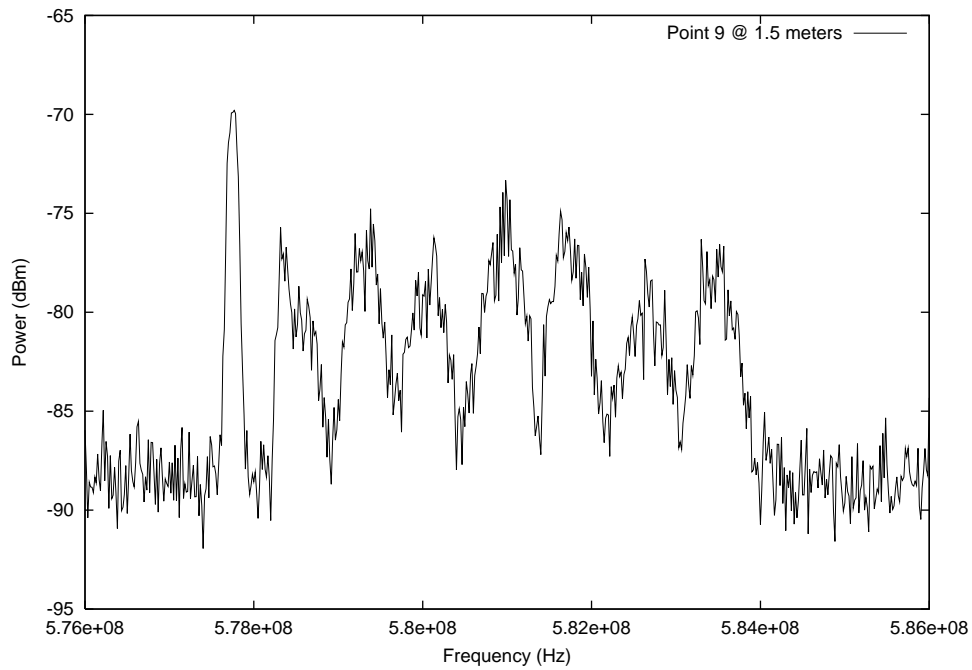
Figure 35: DTV envelope at 1.5 meters in location 9.

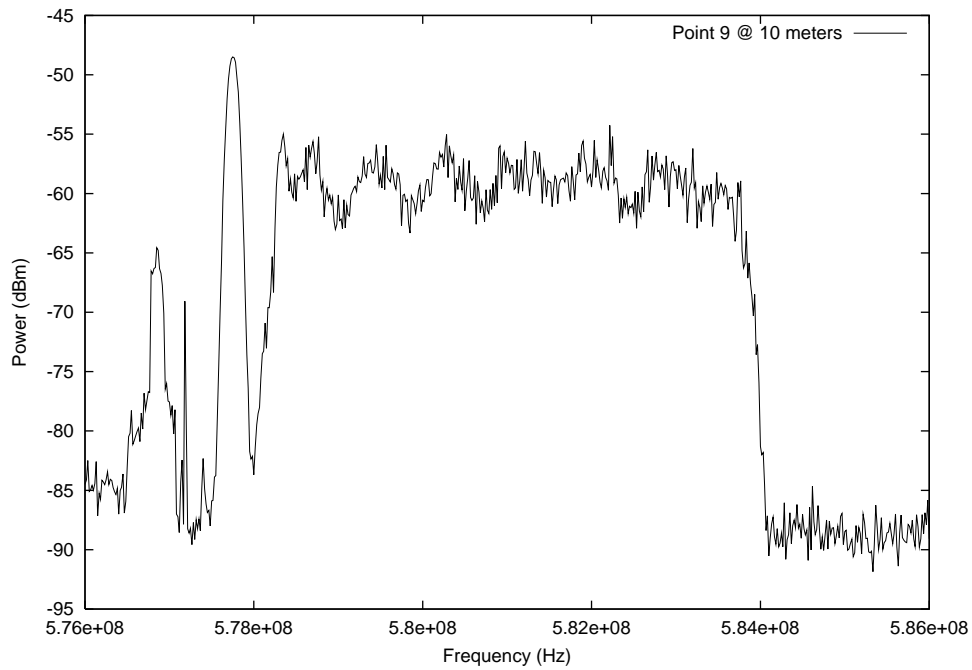
Figure 37: DTV envelope at 10 meters in location 9.

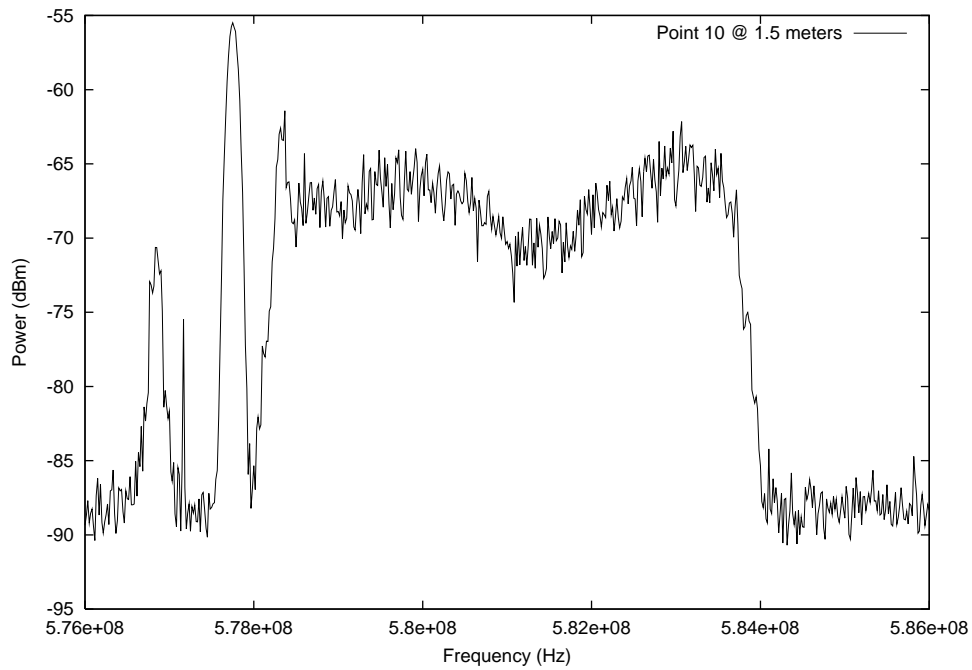
Figure 39: DTV envelope at 1.5 meters in location 10.

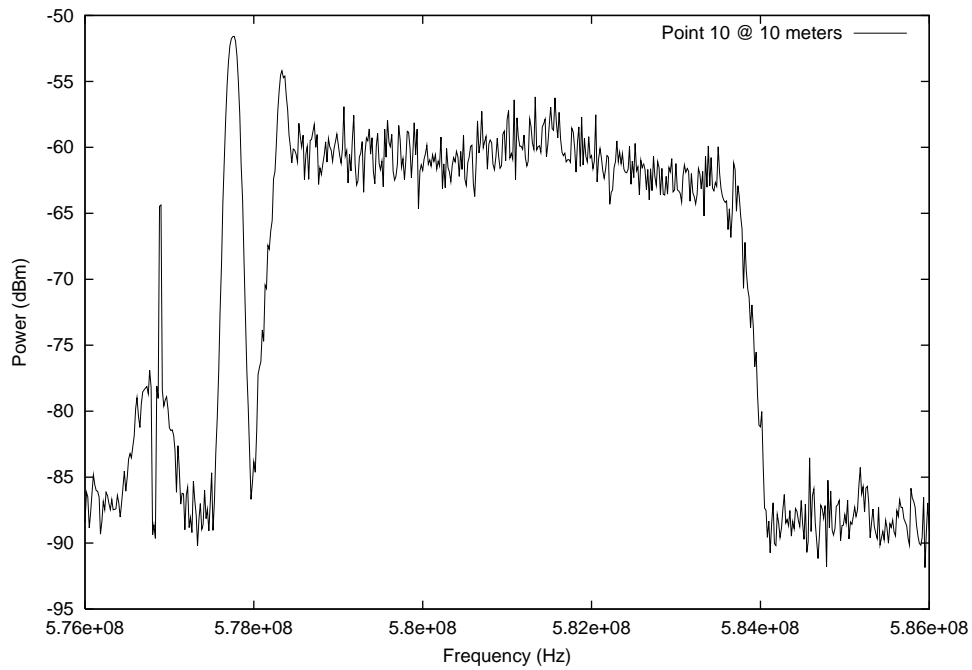
Figure 41: DTV envelope at 10 meters in location 10.

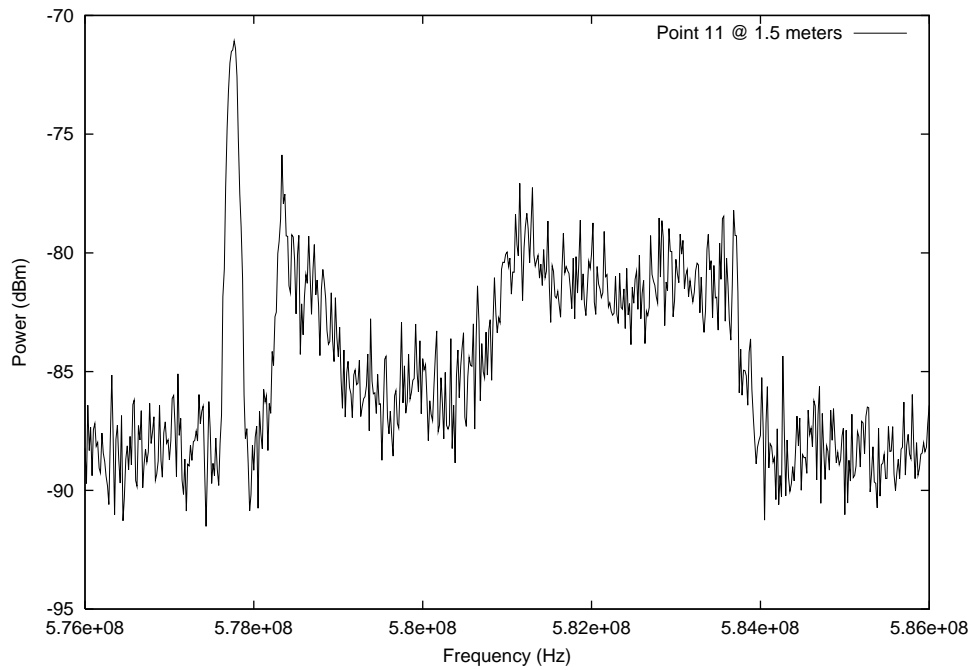
Figure 43: DTV envelope at 1.5 meters in location 11.

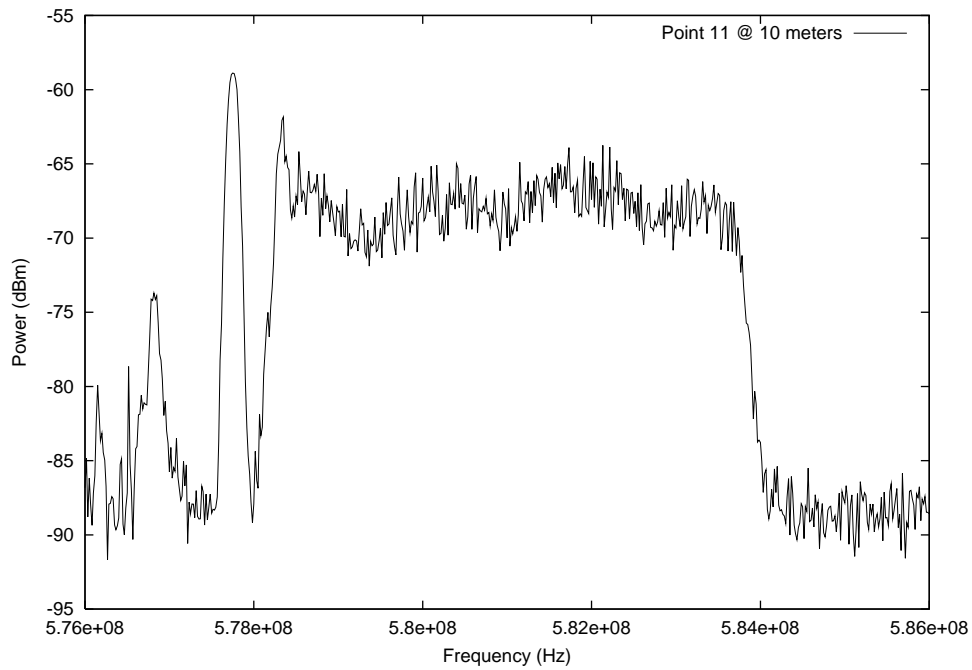
Figure 45: DTV envelope at 10 meters in location 11.

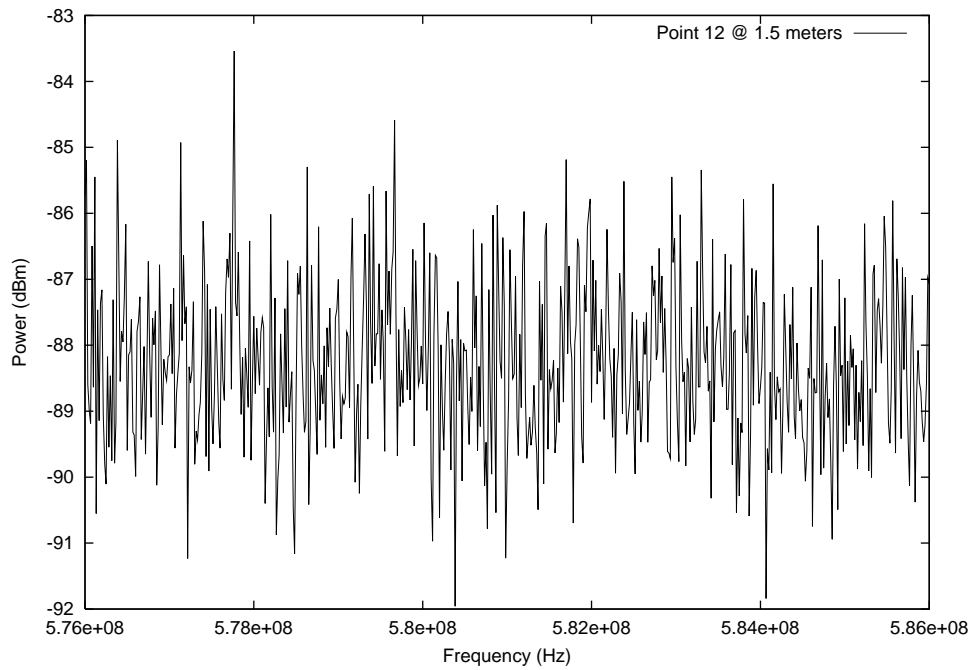
Figure 47: DTV envelope at 1.5 meters in location 12.

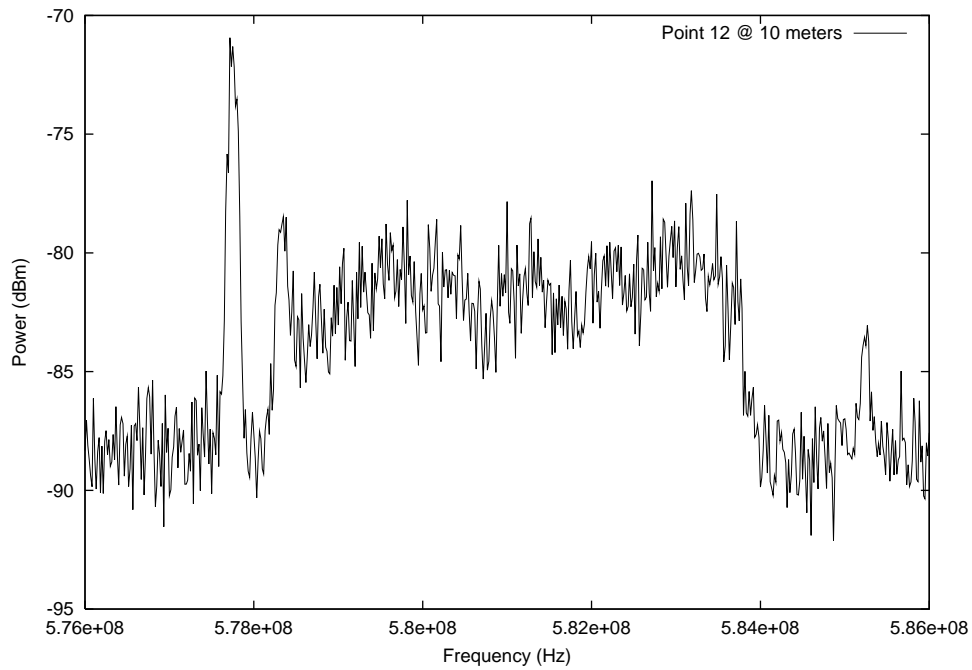
Figure 49: DTV envelope at 10 meters in location 12.

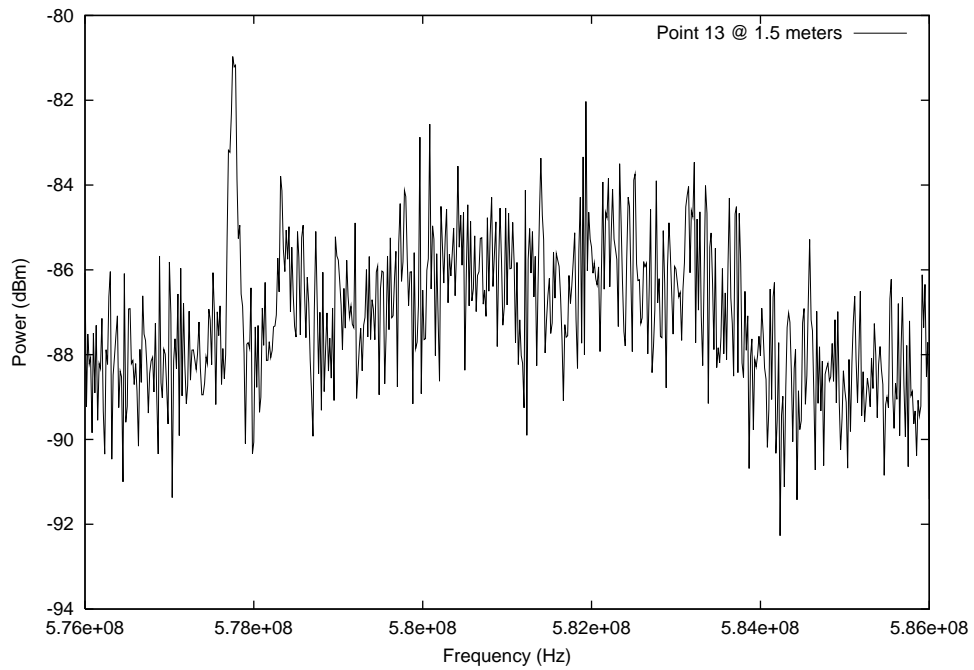
Figure 51: DTV envelope at 1.5 meters in location 13.

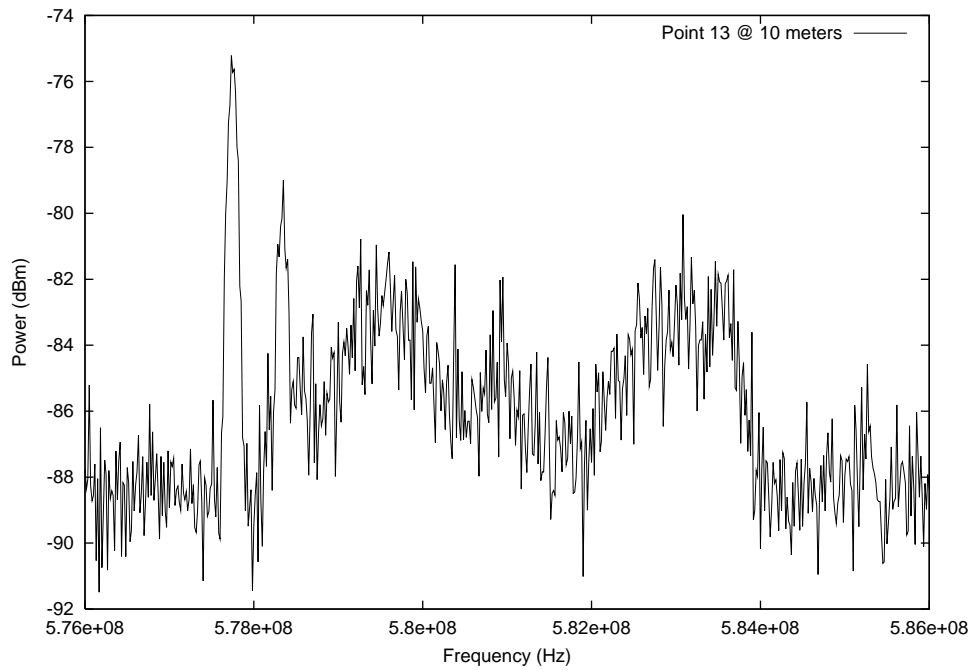
Figure 53: DTV envelope at 10 meters in location 13.

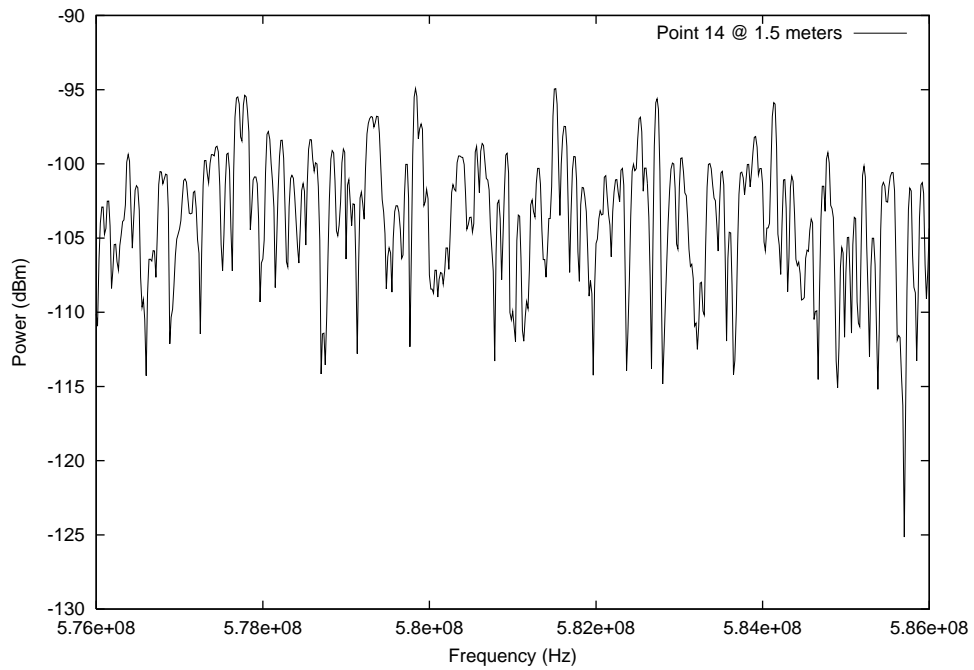
Figure 55: DTV envelope at 1.5 meters in location 14.

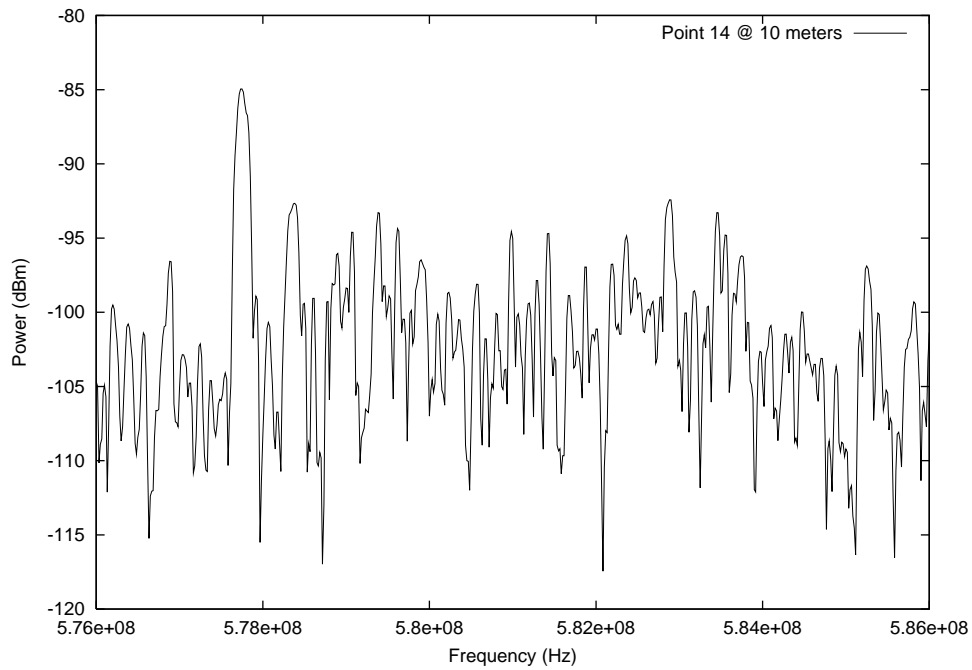
Figure 57: DTV envelope at 10 meters in location 14.

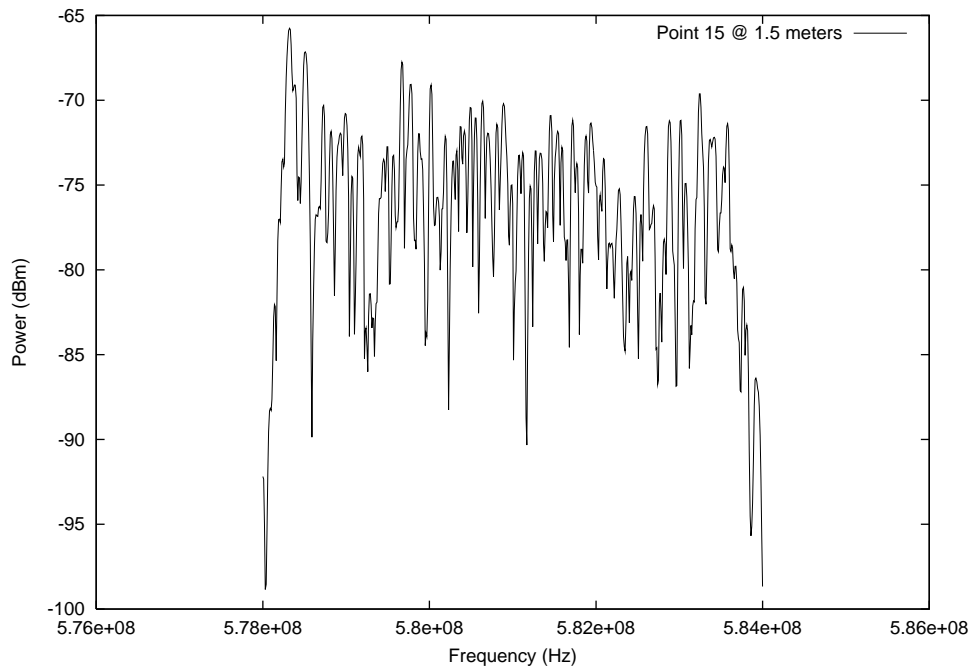
Figure 59: DTV envelope at 1.5 meters in location 15.
