NTIA Technical Memorandum TM-03-405

Digital Television (DTV) Field Strength and Video Quality Study

DIGITAL TELEVISION (DTV) FIELD STRENGTH AND VIDEO QUALITY STUDY

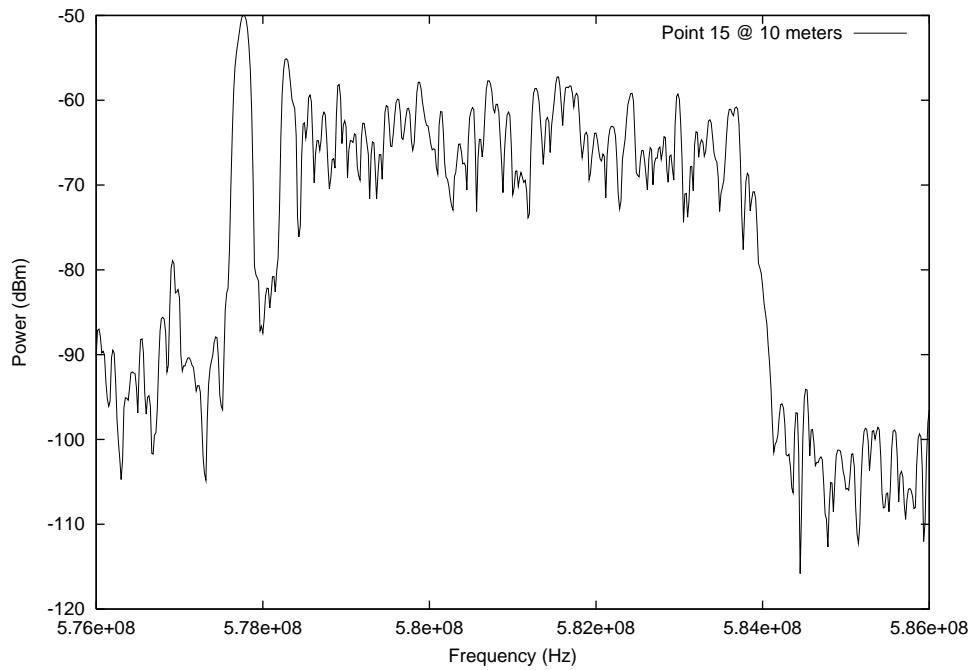
Figure 61: DTV envelope at 10 meters in location 15.

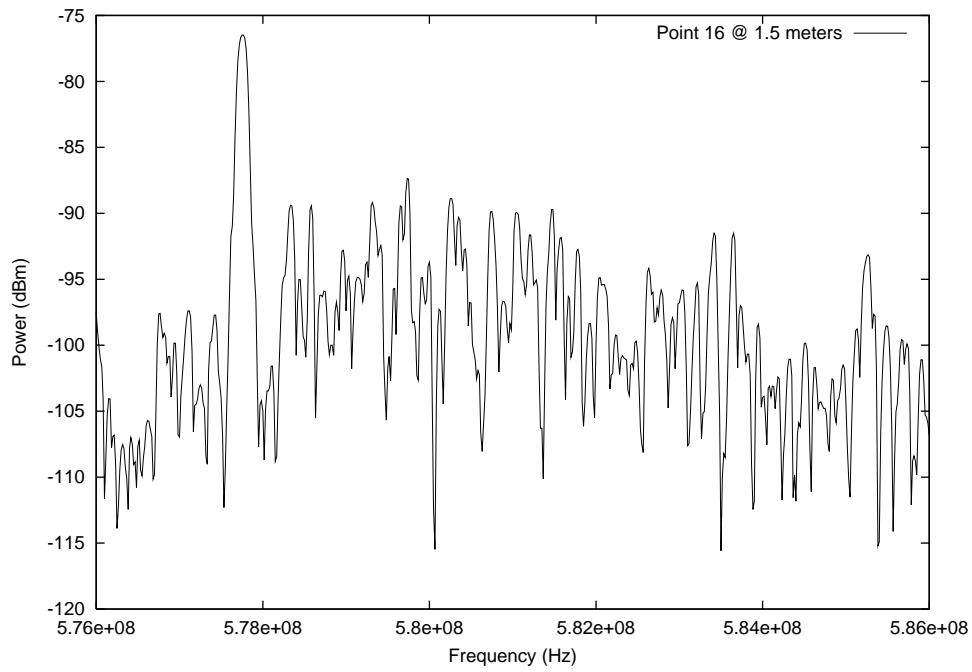
Figure 63: DTV envelope at 1.5 meters in location 16.

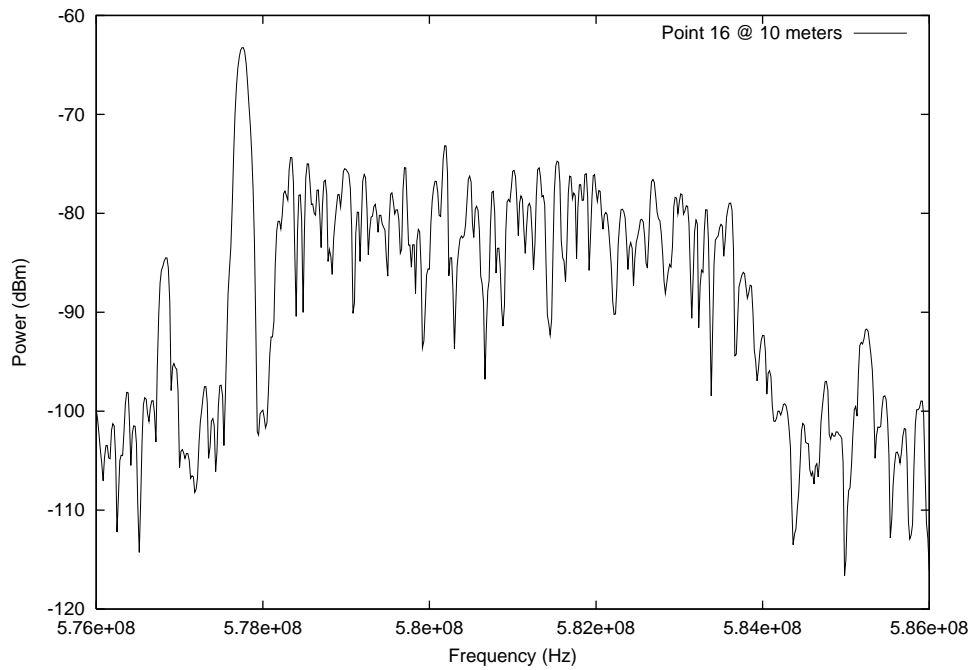
Figure 65: DTV envelope at 10 meters in location 16.

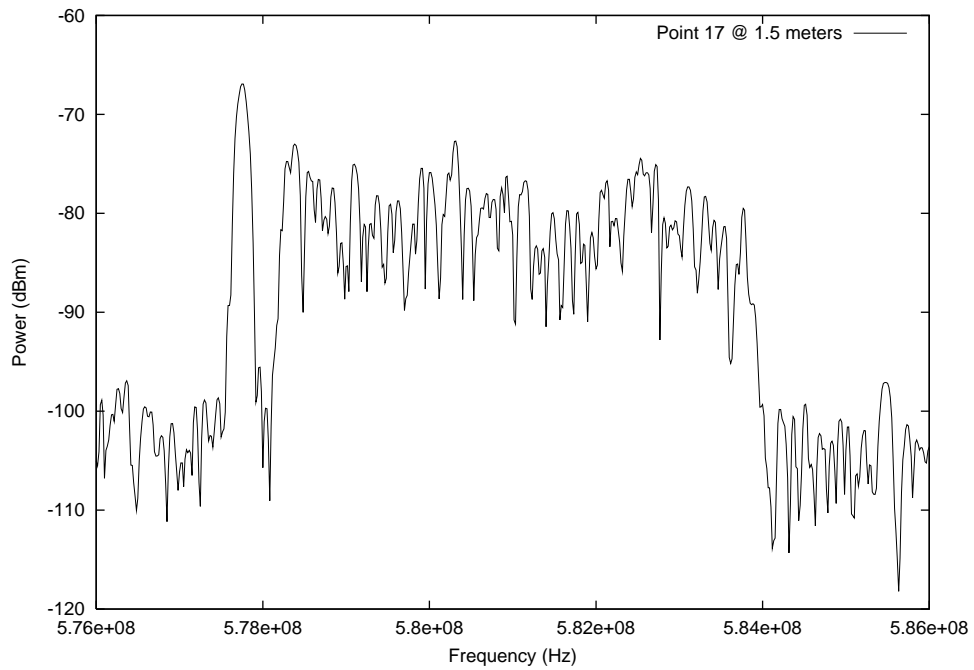
Figure 67: DTV envelope at 1.5 meters in location 17.

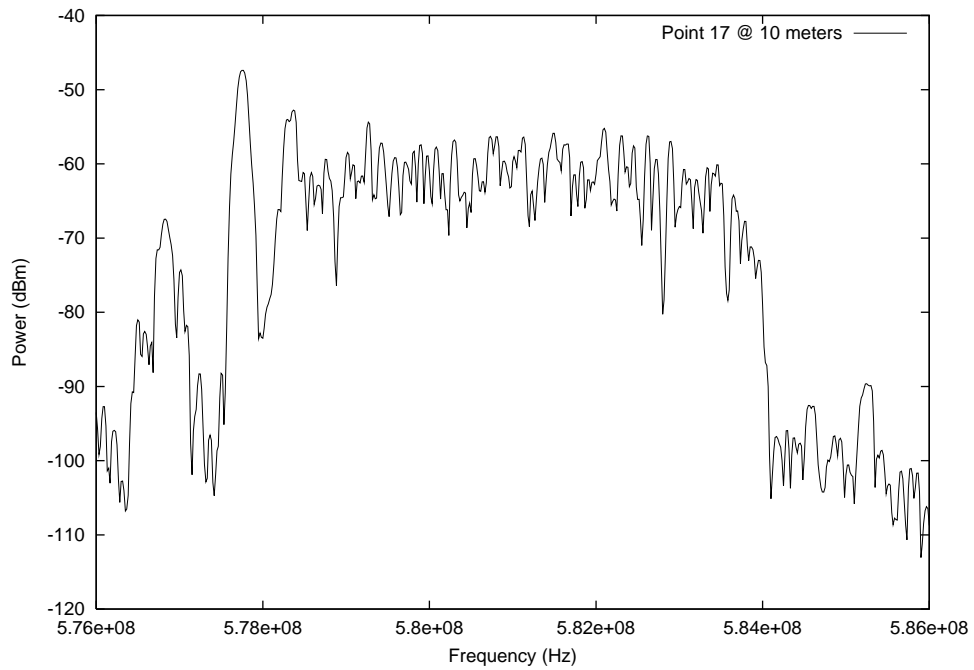
Figure 69: DTV envelope at 10 meters in location 17.

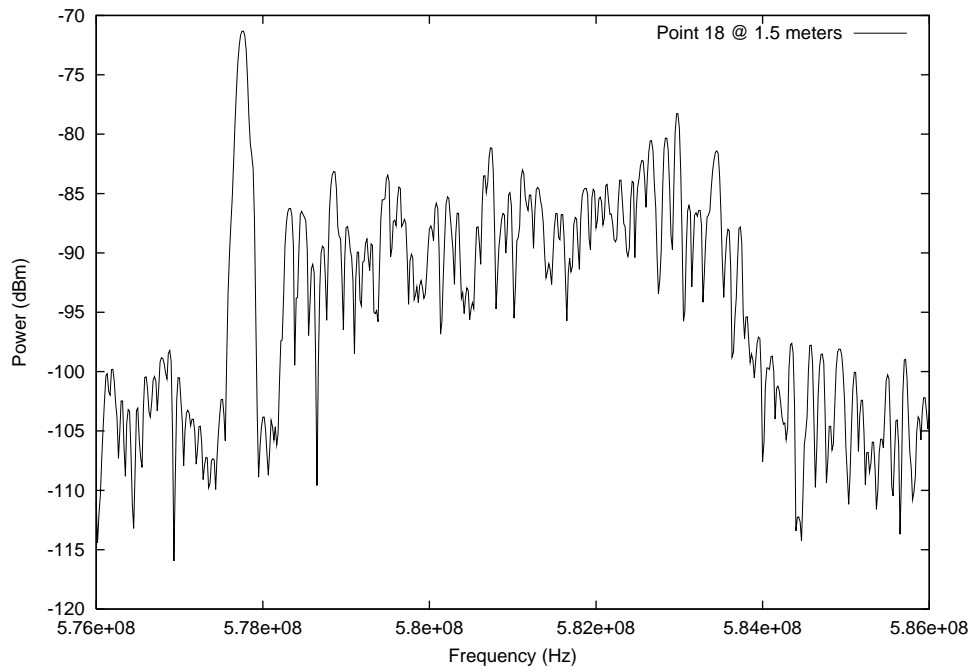
Figure 71: DTV envelope at 1.5 meters in location 18.

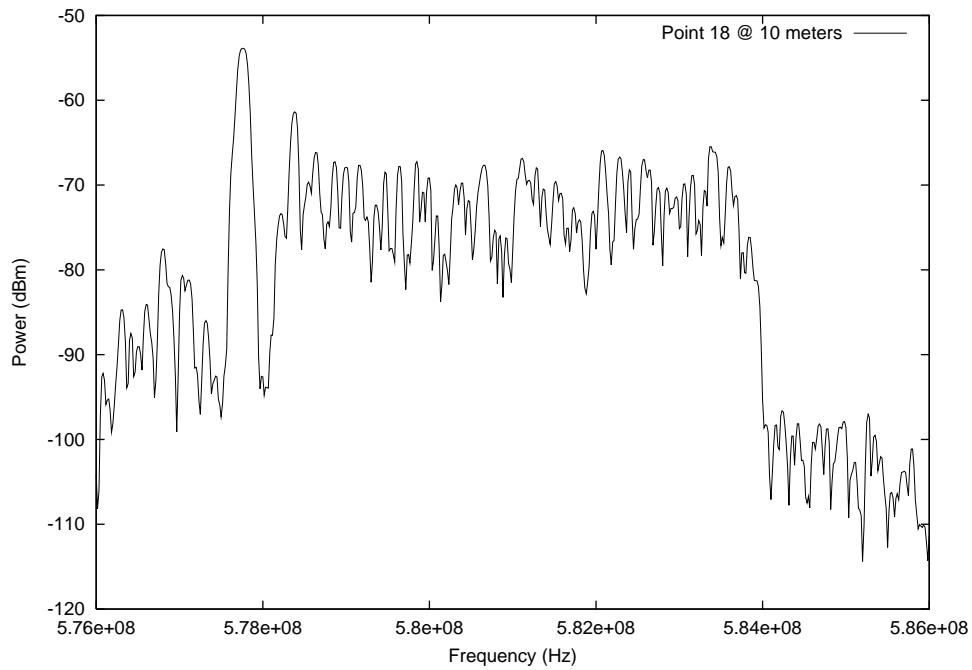
Figure 73: DTV envelope at 10 meters in location 18.

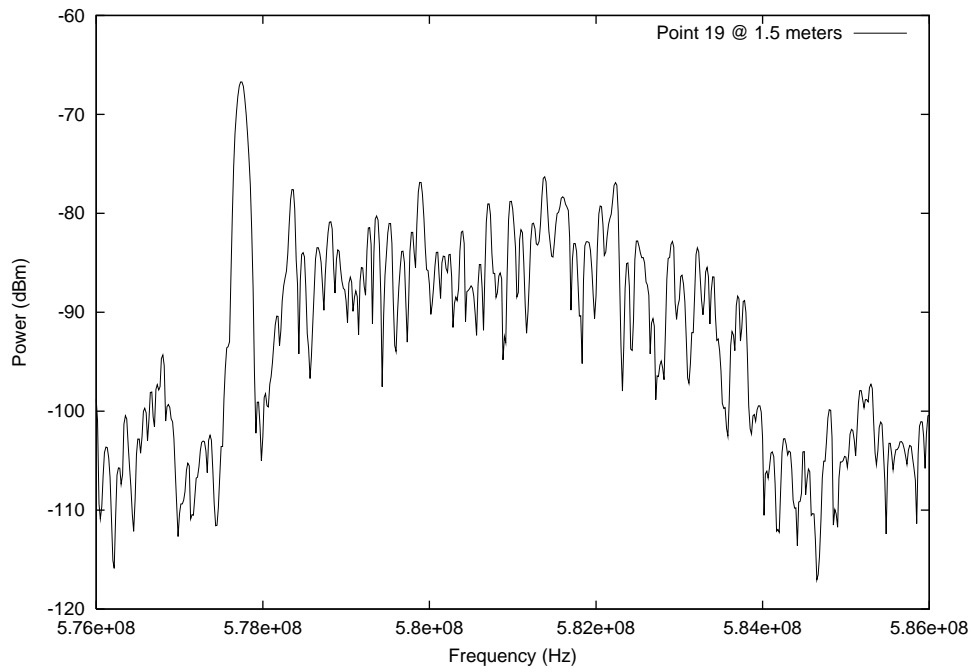
Figure 75: DTV envelope at 1.5 meters in location 19.

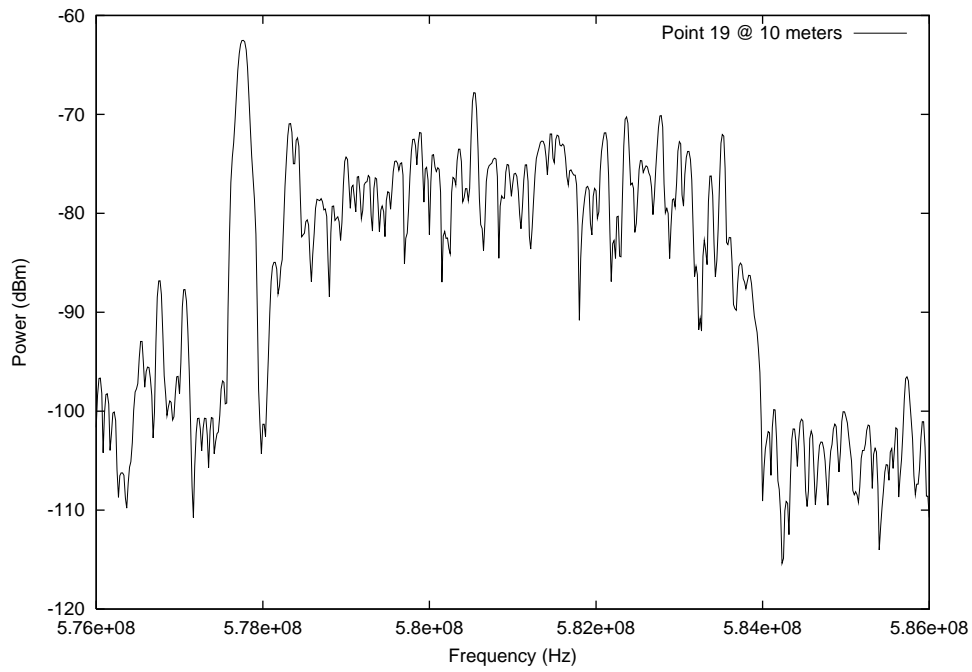
Figure 77: DTV envelope at 10 meters in location 19.

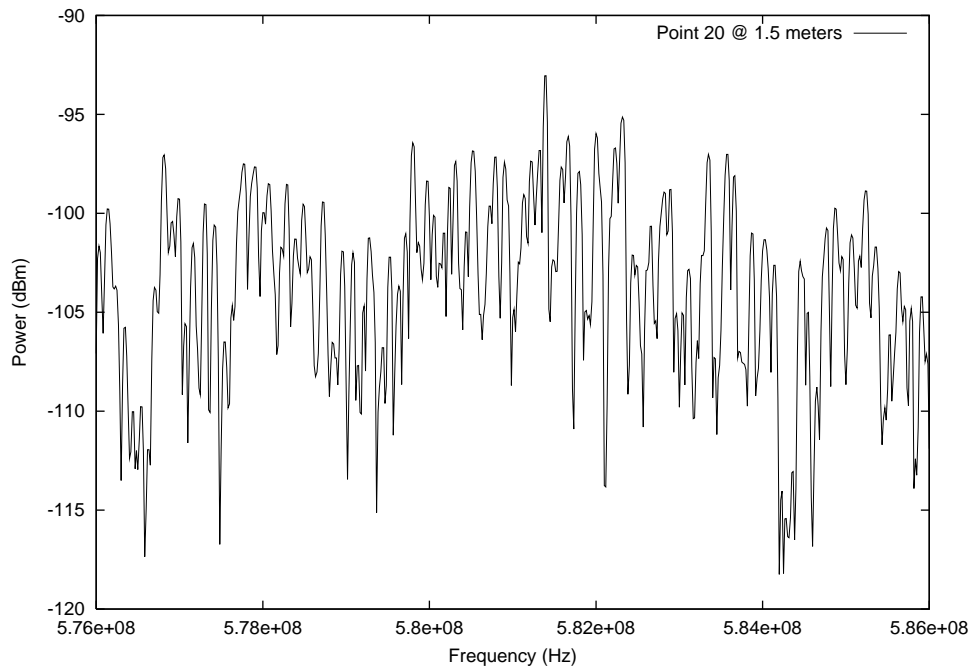
Figure 79: DTV envelope at 1.5 meters in location 20.

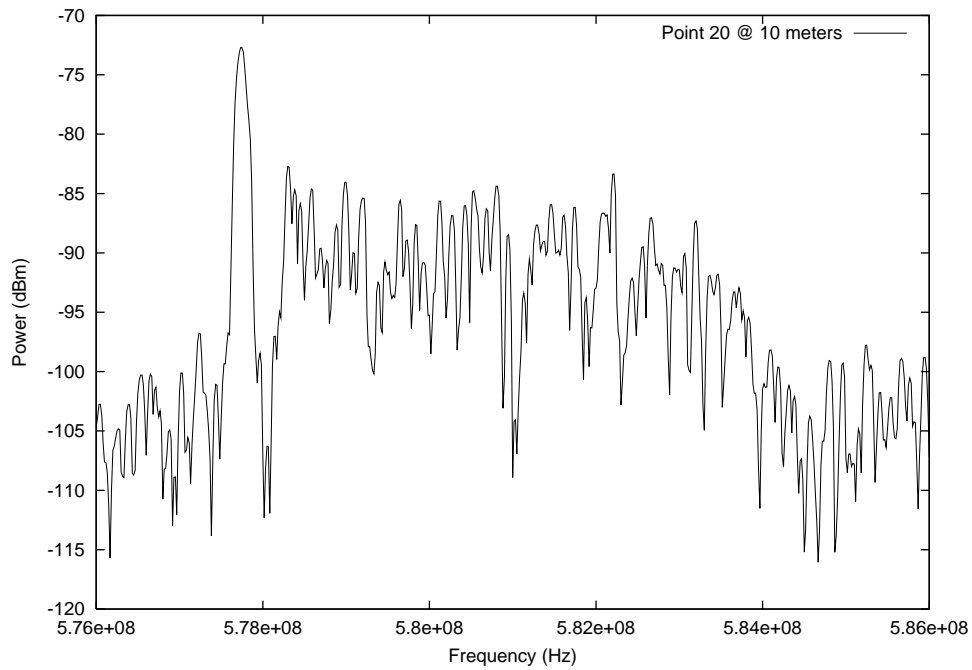
Figure 81: DTV envelope at 10 meters in location 20.

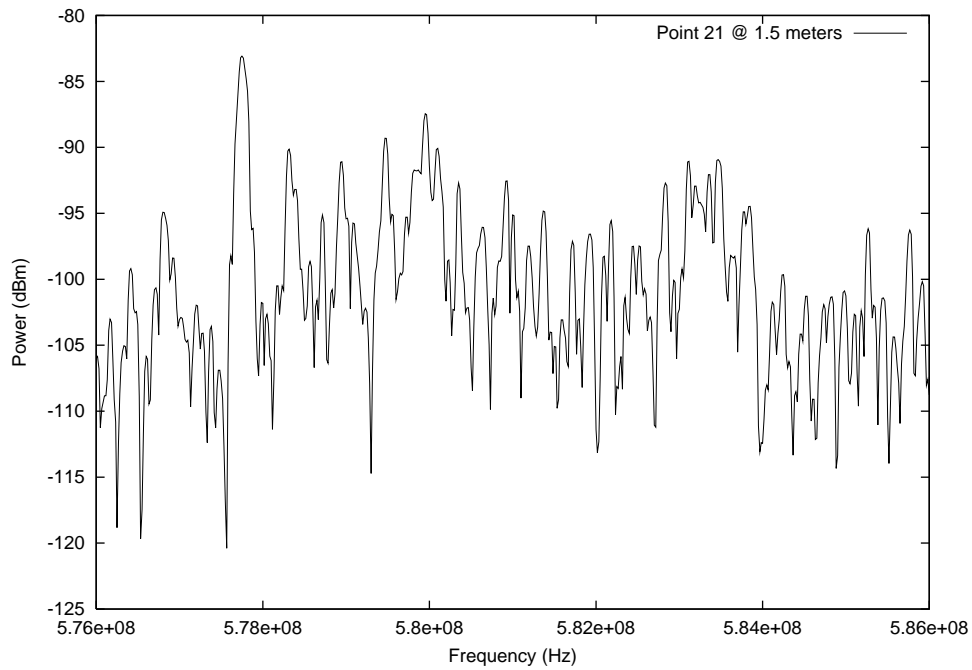
Figure 83: DTV envelope at 1.5 meters in location 21.

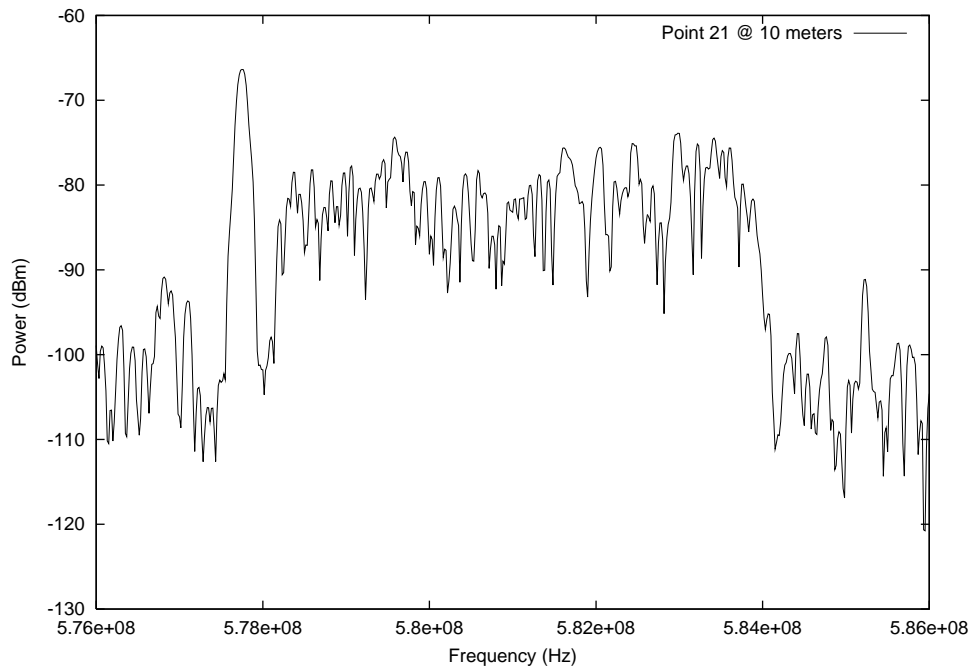
Figure 85: DTV envelope at 10 meters in location 21.

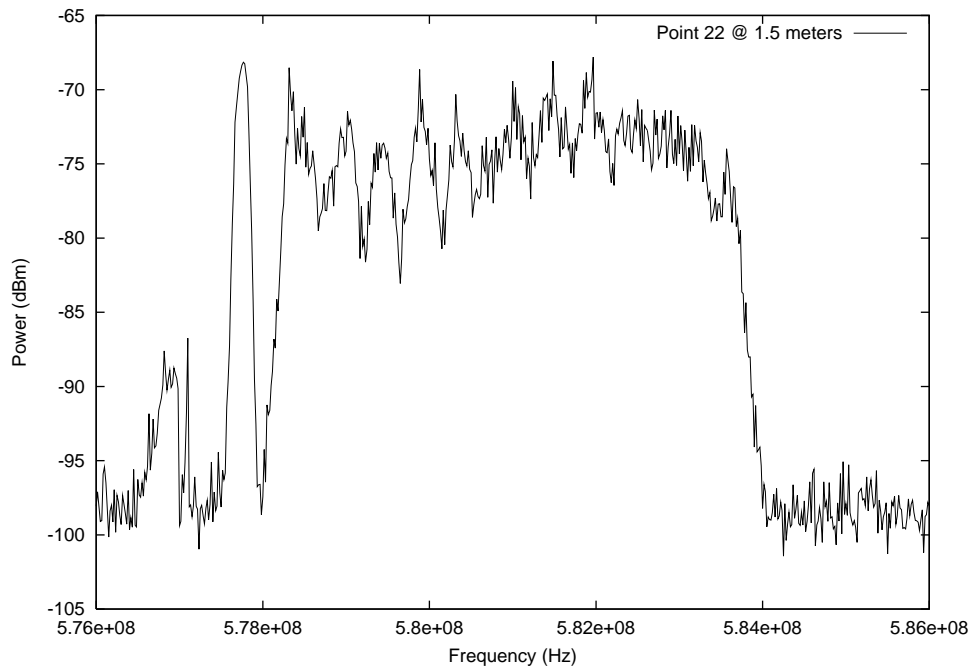
Figure 87: DTV envelope at 1.5 meters in location 22.

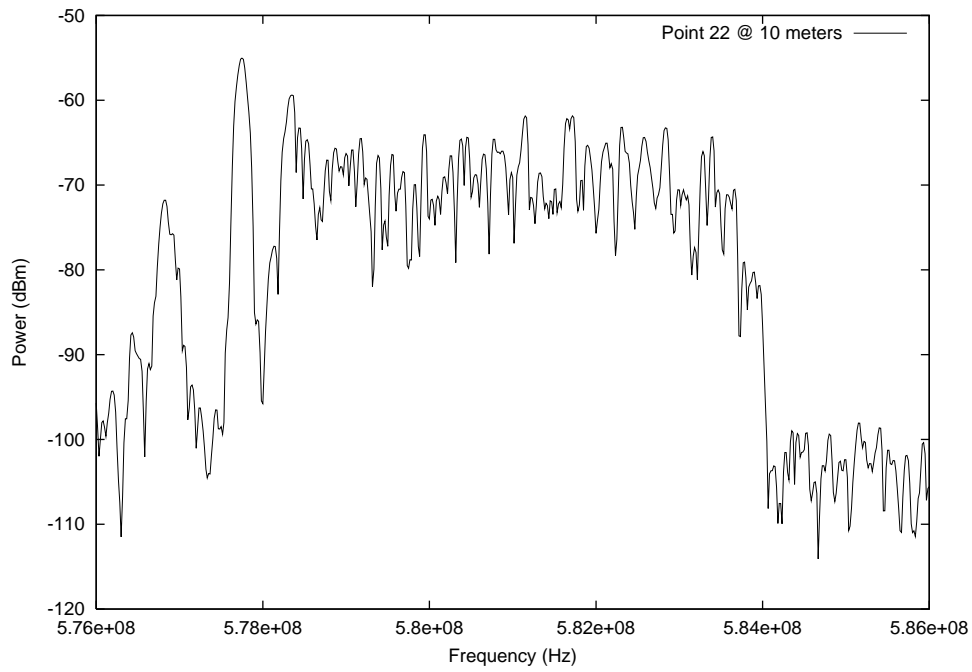
Figure 89: DTV envelope at 10 meters in location 22.

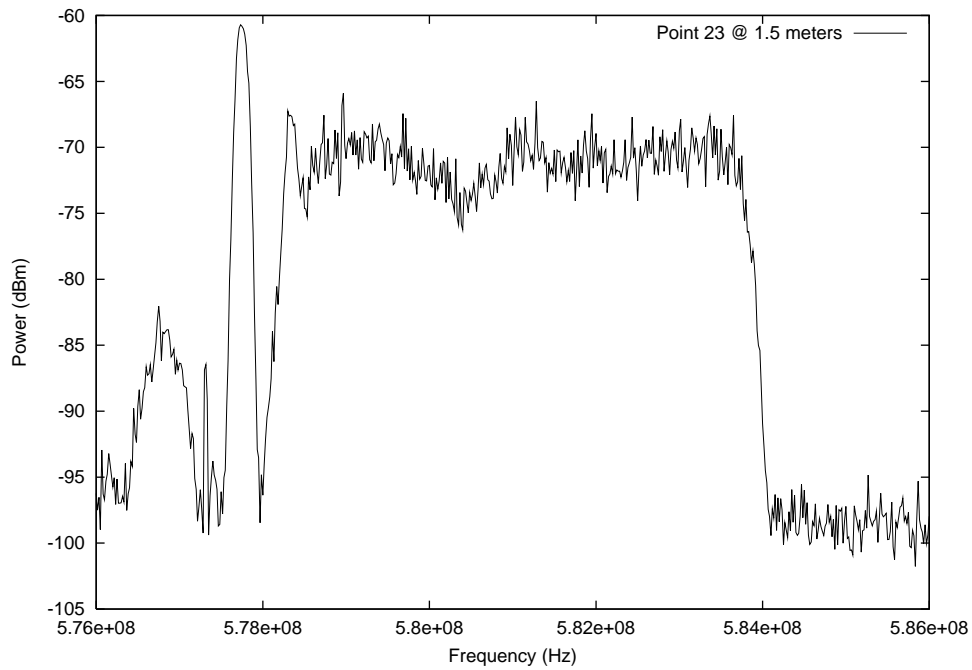
Figure 91: DTV envelope at 1.5 meters in location 23.

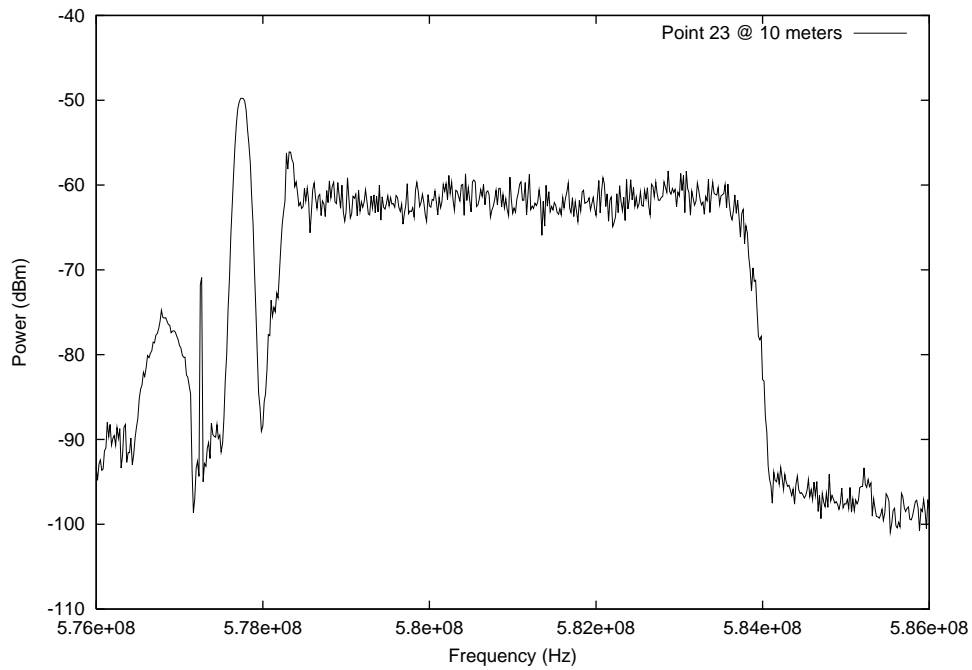
Figure 93: DTV envelope at 10 meters in location 23.

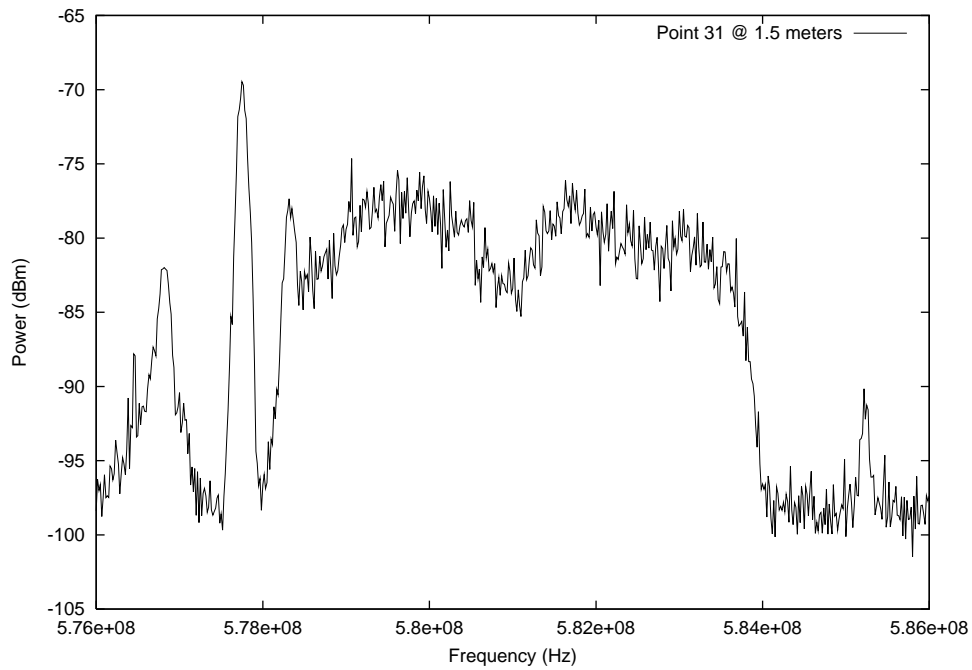
Figure 95: DTV envelope at 1.5 meters in location 31.

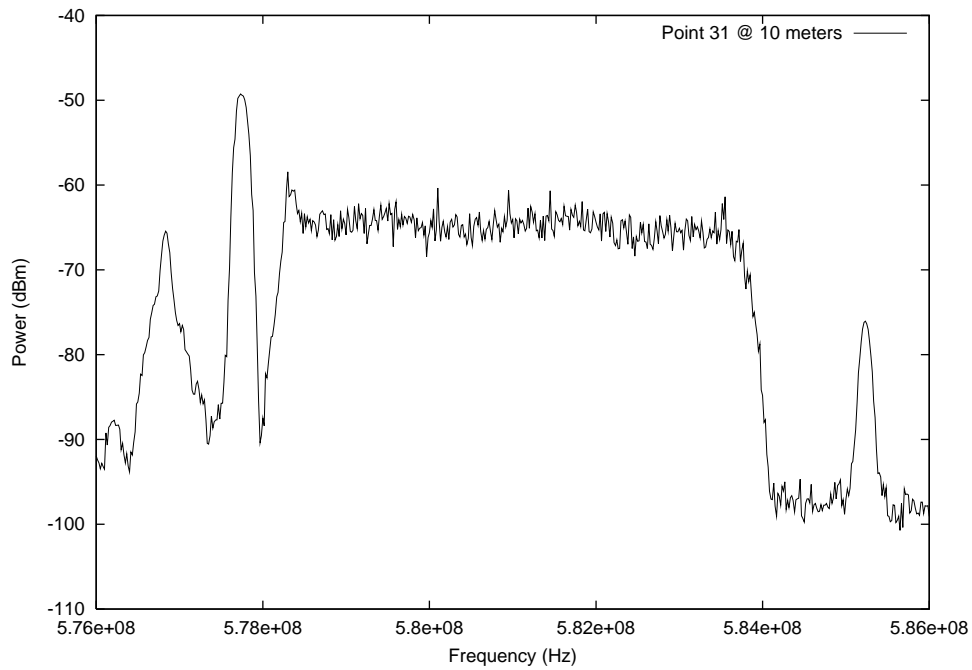
Figure 97: DTV envelope at 10 meters in location 31.

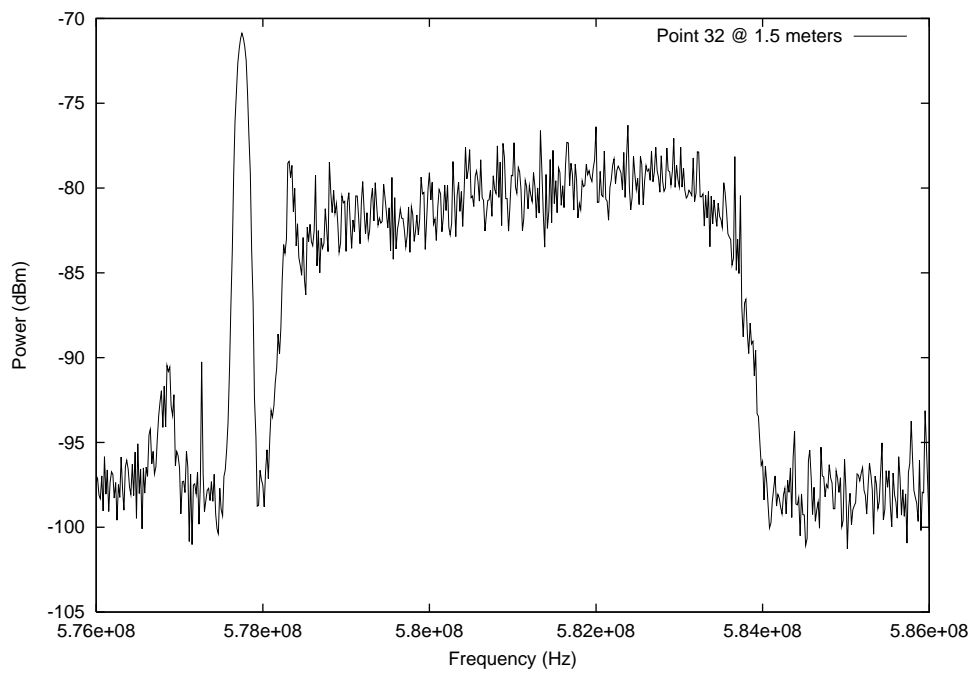
Figure 99: DTV envelope at 1.5 meters in location 32.

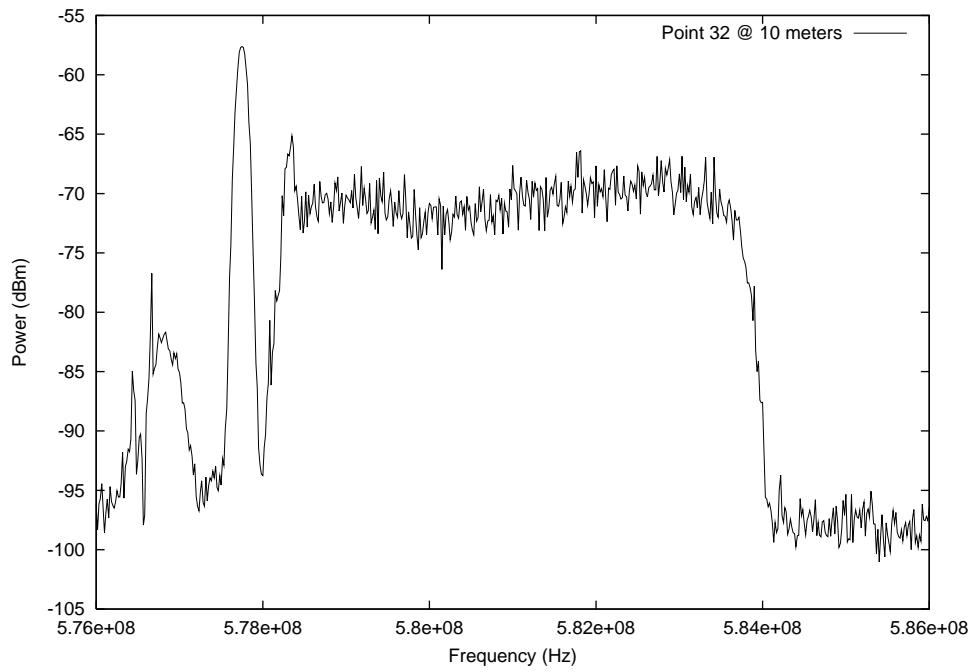
Figure 101: DTV envelope at 10 meters in location 32.

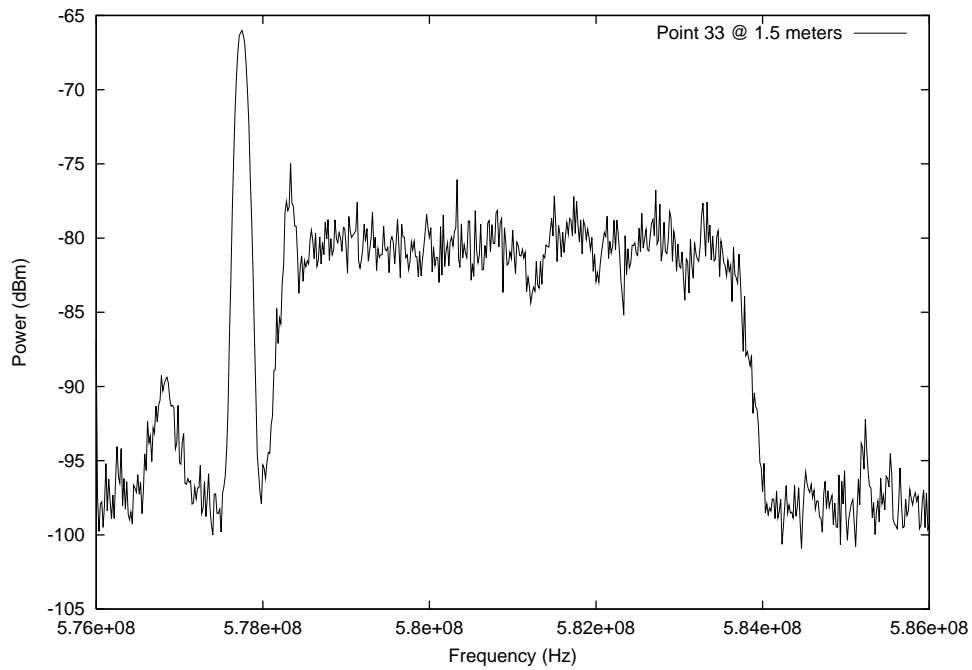
Figure 103: DTV envelope at 1.5 meters in location 33.

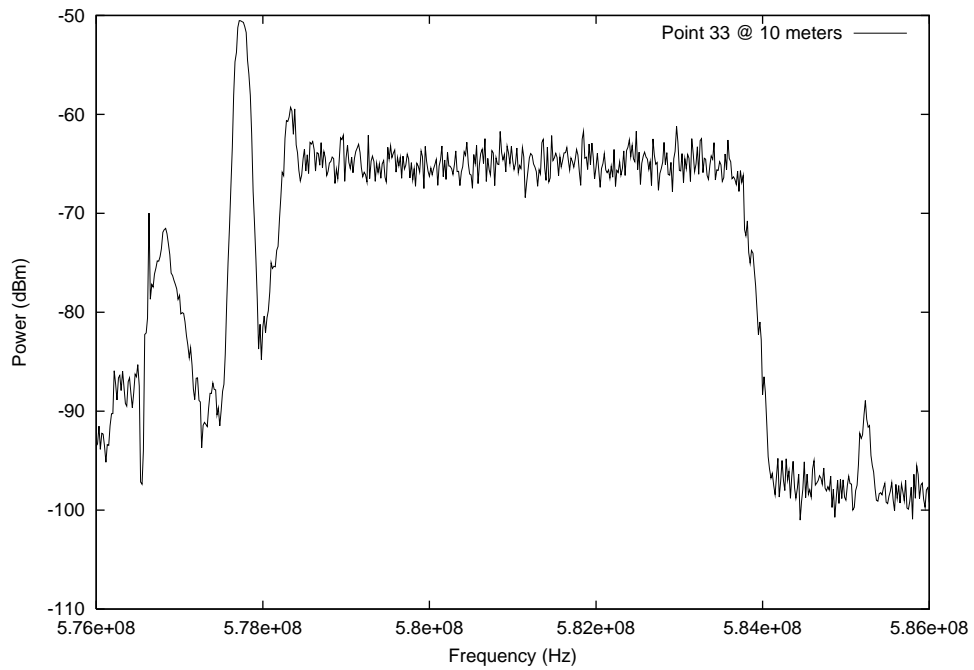
Figure 105: DTV envelope at 10 meters in location 33.

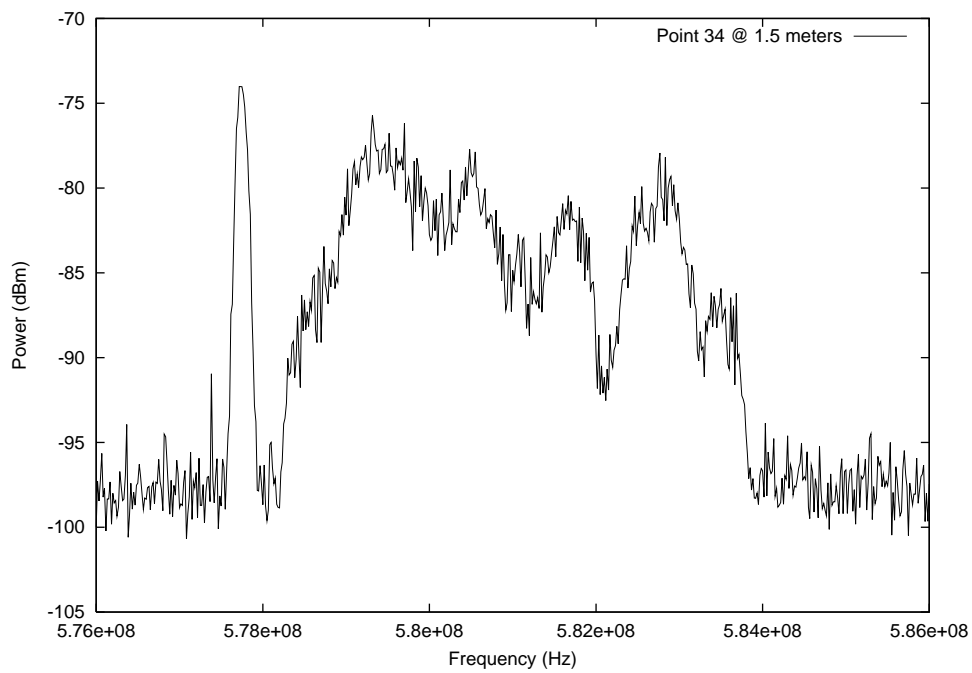
Figure 107: DTV envelope at 1.5 meters in location 34.

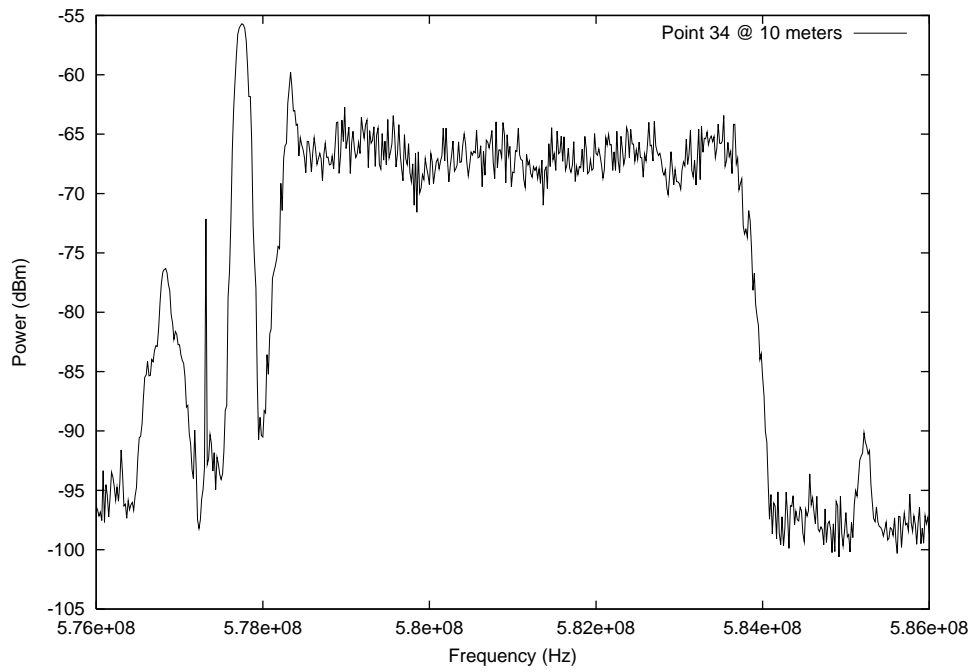
Figure 109: DTV envelope at 10 meters in location 34.

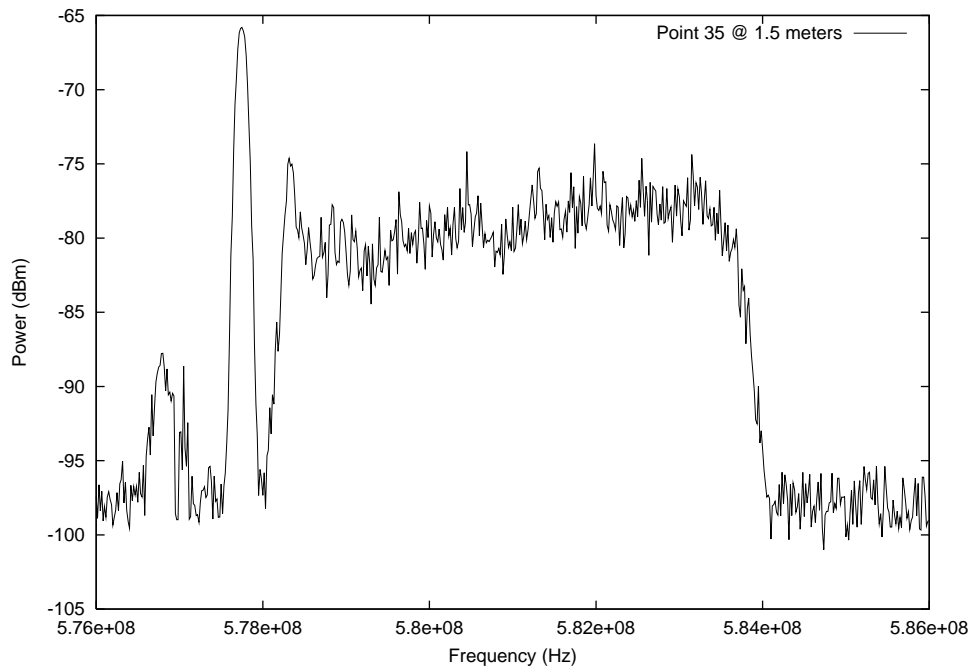
Figure 111: DTV envelope at 1.5 meters in location 35.

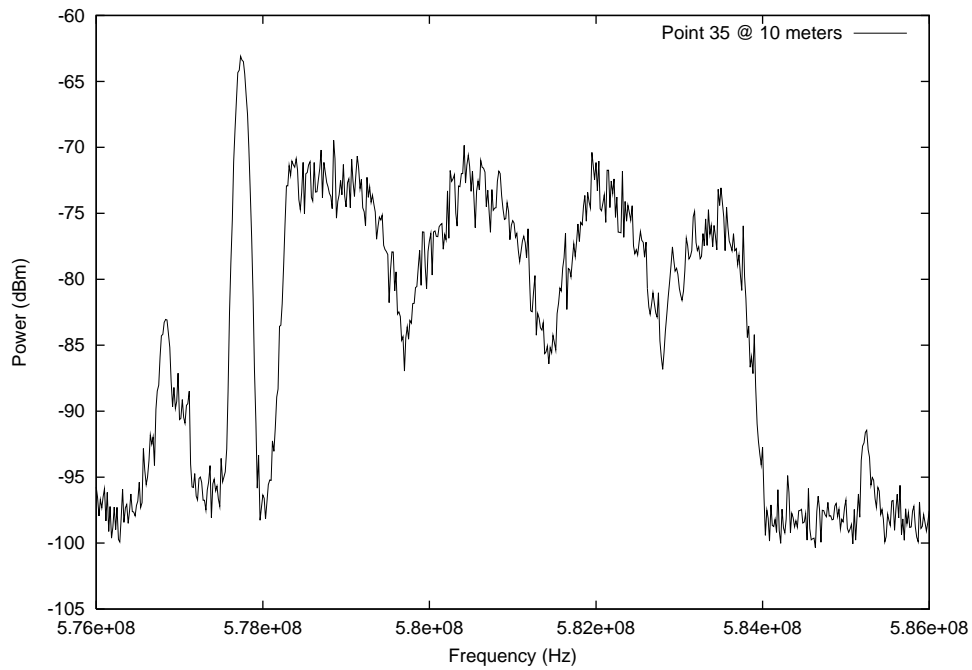
Figure 113: DTV envelope at 10 meters in location 35.

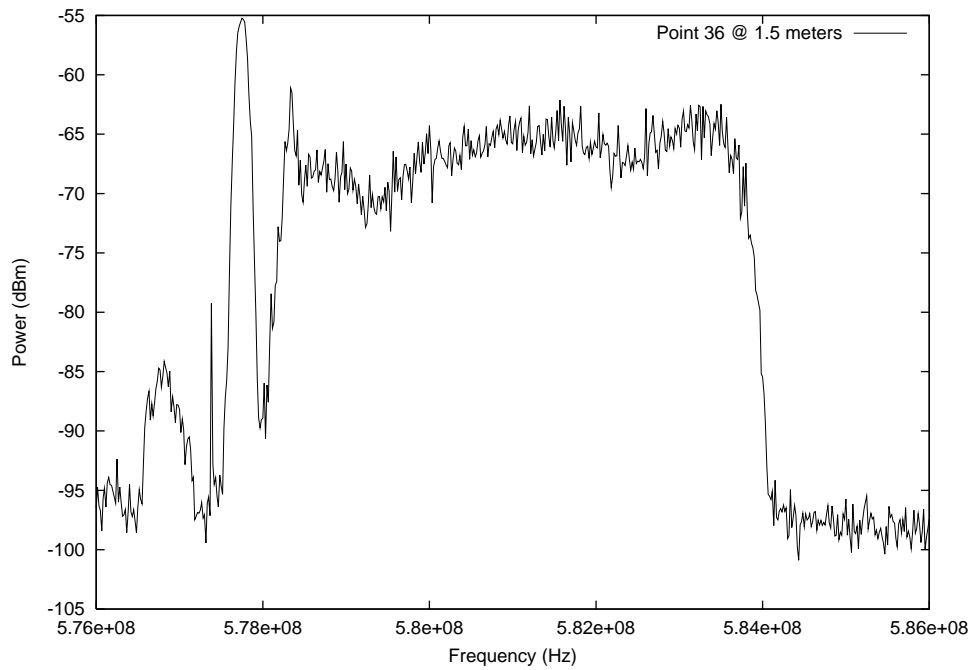
Figure 115: DTV envelope at 1.5 meters in location 36.

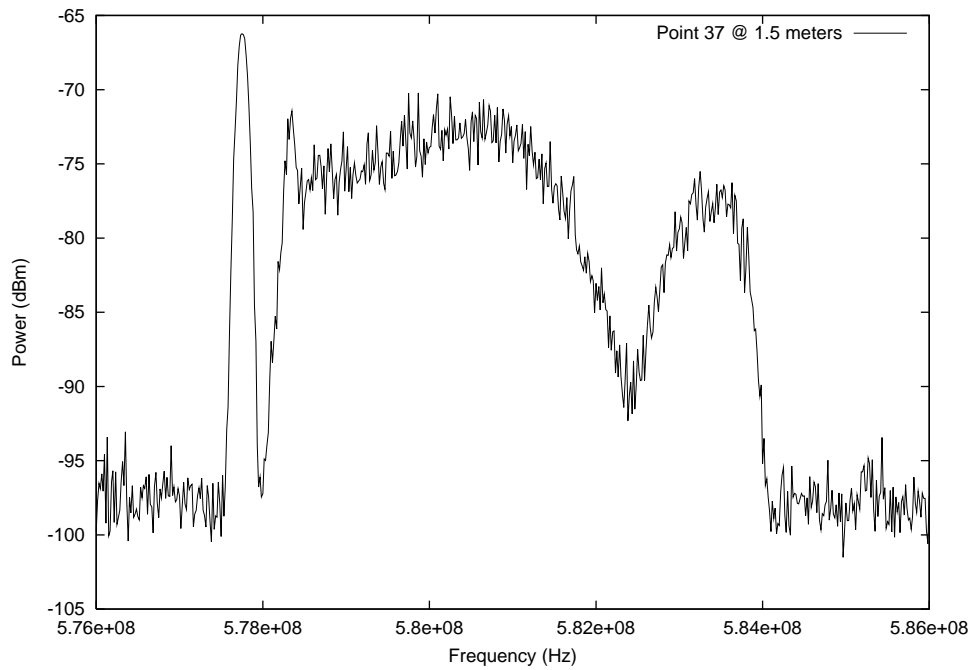
Figure 119: DTV envelope at 1.5 meters in location 37.

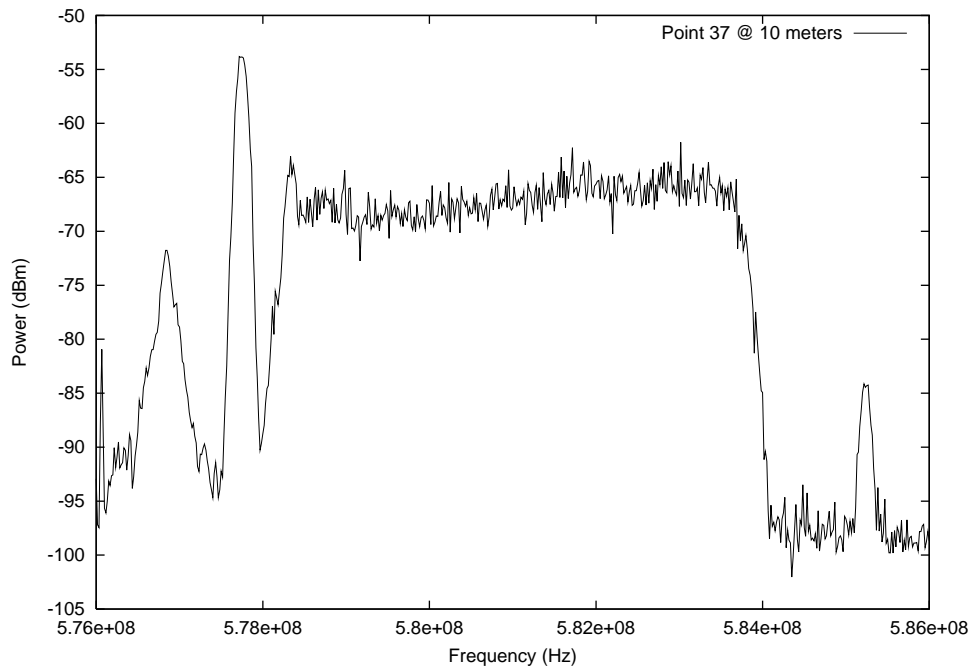
Figure 121: DTV envelope at 10 meters in location 37.

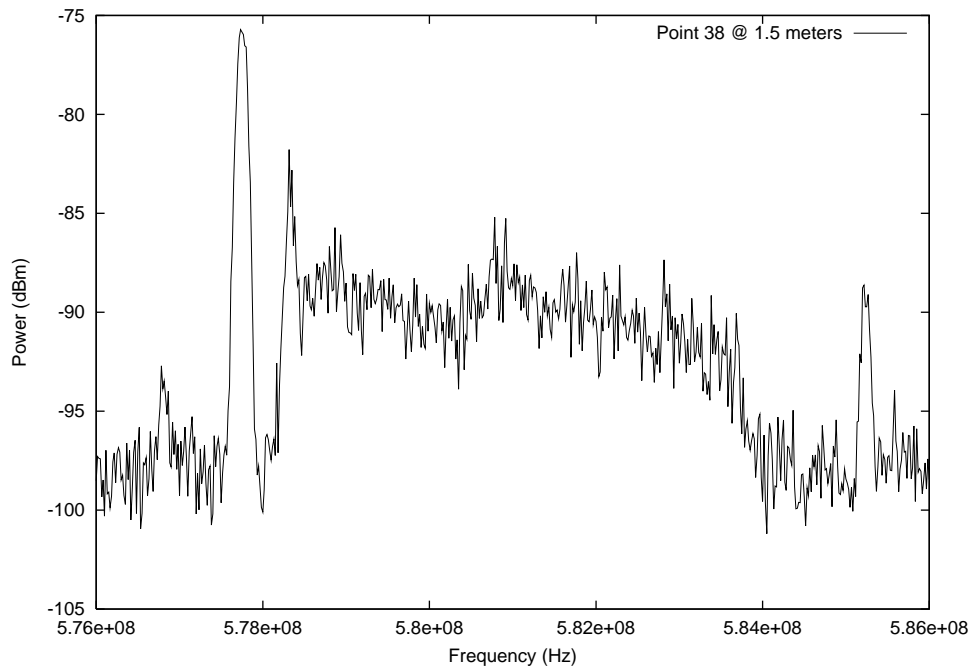
Figure 123: DTV envelope at 1.5 meters in location 38.

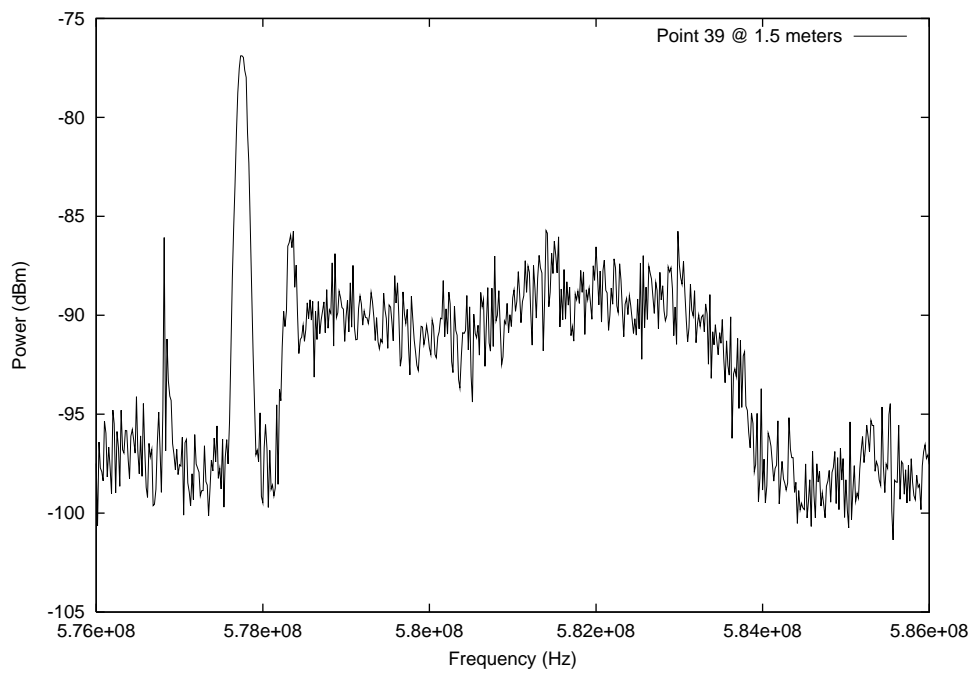
Figure 127: DTV envelope at 1.5 meters in location 39.

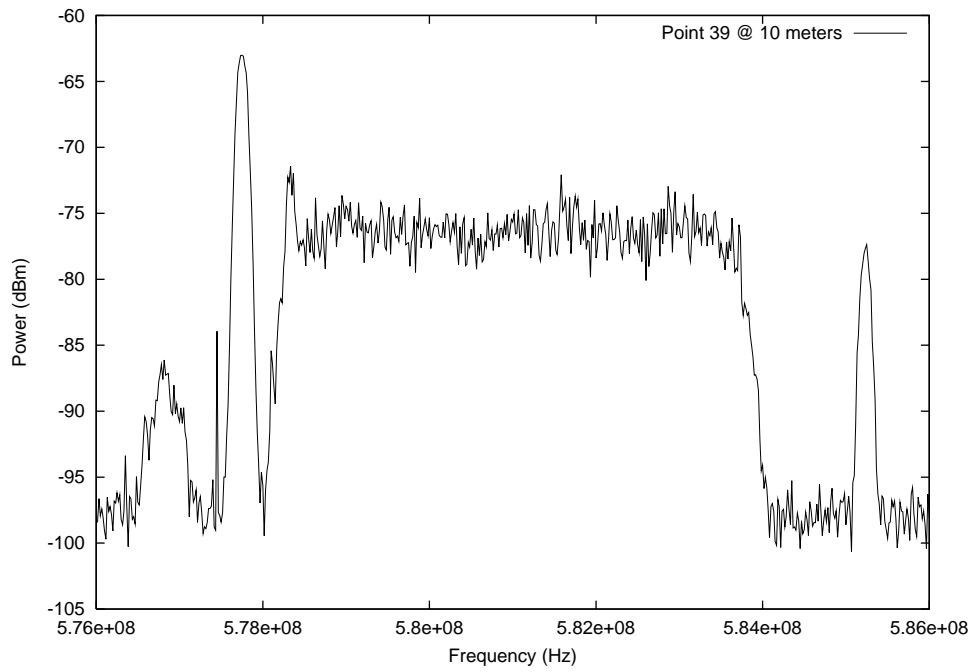
Figure 129: DTV envelope at 10 meters in location 39.

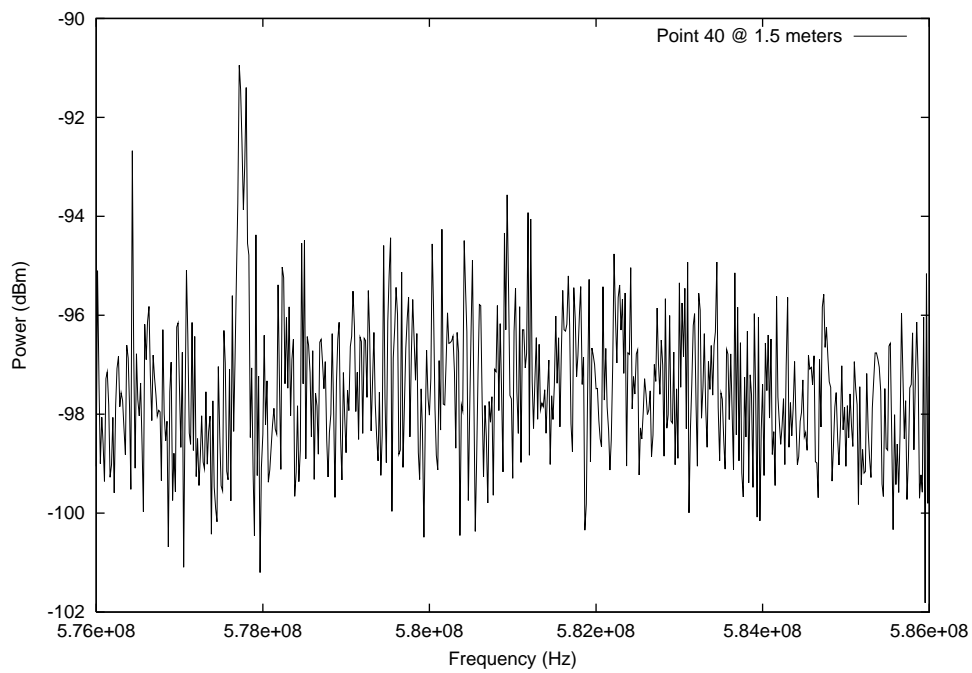
Figure 131: DTV envelope at 1.5 meters in location 40.

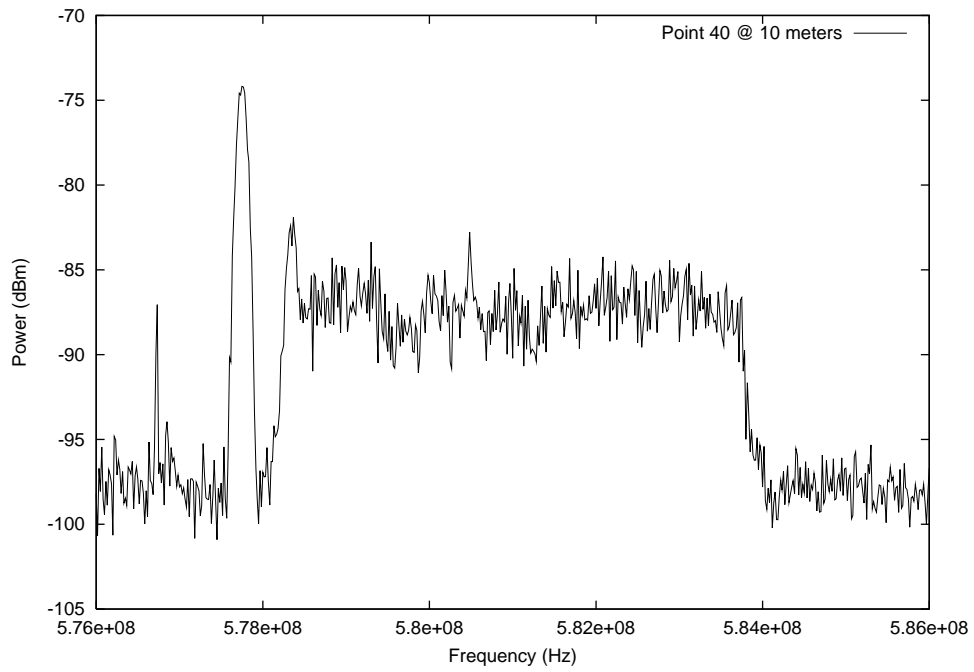
Figure 133: DTV envelope at 10 meters in location 40.
