NTIA Technical Memorandum TM-03-405

Digital Television (DTV) Field Strength and Video Quality Study

DIGITAL TELEVISION (DTV) FIELD STRENGTH AND VIDEO QUALITY STUDY

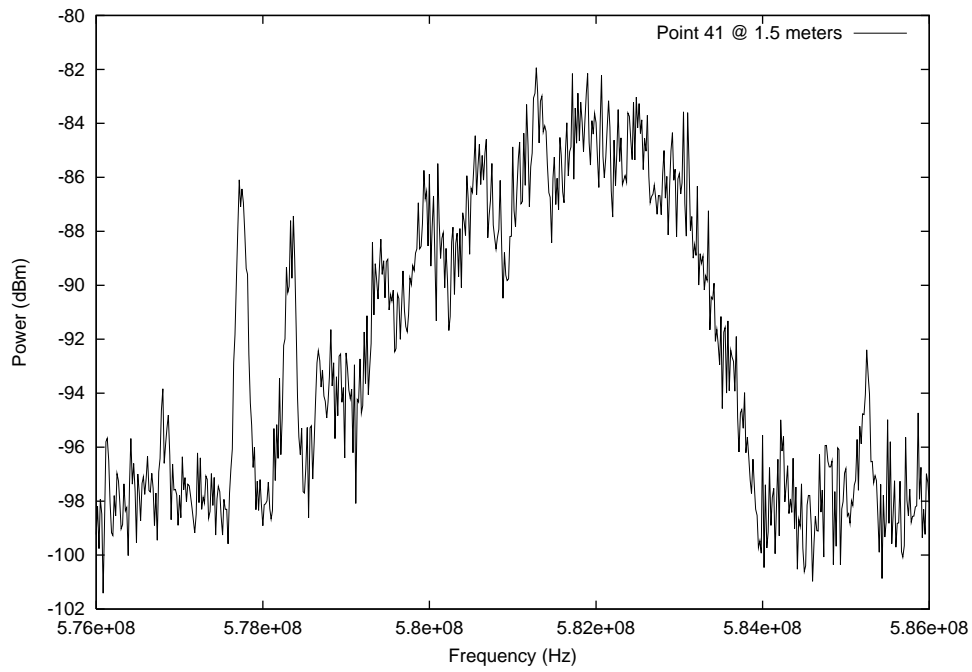
Figure 135: DTV envelope at 1.5 meters in location 41.

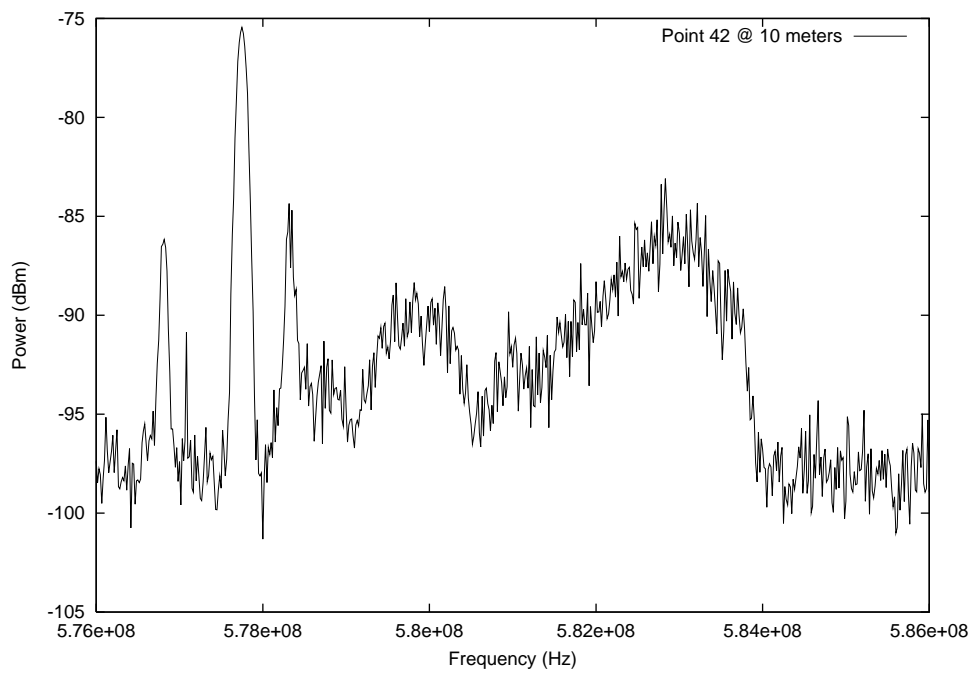
Figure 141: DTV envelope at 10 meters in location 42.
