Research
Paper
FPL-RP-515

Field Performance of Timber Bridges

1. Teal River Stress-Laminated Deck Bridge

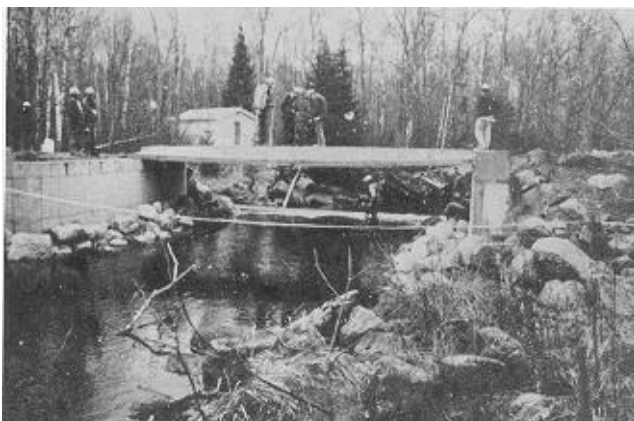
Figure 6—Placement of beam laminations on abutments. (M92 0009-4)

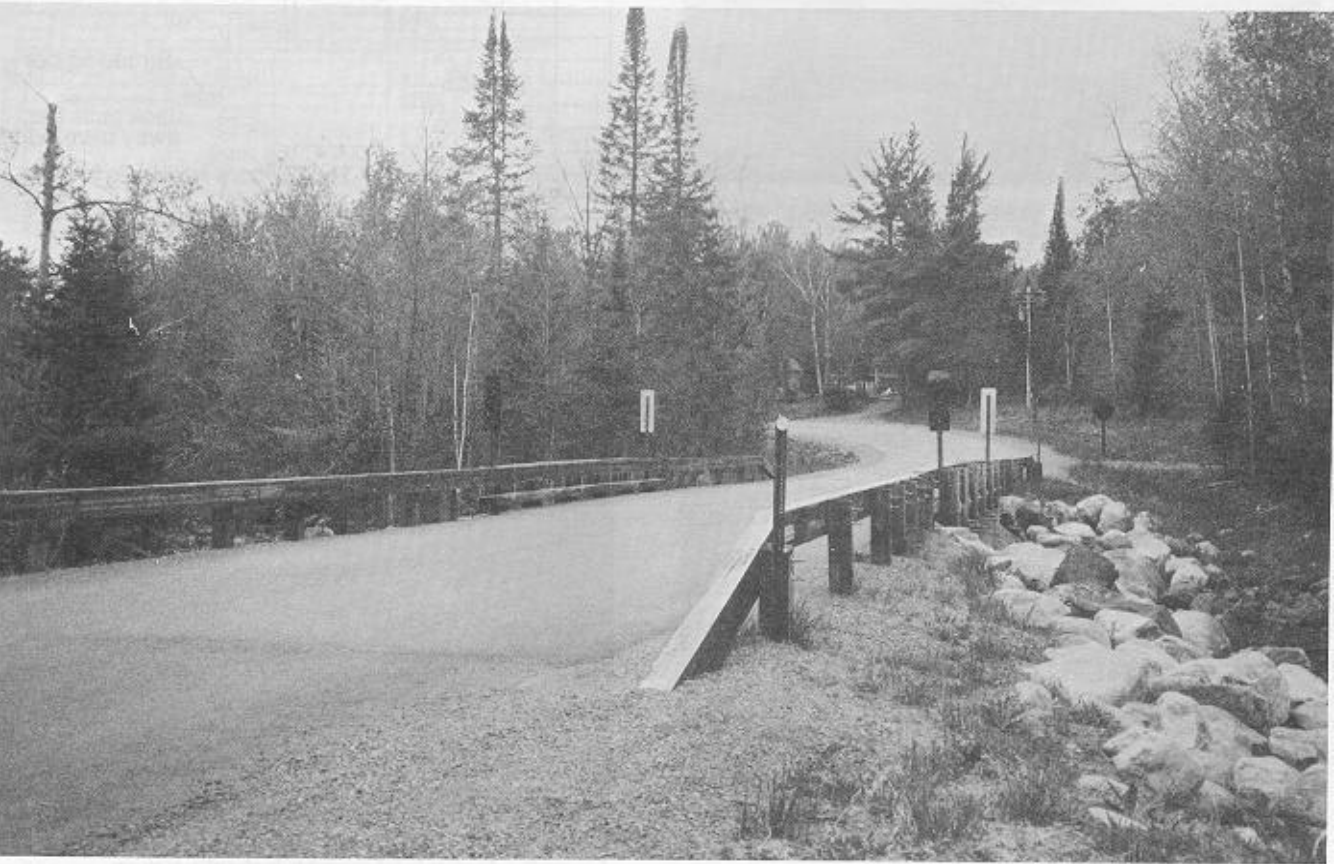
Figure 9—Completed Teal River bridge. (M92 0001-26, M92 0001-24)

Following the initial stressing, the timber curb and rail system was installed, and a glulam timber approach rail was constructed. Approximately 1 week after the initial stressing, the bridge was restressed to compensate for anticipated losses in the bar force (Ritter 1990). Approximately 7 weeks after the second deck stressing, the third and final deck stressings were completed. An asphalt wearing surface was subsequently applied in June 1990. The completed bridge is shown in Figure 9.

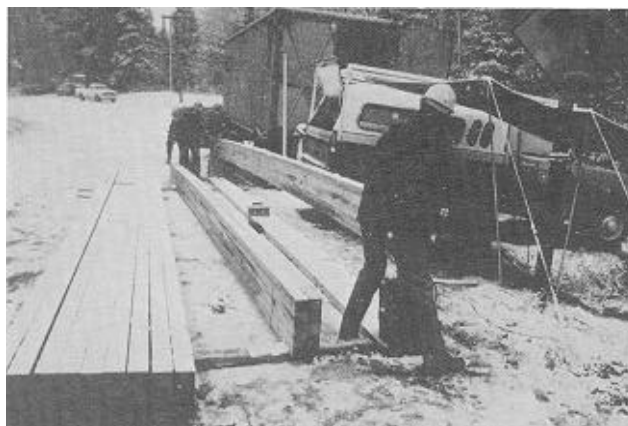
Figure 10—Measurement of the beam lamination MOE at the bridge construction site using the transverse vibration technique. (M92 0009-7)

preservatives. These tests involved a limited number of beam laminations that were previously tested at the manufacturing plant and tagged for identification after treating. The testing methods used in the field were the same as those used at the manufacturing plant and were conducted immediately prior to deck assembly (Fig. 10).

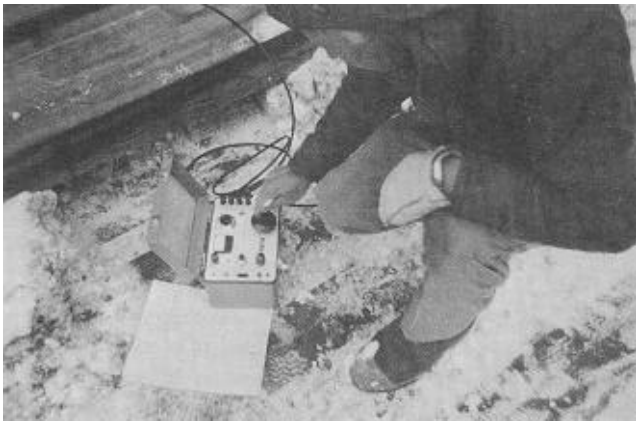
Figure 12—Reading a load cell with a portable strain indicator. (M92 0001-27A)

Load cell measurements were obtained by connecting a portable strain indicator to a plug on the load cell body (Fig. 12). Measurements were taken on a biweekly basis for the first year and monthly thereafter. Approximately midway through the monitoring period, 1 year after bridge construction, the load cells were unloaded and checked for zero balance shift.

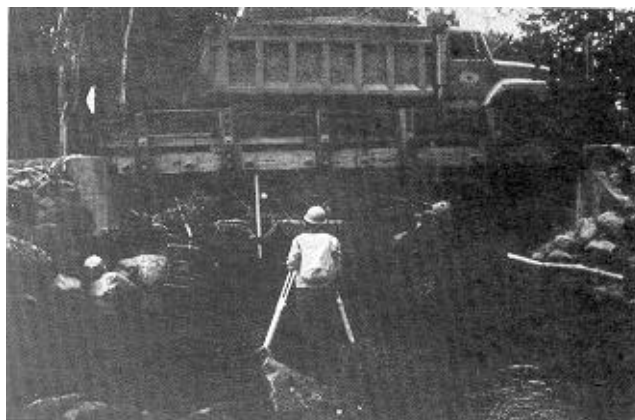
Figure 15—Measuring bridge deflection with surveyor's rod. (M92 0009-9)

were obtained by placing a surveying rod on the deck underside and reading values with a surveyor's level to the nearest 0.005 ft (Fig. 15). The accuracy of this method for repetitive readings is estimated to be ± 0.06 in.

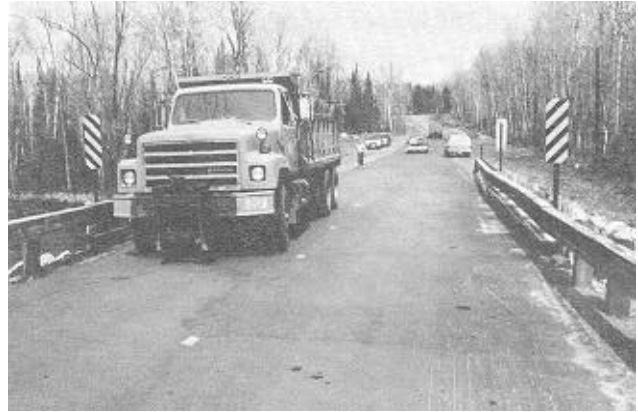
Figure 18—Load position 2 with a single vehicle in the upstream lane. (M92 0009-12)

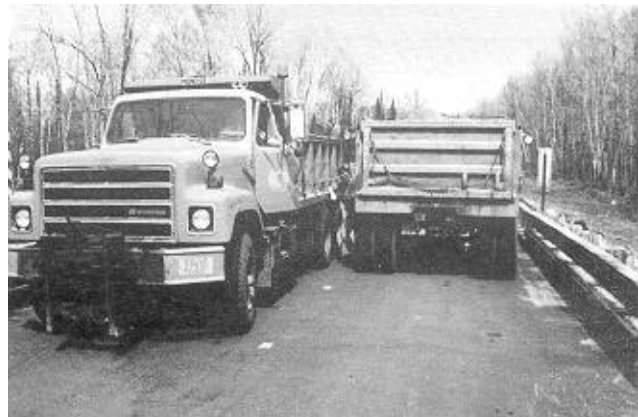
Figure 19—Load position 3 with both vehicles on the bridge. (M92 0009-13)

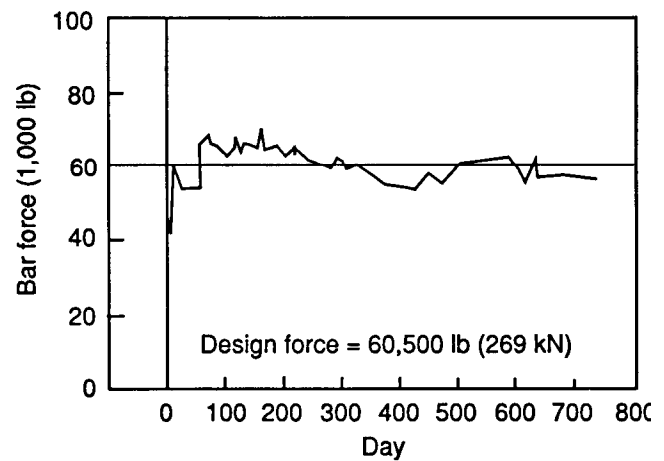
Figure 21—Average trend in bar tension force obtained from load cells installed on two stressing bars.

Figure 21 also reflects the minor fluctuations in bar force as a result of moisture changes and stress relaxation in the deck. However, force losses were minimal, and the average bar force was within 10 percent of the design force at the end of the monitoring period. This can be attributed to several factors, the most significant of which was the initial low moisture content level of the beam laminations. As the deck slowly gained moisture in reaching an equilibrium moisture content, the wood swelled slightly, which tended to offset force losses as a result of transverse stress relaxation. Other stress-laminated decks installed at relatively high moisture content levels had bar force losses as much as 80 percent during 2 years (Ritter and others 1990). On a comparative basis, the Teal River bridge vividly illustrates the advantage of low wood moisture content levels at the time of construction in reducing the rate of bar force loss.
