Research
Paper
FPL-RP-538

Field Performance of Timber Bridges

3. Birchlog Run and Tumbling Rock Run Stress-Laminated Deck Bridge

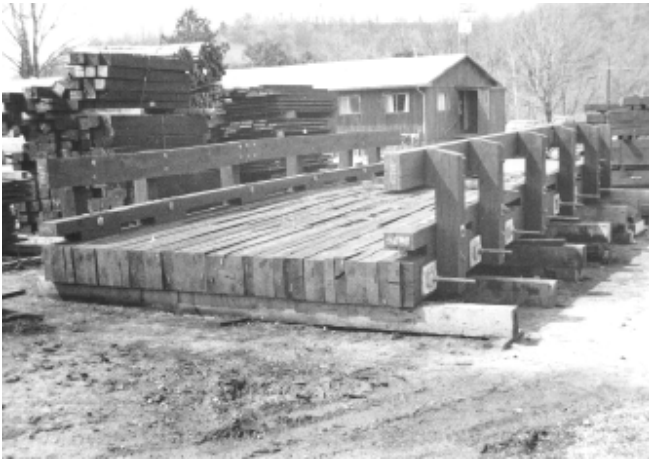
Figure 2—Prefabricated stress-laminated bridge deck at the fabrication facility.

Both the Birchlog Run and Tumbling Rock Run bridges were completely preassembled and stress laminated at a fabrication facility located approximately 75 miles from the construction sites (Fig. 2). The bridges were then transported to the construction sites on tractor trailers (Fig. 3) and lifted into place by a small crane using eye-hooks attached through the deck at several butt joint locations (Fig. 4). The stressing bars for both bridges were initially tensioned to a level of 72,000 lb at the fabrication facility. In addition, 4 and 8 weeks after installation, the bars were tensioned to the same bar force using a single hydraulic jack (Fig. 5). The installation of the two bridges was completed in less than 1 day under favorable weather conditions.

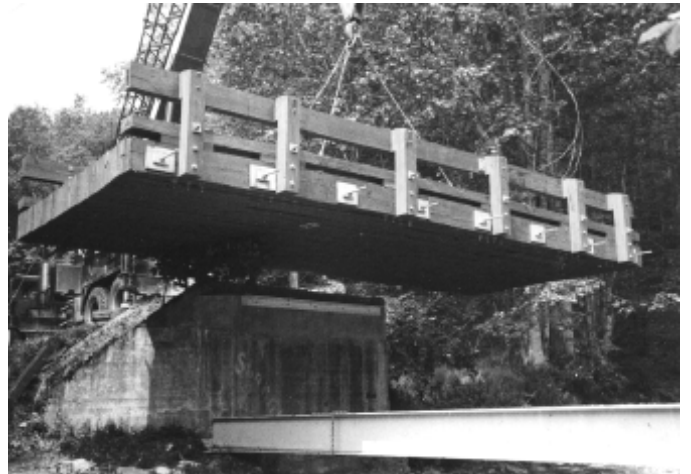
Figure 4—Lifting the prefabricated bridge deck into place with a small crane. Lifting attachments were placed through the deck at several butt joint locations.

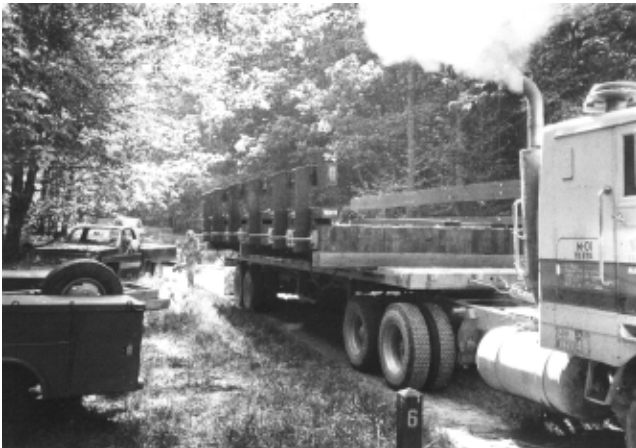
Figure 3—Delivering bridge deck to the construction site on a tractor trailer.

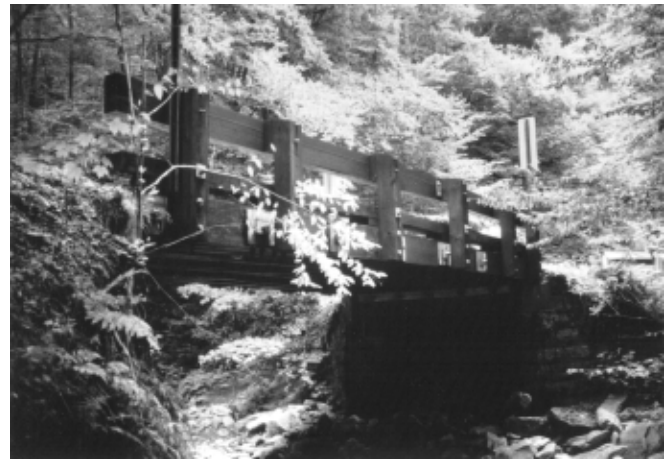
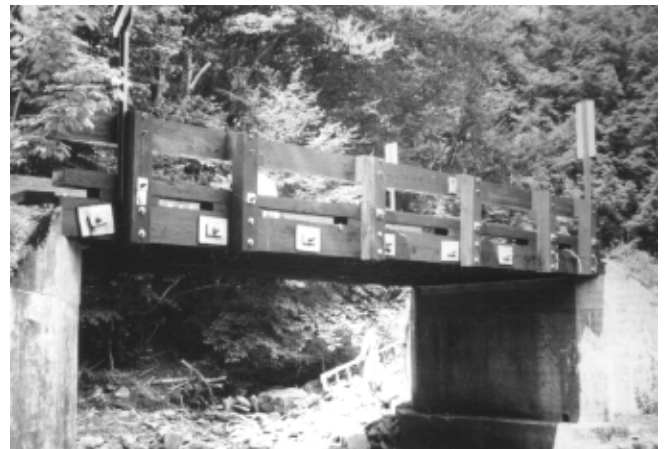
Figure 7—Completed bridges: Birchlog Run bridge, (top) Tumbling Rock Run bridge (bottom).

The as-built configurations for the Birchlog Run and Tumbling Rock Run bridges varied slightly from the design configurations and are shown in Figure 6. The Birchlog Run bridge measured 30.7 ft long and 12.8 ft wide, with an actual deck thickness of 13.5 in. The Tumbling Rock Run bridge was 30.3 ft long and 12.8 ft wide, with an actual deck thickness of 14 in. The span length measured center-to-center of bearings was 29.7 ft and 29.1 ft for Birchlog Run and Tumbling Rock Run, respectively. Overall dimensions of the two bridges indicated that length differed by 0.6 ft and deck thickness differed by 0.5 in. The completed bridges are shown in Figure 7.

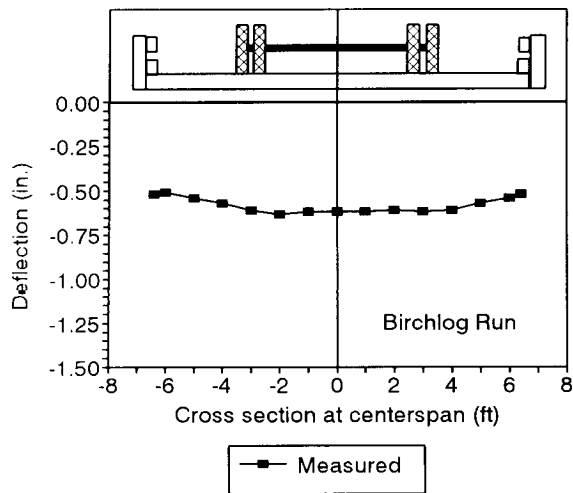
Figure 10—Measured load deflections for the Birchlog Run and Tumbling Rock Run bridges (plots are viewed looking east). Bridge cross-sections and vehicle positions are shown to aid interpretation and are not to scale.

Results of static-load testing of the Birchlog Run and Tumbling Rock Run bridges are shown in Figure 10. Maximum deflection was 0.63 in. for the Birchlog Run bridge and 0.57 in. for the Tumbling Rock Run bridge. For both bridges, the maximum deflection occurred at the edge of the wheel load, 12 in. from the center of the wheel line. The deflected shape for both bridges was similar and typical of the orthotropic plate behavior previously observed for other stress-laminated timber bridges (Ritter and Oliva 1990). Although the MOE of the Birchlog Run Southern Pine laminations was greater than the MOE of the Northern Red Oak laminations of the Tumbling Rock Run bridge, the greater deflection at Birchlog Run was expected because of the longer span and thinner deck.

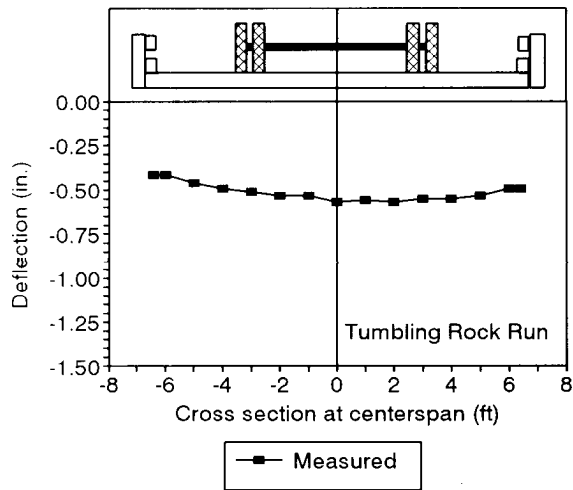
Figure 11—Comparison of the measured load deflections and those obtained by orthotropic plate modeling. Bridge cross-sections and vehicle positions are shown to aid interpretation and are not to scale.

A comparison of the measured deflection and that generated by orthotropic plate modeling is shown in Figure 11. Using the same analysis parameters and criteria, the predicted behavior of both bridges when subjected to AASHTO HS 20-44 loading is shown in Figure 12. For the Birchlog Run bridge, the maximum HS 20-44 deflection was 0.77 in., or 1/463 of the as-built bridge span measured center-to-center of bearings. The maximum HS 20-44 deflection for the Tumbling Rock Run bridge was 0.69 in., or 1/506 of the as-built bridge span. Although the span of both bridges exceeded that assumed in the initial design, the predicted live-load static deflections are well within the 1/360 limit.

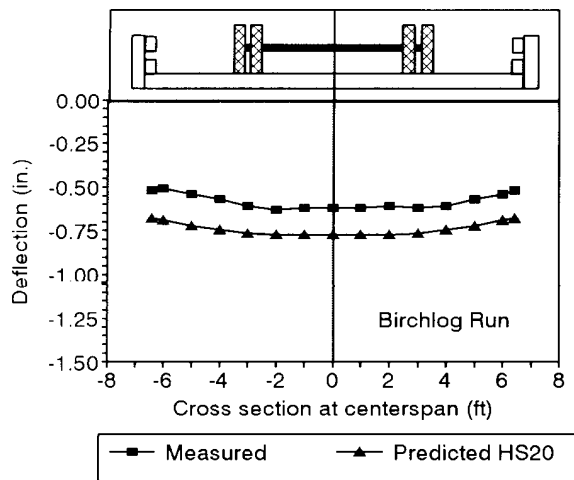
Figure 12—Comparison of the measured load deflection with predicted AASHTO HS 20-44 deflection based on orthotropic plate modeling. Bridge cross-sections and vehicle positions are shown to aid interpretation and are not to scale.

- Load testing indicated that both bridges are acting as orthotropic plates. The maximum deflection as a result of one lane of AASHTO HS 20-44 loading is estimated for the Birchlog Run bridge to be 0.77 in., or 1/463 of the bridge span measured center-to-center of bearings, and for the Tumbling Rock Run bridge 0.69 in., or 1/506 of the bridge span measured center-to-center of bearings.

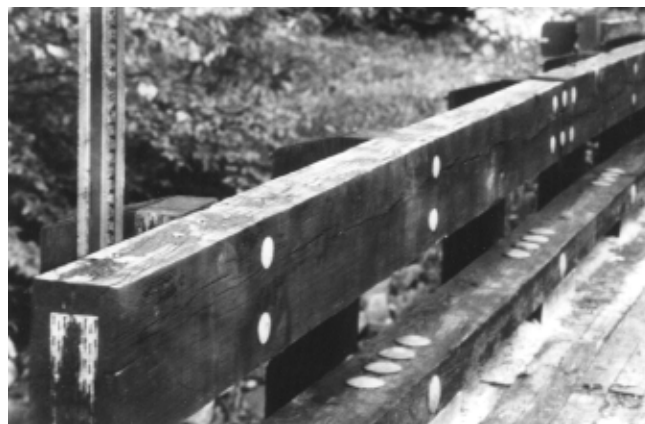
Figure 13—Spiked metal plates in the end grain of sawn lumber curb and rail members.

Inspection of the wood components of both bridges showed no signs of deterioration. Exposed end grain of the sawn lumber curb and rail members were provided with spiked metal plates to inhibit checking as a result of moisture content changes, and the plates appeared to be functioning well (Fig. 13). The tops of the rail posts were heavily coated with creosote, which also inhibited checking. Minor checking was evident in the exposed side grain of the curbs and rails.

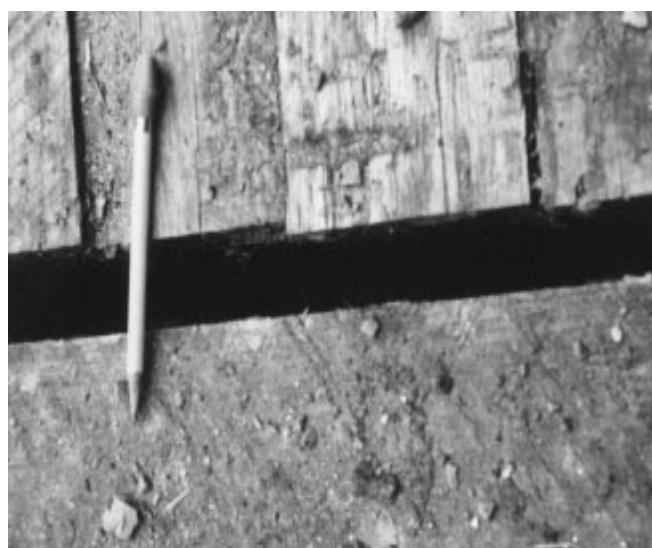
Figure 14—Gap between the bridge end and the substructure backwall at the Tumbling Rock Run bridge.

Inspection of the Tumbling Rock Run bridge revealed a wide gap between the bridge end and the substructure back-wall (Fig. 14). Although no deterioration was noted, dirt and other debris were accumulating in the gap. If left unattended, the debris will likely hold moisture and could lead to premature deterioration of the superstructure end grain.
