Research  
Paper  
FPL-RP-539

# Field Performance of Timber Bridges

## 4. Graves Crossing Stress-Laminated Deck Bridge

James P. Wacker  
Michael A. Ritter

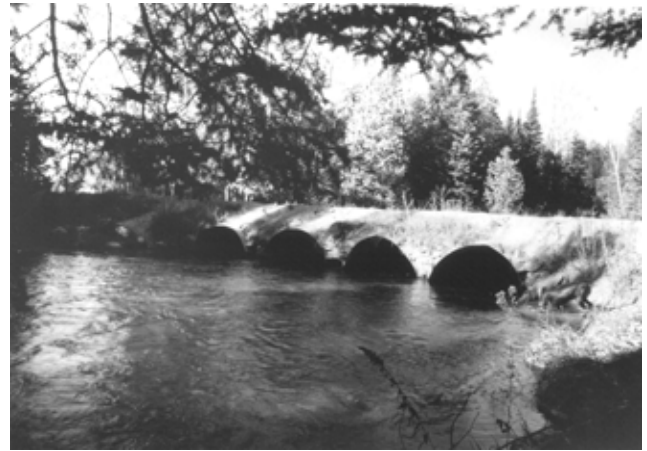
Figure 2—Original Graves Crossing site prior to bridge construction.

Before replacement in 1991, Graves Crossing consisted of a series of four corrugated steel culverts with a 3-ton posted load limit (Fig. 2). The culverts were in poor condition and insufficient to meet the hydraulic flow requirements at the site. Past roadway washouts and severe scour problems required that the culverts be replaced with a new bridge structure designed for greater hydraulic capacity. In addition, a new bridge capable of supporting standard highway loads was needed to provide safe access for fire-fighting vehicles, school buses, and logging trucks. Replacement of the existing culverts with a skewed bridge was determined to be the best alternative, because it would allow alignment of the abutments with the natural stream channel and reduce adverse impacts on the Jordan River.

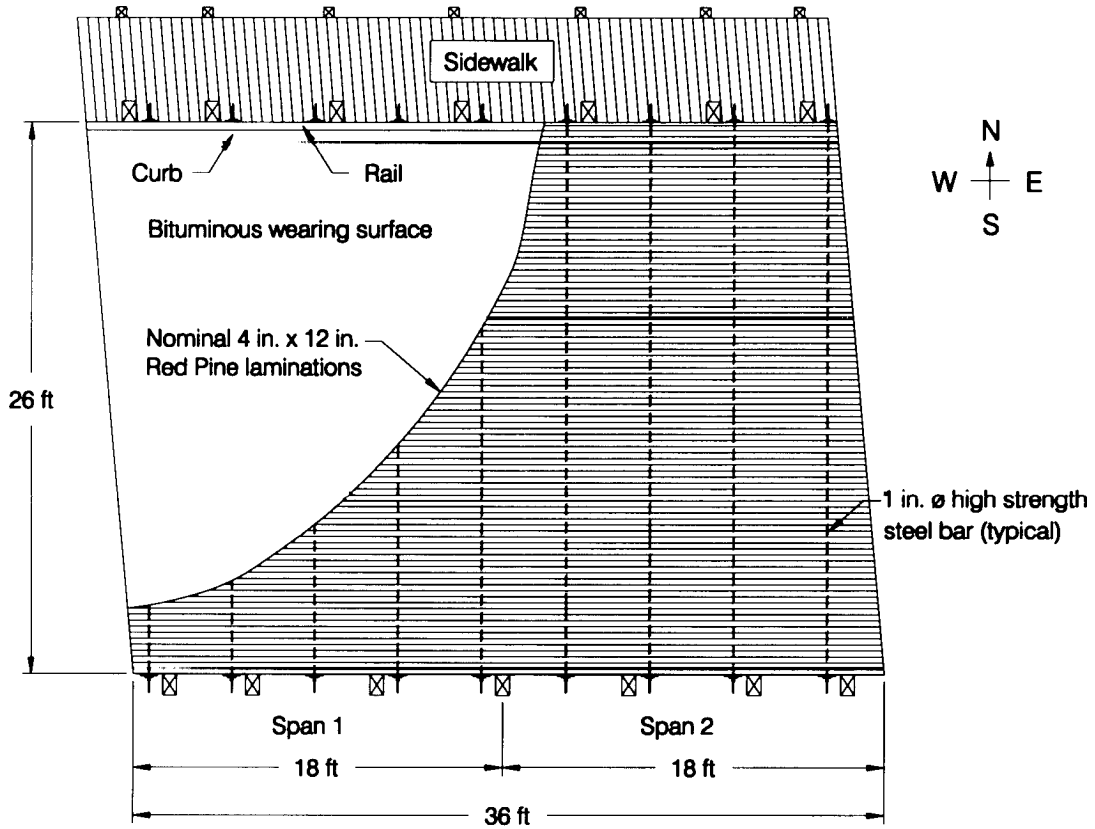
Figure 3—Design configuration of the Graves Crossing bridge.

The design geometry of the Graves Crossing bridge provided for a two-span continuous deck, 36 ft long, 26 ft wide, and 12 in. deep (Fig. 3). The stress-laminated deck consists of

4-in.-thick Red Pine lumber treated with CCA preservative in accord with AWP Standard C14 (AWPA 1989). Because none of the laminations extended the bridge length, butt joints were employed in the deck. Butt joints were spaced across the width and length at intervals of four laminations and 4 ft, respectively.

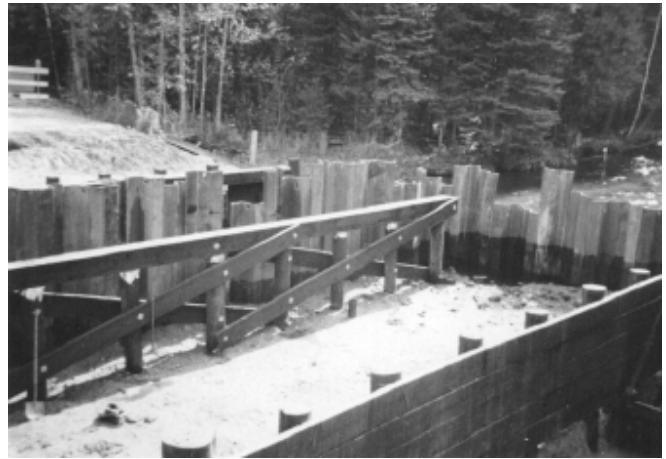
Figure 4—Coffer dam used during installation of timber piling, abutments, and bent.

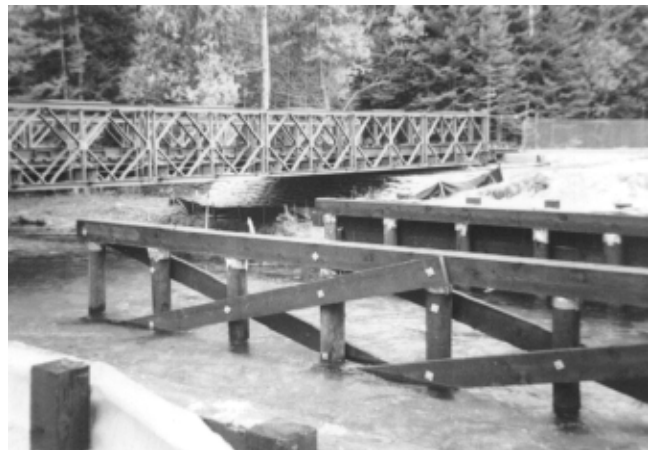
Figure 5—This temporary (Bailey-type) bridge allowed uninterrupted traffic flow across the bridge during the construction of the Graves Crossing bridge.

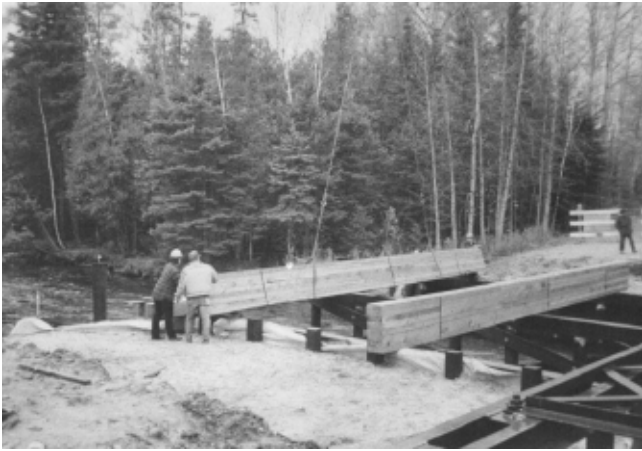
Figure 6—Small crane used to place the strapped lamination bundles onto the abutments.

The lumber laminations for the superstructure were delivered to the site in 4-ft-wide strapped bundles that extended the full length of the bridge. These bundles were placed on the completed substructure by a small crane (Fig. 6). Before removing the metal straps from the bundles, steel stressing bars were inserted through the prebored holes and anchorage plates and nuts were attached. The bridge laminations were intentionally oversized in length because of the bridge skew and were trimmed on-site with a chainsaw (Fig. 7). The field cuts exposed untreated end-grain areas of the laminations that were field-treated with copper naphthanate preservative. A preferable method is to cut the laminations to the correct length prior to preservative treatment.

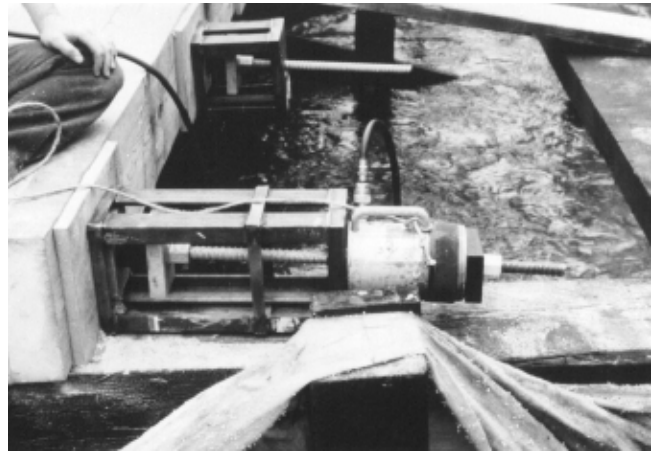
Figure 8—Initial tensioning of the stressing bars was completed with a hollow-core hydraulic cylinder and pump at each successive bar, beginning at one end of the bridge.

After anchoring the centerline of the deck to the substructure with drift pins, hydraulic equipment was used to tension the stressing bars. The initial tensioning was completed immediately after the deck laminations were set on the abutments. Tensioning was completed at each successive bar with a single hydraulic jack system to a force level of 58,000 lb (Fig. 8). During this initial tensioning, the bars were tensioned four separate times to achieve a uniform 100 lb/in<sup>2</sup> interlaminar compressive stress. Subsequent tensioning used the same procedure and force level and was conducted at 1, 10, and 13 weeks after the initial tensioning.

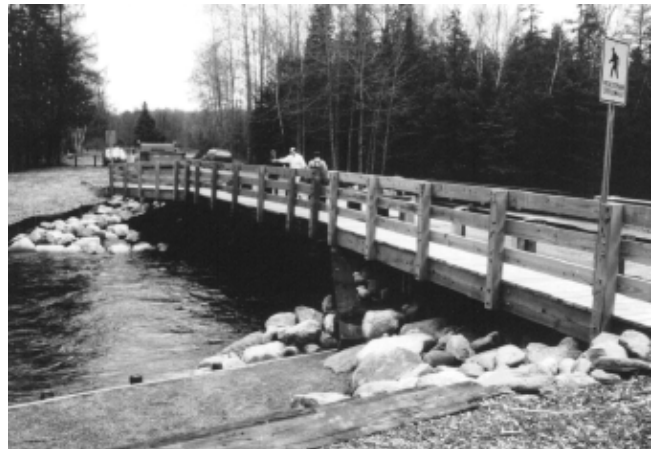
Figure 9—Completed sidewalk structure attached to the superstructure on the downstream side of the bridge.

lumber sidewalk was installed at the downstream side of the bridge to provide safe pedestrian access to an adjacent campground (Fig. 9). Approximately 1 month after the initial bar tensioning, the waterproof geotextile membrane and 3-in.-thick asphalt pavement were installed on the deck (Fig. 10). The completed Graves Crossing bridge is shown in Figure 11.

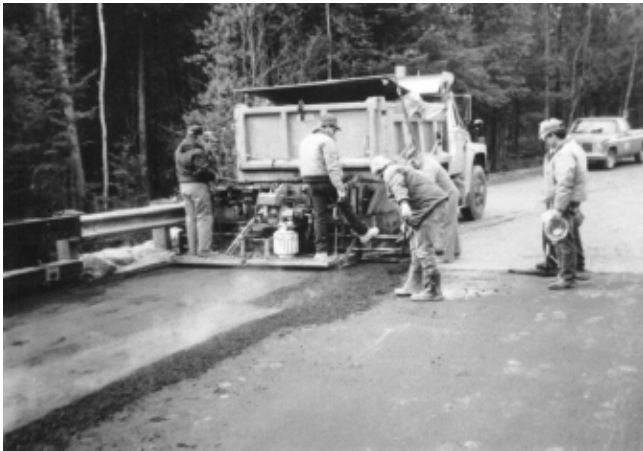
Figure 10—Asphalt pavement wearing surface was applied to the deck approximately 4 weeks after installation.

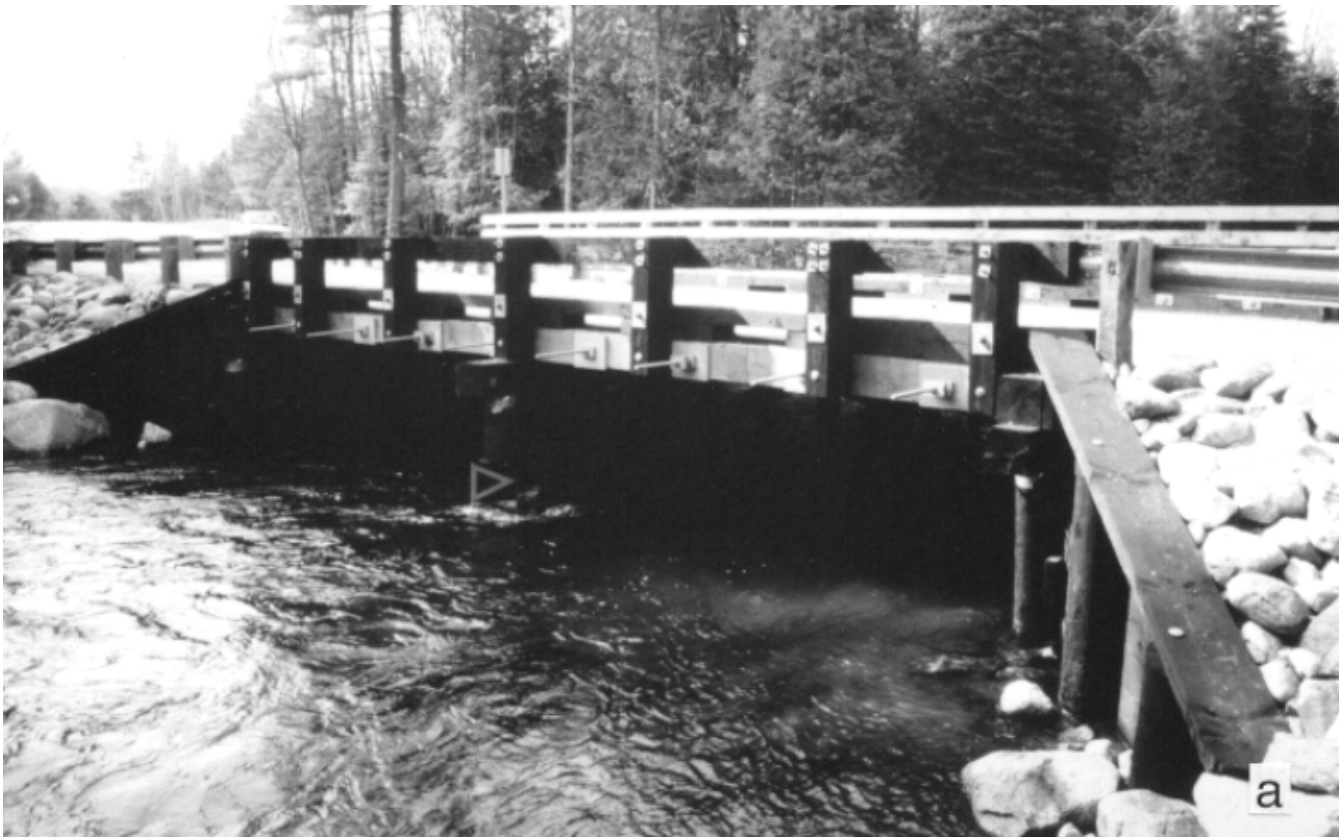
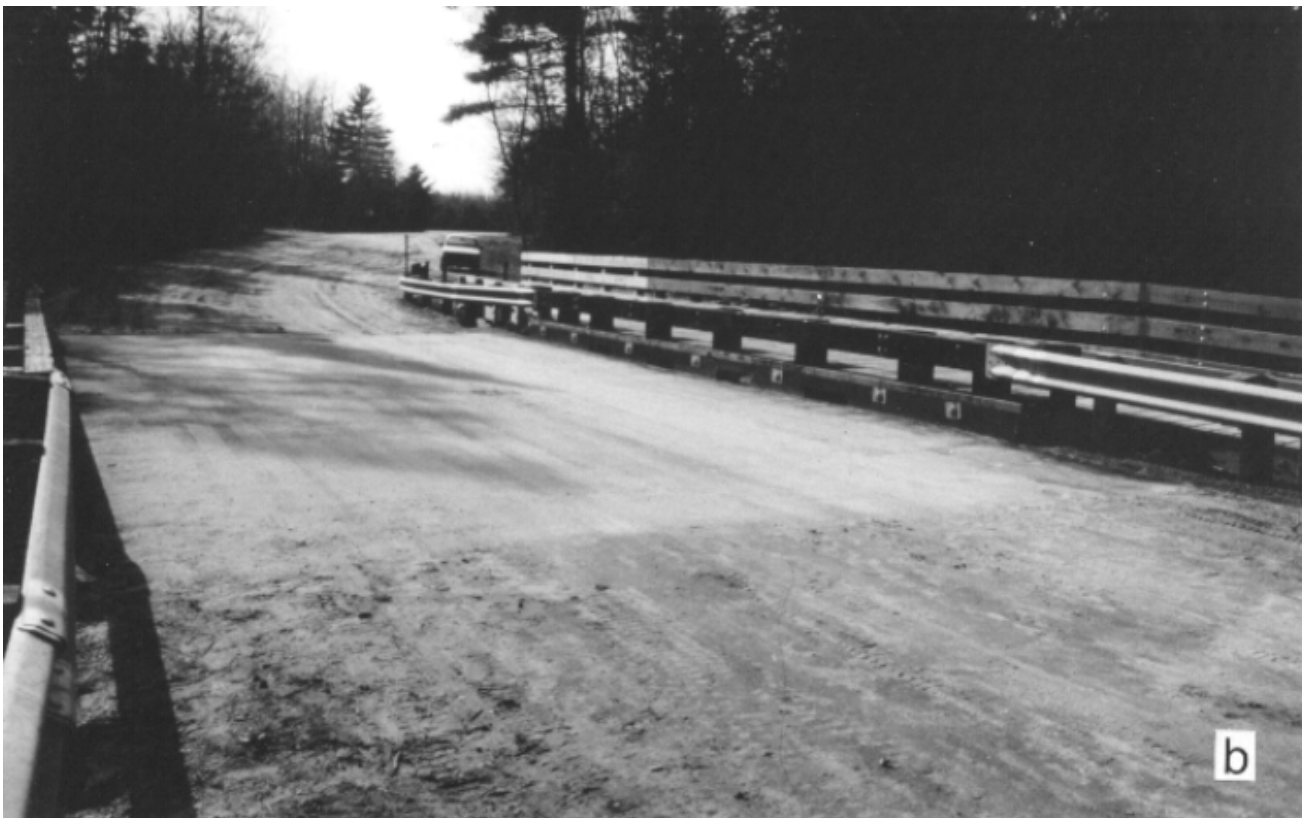
Figure 11—Completed Graves Crossing bridge: (a) side view, (b) end view.

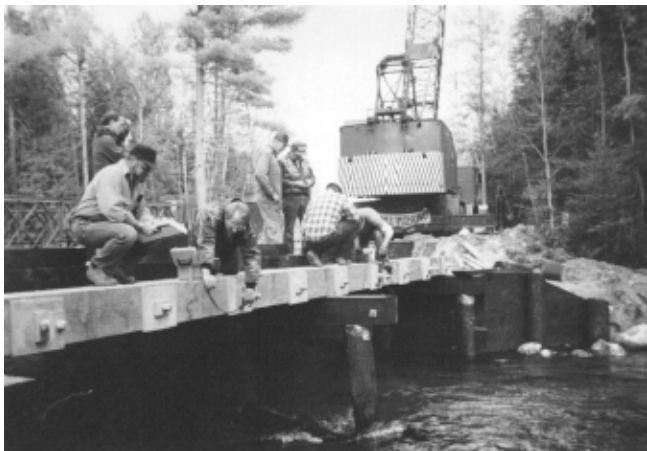
Figure 14—Antrim County personnel collecting load cell readings with a portable strain indicator shortly after the initial tensioning of the stressing bars.

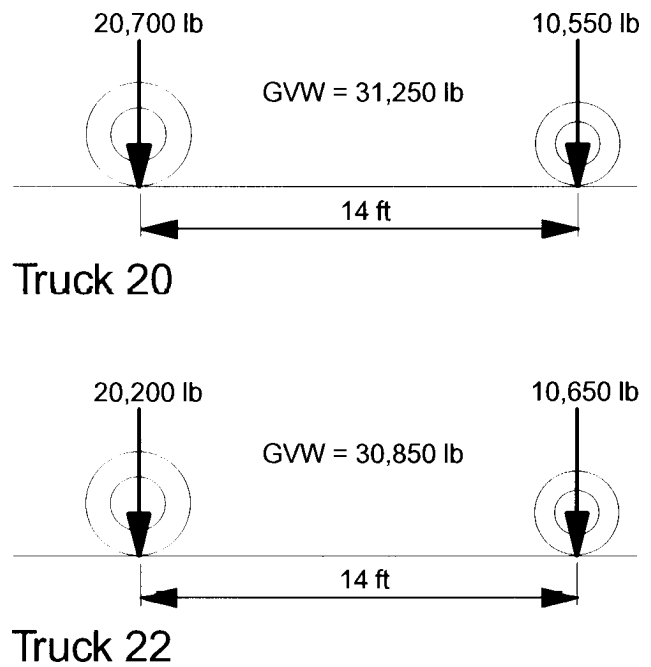
Figure 15—Load test vehicle axle loads and configuration.

The load test was performed April 20, 1992, with two trucks: truck 20 with a gross vehicle weight of 31,250 lb and truck 22 with a gross vehicle weight of 30,850 lb (Fig. 15). Each of the two spans was tested separately using designated posi-

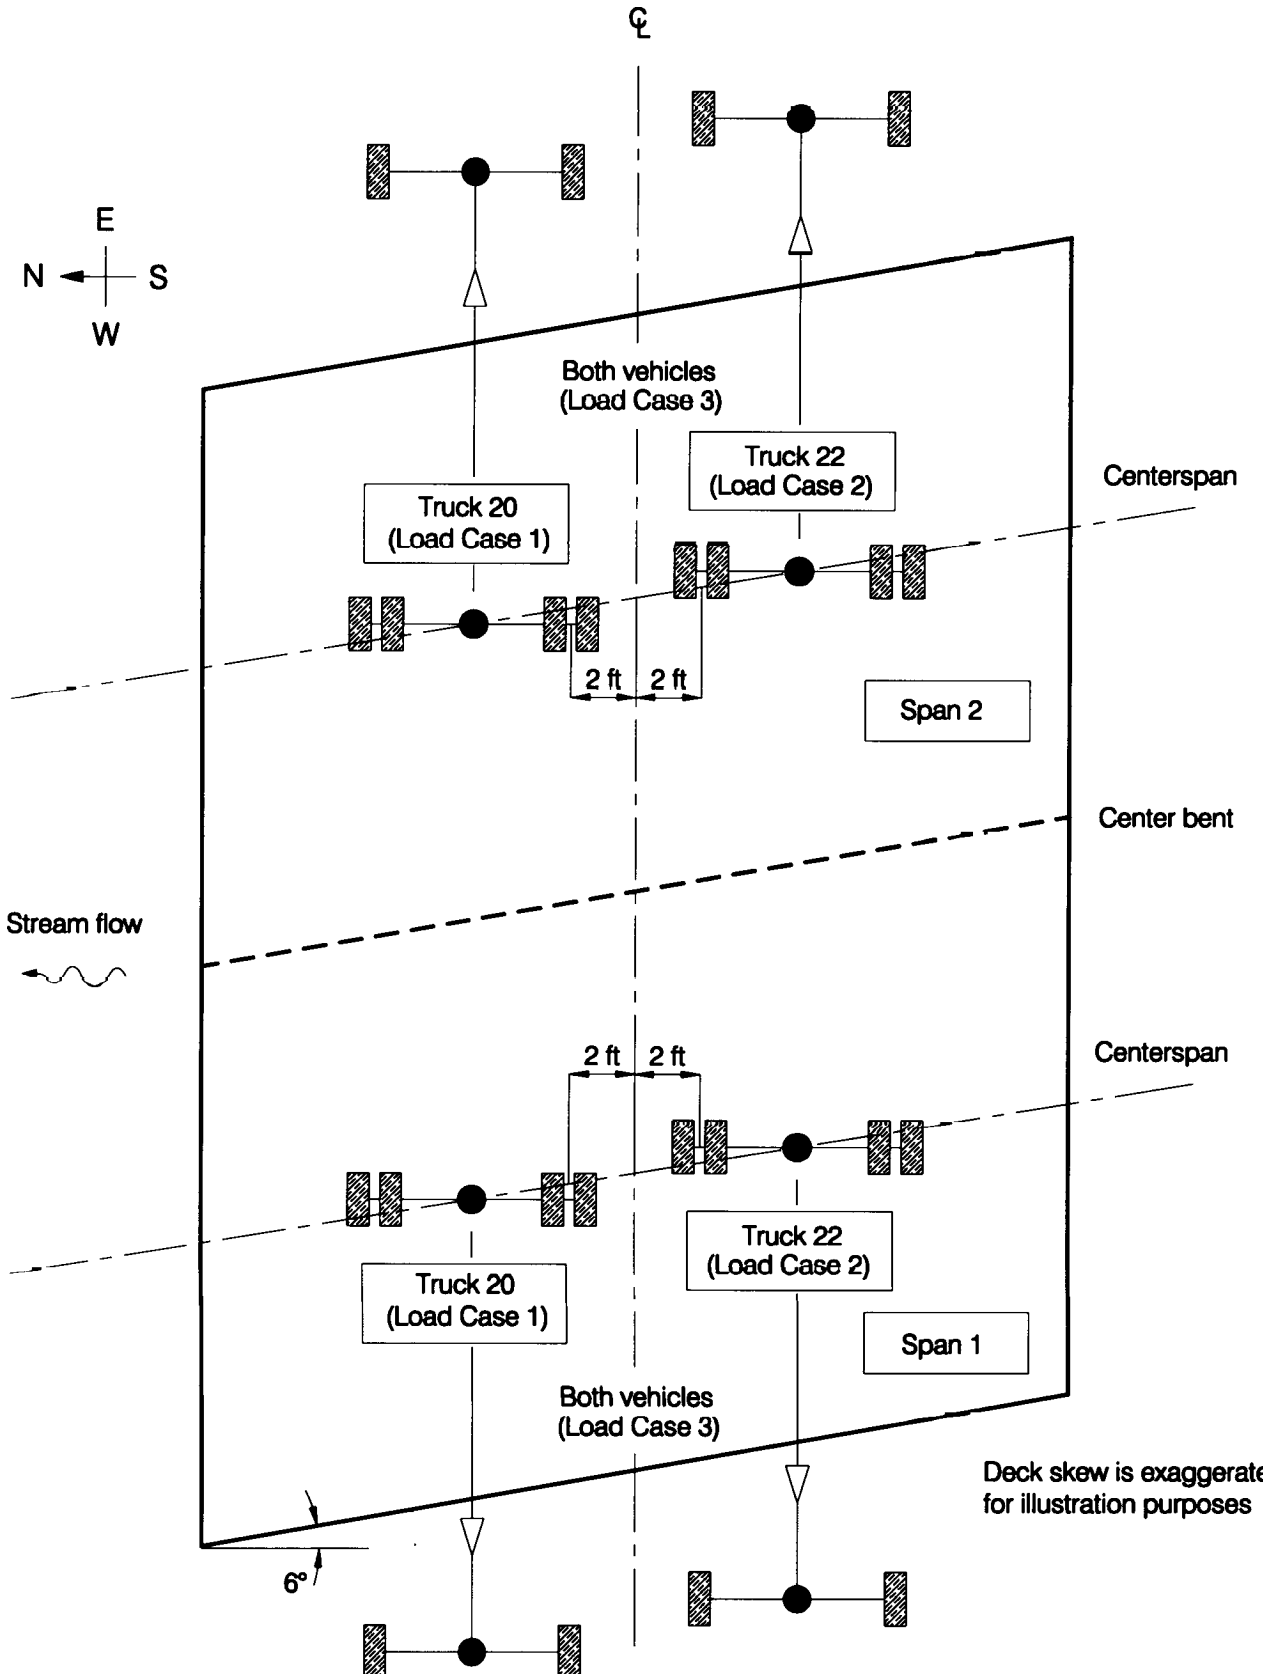
Figure 16—Load test vehicle positioning for all load cases.

tions in the longitudinal and transverse directions to produce the maximum deflection in accordance with AASHTO recommendations (AASHTO 1989). For each span, three load cases were completed by longitudinally positioning the midpoint of the rear truck axle over the skewed centerspan cross section (Fig. 16). For load case 1, truck 20 was positioned with a wheel line 2 ft from the roadway centerline in the downstream lane. For load case 2, truck 22 was positioned with a wheel line 2 ft from the roadway centerline in the upstream lane. For load case 3, trucks 20 and 22 were simultaneously positioned in the same locations as load cases 1 and 2, but facing in the opposite direction. Figure 17 shows the three load positions completed for span 1.

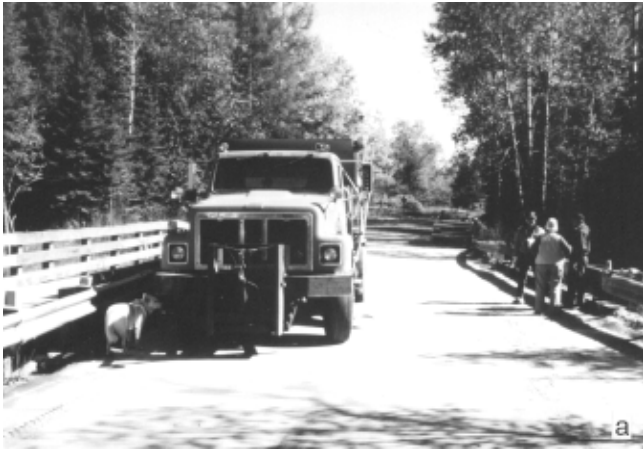
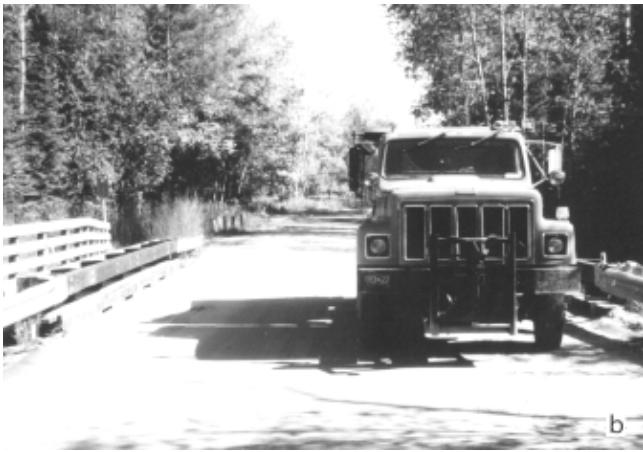
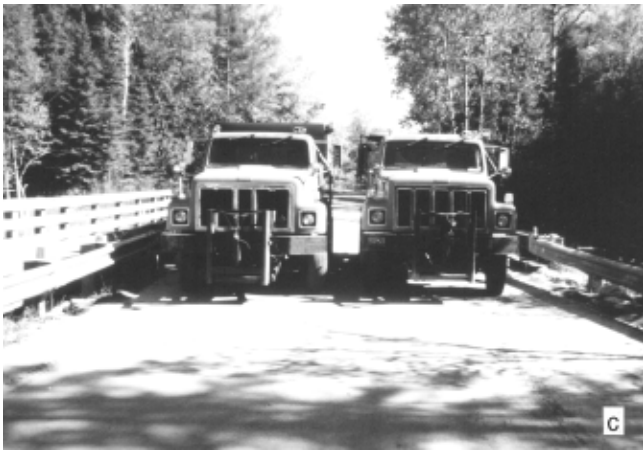
Figure 17—Load cases 1, 2, and 3 used during load testing of span 1 (west): (a) load case 1, (b) load case 2, (c) load case 3.

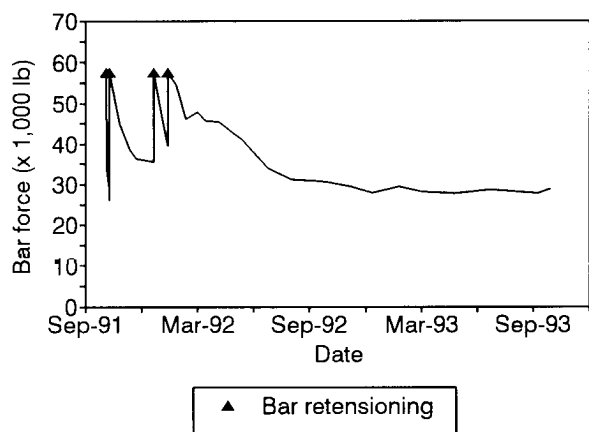
Figure 19—General trend in stressing bar forces based on load cell measurements.

The general trend in bar force measurements is shown in Figure 19. Bar tensioning was conducted on four occasions during the first several months after installation. After each

successive bar retensioning, the rate of bar force loss decreased. After the final retensioning in January 1992, the average bar force decreased to 30,000 lb, or 50 lb/in<sup>2</sup> interlaminar compressive stress, during the next 12 months. During the last 8 months, the bar forces stabilized at approximately 30,000 lb, or 50 lb/in<sup>2</sup> interlaminar compressive stress. Stressing bar forces measured with hydraulic equipment at the end of the monitoring period confirmed the 30,000-lb load measured with the load cells.

The majority of the bar force loss during the monitoring period is attributable to stress-relaxation of the lumber laminations and occurred within 1 year of the final deck stressing in January 1992. Other factors that contributed to bar force losses were relatively minor and included fluctuations in lamination moisture content, slight deck deformation under steel anchorage plates, and thermal effects. It is anticipated that the bar force will drop below the 40 percent of design level during the next several years. At that time, retensioning the bars to a full design load of 58,000 lb is recommended.

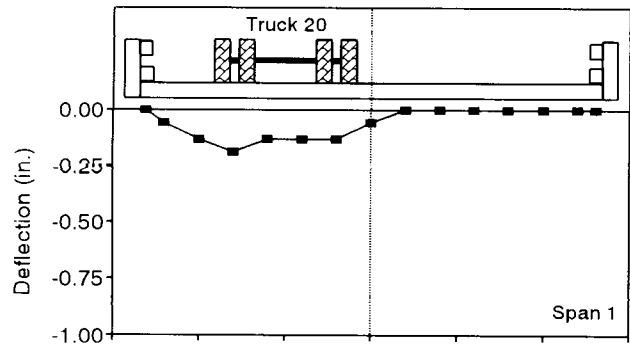
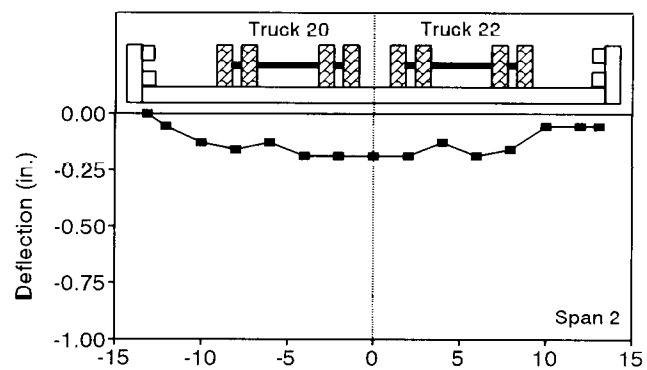
Figure 20—Transverse deflection measured at bridge centerspan (looking east) of the Graves Crossing bridge. Bridge cross-sections and vehicle positions are presented to aid interpretation only and are not to scale.

Figure 20 presents transverse deflection for the three load cases for each span. For span 1, the maximum deflection measured for load case 1 was 0.19 in., occurring under the wheel line near the downstream curb (Fig. 20a). Maximum

deflection measured for load case 2 was 0.13 in., occurring under both wheel lines (Fig. 20b). Maximum deflection measured for load case 3 was 0.19 in., occurring under the wheel line near the outside wheel line of truck 20 (Fig. 20c). Similarly at span 2, the maximum deflection measured for load case 1 was 0.16 in., occurring under the wheel line near the downstream curb (Fig. 20d). Maximum deflection measured for load case 2 was 0.19 in., occurring between the wheel lines (Fig. 20e). Maximum deflection measured for load case 3 was 0.19 in., occurring under both wheel lines closest to the bridge centerline (Fig. 20f).

If both spans of the two-span continuous bridge were equal in length, the measured deflections for the same truck loading should be the same. However, small differences in the measured deflections for each span were recorded for the same truck loading. These small differences are attributed to the variations in the span lengths previously noted (Fig. 12) and are within the precision of the measurement technique.

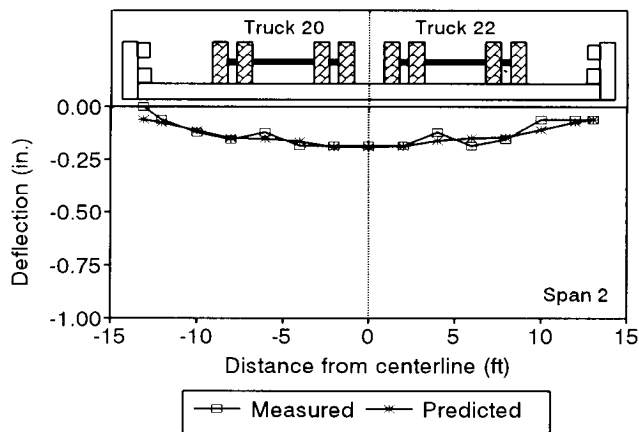
Figure 22—Comparison of the measured deflections from load case 3 and the predicted deflection using orthotropic plate analysis.

The predicted deflection based on the orthotropic plate analysis and measured deflection from load case 3 of the static-load testing are shown in Figure 22. The predicted deflections are equal or slightly greater than measured deflections at most data point locations. For span 1, the measured deflection beneath the outer wheel line of truck 20 was slightly greater than predicted. For span 2, the measured deflection between the wheel lines of both wheel lines was slightly greater than predicted. In general, the analytical prediction represents a close approximation of the actual deflections, because the minor differences noted are within the precision of the measurement technique.

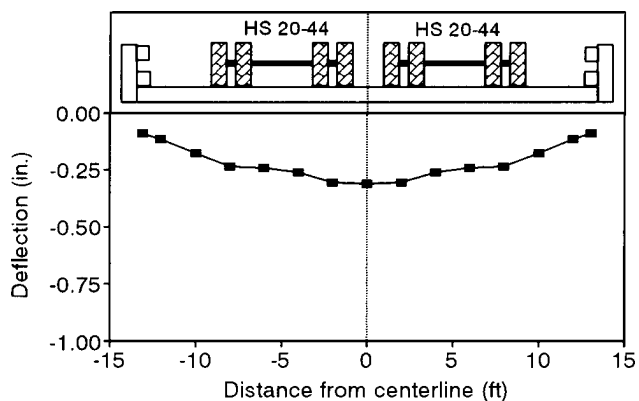
Figure 23—Predicted deflection at the bridge centerspan for two HS-20 vehicles, each positioned 2 ft from the roadway centerline (load case 3).

The predicted deflection for two HS20-44 vehicles positioned similar to load case 3 is presented in Figure 23. The maximum predicted deflection of 0.32 in. occurs at the bridge centerline and is equivalent to 1/650th of the bridge span, which measures 17.3-ft center-to-center of bearings.
