Performance Level 2 and Test Level 4 Bridge Railings for Timber Decks

BARRY T. ROSSON, RONALD K. FALLER, AND MICHAEL A. RITTER

The Midwest Roadside Safety Facility, in cooperation with the Federal Highway Administration and U.S. Department of Agriculture Forest Service, Forest Products Laboratory, developed and tested two bridge railings for use on longitudinal timber bridge decks: (a) a steel railing system (TBC-8000) and (b) a glulam timber railing system (GC-8000). The test for the TBC-8000 was conducted according to Performance Level 2 as specified in the AASHTO *Guide Specifications for Bridge Railings* (1989). The tests for the GC-8000 were conducted according to Test Level 4 as specified in *NCHRP Report 350*. The safety performance of each of the bridge railings was acceptable according to each applicable crash test criterion. Both railings provide aesthetically pleasing and economical alternatives for use on higher-service-level timber bridges.

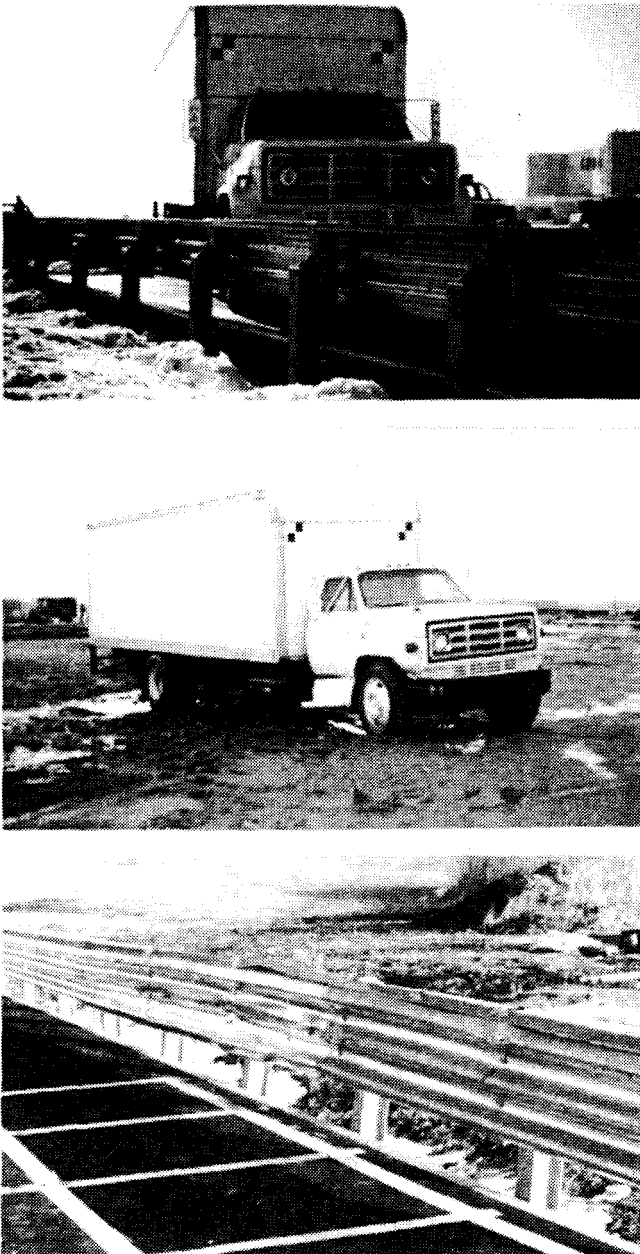
FIGURE 2 Impact location, vehicle damage, and bridge rail damage, Test FSTC-1.

Test FSTC- 1 [8, 165-kg (18,000-lb), 76.3 km/hr (47.4 mph), 16.1 degrees] struck the bridge railing at Post No. 4 (Figure 2). A summary of the test results and the sequential photographs is presented in Figure 3.

Vehicle damage was relatively minor and was limited to the right-front corner of the truck cab, box, and front bumper (Figure 2). The bridge rail damage was moderate, consisting mostly of deformed thrie-beam sections, C-rail sections, and steel posts (Figure 2). Examination of the top and bottom surfaces of the timber deck laminations revealed no physical damage or separation.

The length of vehicle contact along the top of the C-rail was approximately 11.4 m (37 ft 6 in.). Physical evidence revealed that lateral buckling of the C-rail occurred between Post Nos. 4 and 5 (Figure 2). The physical damage to the thrie-beam rail revealed that approximately 7.6 m (25 ft) of rail was damaged. The maximum permanent set deflections of the C-rail and thrie-beam rail were 19.3 cm (7.6 in.) and 20.8 cm (8.2 in.), respectively.

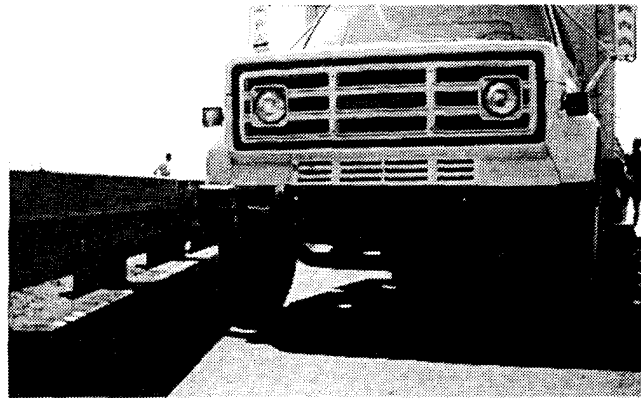
FIGURE 5 Impact location, vehicle damage, and bridge rail damage. Test FSCR-1.

upstream from Post No. 4 (Figure 5). A summary of the test results and the sequential photographs are presented in Figure 6.

Exterior vehicle damage was moderate (Figure 5). Vehicle damage occurred to several body locations, including the door and quar-

The moderate bridge railing damage near the impact area is shown in Figure 5. The downstream end of the glulam rail adjacent to Post No. 4 was fractured on the lower part of the rail. The curb rail received significant gouging between Post Nos. 4 and 5. Deep gouges and scrapes occurred to the top of the glulam rail from Post Nos. 7-14. Nine timber bridge posts, Post Nos. 7-15, were damaged during the crash test, as shown in Figure 5. The glulam timber bridge deck received some superficial surface cracks near Post No. 4. The crack width ranged between 1.6 to 3.2 mm (1/16 and 1/8 in.).

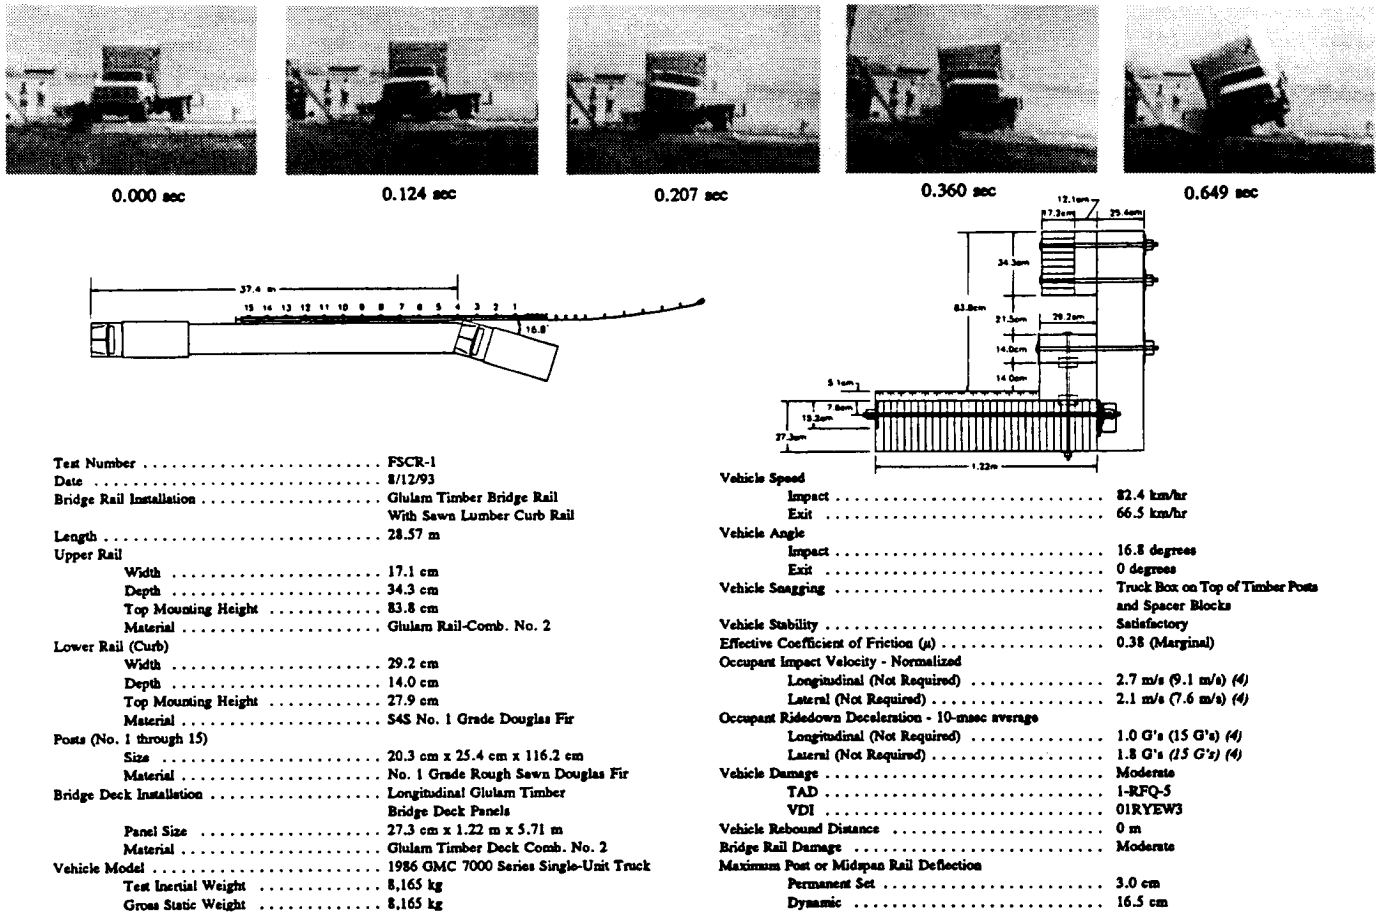
FIGURE 6 Summary of test results and sequential photographs, Test FSCR-1.
