ULTRASONIC INSPECTION OF LARGE BRIDGE TIMBERS

ROBERT EMERSON*
DAVID POLLOCK*
DAVID MCLEAN
KEN FRIDLEY*
ROY PELLERIN*
ROBERT ROSS*

©Forest Products Society 2002.
Forest Prod. J. 52(9):88-95.

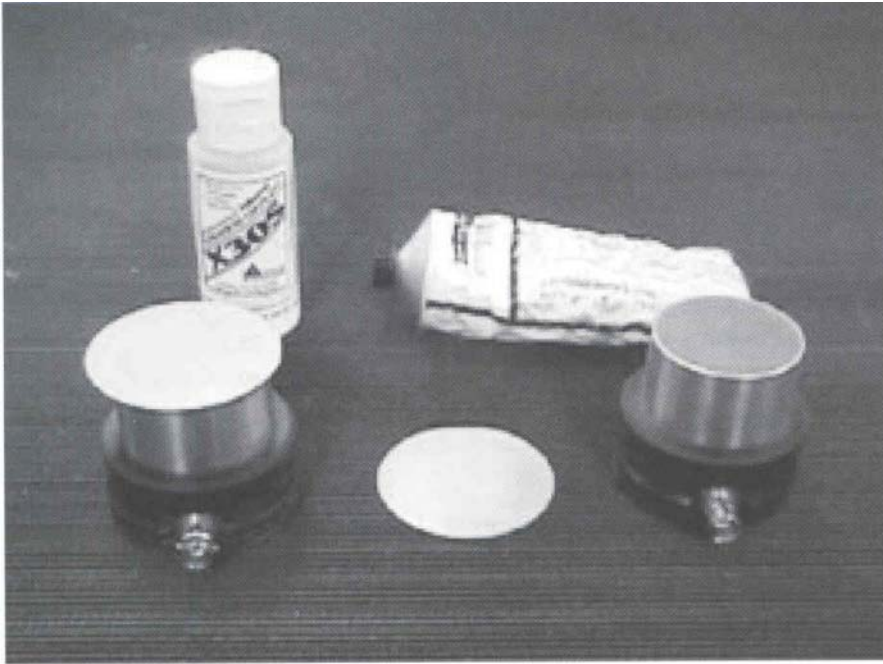
Figure 2. — Ultrasonic transducers and coupling materials.

surfaces is relatively easy, requiring only a small amount of liquid couplant and slight finger pressure. Coupling the transducers to the rough-sawn timbers posed a few problems and was a trial and error process. Excessive amounts of liquid or gel couplant were required to effectively transmit an ultrasonic wave. The timber also absorbed the gel. Fortunately, a dry, flexible membrane couplant was found that transmitted the wave effectively. The dry couplant membrane was a thin elastomeric disk that provided adequate coupling by fitting to the contour of the rough surface of the timbers. For convenience, a thin layer of silicone gel couplant was used to adhere the dry couplant membrane to the ultrasonic transducer. The transducers and coupling materials are shown in **Figure 2**.

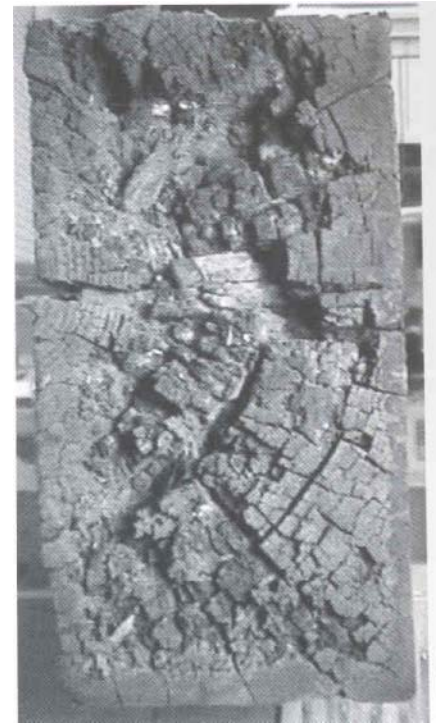
Figure 1. — Beam with extensive decay at end.

Two large, rough-sawn, creosote-treated Douglas-fir timbers were obtained from a stockpile of used timbers that had been salvaged from retired/replaced railroad bridges near Pullman, Washington. The first timber, a railroad bridge pile cap, was selected as a relatively sound creosote-treated timber based on visual inspection. The dimensions of the pile cap were 8-1/4 inches wide, 10 inches deep, and 120 inches long. Spike holes were present in this timber. The spike holes were initially considered locations for potential decay. The pile cap was subjected to ultrasonic inspection transverse to the grain. Then it was dissected to assess the actual internal condition. The second timber, an obviously decayed railroad bridge beam, was subjected to ultrasonic inspection transverse to the grain. The dimensions of the decayed beam were 8 inches wide, 14 inches deep, and 120 inches long. Extensive decay was present at one end, as shown in **Figure 1**. After ultrasonic inspection, the decayed beam was dissected to assess the actual internal condition. Smaller specimens were then removed from the wood adjacent to the decayed area for further study. These small specimens were individually subjected to ultrasonic inspection followed by compression perpendicular-to-the-grain testing in accordance with ASTM D 143.³ Compression perpendicular-to-the-grain tests were employed for two reasons. First, timber bridge flexural elements commonly fail at the supports due to compression perpendicular to the grain failure of decayed wood. Second, limited data exist on the effects of decay on perpendicular-to-the-grain strength.

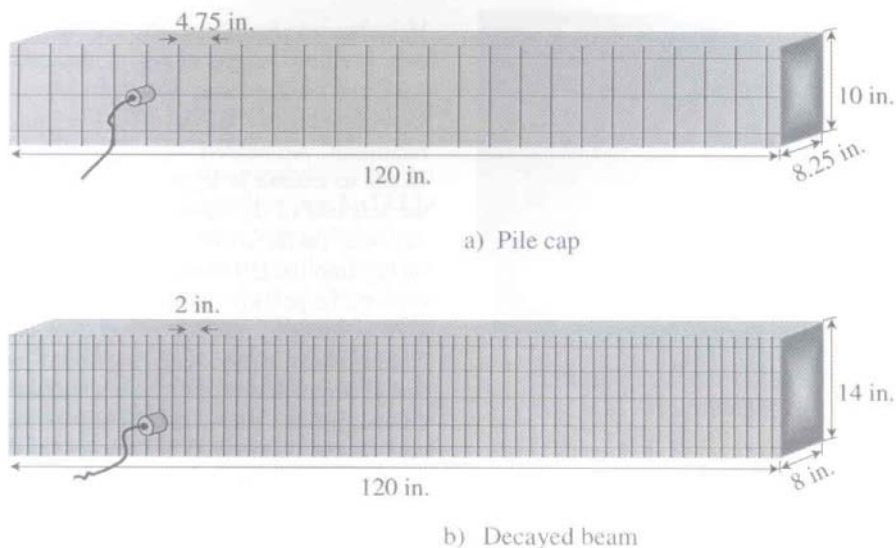
Figure 3. — Inspection grids for the pile cap and decayed beam for transverse inspection.

over a grid of inspection points. For the pile cap, three transverse measurements were taken along the depth at 25 locations along the length. The measurements were taken at mid-depth and at 1 - 1/2 inches from the top and bottom at 4-3/4-inch intervals along the length. For the decayed beam, 5 transverse measurements were taken along the depth at 60 locations along the length. The measurements were taken at the center and at 1-1/2 inches and 4-1/4 inches from the top and bottom at 2-inch intervals along the length. The fine grid was chosen for the 8- by 14-inch beam in order to provide a more precise assessment of wood quality in the region containing incipient decay. Graphical representations of the transverse measurement locations for each member are depicted in **Figure 3**.

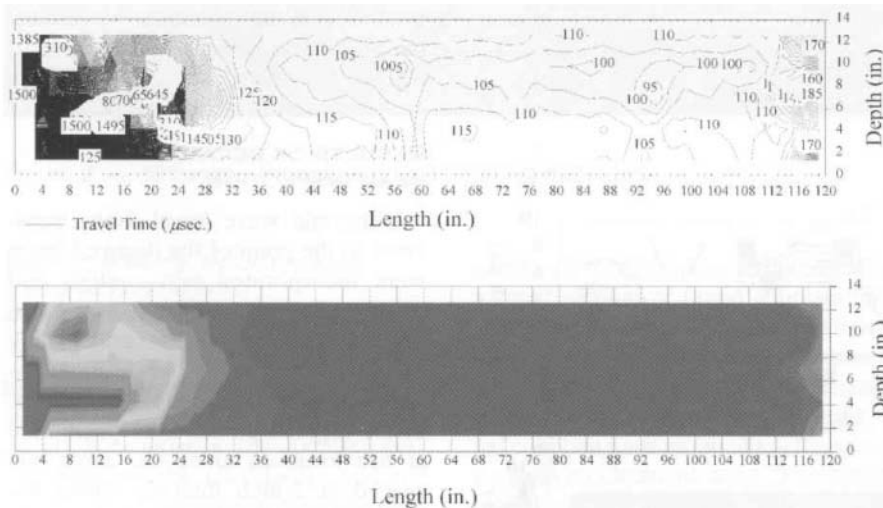
Figure 6. — Contour and color gradient plots of wave travel time through the decayed beam for the fine inspection grid.

Ultrasonic wave travel times transverse to the grain of the decayed beam were incorporated into contour and color gradient plots along the beam profile for three inspection grids using SigmaPlot software. The original inspection grid contained 300 points. These original points were positioned at five locations along the depth and spaced at 2-inch intervals along the length, providing a fine inspection grid. Contour and color gradient plots of wave travel time for the fine inspection grid are presented in **Figure 6**. Contour and color gradient plots were also developed for medium and coarse inspection grids. The medium inspection grid contained 150 points. These points were positioned at five locations along the depth and spaced at 4 inches along the length. Contour and color gradient plots of wave travel time for the medium inspection grid are presented in **Figure 7**. The coarse inspection grid contained 90 points. These points were positioned at three locations along the depth and spaced at 4 inches along the length. Contour and color gradient plots of wave travel time for the medium inspection grid are presented in **Figure 8**.

The three inspection grids provided similar information on the internal condition of the beam. The fine and medium inspection grids predict severe decay in the lower third of the left end of the beam and extending approximately

16 inches into the beam. The coarse grid only predicts severe decay at the end. All three grids predict locations of advanced and moderate decay in the same locations. Advanced decay was predicted to extend at least 15 inches into the left end of the beam. Moderate decay was predicted to extend up to 30 inches into the left end of the beam. Ultrasonic inspection detected knots at 55 and 94 inches from the left end of the beam. These knots were confirmed by visual inspection of the beam's surface. Longer travel times were present at the end of the beam with full penetration creosote treatment.

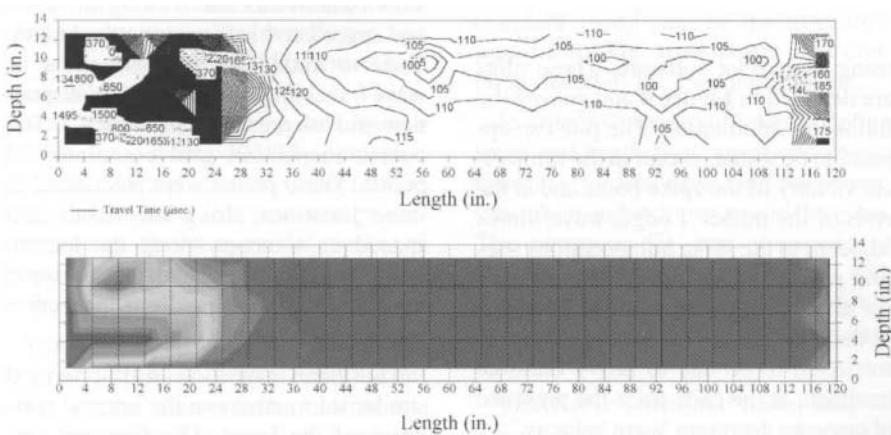
Figure 7. — Contour and color gradient plots of wave travel time through the decayed beam for the medium inspection grid.
