SOUTH FORK MILLS RIVER TRAIL RESTORATION

By Richard Burns, Forest Hydrologist

FINAL REPORT – December 19, 2000

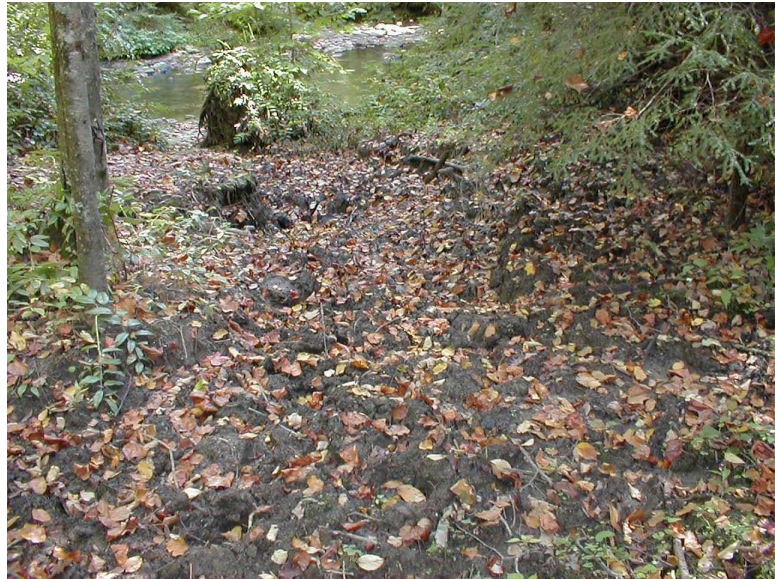
Recreational trail use is and has been extremely heavy. These trails are used for hiking, mountain biking and horse back riding. They also provide access for hunting and fishing. Most water bars that existed on the old roads were lost through erosion and lack of timely maintenance. Some trails have become chronic sources of sediment for the SFMR, especially those immediately adjacent stream channels. Prior to this project the Forest Service Hydrologist estimated that watershed-wide, as much as 50 percent of the trail surface drained directly to a stream channel, with some trail sections yielding as much as 90 percent of their runoff and sediment to a stream (Figure 3).

Figure 3. Runoff and sediment to the river

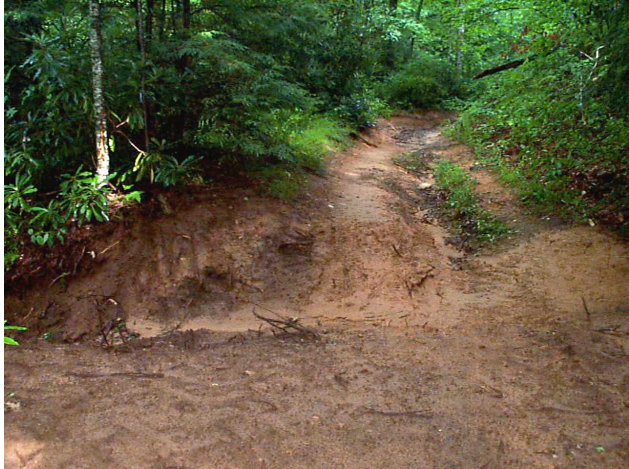
Figure 4. New water bar

Fieldwork was initiated in May 1999 and extended over two seasons, finishing in October 2000. The main focus of the project was the elimination or significant reduction of chronic sediment loading of the SFMR and its tributaries by recreation trails. This was accomplished by the construction of new or the reconstruction of existing water bars (Figure 4). Sediment traps were dug at the end of the water bar outlets if there was not adequate area to infiltrate the runoff (Figure 5).

Water bars were constructed using material from the trail itself, spoil from an adjacent sediment trap, or borrow from the cut slope. Water bars were spaced closely to minimize the volume of runoff at any one outlet. This resulted in water bars about every 75 to 150 feet depending on the trail grade. Water bars were constructed high enough to withstand the use pressure but low enough so they did not generally impede the user.

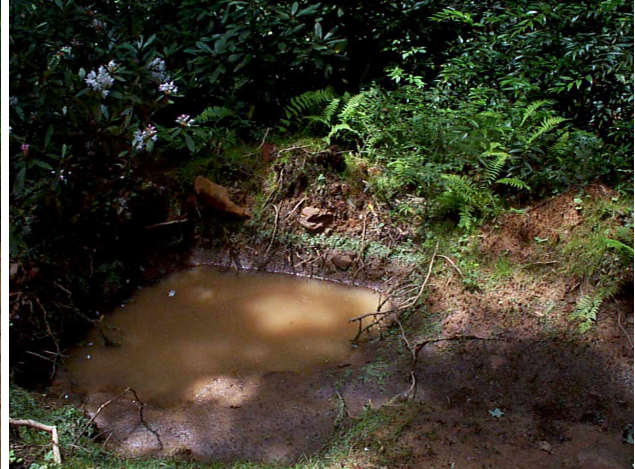
Figure 5. New sediment trap

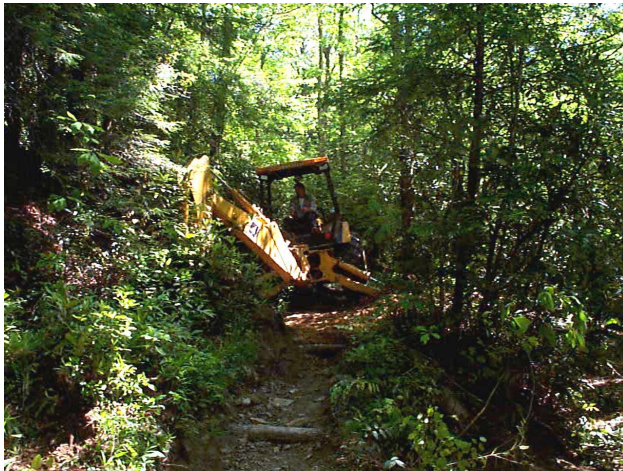
Figure 6. Backhoe working trail

using either a rubber tired tractor-mounted backhoe (Figure 6) or a mini-excavator (Figure 7). All the treated trails are open to horses trails, which means they are wider than foot trails. Hence the equipment, especially the mini-excavator, was narrow enough to negotiate the trails without creating additional damage. Field design allowed the placement and construction of the water bars and traps to be adjusted to the specific site conditions rather than be locked into fixed design.

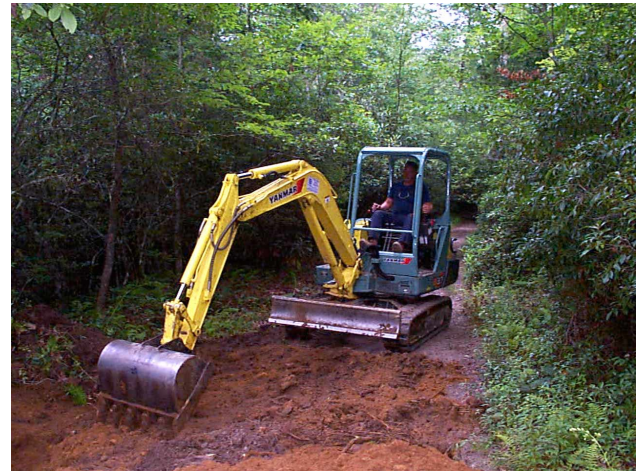
Figure 7. Mini-excavator working trail

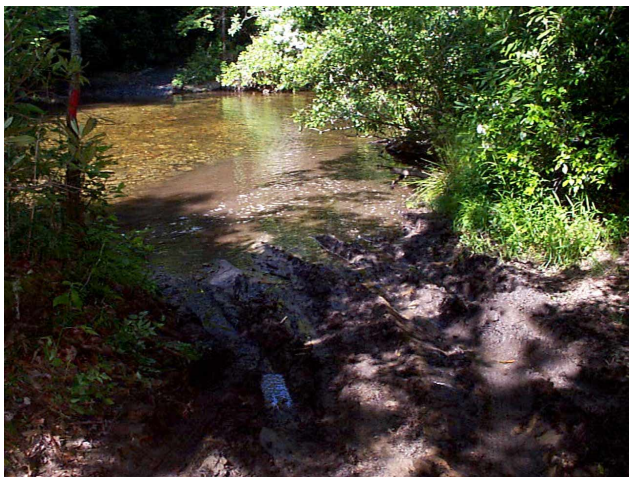
River crossing: Horseback riders heavily use the first main river crossing of the Bradley Creek trail. The approaches were always muddy and funneled trail runoff directly into the river (Figure 8). The approaches were hardened with oversized (3-inch diameter) clean stone so the horses would no longer erode the riverbanks or churn the bottom (Figure 9). Trail runoff entering the crossing was nearly eliminated by bracketing the approaches with new water bars and sediment traps. After more than a year of use, the crossing appears very stable and non-polluting. Three other main river crossings were stable, non-eroding and only required eliminating the trail runoff entering the river.

Figure 8. Muddy river crossing, Bradley Ck Trail

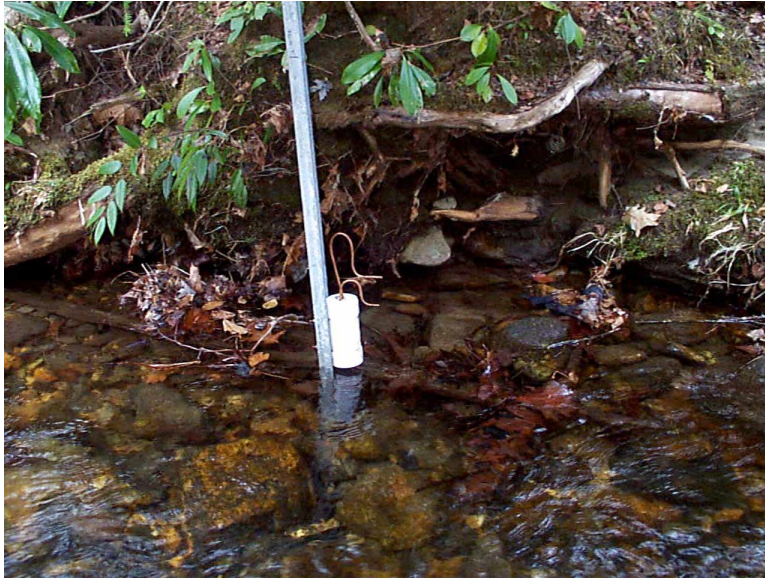
Suspended sediment sampling: Ten single-stage suspended sediment samplers were installed in the project area with the cooperation of the Tennessee Valley Authority (Figure 10). These samplers collect a sample of stream water whenever the flow rises to the top of the sampler tube. Samplers were all set to collect a sample at about the same stream height, which is approximately $\frac{3}{4}$ of bankfull. This common height setting was to make the samples more comparable to each other since they would be collected at

Figure 10. Suspended sediment sampler

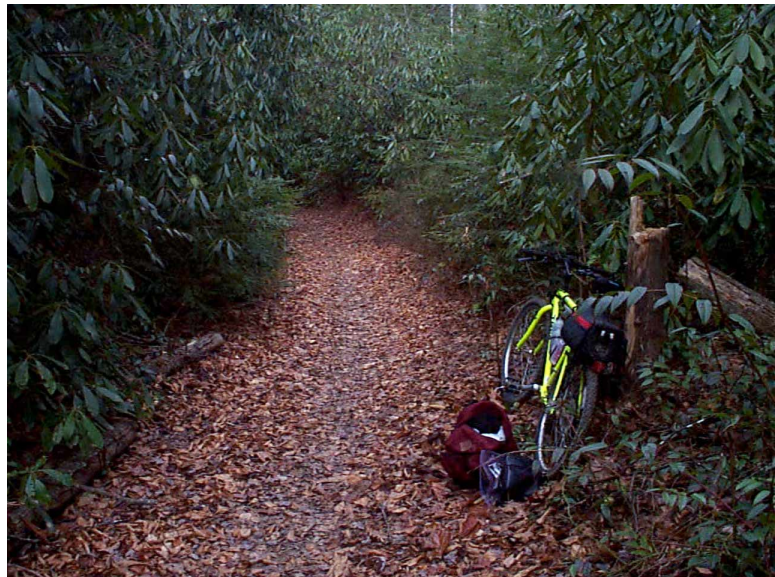
Figure 11. Treated trail with runoff controlled

Visual observations: Since monitoring changes in suspended sediment loading is difficult, visual observations of runoff and sediment deposits are invaluable. Sediment and leaf deposits were observed in many traps following rainstorms. This showed that material and runoff that previously reached the river was now being stopped. Long sections of trail, which pre-project were free of leaves due to flow on the trail, remained leaf-covered throughout the wet seasons (Figure 11). This indicates there was no longer sufficient runoff on the trail to wash off the leaves. Based on these observations it is the opinion of the Forest Hydrologist that as much as 90 percent of the runoff that previously reached the river from the treated trails has been stopped.
