Appendix C - Turbidity Monitoring of Fubar Creek Restoration

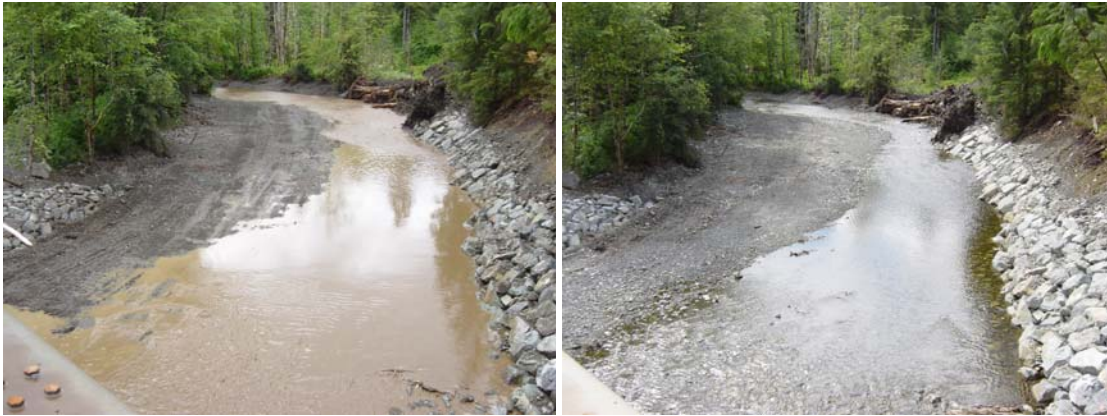
Photos 1a, and 1b. Looking upstream from the bridge at the Fubar Creek Restoration. Photo 1a was taken during the diversion of water back into the channel on July 27 following 3 weeks of in-stream work. Photo 1b is taken on August 13 following the completion of the project.

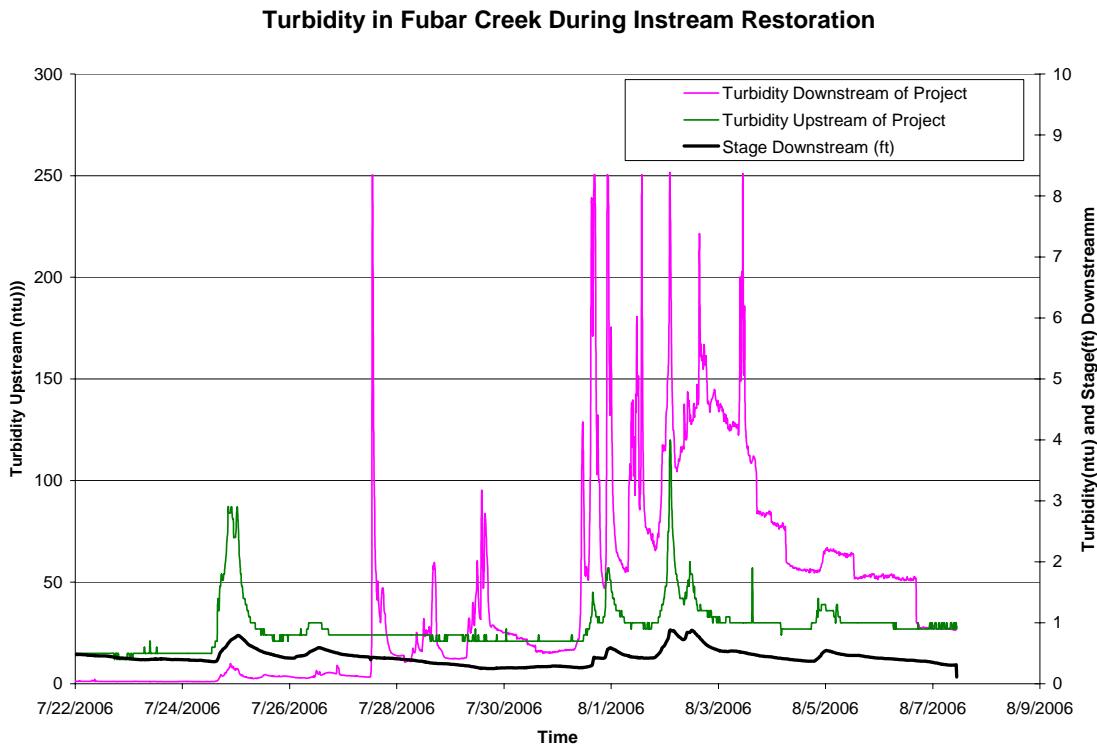
Figure 1. Results of water levels in Fubar Creek downstream of the project area and turbidity levels both upstream and downstream of the project area

Results from the turbidity monitoring are shown in Figure 2 and the timeline of project work is displayed in Table 1. Upstream of the project area turbidity ranged between 0.3 and 4 NTU's. Increases in turbidity were a function of increased water levels which resulted from rainfall in the watershed. The downstream turbidities ranged between 0.8 and 250 NTU's. The turbidimeters do not measure beyond 250 NTU's, hence the level of turbidity probably exceeded 250 at times. Increased in turbidity downstream were a function of heavy equipment working in-stream and water level increases resulting from rainfall within the watershed.

in an effort to work on the upper channel portion. This diversion is seen on Figure 2 as a spike in turbidity downstream of the project area. The turbidity increased from 3 NTU's to 250 NTU's in 15 minutes. This input of water was carrying all the turbidity that had accumulated over the previous three weeks and flushing it out of the drainage system. Within 3 hours the turbidity had decreased 88% to 30 NTU's and within 15 hours it had reduced 96% to 11 NTU's. The levels did not continue to decrease because equipment was again (the following morning) in-stream working on the upstream project area. Another diversion was installed upstream to complete the upstream channel design.

This diversion utilized a side channel that merely diverted the water away from the immediate working area and returned it to the stream 100m downstream. Hence, the water was still flowing through the lower project area and past the downstream turbidimeter. The spikes in turbidity following the initial pulse were early morning times when the equipment was again working in-stream. A gap in the pulses of turbidity occurred on July 31, a Sunday when no work occurred. The following day increased turbidity resulted from both the action of heavy equipment in-stream and a rainfall event. You can see two spikes in the upstream turbidity levels resulting from these same rainfall events.

The last day of in-stream heavy equipment work was on August 3. This is reflected in the decrease of turbidity data in Figure 1. Following the removal of heavy equipment

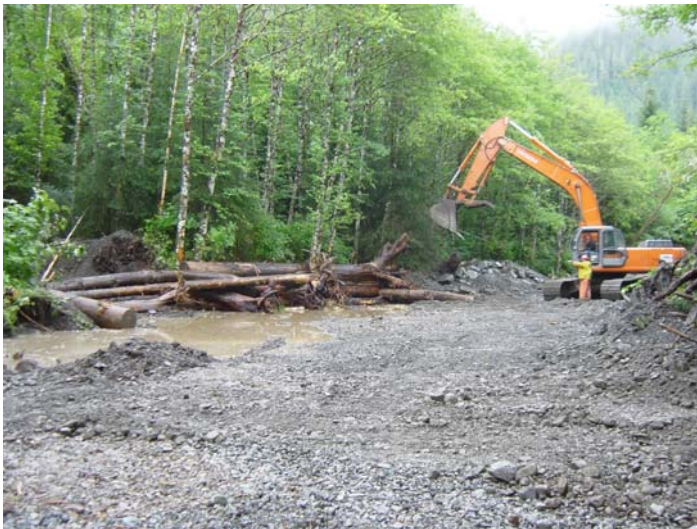
Photo 2. Photo of heavy equipment in-stream and mobilization of wood and rock occurring upstream of the bridge

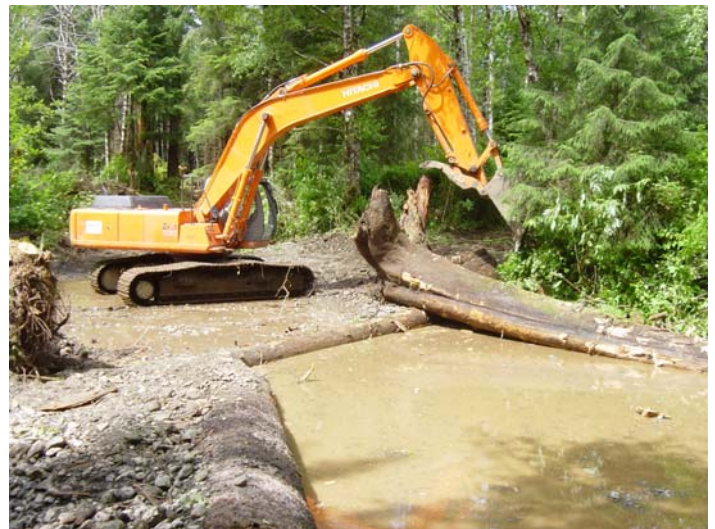
Photo 3. Installing a log structure. Notice the turbidity resulting from the movement of heavy equipment and mobilization of stream materials.
