Submarine Division of the Naval Safety Center Factual Lines About Submarine Hazards

Apr-Jun 08

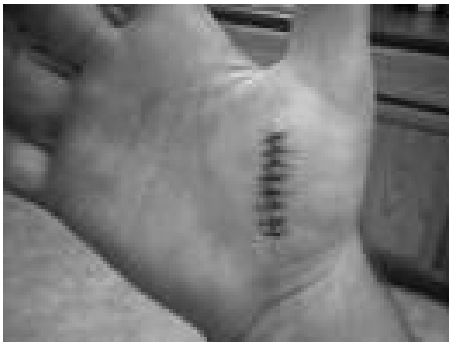
The "cut hazard" and the "eye poke hazard." The "cut hazard" comes when the excess tie-wrap is cut off removing the unsightly extra unneeded end of the tie-wrap, leaving a sharp razor-like point. Usually, wider and stiffer tie-wraps leave a sharper cut edge with higher cut potential. I have often seen Tie-Wraps used to secure the ships banner or connect lights to the brow, these are usually cut then rolled down so that the lock and ugly cut end are not viewed by personnel crossing the brow. This places the unseen cut hazard in the perfect location for a Sailor's hand and could quickly result in stitches, light duty, or worse. When securing items to your brow or other locations, where a Sailors hand might grab for support, here are ways to reduce the potential cut hazard: Use white cotton line, it is inexpensive, easy on the environment and will re-introduce the lost art of knot tying. Leave the

excess tie-wrap long and roll the excess out of the way so that it is not a poke hazard. Cut the excess off flat against the lock and sand or file any sharp edges.

The "poke hazard" is most commonly noted in major repair or shipyard environments. This occurs when tie-wraps are used to secure temporary services, hoses, cables, or ducts to the overhead or bulkhead. Uncut tie-wraps hanging in the overhead passageway becomes an

eye poke hazard. Many shipyards have shifted to strict use of marlin or other similar materials for securing temporary services to eliminate this hazard and reduce operating costs. Keep an eye out for these overhead tie-wrap hazards before someone has their eye put out by one. Tie-wraps are tools that have a purpose in our Navy, your ORM and safety practices will prevent tie-wraps from injuring your Sailors.
