NASA Contractor Report 172462

Structural Tests and Development of a Laminar Flow Control Wing Surface Composite Chordwise Joint

LOCKHEED-GEORGIA COMPANY
Marietta, Georgia 30063

CONTRACT NAS 1-17487
December 1984

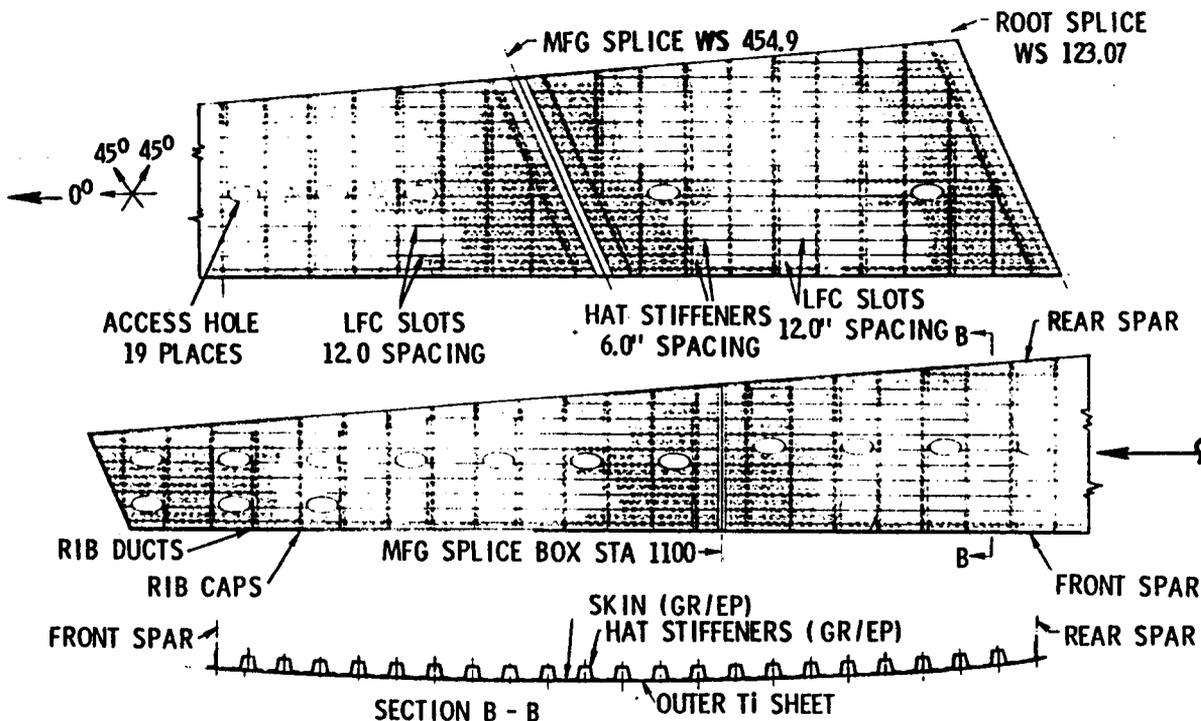
Figure 3. Wing Box Upper Cover - 1993 LFC Transport

The LFC wing box upper cover for the 1993 LFC transport is shown in Figure 3. The wing box upper surface extends from the WS 123 root splice to the W.S. 1439 tip. The cover is broken into three sections for manufacture and spliced at WS 454 and Box Sta. 1100. Each cover segment consists of a bonded assembly of titanium outer sheet, graphite/epoxy inner skin, spanwise hat stiffeners, rib caps, rib ducts, spar caps, and miscellaneous clips.

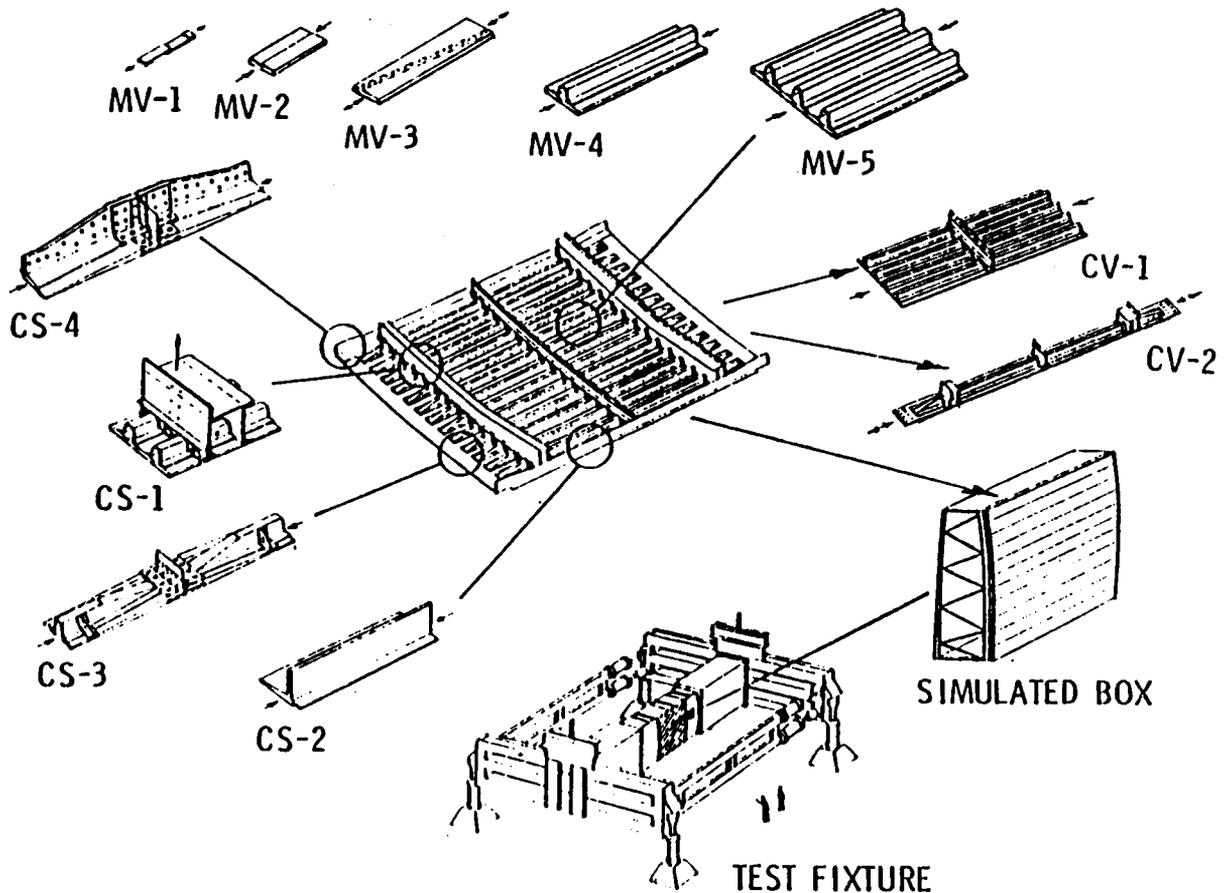
Figure 5. Integrated Wing Surface Panel Development

The original long-range plan for developing the LFC wing surface is summarized in Figure 5. A series of material verification (MV) specimens were fabricated and tested to verify the materials and processes. Concept selection (CS) specimens were used to develop the critical design details, tools and manufacturing processes. Concept verification (CV) anticipates the manufacture and test of the large surface panel. The first panels made on the wing surface tool will be structurally tested to verify the design and the tool. These panels are identified as CV-1 and CV-2. The large panel assembly with ribs, rib ducts, chordwise joints and spar caps is identified as CV-4. CV-4 will be installed in a simulated wing box for testing the integrated LFC wing structure under simulated flight loads. The CV panels were not fabricated in the original WSSD program (reference 2). The present report summarizes the fabrication and test of the chordwise joint CV2 panel.

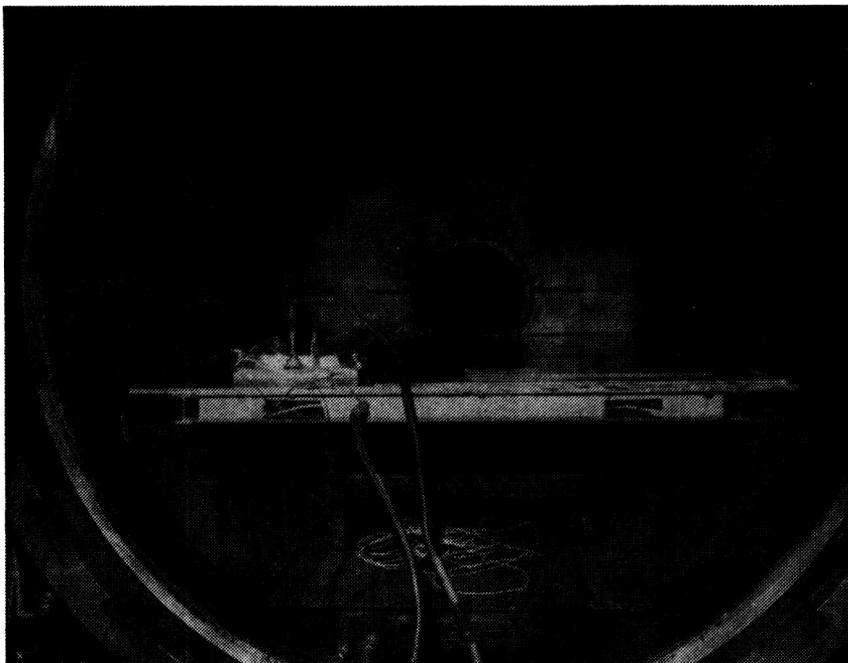
Figure 13. View of Hat Tool and Layup in Autoclave

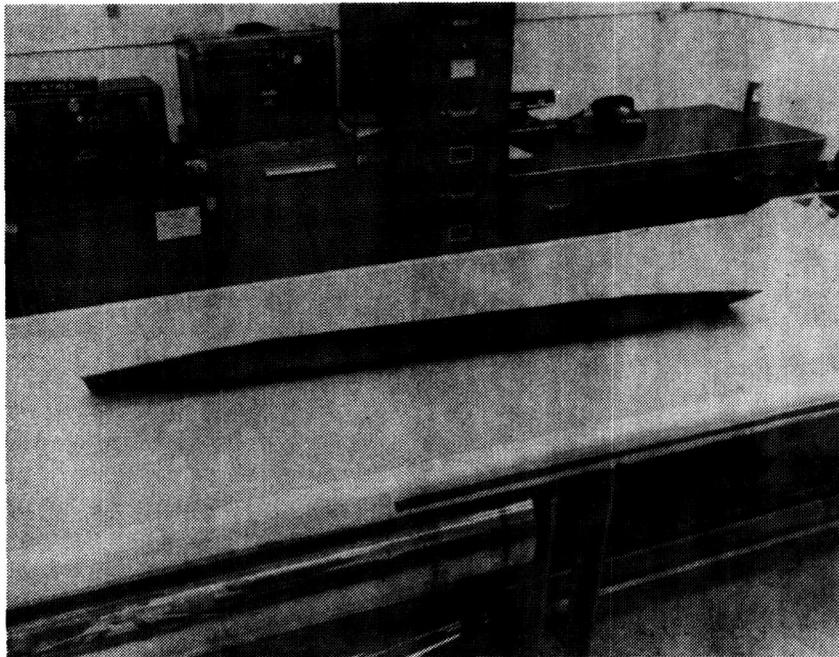
Figure 14. Cured Hat Stiffener

This cure cycle allows the resin to gel under isothermal conditions and well below the boiling point of water at 100 psi pressure. Therefore, water in solution in the prepreg resin stays and does not volatilize and form porosity. Two hat stiffeners were made. Both were free of porosity when inspected by C-scan ultrasonic procedure. While a no-bleed system was employed, it appears that the high degree of resin wetted surfaces inside the tool used more resin than anticipated as there was no exterior bleed of resin. Detail thickness was at the lower limits in accordance with STP 61-220 which specifies 0.0046 to 0.0054 inch per ply. Figure 14 shows a cured hat stiffener.

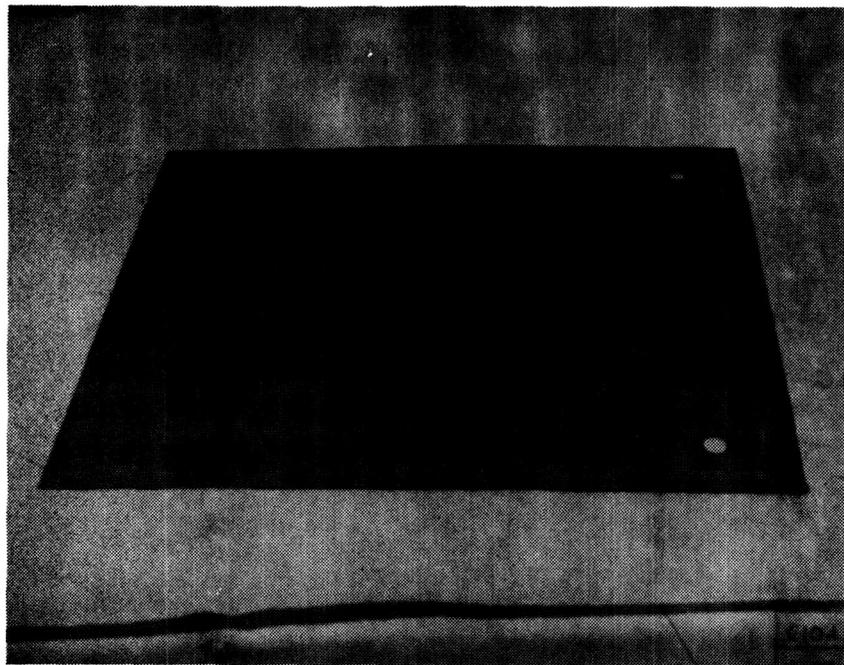
Figure 15. Titanium Detail with Adhesive Applied

Layup of the skin panel was accomplished using a detailed layup sheet which specified which ply, graphite/epoxy or titanium, where it was located, and where adhesive was required. No ply templates were used as all G/E plies were rectangular. White cotton gloves were used when handling all titanium plies. The basic tool was coated with mold release, and two machined fiberglass filler details were placed on each end per drawing. The fiberglass part nearest each end was wrapped with teflon tape to prevent it from being bonded to the assembly at this time. Titanium and graphite/epoxy plies were carefully laid up with a layer of FM300 adhesive being used to bond the titanium plies to each other and

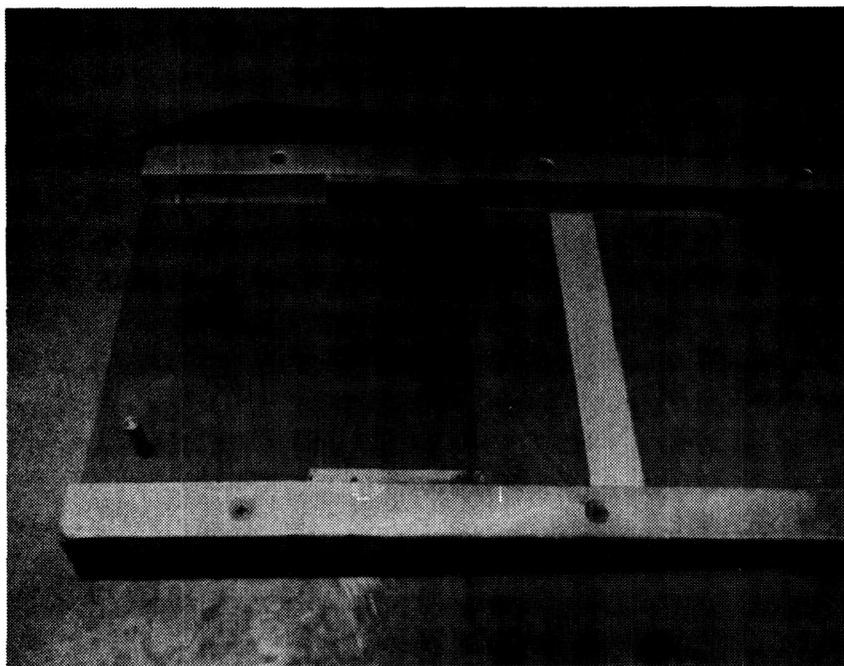
Figure 16. Skin Tool Showing First G/E Ply in Place and Titanium Detail Pinned to Locater Pins

to the graphite/epoxy plies. The skin panel was vacuum debulked several times during the layup sequence. Figures 16, 17, and 18 show the skin panel with the layup process nearly completed. Figure 19 shows the completed layup with rubber plate just prior to vacuum bagging for the autoclave. Figures 20 and 21 show the skin panel after removal from the autoclave. Figure 22 shows the end of the titanium plies where they are not completely bonded to each other. It was thought that this condition was caused by small differences in the forming of the titanium plies.

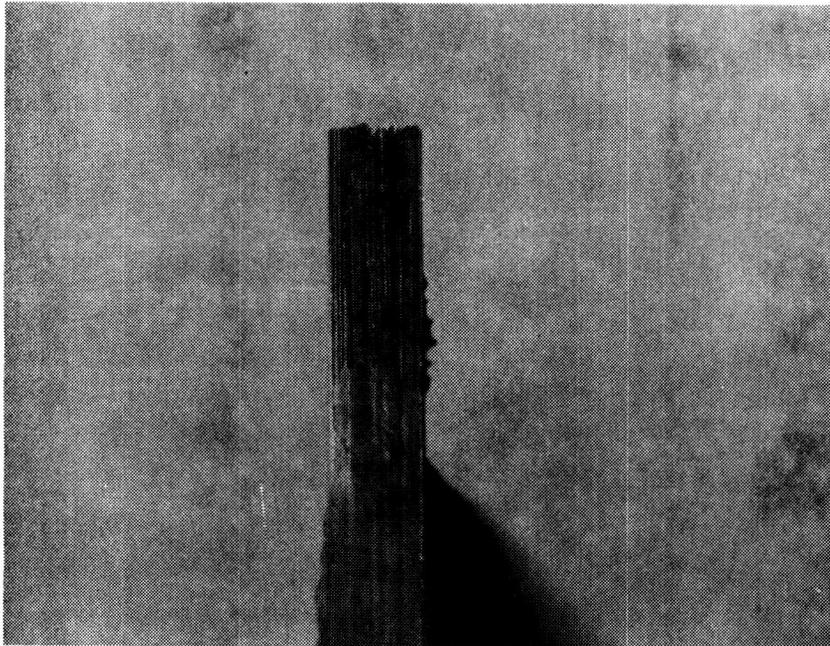
Figure 22. End of Skin Showing Titanium Detail Misfit

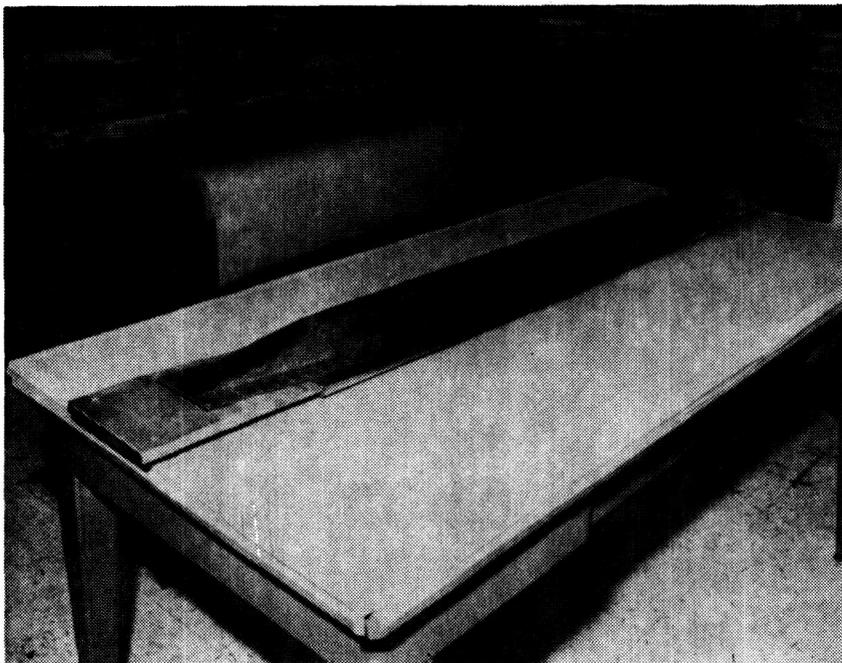
Figure 23. View of Hat and Skin Stiffener Being Prefitted Prior to Bonding

After trimming the hats and skins to dimension, they were prefitted for bonding as shown in Figure 23. A verification bond cycle was conducted on both specimens. Two layers of FM73 adhesive -(0.06PSF), STM 30-102, was placed between one mil thick Teflon film and the hat and skin assemblies. The skin tool was used as the bond fixture. After curing the adhesive at 250°F and under 30 psi pressure, the details were separated and the teflon and cured adhesive film removed. Thickness of the adhesive film along the bond line was determined and low-pressure areas noted for additional layers of adhesives. Less than 5 percent of the bond needed an additional layer on either assembly. Fit of the

details was considered good and well within bonding tolerance. The details were then cleaned and adhesive applied in accordance with the verification results. Cure of the assembly was accomplished in an autoclave at 30 psi pressure and 250°F for 60 minutes. Following bonding of the assemblies, an ultrasonic nondestructive inspection was conducted. No disbonds were found in either the CV2-1 or CV2-2 specimens.

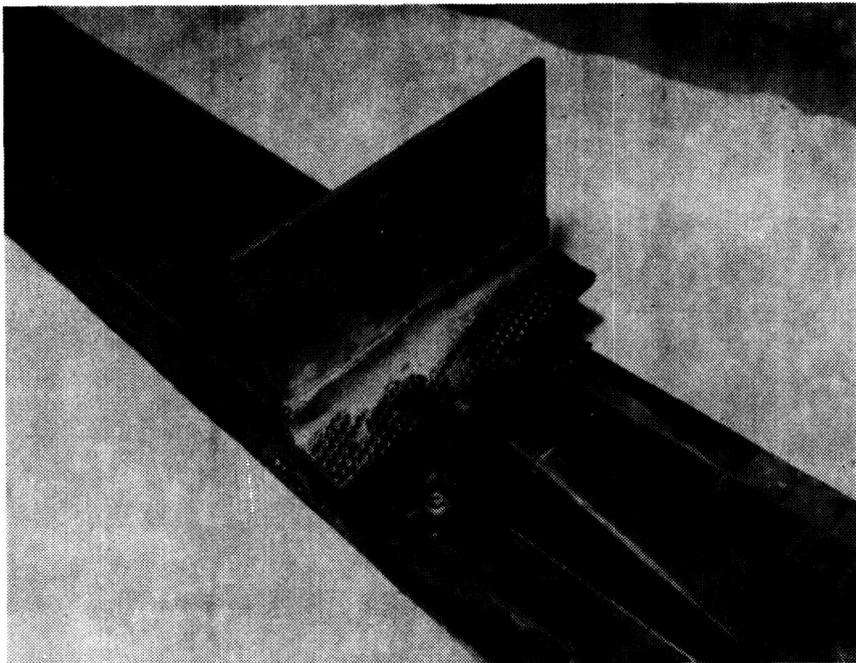
Figure 24. View of Rib Cap Assembly from Specimen End

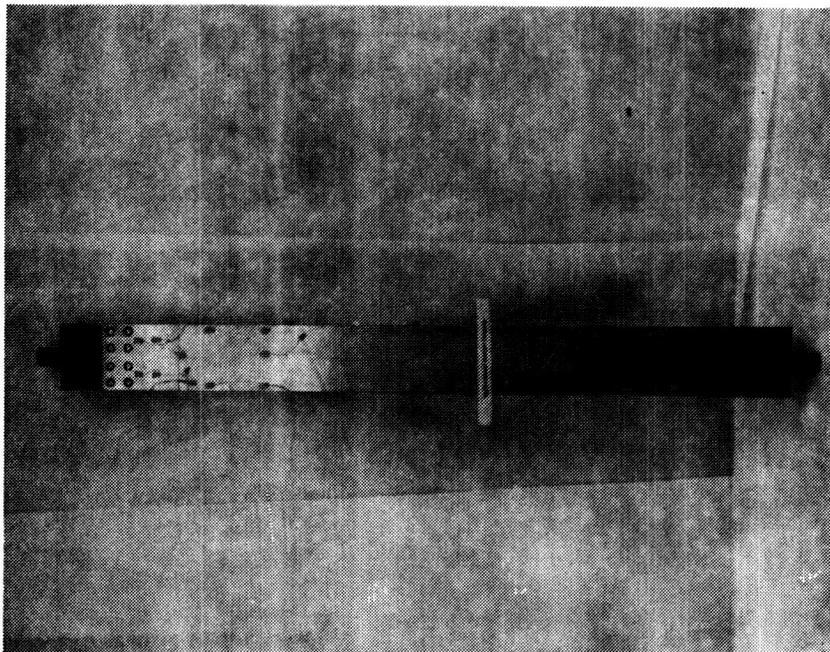
Figure 30. View of Outer Surface with Instrumentation Installed

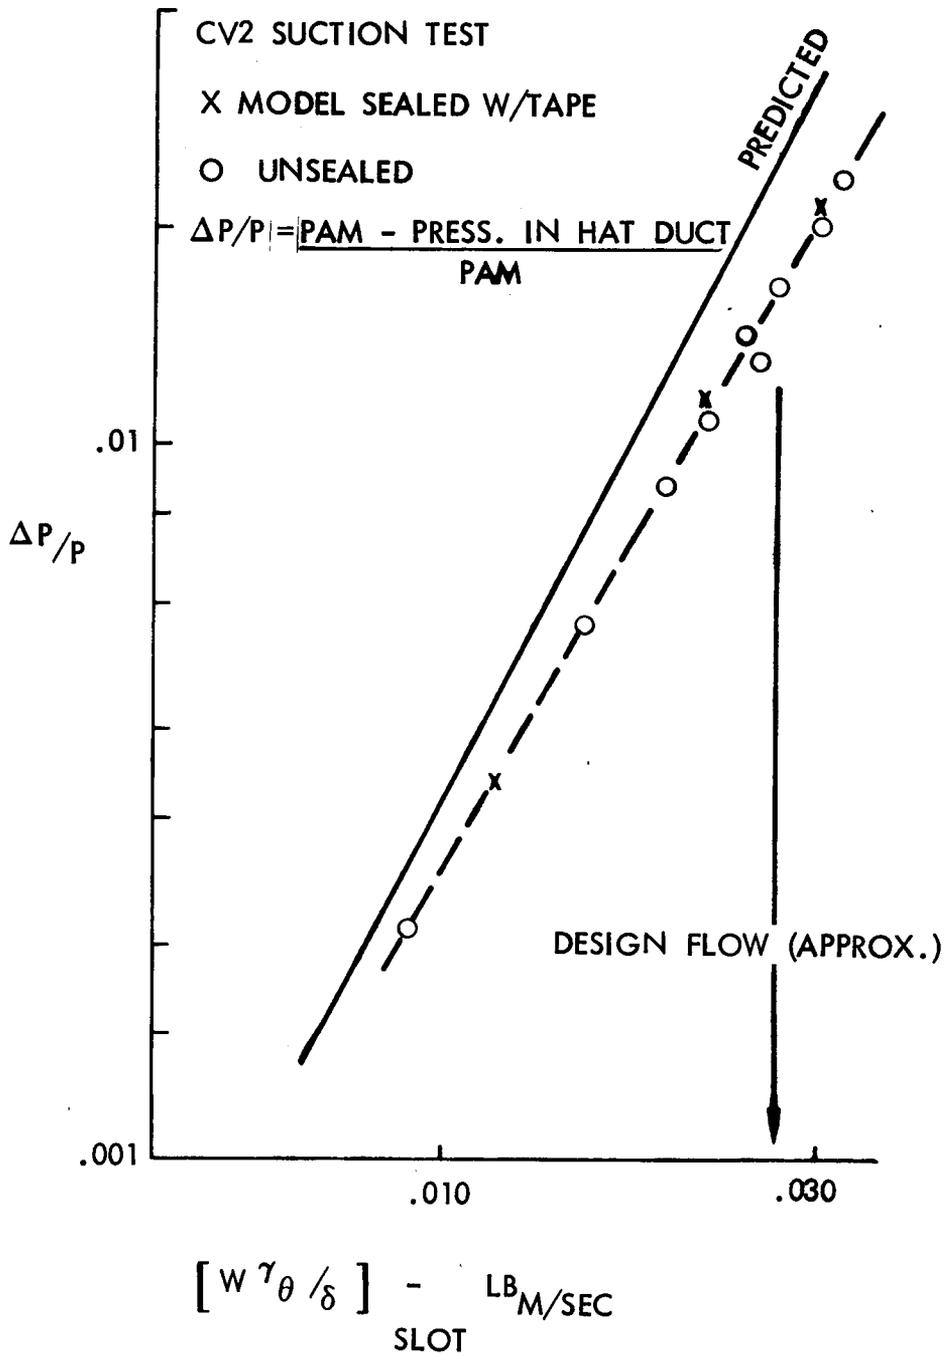
Figure 31. Flow vs. Pressure Loss

Data are shown for the model "sealed" and "unsealed." Considerable leakage was found along the edges of the test piece and at the bolt hole openings in the surface skin at both ends of the panel. The model was sealed with duct tape and vacuum putty in an attempt to stop the leakage. It is suspected that some leakage still occurred after the model was sealed although use of an acoustic leak detector apparatus failed to locate any additional source of leaks. However, the results seem to indicate that leakage did not adversely impact the test results.

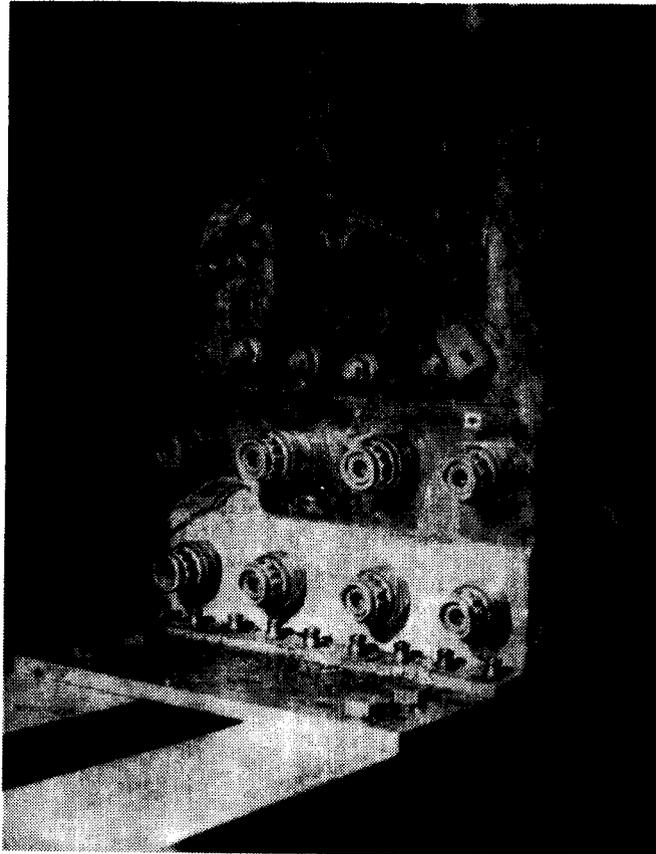
Figure 36. CV2-1 Specimen Damage - Bolt Bearing

The CV2-1 specimen damage consisted of titanium skin and composite material failure in the region of the lower composite rib (Figure 35) plus combined failure of the hat section, and bearing failures around the lower 14 repair bolts (Figure 36). Panel measured width was 6.98 in.

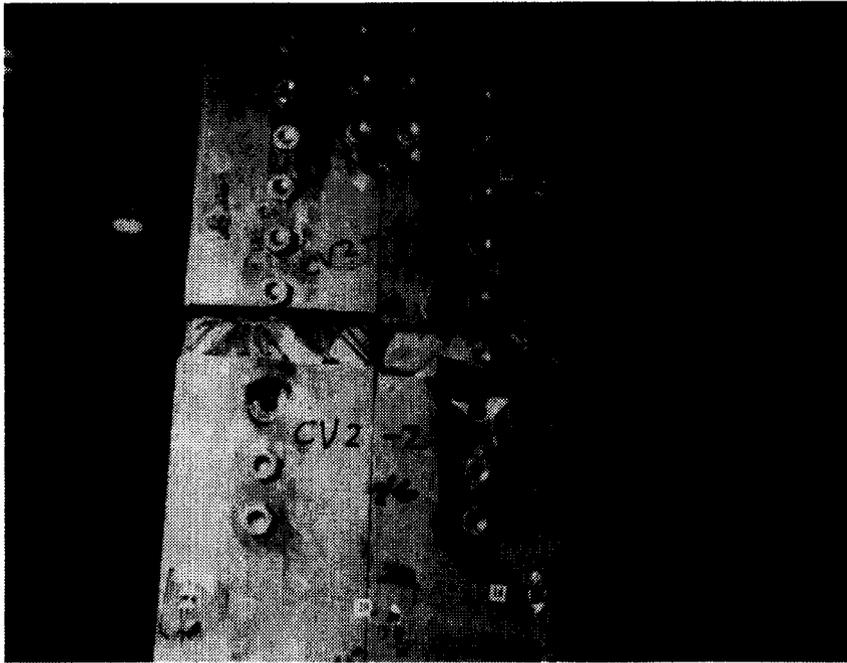
Figure 41. CV2-2 Residual Strength Test Damage - Titanium Skin

The CV2-2 residual strength test failing load was 130 KIPS. The failure mode was net section failure (including titanium outer skin), (Figures 41, 42, 43, and 44) at a point four inches above the upper composite rib cap. Note that the hat also failed in a net section failure mode, therefore the 24 bolts of 5/16 diameter prevented peel or shear tear out failure modes.

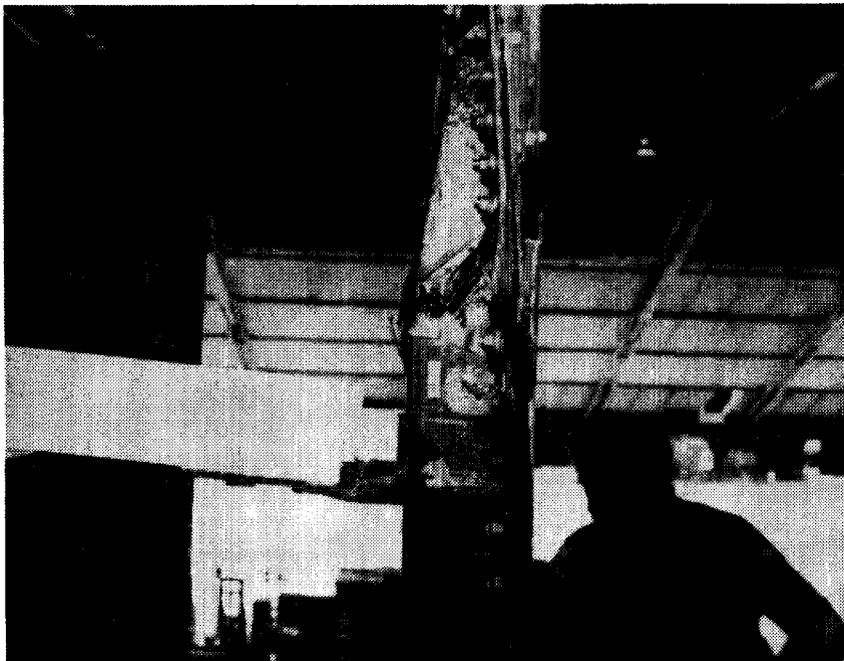
Figure 42. CV2-2 Residual Strength Test Damage - Hat and Skin

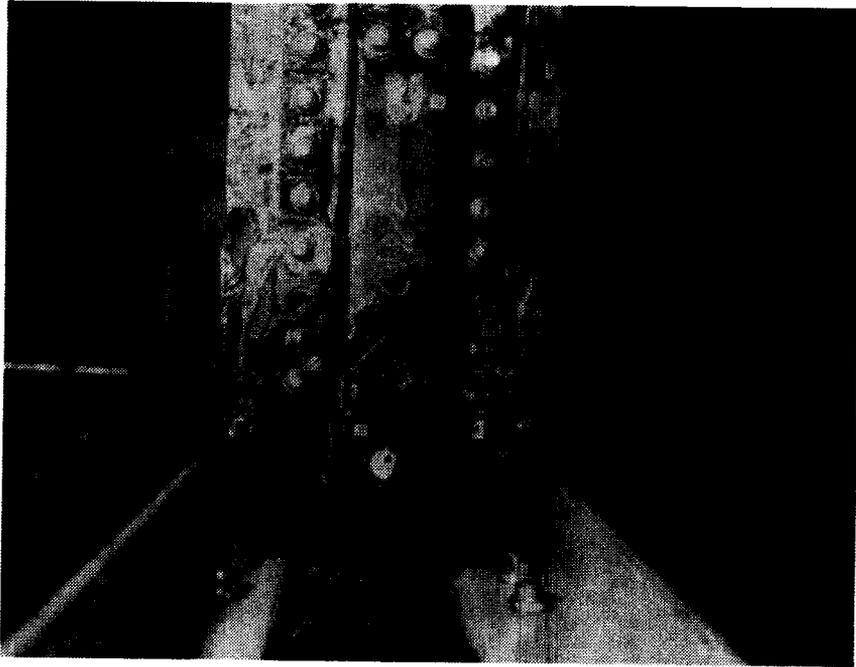
Figure 43. CV2-2 Residual Strength Test Damage - Hat/Skin Side

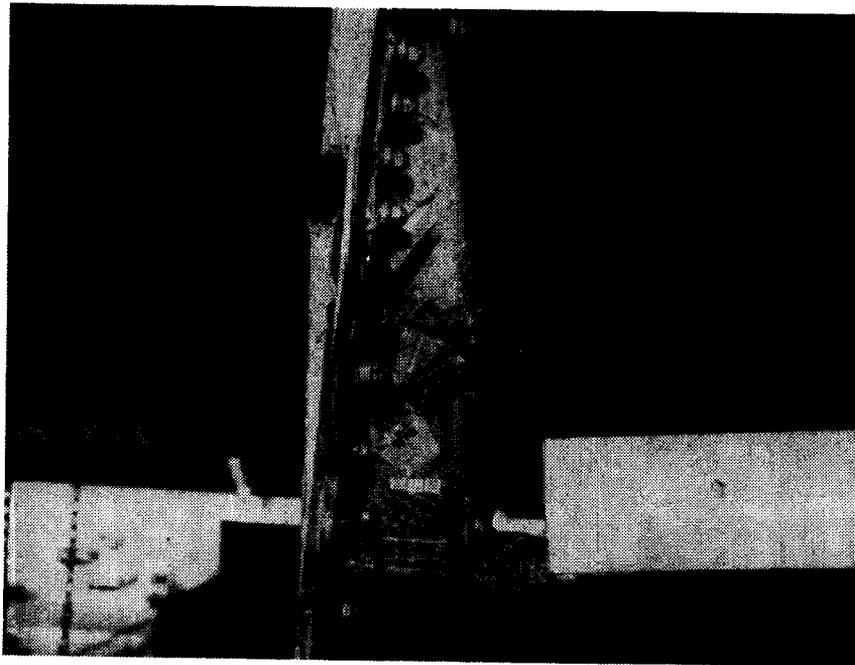
Figure 44. CV2-2 Residual Strength Test Damage - Hat and Skin

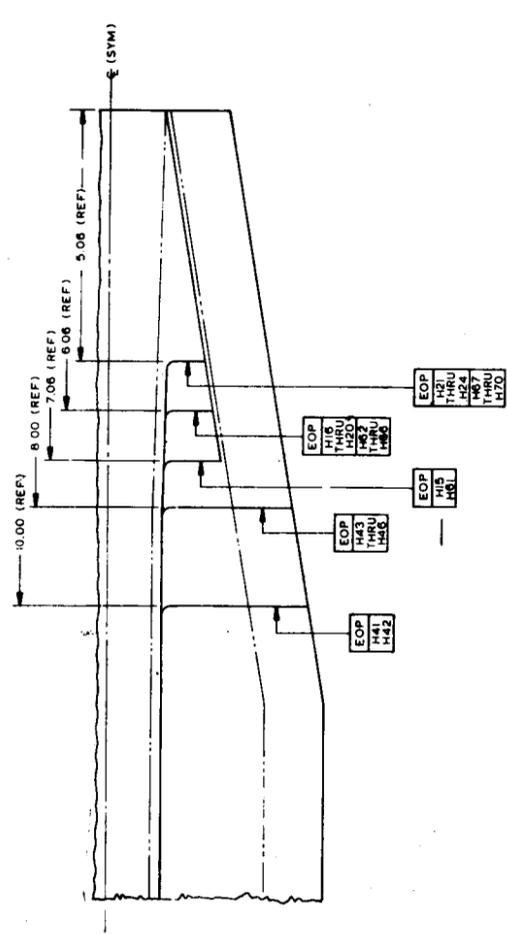
FLAT PATTERN SCHEMATIC
OF NOTED PLIES
NO SCALE

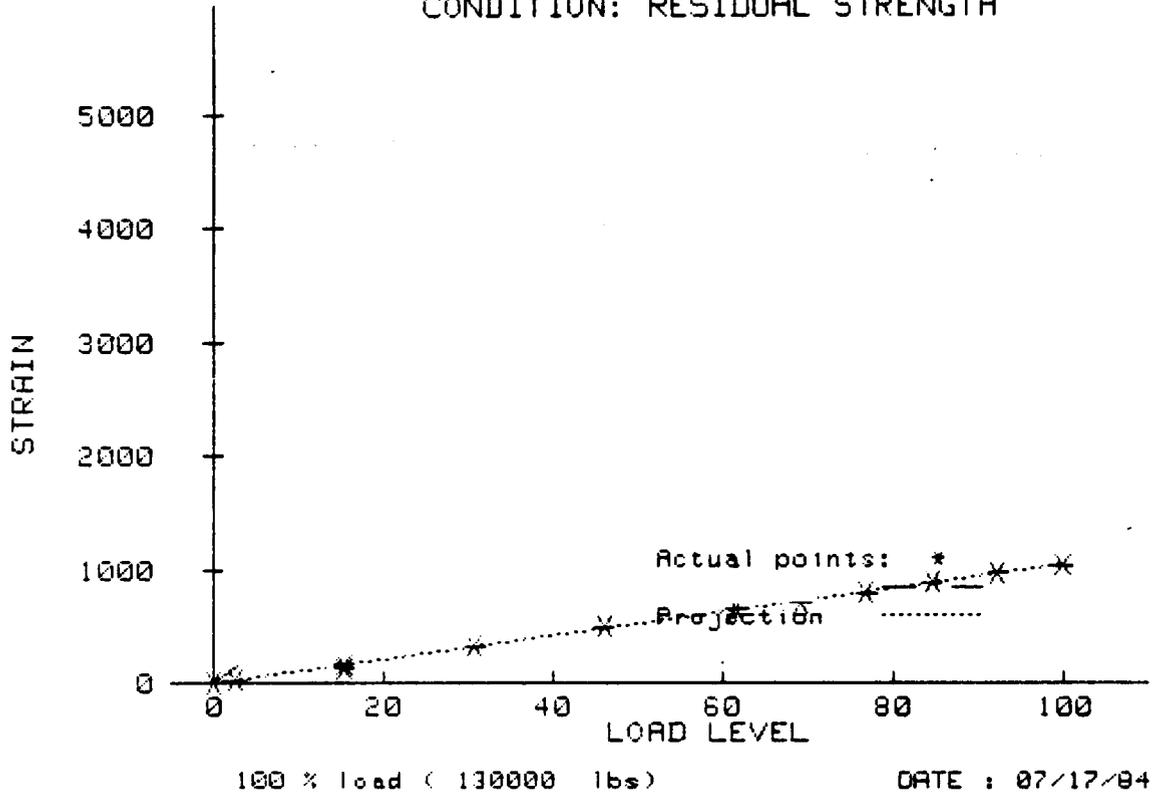
GAGE: 1A
SPECIMEN: CV2-2
CONDITION: RESIDUAL STRENGTH

Figure H-1. CV2-2 Residual Strength Tension Test -
Strain Gauge Readings - Plot Gage 1

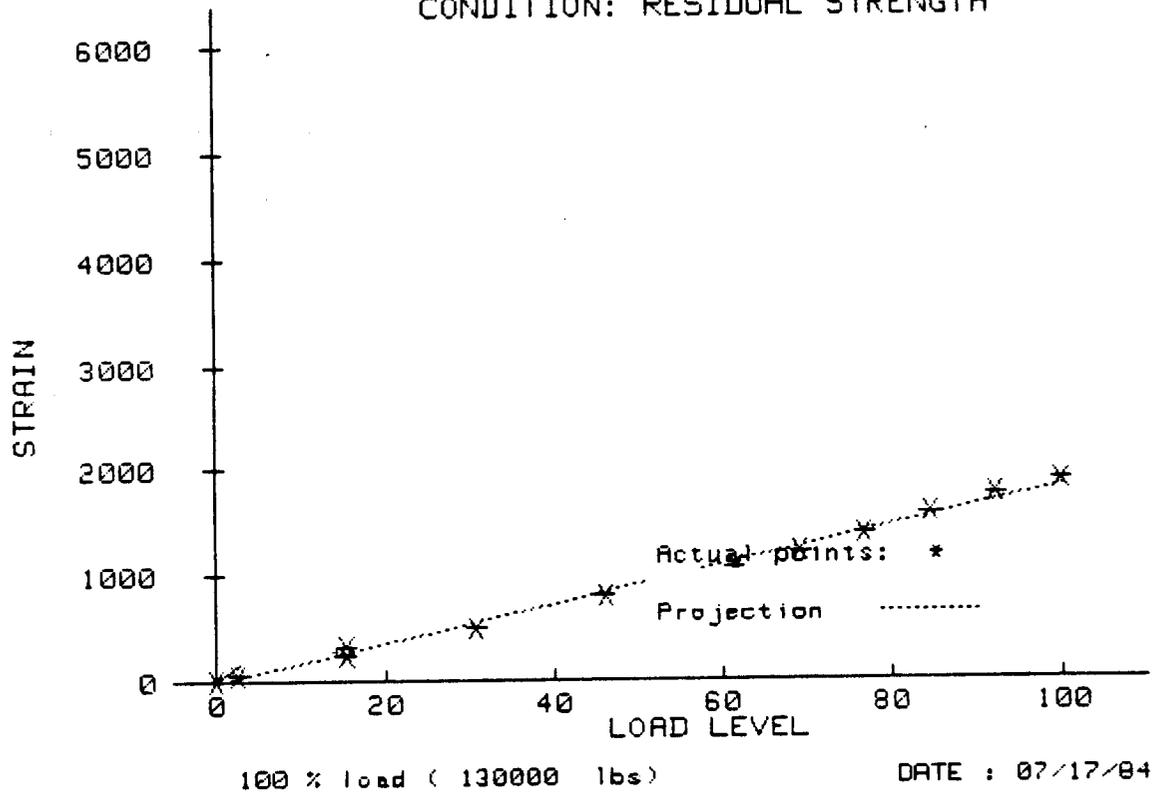
GAGE: 2A
SPECIMEN: CV2-2
CONDITION: RESIDUAL STRENGTH

Figure H-2. CV2-2 Residual Strength Tension Test - Strain Gauge Readings - Plot Gage 2
