NASA Contractor Report 3762

Lightning Protection Guidelines and Test Data for Adhesively Bonded Aircraft Structures

J. E. Pryzby and J. A. Plumer
Lightning Technologies, Inc.
Pittsfield, Massachusetts

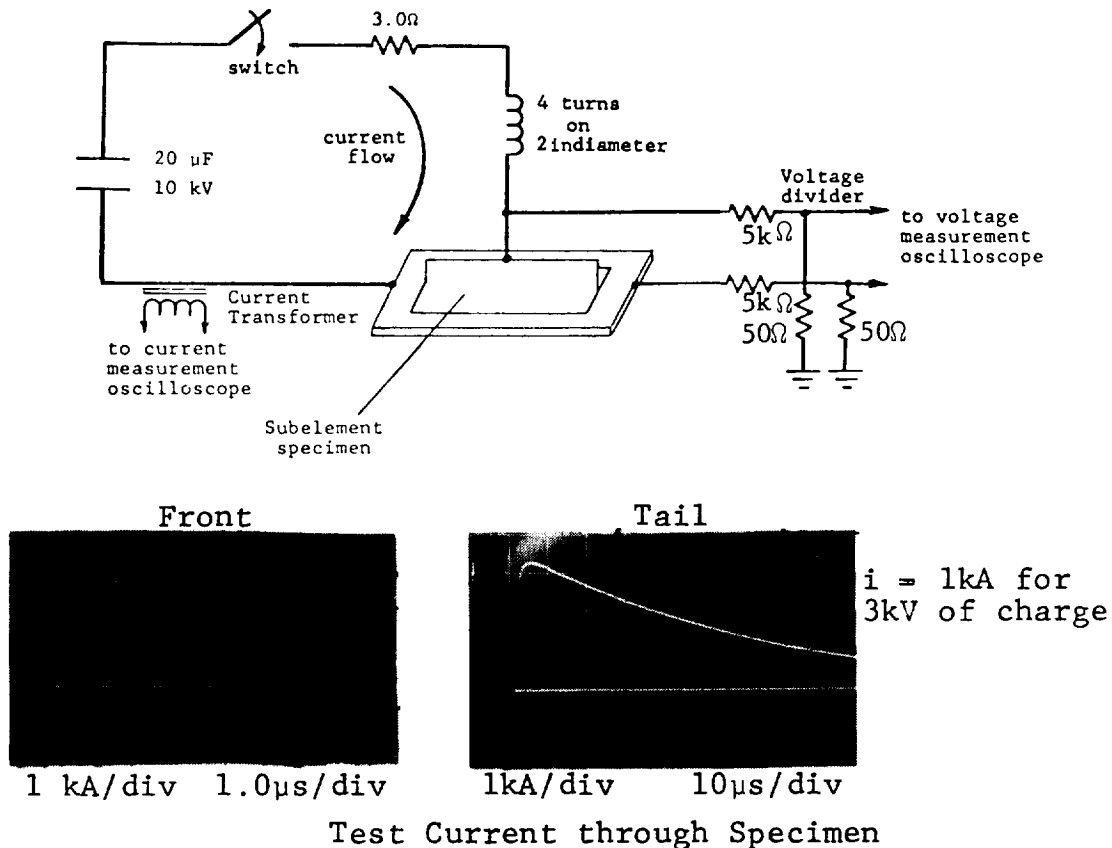
Figure 2.2 - Test Circuit Parameters for Generating the $2 \times 50 \mu\text{s}$ Simulated Lightning Current Pulse.

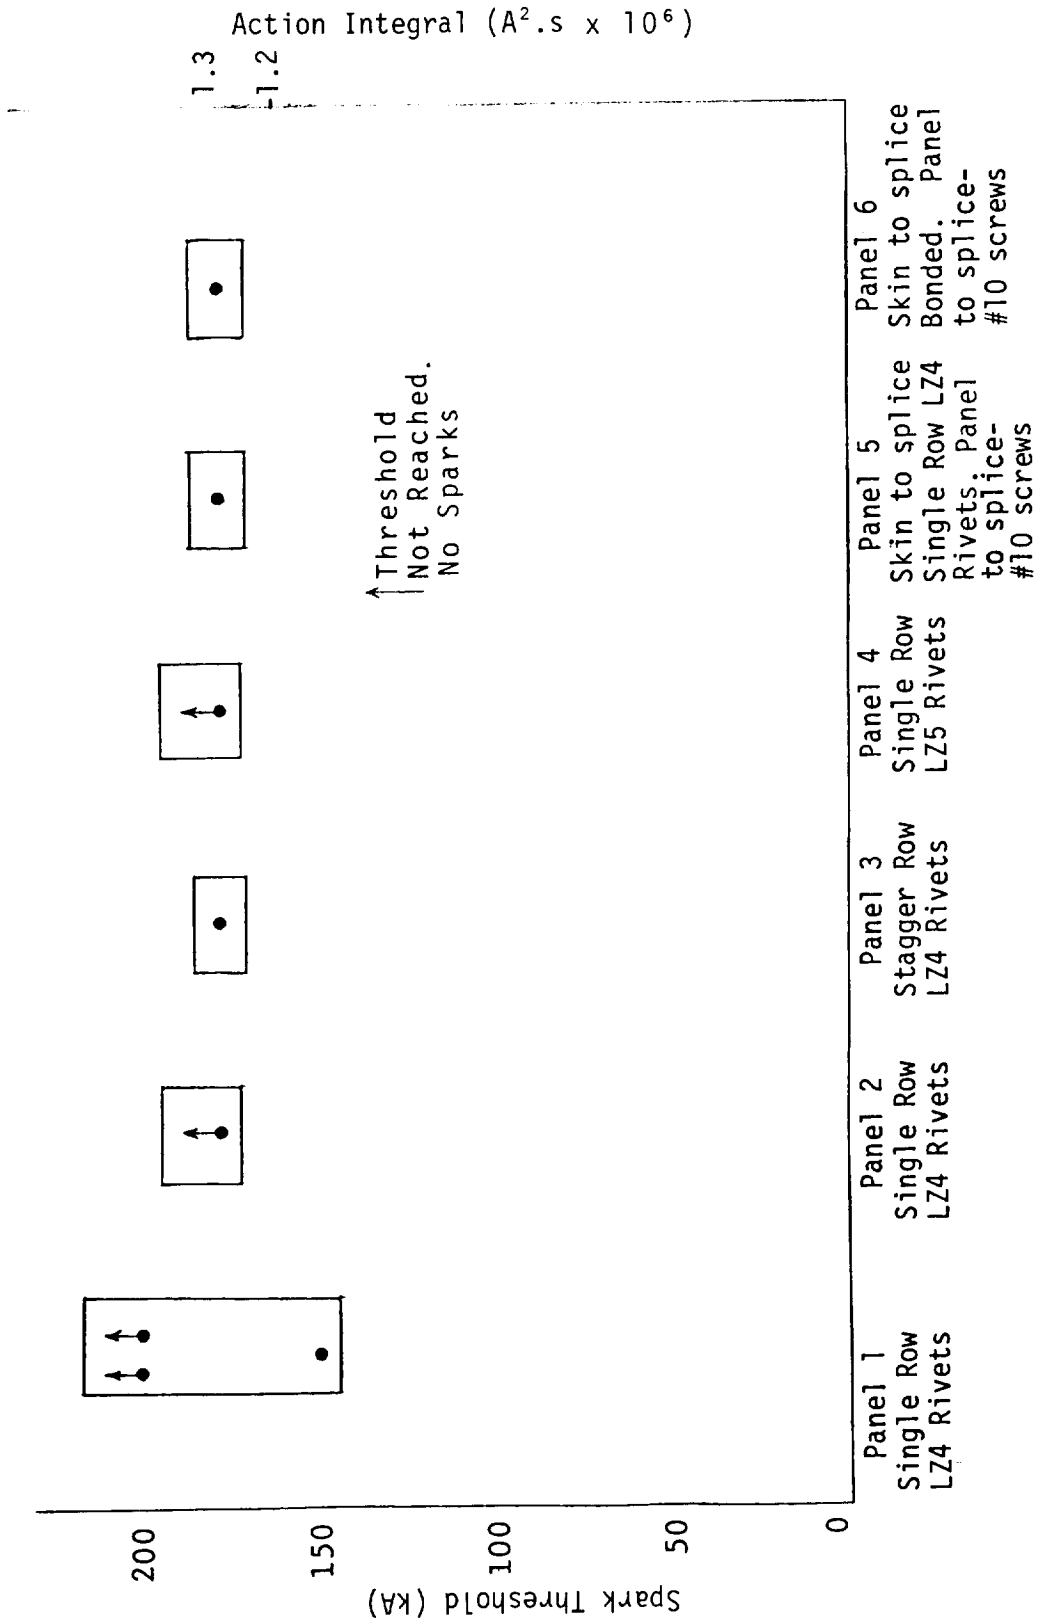
Figure 2.26 - Spark Threshold Levels - Direct Strike to Center of Access Door.

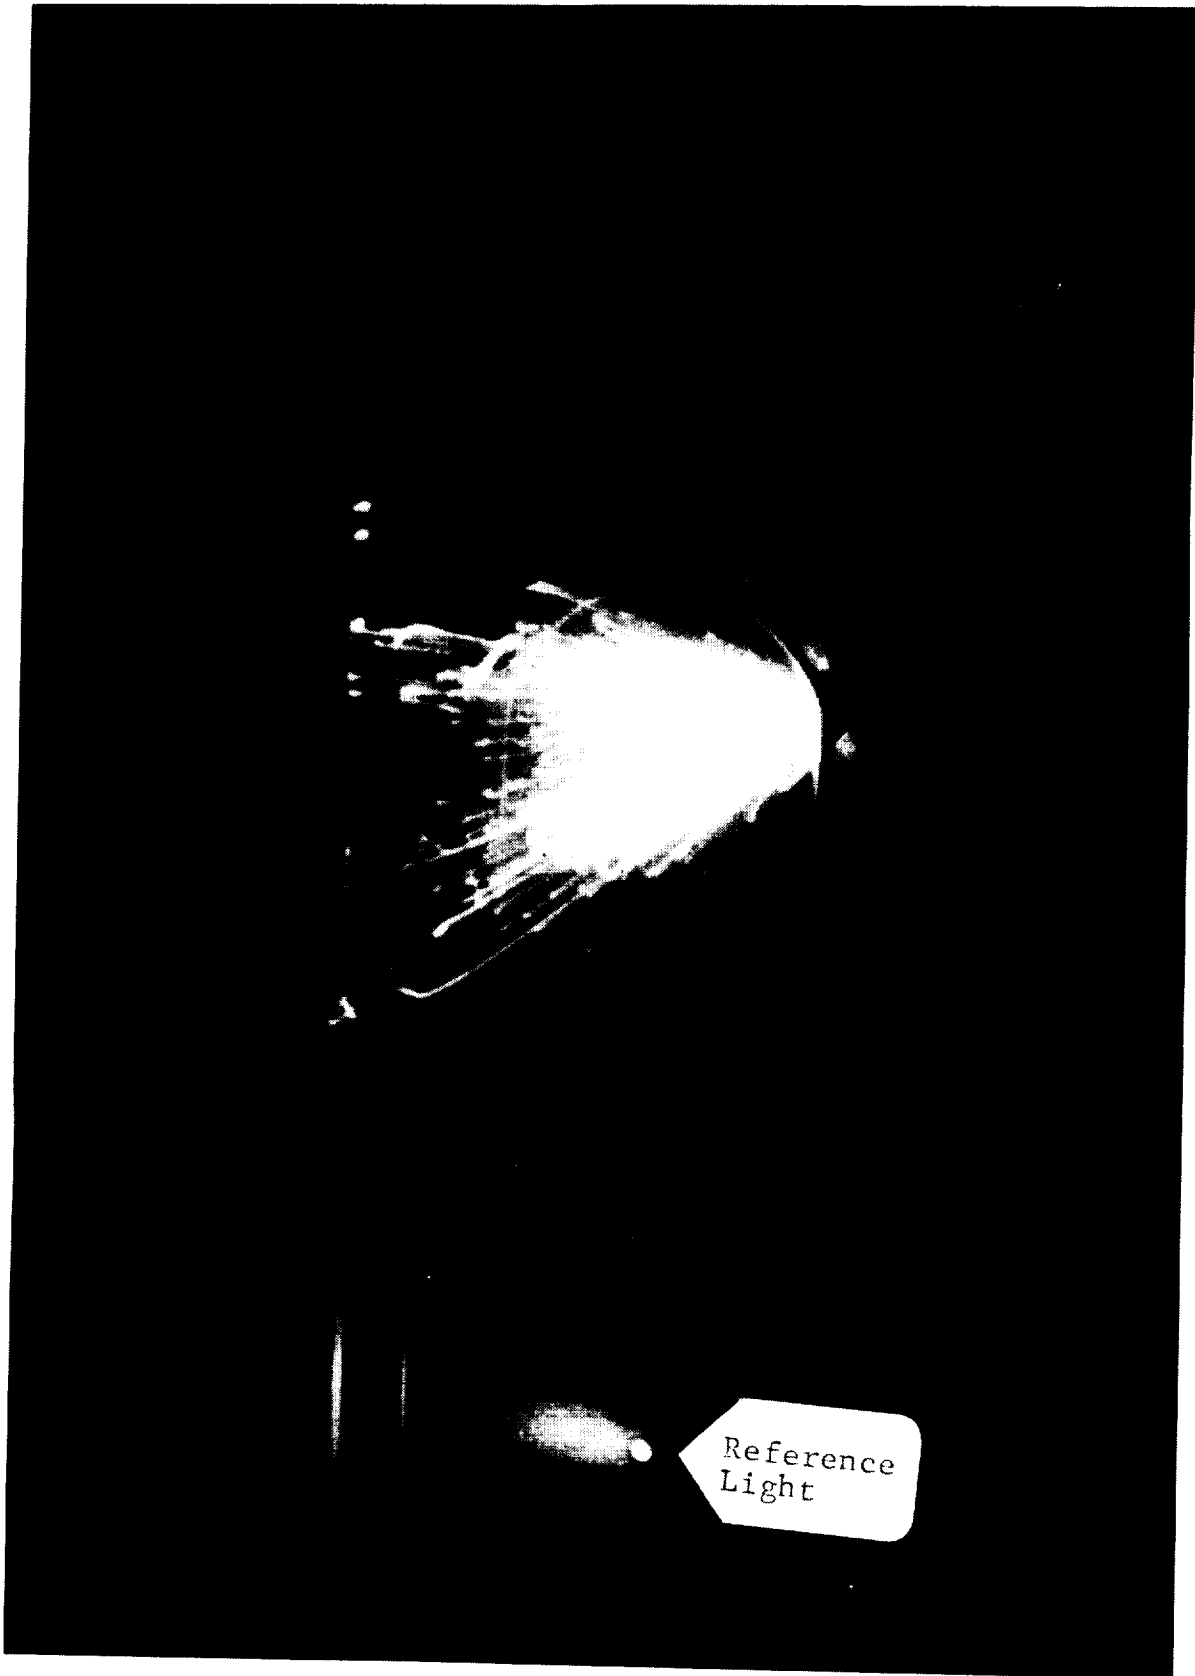
Figure 2.29 - Transfer of Current from Access Door to Splice Plate.

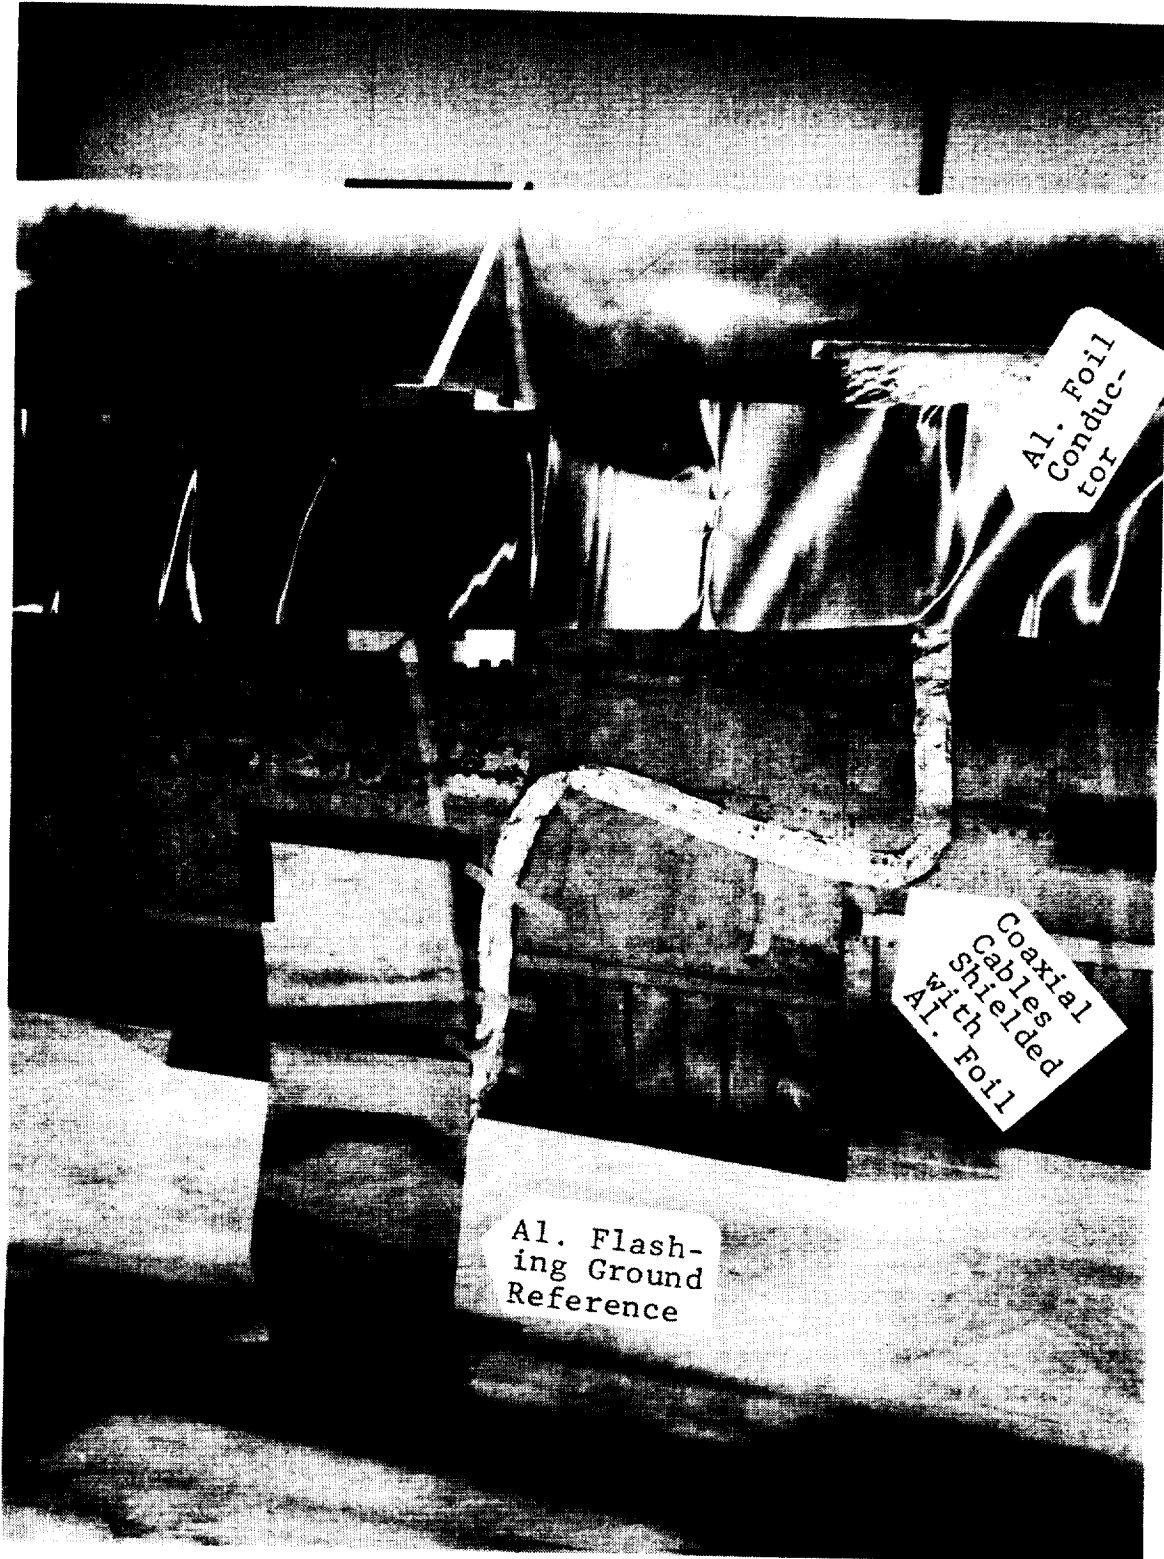
Figure 3.6 - Lab Setup for Measurement of Bond Line Voltages
on Bonded Aluminum Wing.

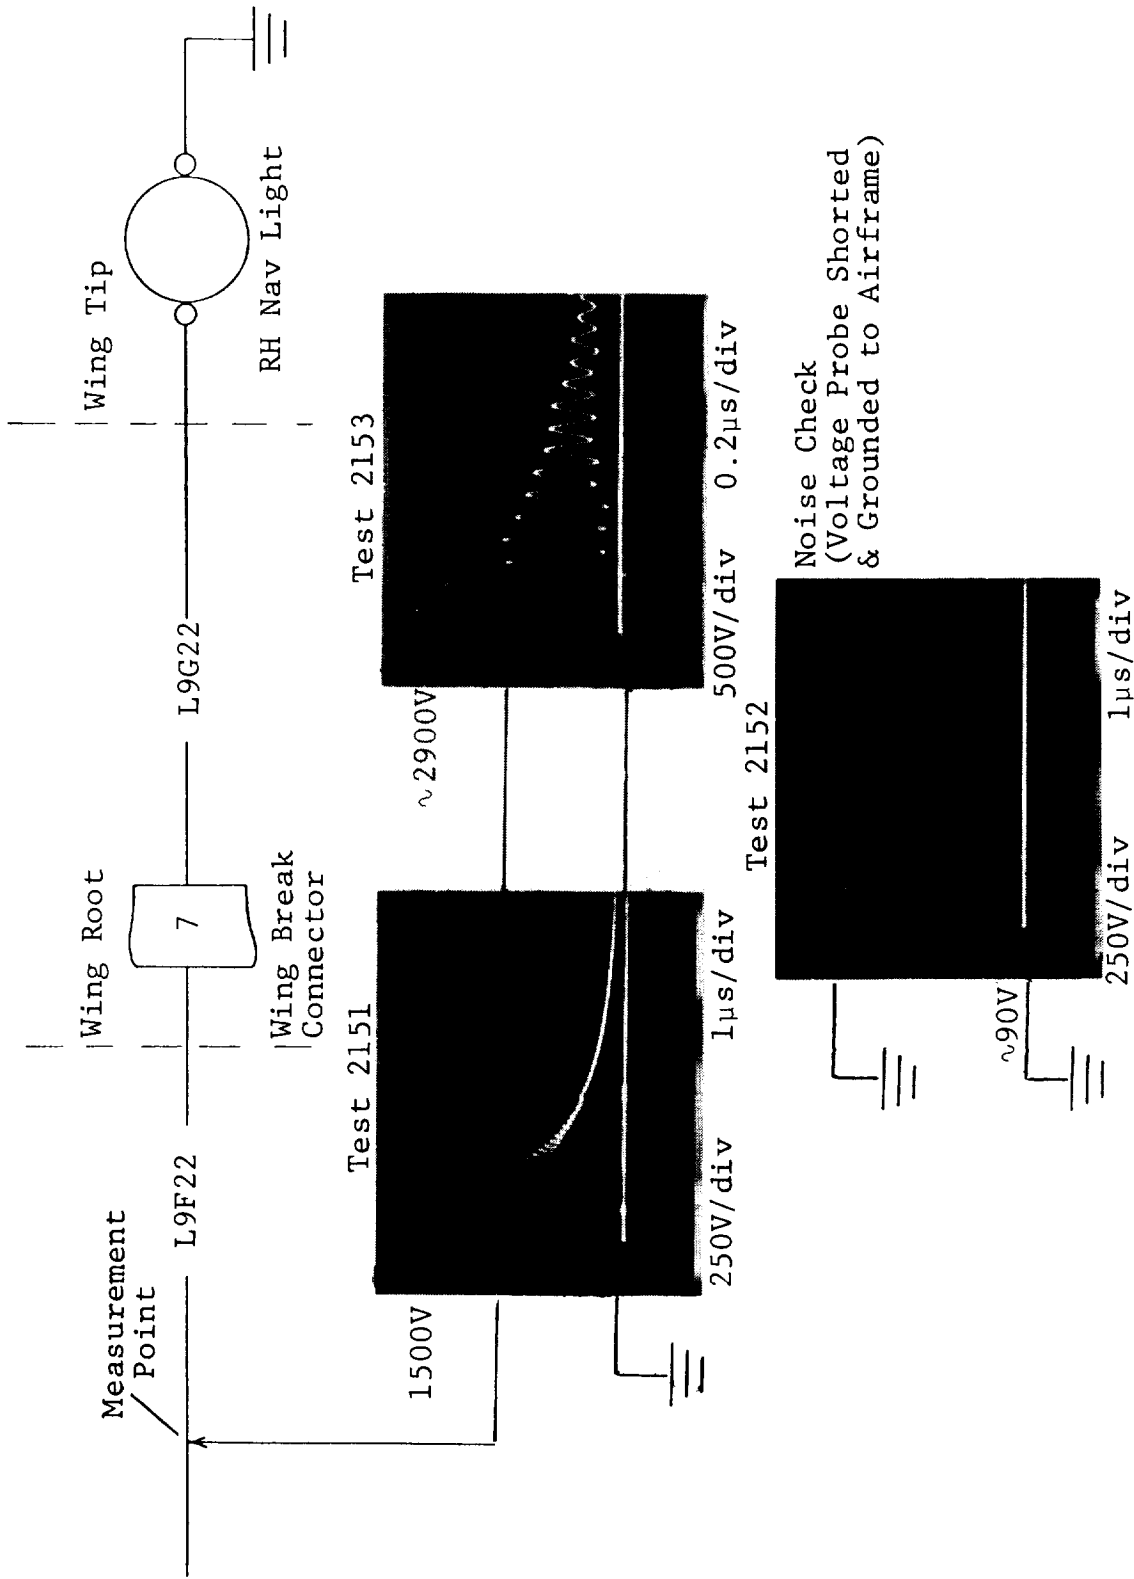
Figure 3.24 - Voltage Induced in RH Navigation Light Circuit, by 7 kA, 4x50μs Simulated Lightning Strike to RH Nav Light Housing of Bonded Aluminum Wing.

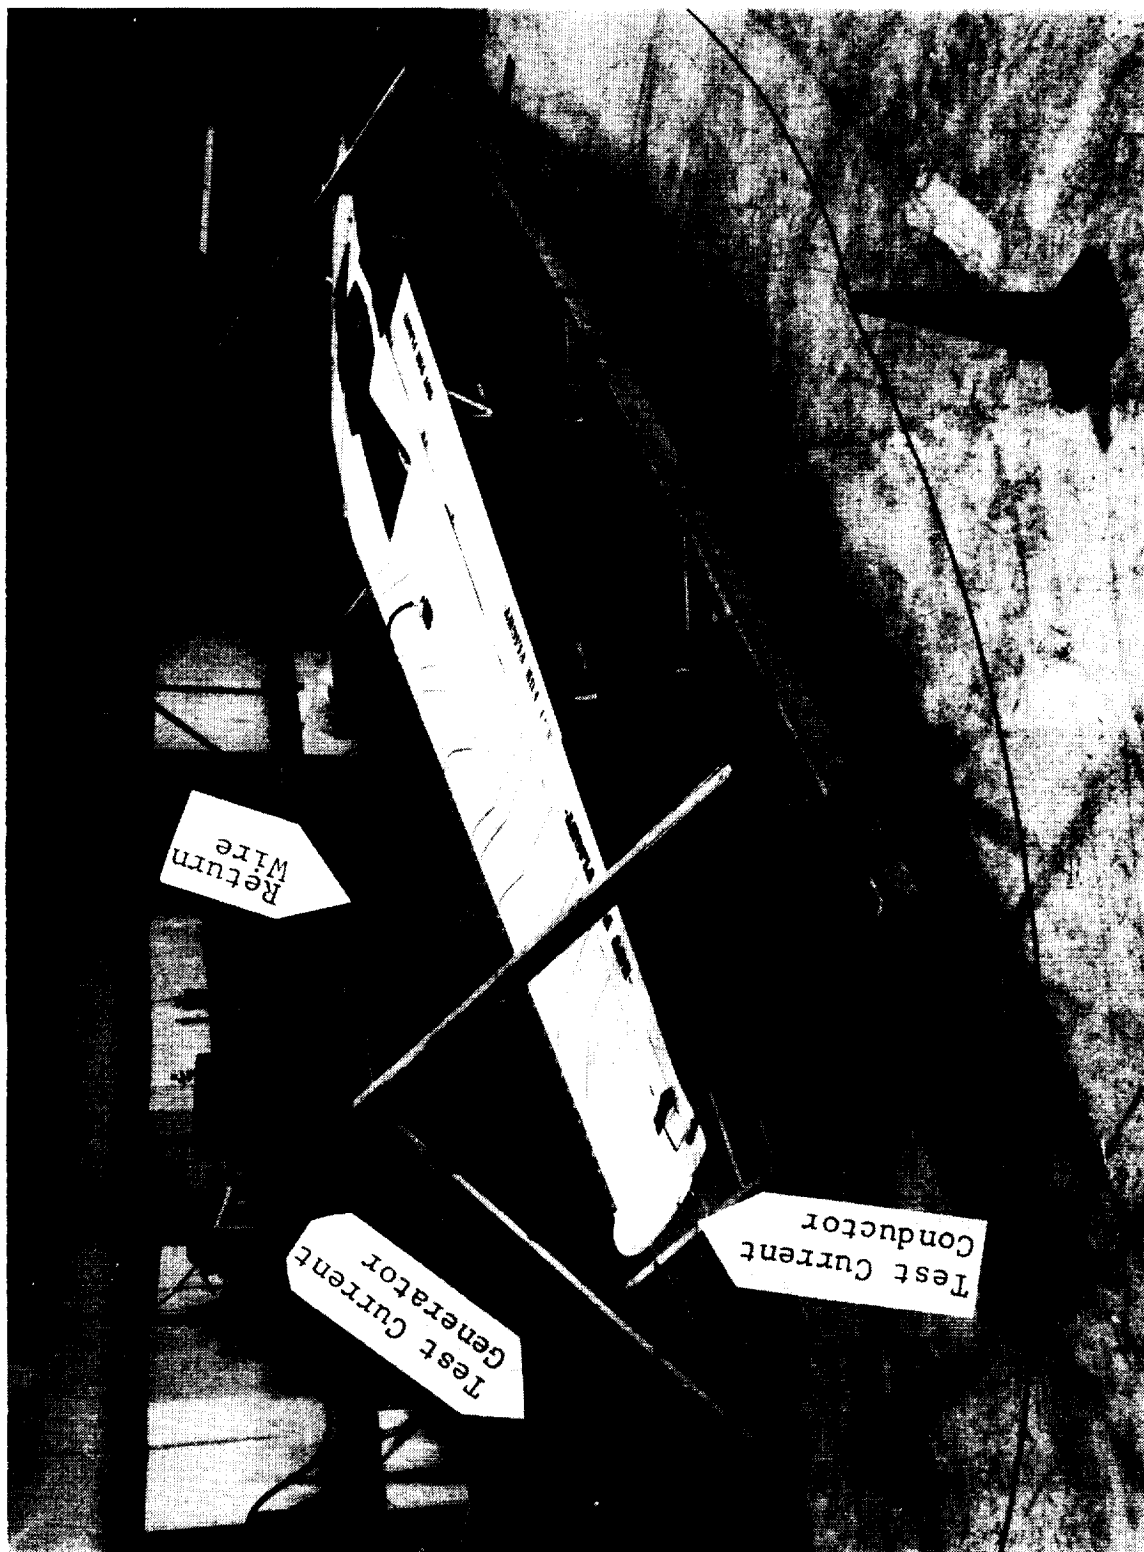
Figure 3.30 - gr/E Wing Test Setup.

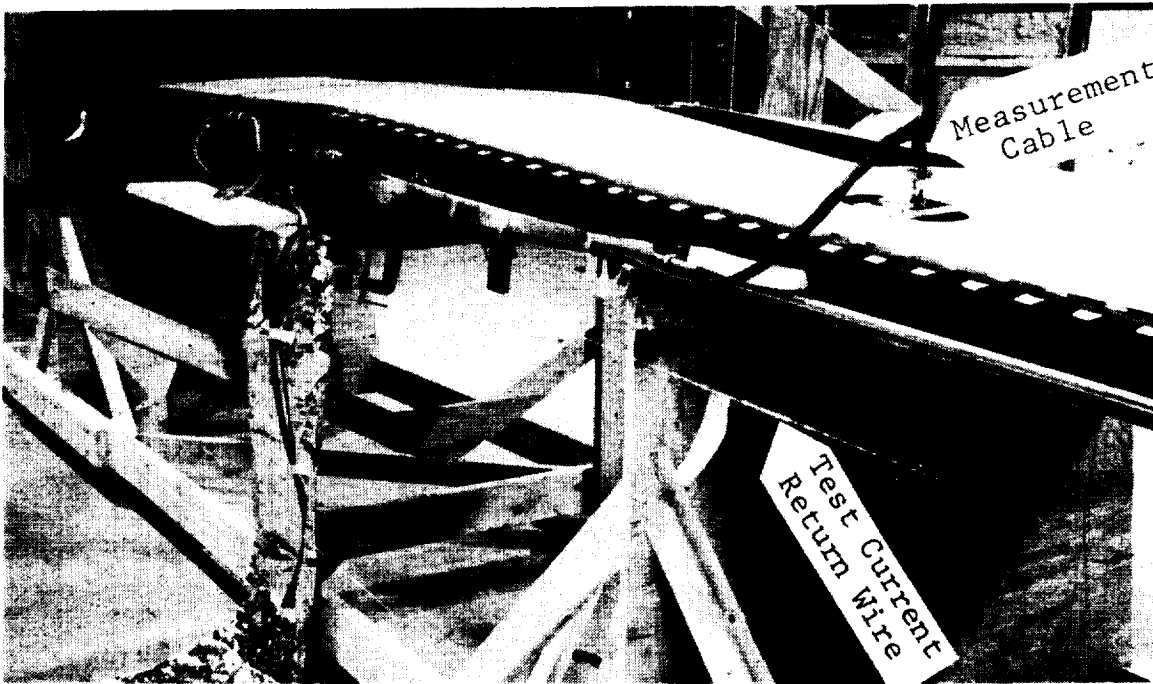
Figure 3.34 - Lab Setup for Bond Line and Fuel Probe Voltage Measurements in gr/E Wing.
