Historical and Simulated Changes in Channel Characteristics of the Kalamazoo River, Plainwell to Otsego, Michigan

Scientific Investigations Report 2005-5044

By Cynthia M. Rachol, Faith A. Fitzpatrick, and Tiffany Rossi

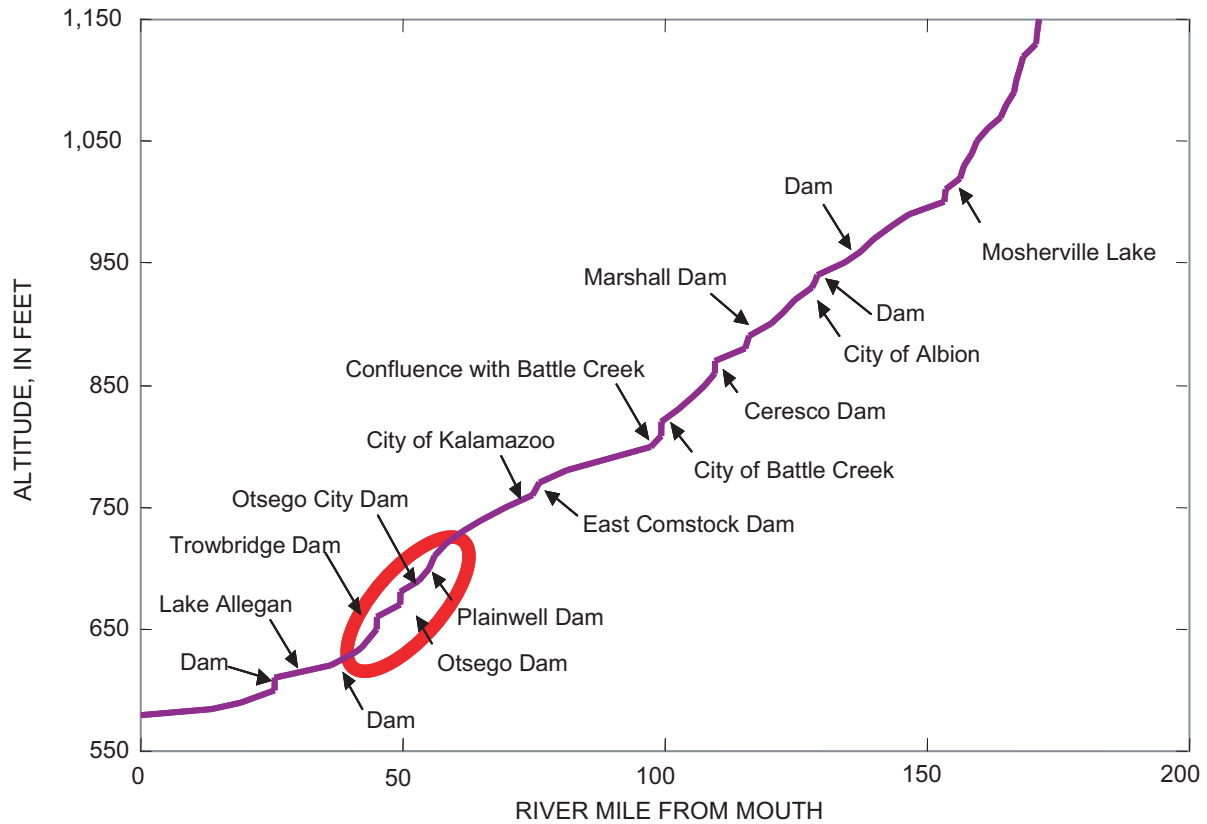
Figure 13. Longitudinal profile of the Kalamazoo River, Michigan, from its headwaters to mouth at Lake Michigan. Locations of dams within study area are highlighted in red.

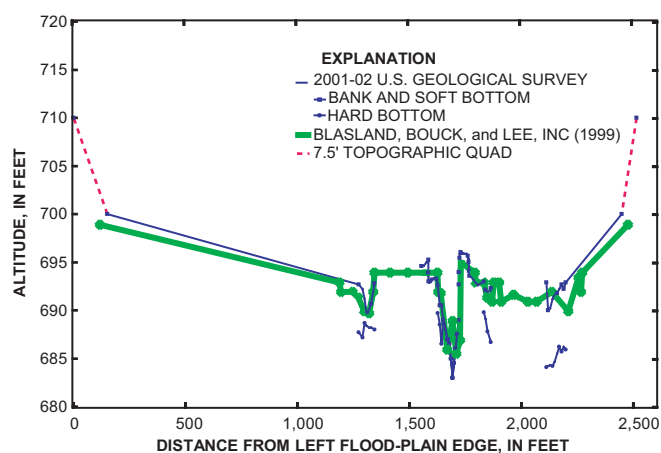
Figure 15. Example cross section of the Kalamazoo River Valley, Michigan.

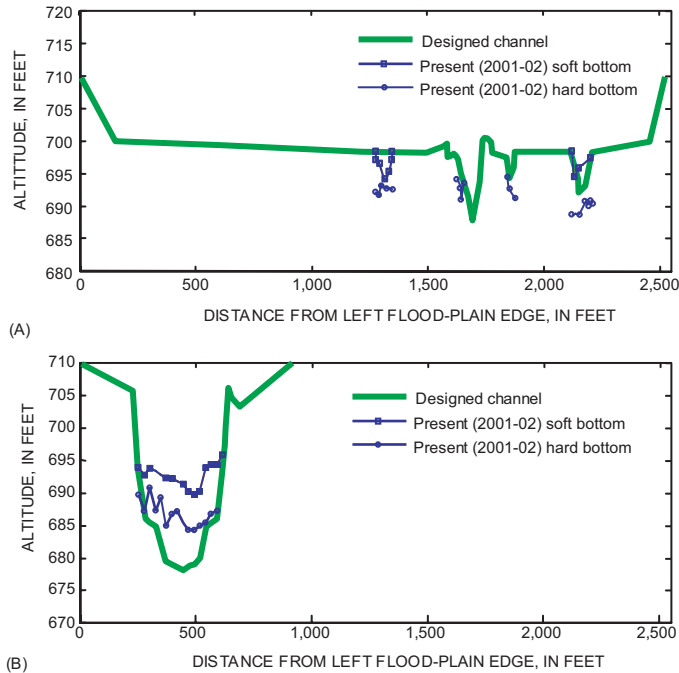
Figure 16. Cross sections 54.41 (A) and 53.05 (B) for present (2002) conditions and designed channel with dams removed, Kalamazoo River, Michigan.

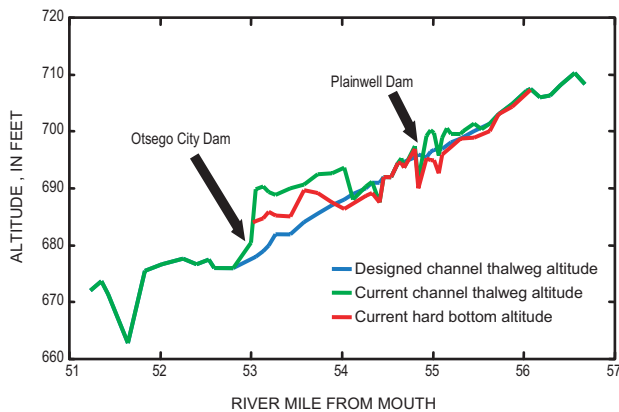
Figure 17. Longitudinal profile of present thalweg, present hard bottom lowest elevation, and designed channel thalweg in the Plainwell to Otesgo reach of the Kalamazoo River, Michigan.

(appendix A). Cross sections in the impounded area upstream of Plainwell Dam, from river mile 54.93 to 55.30, were mainly modified by lowering the channel to its pre-dam elevation and removing impounded sediment to increase flood-plain area (appendix A). The slope through this reach is similar to that for pre-dam conditions (fig. 17).

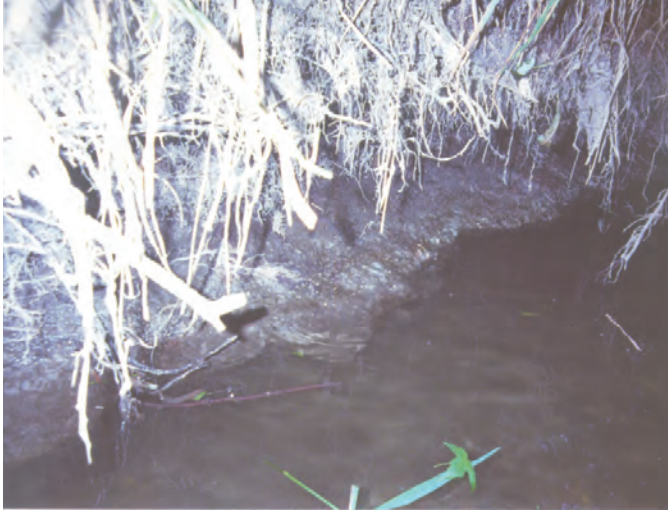
Figure 20. Undercut banks typical of the Plainwell to Otsego reach, Kalamazoo River, Michigan. *Photograph by C.M. Rachol.*

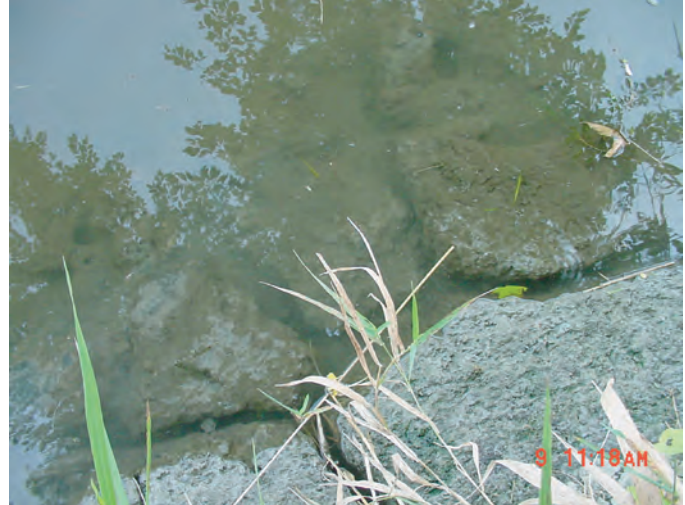
Figure 22. Material eroded from the bank becomes part of the bank toe, Kalamazoo River, Michigan. *Photograph by C.M. Rachol.*

The effects of steepening the slope on the streambanks can be seen when comparing the results of the bank-stability assessment. Under present conditions, toe erosion resulted in undercut bank profiles. Field observations show that many of the locations analyzed were in the process of becoming undercut (fig. 20). The progression of bank undercutting would lead to the eventual localized failure of the bank as more sediment was removed (fig. 21). Once failure occurs, the bank material that is sloughed into the river acts to temporarily reinforce the bank and becomes part of the new bank toe (fig. 22). Over time, the root mass shown on top of the failed bank in figure

20 will erode away and the bank toe will resemble that shown in figure 22.

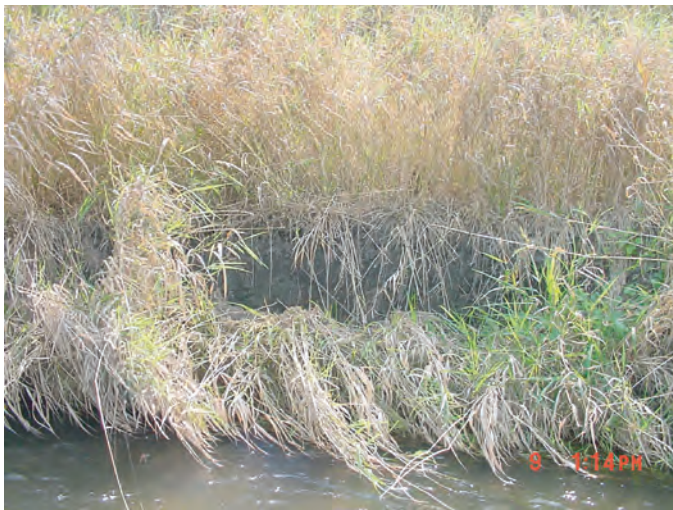
Figure 21. Localized bank failure site included in sstudy (river mile 51.23; see Figure 11), Kalamazoo River, Michigan. (Failed bank is approximately 6 feet wide) *Photograph by C.M. Rachol.*

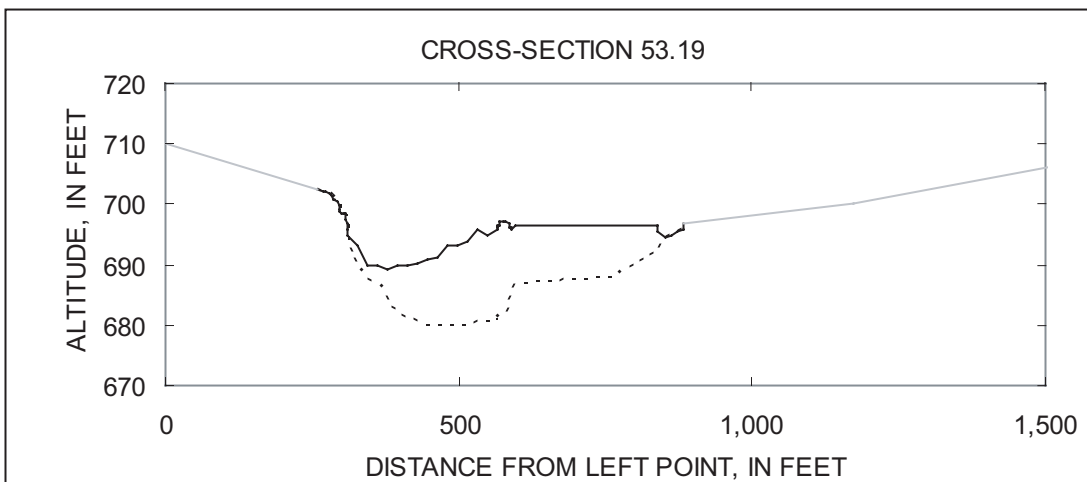
Appendix A. Valley and designed cross sections for the Kalamazoo River from Plainwell to Otsego, Michigan. Designed channel modifications shown by dashed line; cross-section extensions based on topographic map elevations shown in grey. Cross-section locations within study reach are shown on Figure 14 -- continued.
