# Verification of 1921 Peak Discharge at Skagit River near Concrete, Washington, Using 2003 Peak-Discharge Data

Scientific Investigations Report 2005–5029

By M.C. Mastin and D.L. Kresch

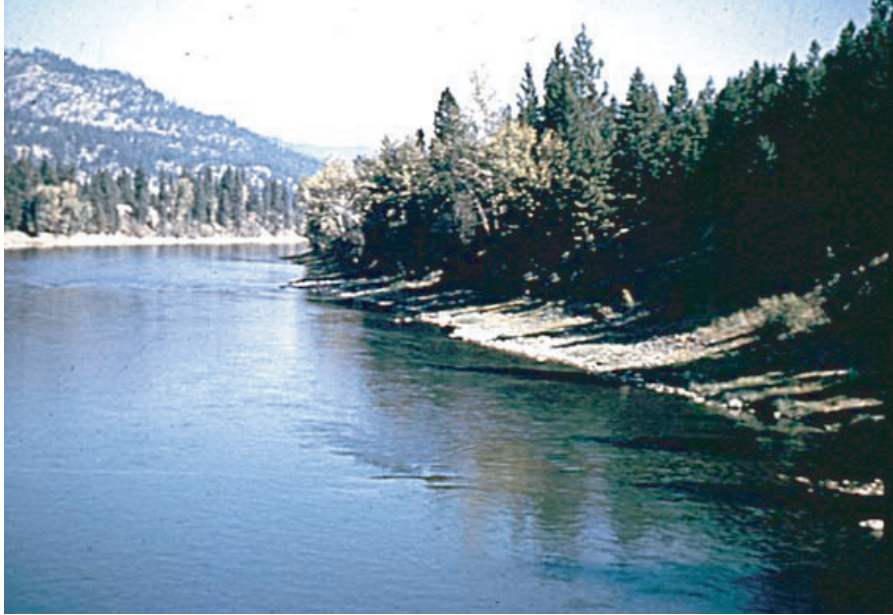
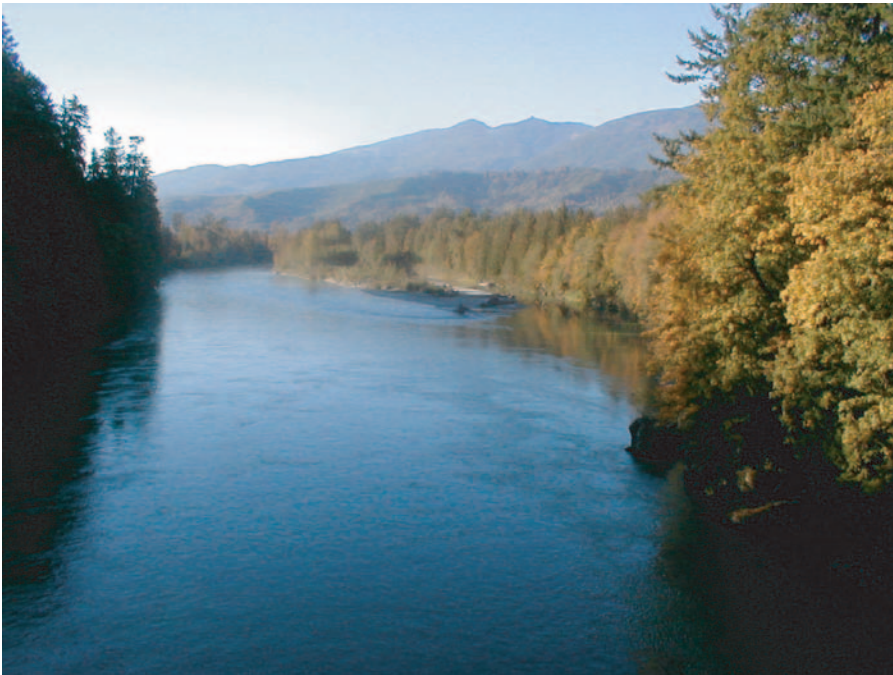
**A.** Clark Fork at St. Regis, Montana, showing cobble bed material and fairly dense vegetation along the banks (Barnes, 1967, p. 24).

**B.** View from Dalles Bridge looking downstream at the upstream end of island at Skagit River near Concrete, Washington, August 2004. (Photograph taken by D. Miller, U.S. Geological Survey, 2004.)

**Figure 5.** Comparison of two  $n$ -verified river reaches with  $n$  values of 0.028.

velocity of 11.09 ft/s from the current-meter measurement of 138,000 ft<sup>3</sup>/s on October 21, 2003. The accuracy of the average of the two calculated  $n$  values (0.028) can be evaluated by comparing it with verified  $n$  values on other rivers such as Clark Fork at St. Regis, Montana, where Barnes (1967) determined an  $n$  value of 0.028. The bed material and bank vegetation (fig. 5A) for Clark Fork at St. Regis appear to be similar to the channel characteristics of Skagit River near Concrete (fig. 5B), although vegetation along the banks of Skagit River probably is more dense.

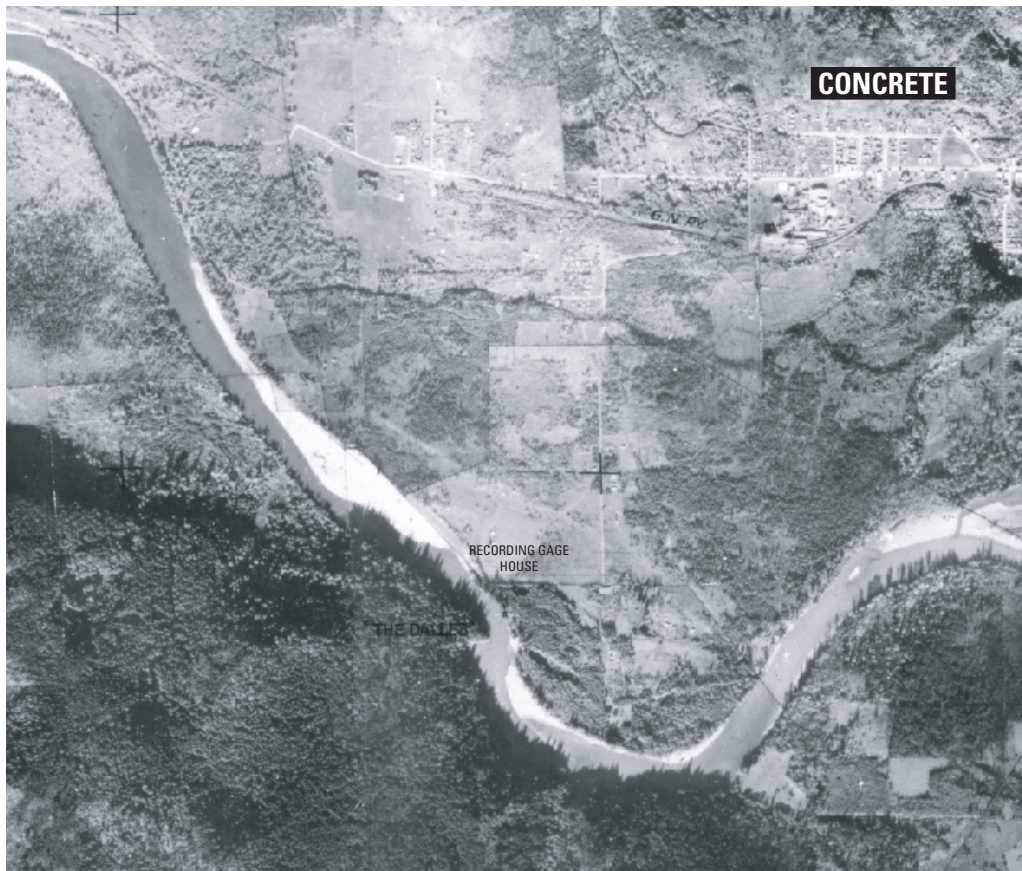
**Figure 6.** Skagit River near Concrete, Washington, recording gage house and barren island/cobble bar in the study reach in 1937 (Skagit County, 2003).

Use of an  $n$  value determined from October 21, 2003, flood data to verify peak discharge of the 1921 flood is valid only if the reach used for both analyses has not changed significantly since 1921. A comparison of historical and current aerial photographs of the reach (figs. 6 and 7) indicates that the reach has not significantly changed. The size and shape of an island near the right (north) bank of the river in the study area reach (left of center in the photographs) has not changed much over time, but the density of vegetation on the island has changed significantly. In the 1937 photograph (fig. 6), the island is bare of vegetation. Historical photographs from 1948 and 1962 show a gradual increase in vegetation

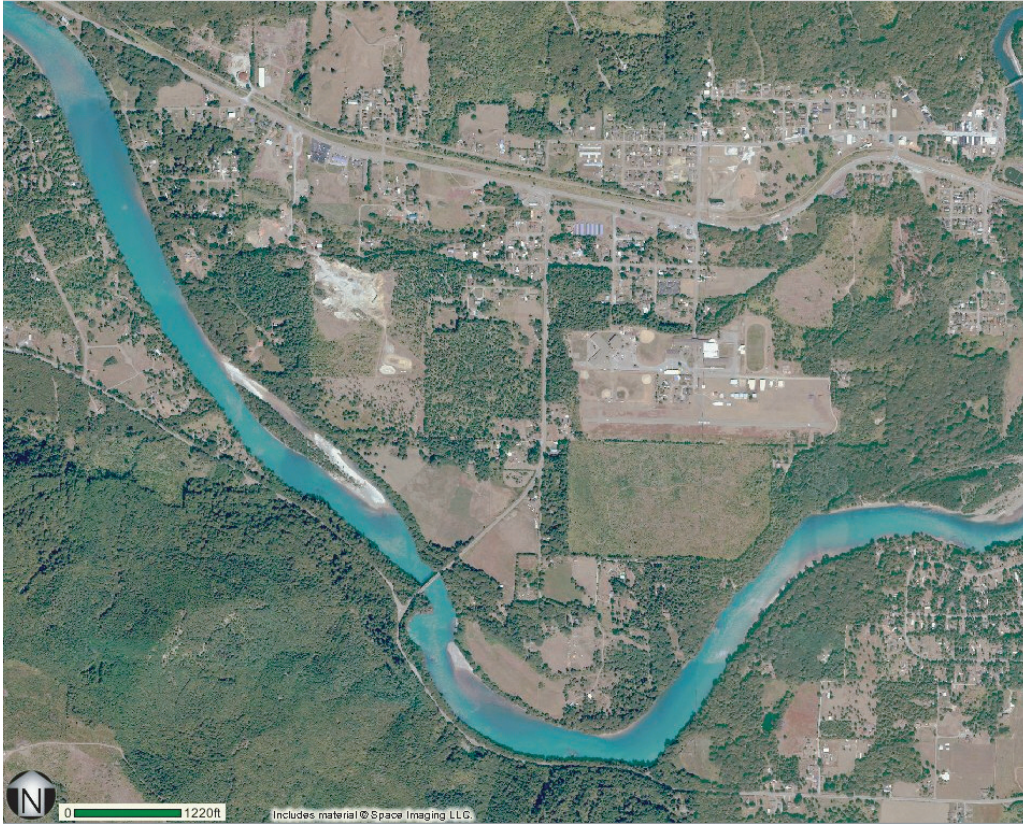
**Figure 7.** Skagit River near Concrete, Washington, and vegetated island/cobble bar in the study reach in 2001 (Skagit County, 2003).

on the downstream part of the island. As of 2004, the downstream part of the island is covered with a dense forest of mostly alders (many more than 2-ft diameter), maples, and cottonwoods.
