NASA Technical Memorandum 102549

Experimentally Determined Wear Behavior of an Al₂O₃-SiC Composite from 25 to 1200 °C

Christopher DellaCorte and Serene C. Farmer
Lewis Research Center
Cleveland, Ohio

Prepared for
The Tribology of Composite Materials
sponsored by ASM International
Oak Ridge, Tennessee, May 1-3, 1990

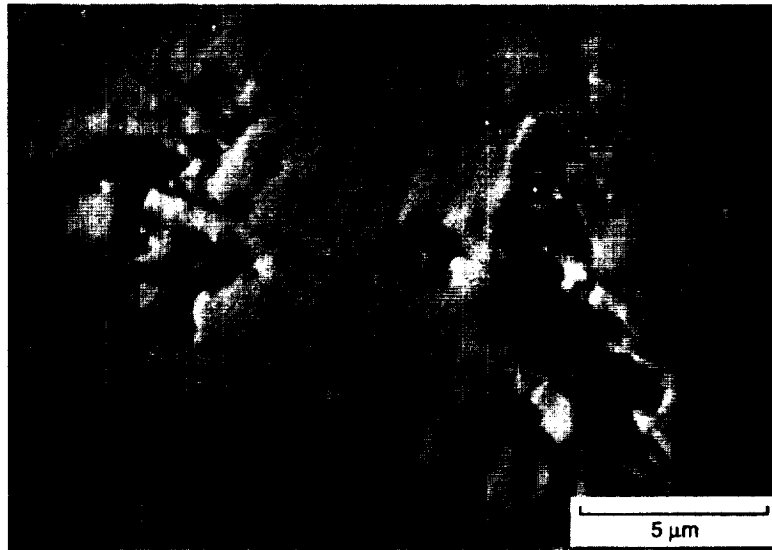
Figure 1. - SEM micrograph of ceramic surface showing orientation of whiskers in planes parallel to surface and sliding plane.

The composite is made by hot pressing high purity (>99.5 purity) alumina powder mixed with single crystal SiC whiskers. During consolidation, most of the whiskers preferentially align themselves in a plane perpendicular to the pressing direction (Ref. 8). The pins and disks tested in this study have their rubbing surfaces parallel to the whisker planes. See Fig. 1.

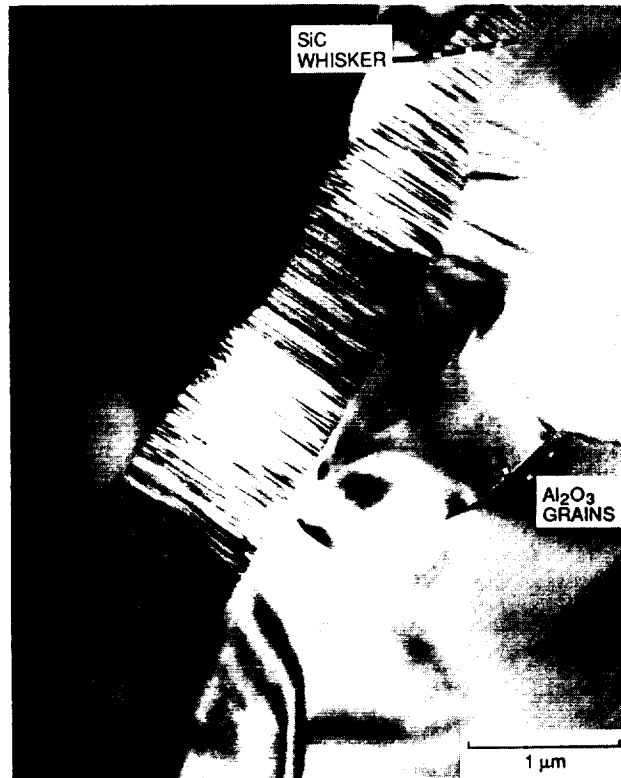
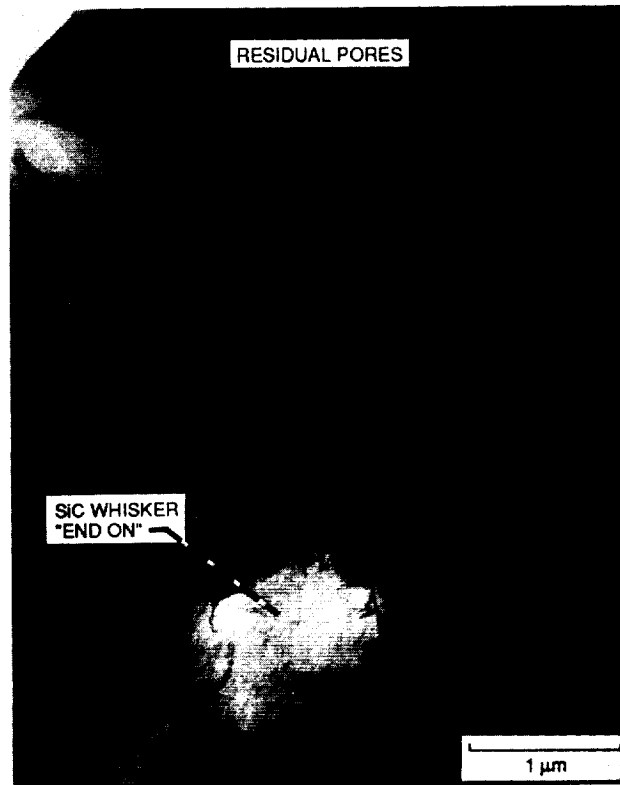
Figure 2. - TEM micrographs of virgin (unslid) material.

(a) Interface between whiskers and matrix is free from inclusions, large scale asperities, voids, etc. Alumina matrix grains visible.

(b) Whisker cross-section, some small enclosed pores, matrix grain structure.

Figure 2 shows some TEM micrographs of the virgin material. From this figure it can be seen that there is little residual porosity and that there is good contact between the matrix and the whiskers, i.e., there are no large voids between the whiskers and the matrix. Figure 2(a) shows a lengthwise cross-section of a whisker and Fig. 2(b) shows a whisker end on.

TEM analysis of the virgin material indicates that it is mostly free from voids, cracks, and dislocations. Therefore, changes in the material after testing can be attributed to effects from the sliding.

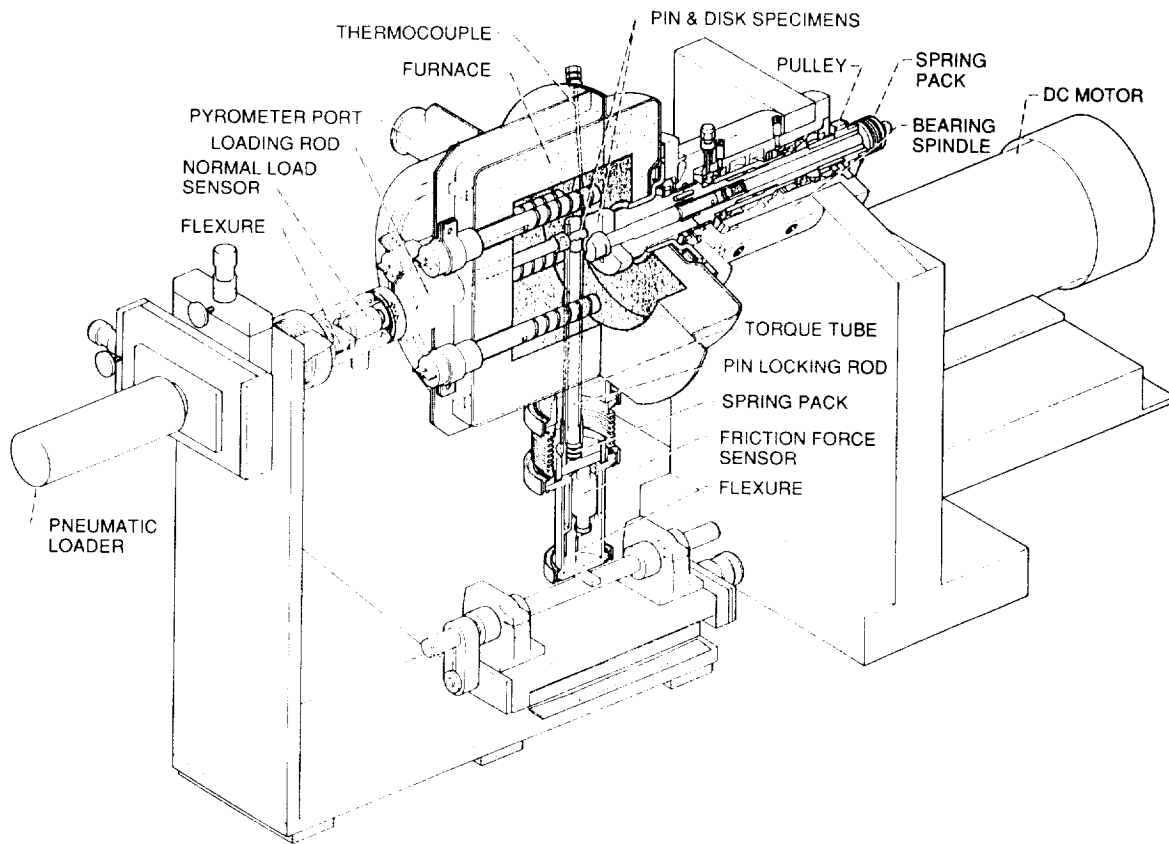
Figure 3. - High temperature friction and wear apparatus.

The specimens were tested in a high temperature pin-on-disk tribometer. With this apparatus, the pin is held in a torque tube and is loaded against a rotating disk. The disk specimens are mounted on a ceramic spindle which is rotated by a variable speed DC motor. Sliding velocity during these tests was 2.7 m/sec (1000 rpm). The rig has a well insulated SiC glowbar furnace capable of heating the specimens to 1200 °C. The test atmosphere was ambient air with

The torque tube which holds the pin specimen is connected to a temperature compensated strain gauge load cell which is connected to the rig table through a flexure. The pin is loaded against the rotating disk by a ceramic load rod. Like the torque tube, the load rod is connected to a load cell and then to a flexure which is connected to the rig support. The flexures allow for minute displacement of the load cells so that the friction and load forces can be measured. See Fig. 3. With this design, the actual applied load and friction force are measured without any parasitic losses encountered with pivots or support bearings. Thus the data from the rig is very accurate.

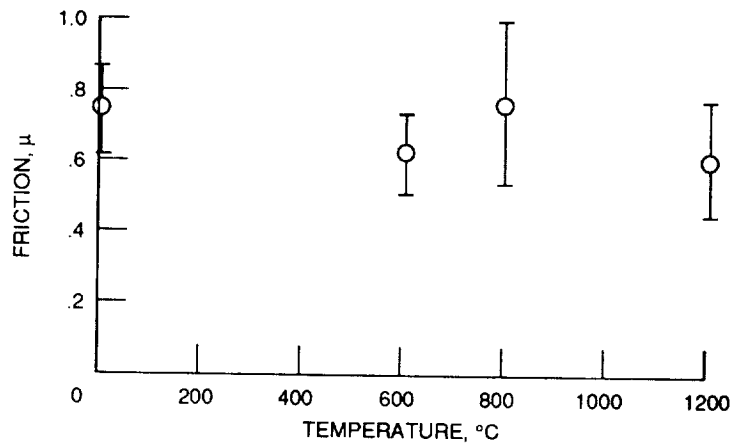
Figure 4. - Friction coefficient versus test temperature for the Al_2O_3 -SiC composite sliding against itself in air at 2.7 m/s, 26 N load.

RESULTS: FRICTION AND WEAR - The friction and wear data (for both the pin and the disk) are given in Table II and plotted as a function of temperature in Figs. 4 to 6. The data indicate that only the pin wear significantly varies as

In general, average friction coefficients for the Al₂O₃-SiC composite sliding against itself vary from a low of 0.58 to a high of 0.72 in the range of 25 to 1200 °C. Although these friction coefficients are high, the wear is relatively low when compared to steel sliding against steel or alumina sliding against alumina which have wear factors in the range of 10⁻³ to 10⁻⁴ mm³/N-m (Refs. 9 and 12). Disk wear factors for the alumina composites tested here are in the range of 4 to 9x10⁻⁷ mm³/N-m. Pin wear factors show an increase with temperature from 2x10⁻⁷ at 25 °C to 12x10⁻⁷ at 1200 °C. The pin wear factor at 600 °C is highest, 15x10⁻⁷ mm³/N-m. This may represent normal wear data scatter, however, since only two specimens were tested at this temperature whereas more than two specimen sets were tested at the other test temperatures.

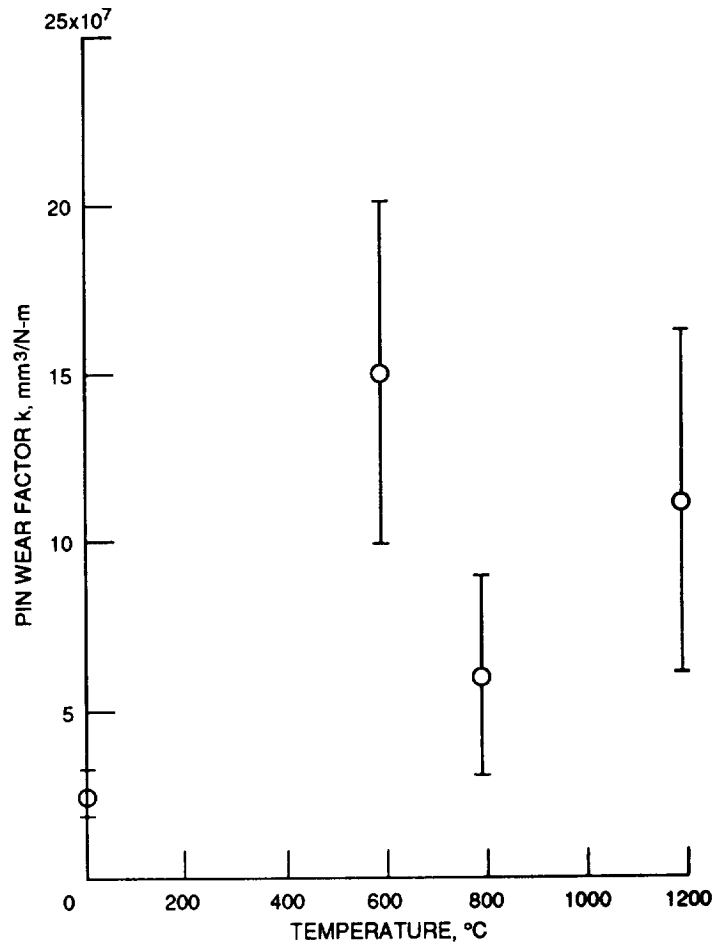
Figure 5. - Pin wear factor, k, versus temperature for the Al_2O_3 -SiC composite sliding against itself in air at 2.7 m/s, 26 N load.

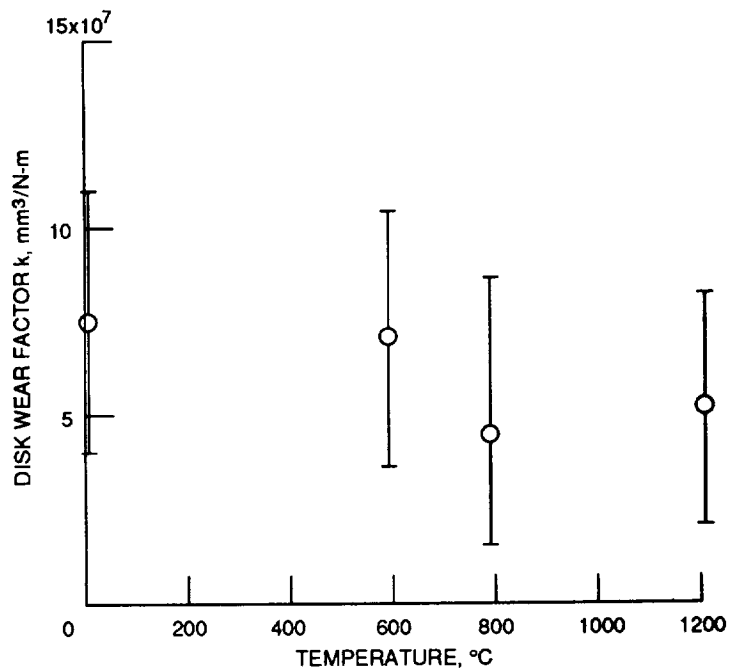
Figure 6. - Disk wear factor, k, versus temperature for the Al_2O_3 -SiC composite sliding against itself in air at 2.7 m/s, 26 N load.

a function of test temperature. Both the disk wear factor and the friction coefficients, remain relatively constant as the test temperature is increased from 25 to 1200 °C. The reasons for this behavior are not clear but may be due to a variety of factors including the development of glassy surface layers and wear debris.

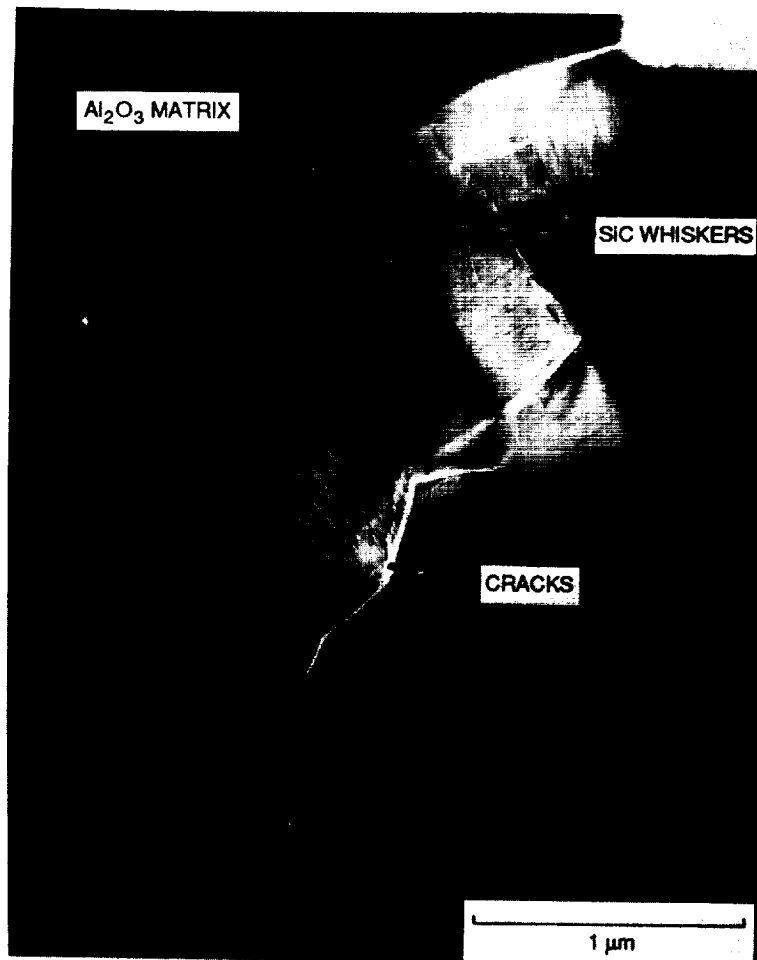
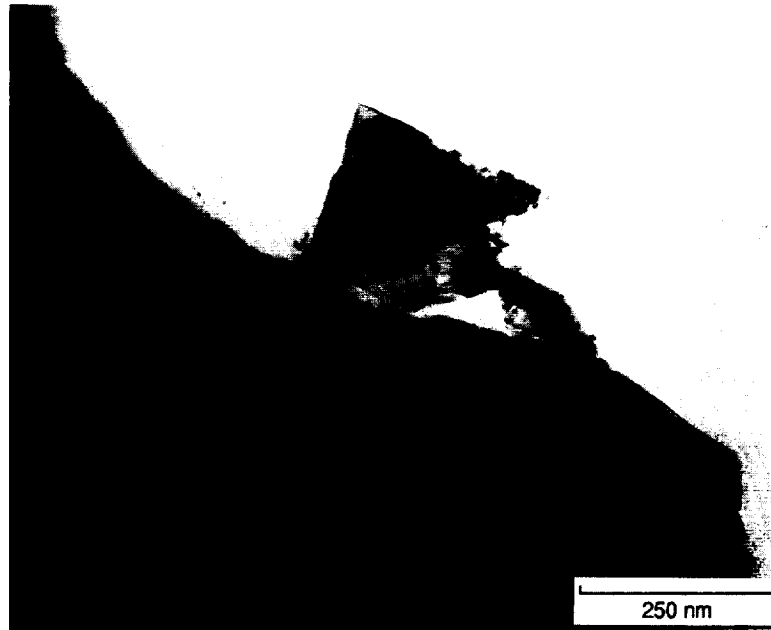
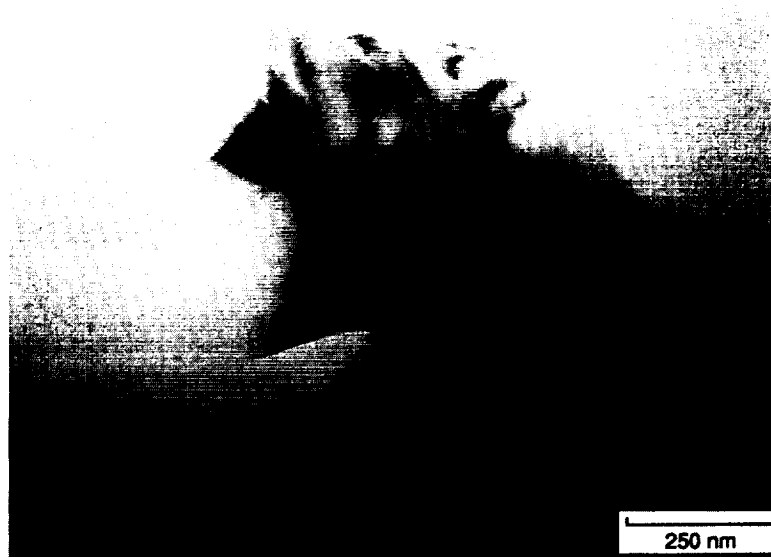
Figure 7. - TEM micrographs of pin wear surface from room temperature test.

(a) Photo shows cracking in matrix and whisker as evidence for brittle behavior.

(b) Brittle fractured wear debris particle.

(c) Brittle fractured wear debris particle. Note no dislocations or evidence of plastic behavior detected.

RESULTS: ELECTRON MICROSCOPY - TEM analyses of the room temperature pin wear scar show large regions of brittle fracture, individual wear particles, and many cracks. Little or no evidence of plastic behavior (dislocations) was seen. Figures 7(a) to (c) show typical TEM photomicrographs. These micrographs suggest that, under these conditions at room temperatures, the wear mode is conventional, i.e., generalized brittle fracture and subsequent removal of material.

The TEM analyses also detected cracking in samples prior to particle removal. This observation further supports the theory of a brittle fracture wear mode. See Fig. 7(a). Analyses of unslid samples showed no pre-existing cracks or large voids.

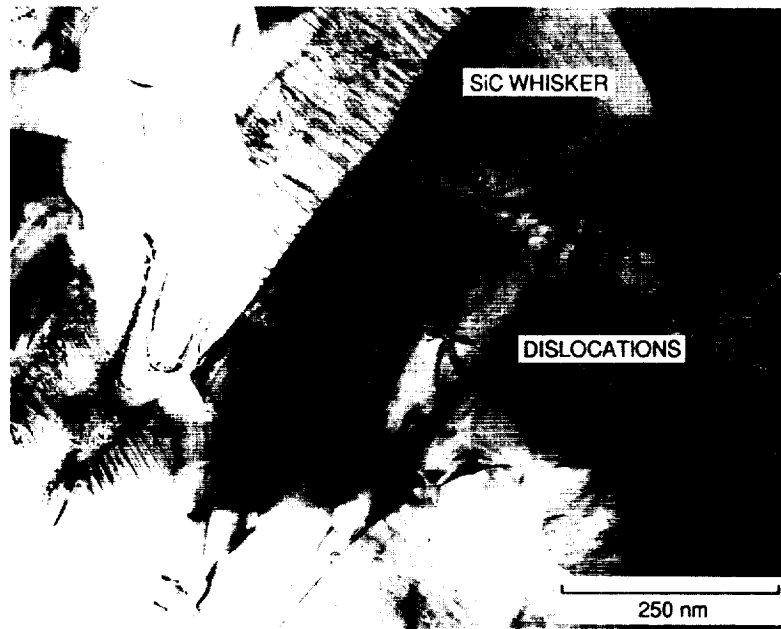
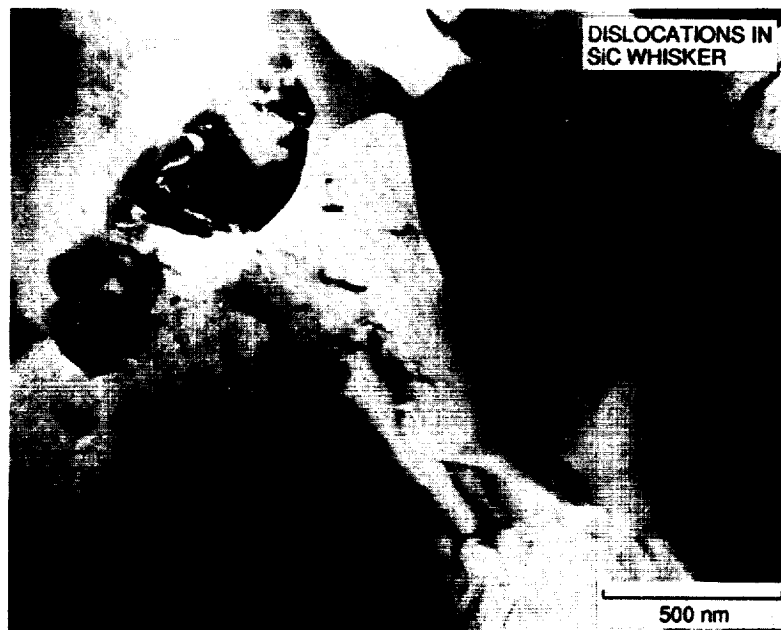
(a) Whiskers shown lengthwise.

(b) Whisker shown head on.

Figure 8. - TEM micrograph of pin wear surface region from 1200 °C test sample. Note dislocations induced from sliding. No wear debris detected on wear surface area.

TEM analysis of pin wear scars at 1200 °C exhibit markedly different features. Very few cracks were found, no wear particles were discovered, and some dislocations were detected. See Figs. 8(a) and (b) for representative photomicrographs. Clearly the wear behavior at 1200 °C differs from that at 25 °C.

The pin wear rate at elevated temperatures was much higher than at room temperature, yet the friction coefficient was relatively stable. TEM analyses of the pin surface from the 1200 °C tests indicated that some dislocations in the alumina matrix were present. See Fig. 8. The presence of dislocations supports the theory that plastic behavior may be playing an important role in high temperature wear. However, too few dislocations were found to have a significant effect on the wear rate. Thus, the theory that plastic deformation and subsequent particle removal is dominating the high temperature wear behavior is not likely.

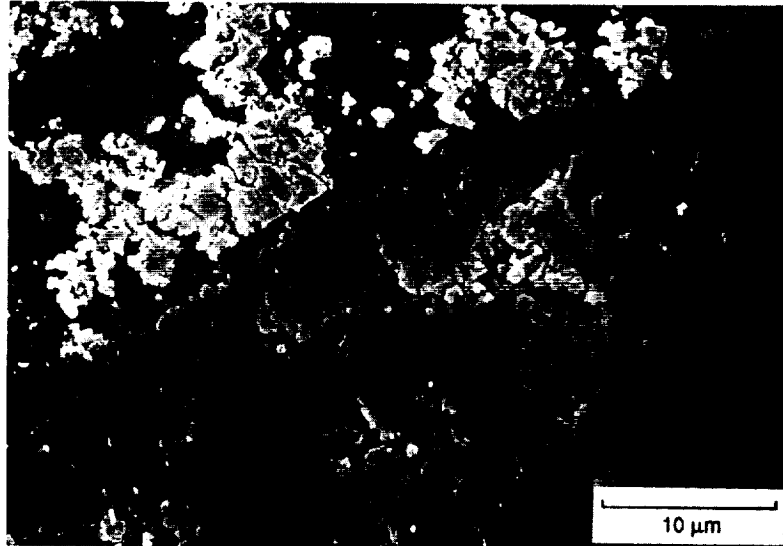
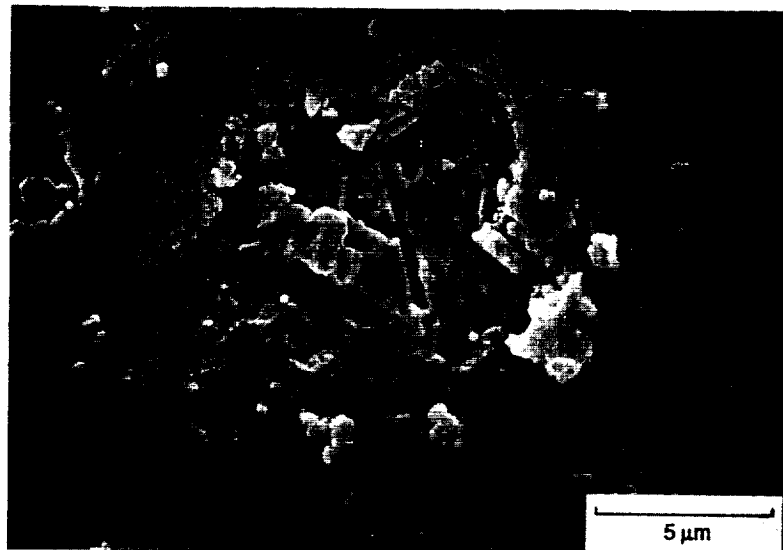
Figure 10. - Whisker pockets left behind by pulled-out whiskers on pin wear surface from 600 °C test.

In contrast, the SEM analysis of the pin wear surface and wear debris from the elevated temperature tests indicates a radically different wear mode. At 600 °C, the pin wear scar shows evidence of whisker pullout. This can be seen as empty whisker pockets or troughs on the pin wear scar. See Fig. 10. Also detected at 600 °C, but not at 1200 °C, were occasional wear debris particles that were in the form of wear rolls. See Fig. 11. These rolls are probably the remnants of a glassy Al₂O₃/SiO₂ surface layer which forms as the oxidation product of the SiC whiskers and the Al₂O₃ matrix. As wear takes place, this glassy layer debonds and is rolled upon itself to form the needle-like roll debris. This type of behavior with ceramics has been observed by other authors (Ref. 13). At 1200 °C, large areas of long, unbroken whiskers, many as long as in the original material and devoid of Al₂O₃ matrix particles, are found outside the wear scar. See Fig. 13. Near the scar, long whiskers and matrix particles are present. The long whiskers indicate whisker pullout. Since the whiskers are largely unbroken it is plausible that they are somehow debonding from the matrix.

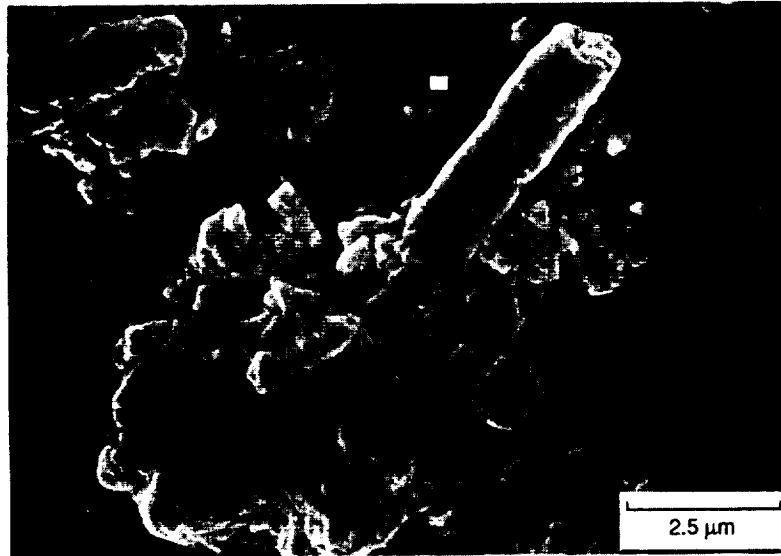
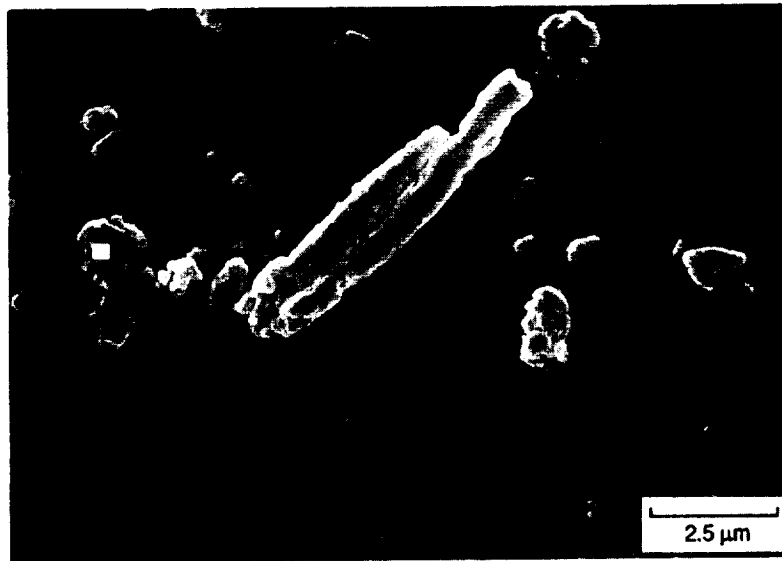
Figure 11. - Wear debris "rolls" or needles from 600 °C test specimens. Note seam along needles and small diameters ($\approx .4 \mu\text{m}$) distinguish these from whiskers.

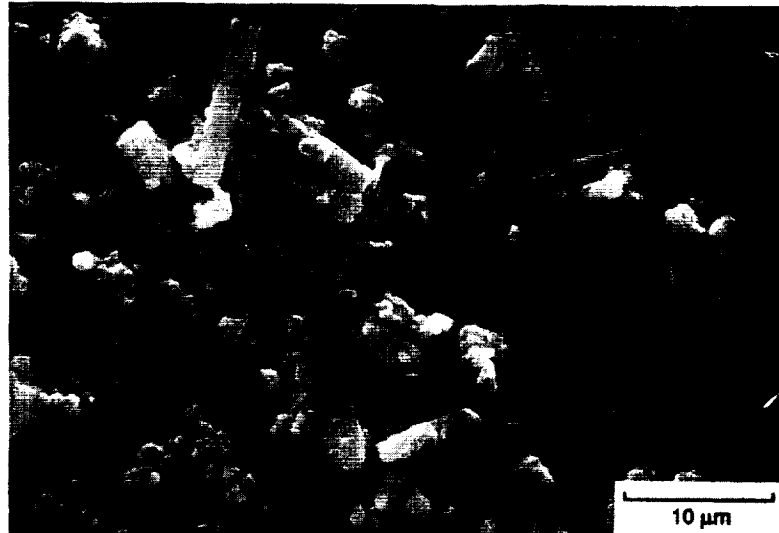
Figure 12. - Pulled-out whiskers from 1200 °C test. Note uniform whisker diameters and lack of seams distinguish these whiskers from debris "rolls".

This conclusion, when coupled with the detailed SEM analysis, yields an alternative theory. The SEM photomicrographs of the wear debris outside the wear scar from 1200 °C samples show large areas of debris which are predominantly long whiskers with little or no matrix material debris. Many of the pulled out whiskers are 30 to 50 μm long and have very high aspect ratios. That is, these whiskers in the wear debris are as long as those in the virgin material indicating that they have been dislodged rather than broken off. It is very unlikely that these loose whiskers could be the result of matrix cracking alone. Rather, it is more plausible that the long whiskers have been pulled out because they were loosely held by the matrix.

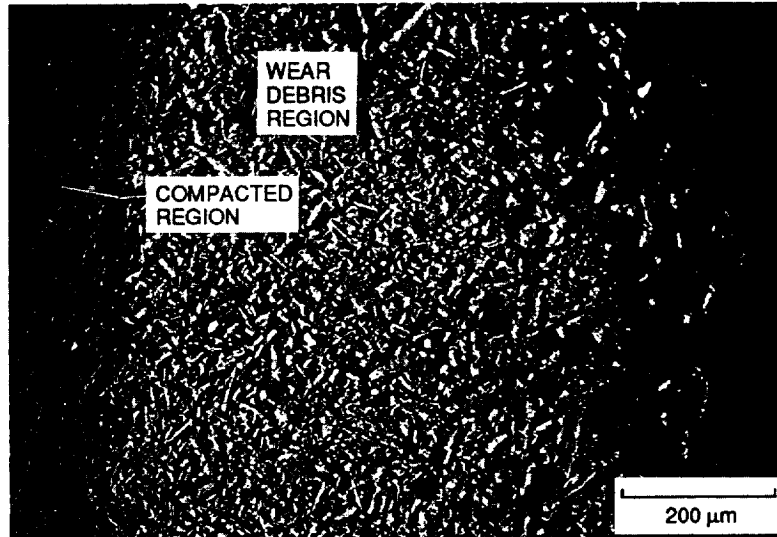
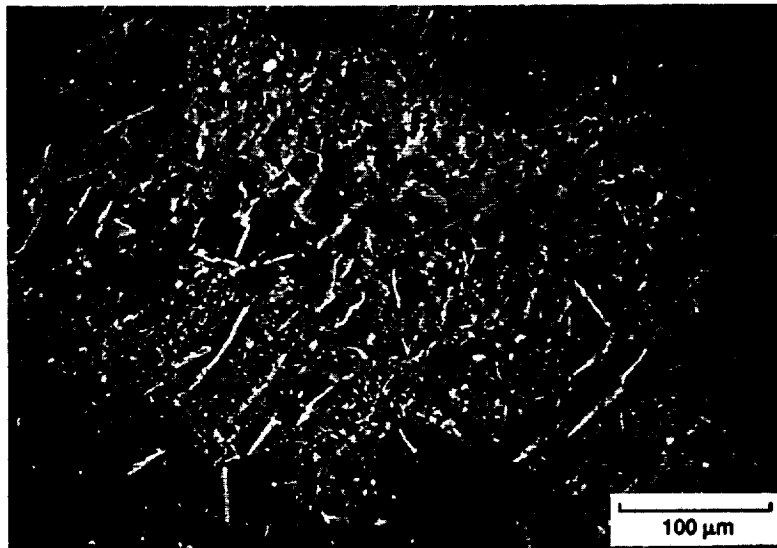
Figure 13. - SEM micrograph of "pulled-out" whiskers outside wear scar from 1200 °C sample. Note that most of the whiskers are 10-75 μm in length.

(a) Debris at 105x magnification.

(b) Debris at 200x magnification.

Evidence for this wear mode is found by examining the large numbers of unbroken, long whiskers outside the wear scar after testing at 1200 °C. Wear debris from 25 °C tests show only short whisker pieces and matrix presumably due to the fact that at lower temperatures the whiskers are strongly held by the matrix and are being broken by the wear process rather than being pulled out.

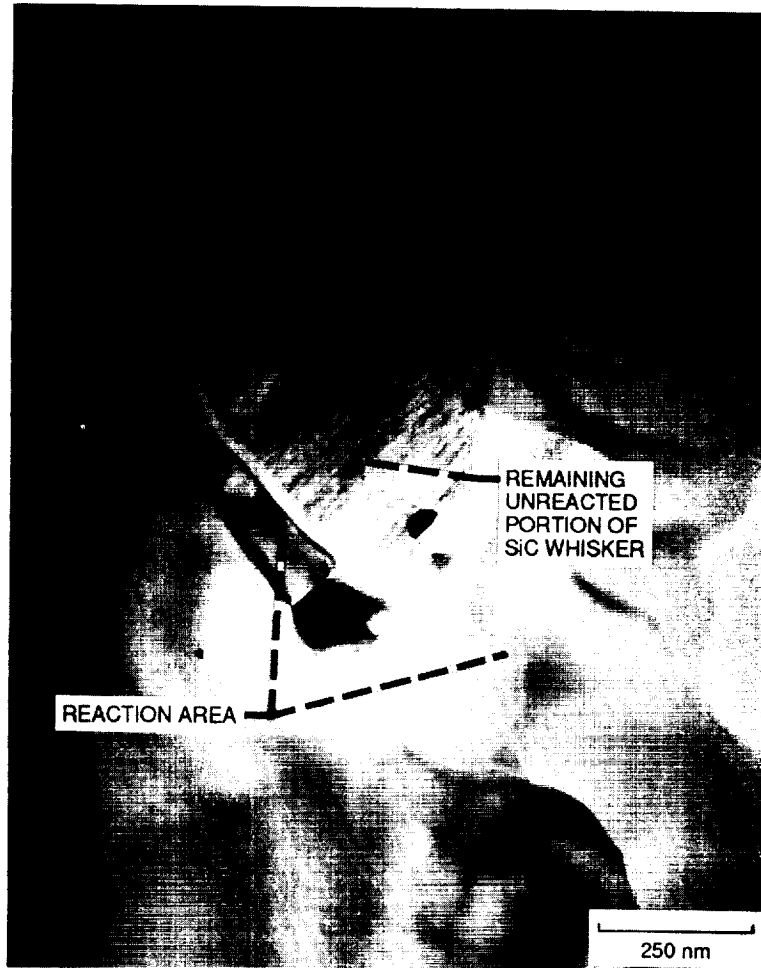
Figure 14. - TEM micrograph of pin wear scar from 1200 °C test. Figure shows a SiC whisker which has partially reacted with impurities and matrix. Reaction products may be promoting whisker loosening and pull-out.

Figure 14 shows a TEM micrograph of a whisker which has reacted with impurities in the matrix, possibly iron, when slid at 1200 °C. The reaction product, identified by the TEM diffraction pattern is iron silicide. Since iron silicide is liquid at 1200 °C the remaining unreacted part of the whisker may be debonding and, hence, easier to pull out. Thus, at 1200 °C the wear mode seems to be whisker loosening, pullout and breakup of matrix with possible whisker/matrix reactions.

TEM diffraction analyses indicate that at 1200 °C some reaction between whisker and matrix may be occurring. The reaction products may have an effect on the friction and wear especially since there appears to be a glassy layer forming at the sliding surface at 600 °C as evidenced by the roll debris observed. Also, perhaps a low shear strength reaction product such as mullite or iron silicide due to iron impurities in the Al₂O₃ is forming at the matrix whisker interface. If the reaction products are liquid at the sliding temperatures they may be allowing easier whisker pullout. SEM Energy Dispersive analyses (EDS) was inconclusive for this material because the analysis area was larger than the whisker diameter and spacing between whiskers.
