# GEOMORPHIC CHANGES ON THE MISSISSIPPI RIVER FLOOD PLAIN AT MILLER CITY, ILLINOIS, AS A RESULT OF THE FLOOD OF 1993

By Robert B. Jacobson and Kevin A. Oberg

Floods in the Upper Mississippi River Basin, 1993

U.S. GEOLOGICAL SURVEY CIRCULAR 1120-J

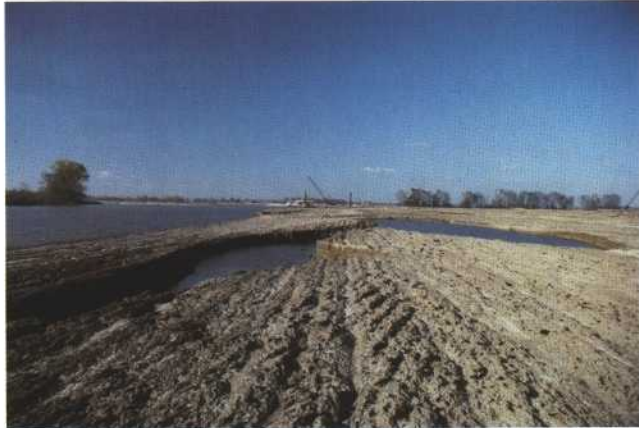
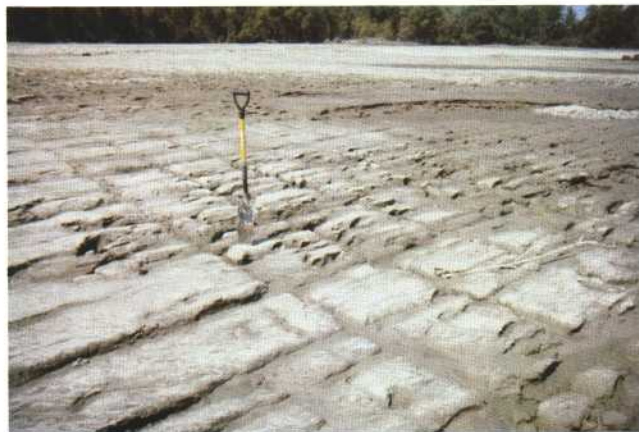
which leaves less erodible B-horizons and plow pans. Stripped zones commonly have shallow, rounded scours near their upstream margin and are characterized by abundant grooves (fig. 3). Some grooves are parallel to flow directions and seem to have been carved by debris carried by the floodwaters, whereas other grooves are evidently related to preexisting weaknesses in the soil, such as those caused by plowing (fig. 3).

**Figure 3.** Examples of stripped surfaces from the Miller City, Illinois, levee-break complex. A, Flow was toward the viewer; B, Flow was from left to right; with grooves.

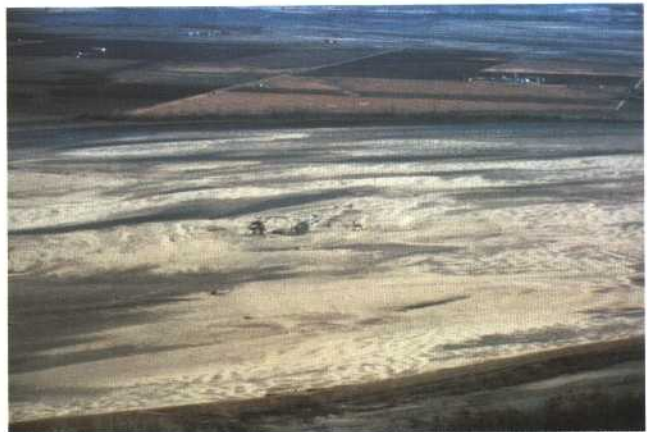
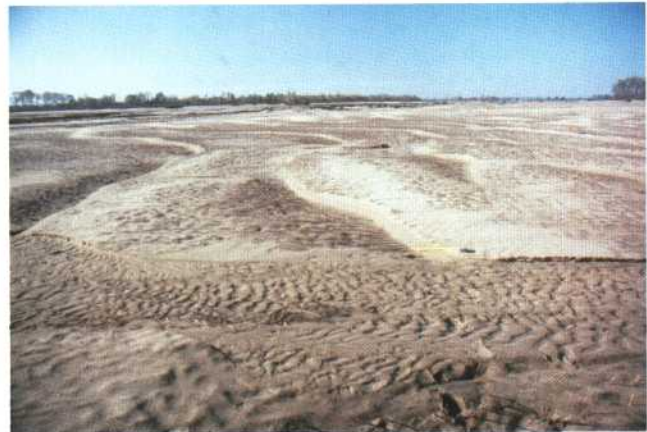
current ripples; commonly, areas of dunes and current ripples are draped with mud that was deposited during recession of the floodwaters or by subsequent floods (fig. 4). Extensive areas of the flood plain used for agriculture were covered with sand deposits, some of which were as much as 4 m thick; according to Vance (1994), some sand deposits were as much as 6 m thick on the Missouri River flood plain. Mud deposition seemed to be minor in extent. Mostly, mud was left as thin deposits in eddies or slackwater areas or was deposited during recession of the floodwaters in low areas that existed before the flood. The geomorphic effects of mud deposition were minor.

**Figure 4.** Sand dunes on the Missouri River flood plain between Kansas City and Hermann, Missouri, and in the Miller City, Illinois, levee-break complex. A, Missouri River Flood plain between Kansas City and Hermann, Missouri. View is to the north; flow was from left to right; B, Miller City, Illinois, levee-break complex. View is to the northwest; flow was from right to left.

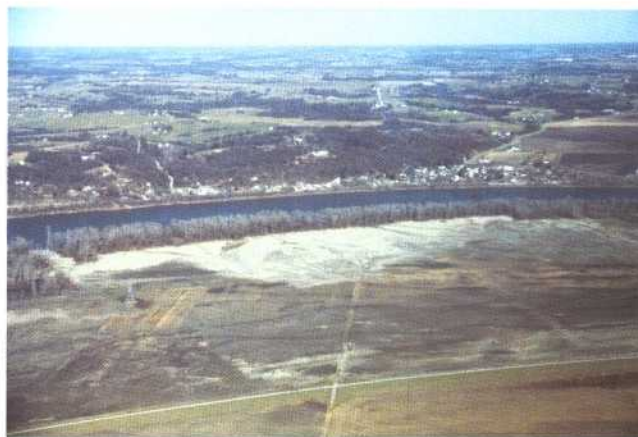
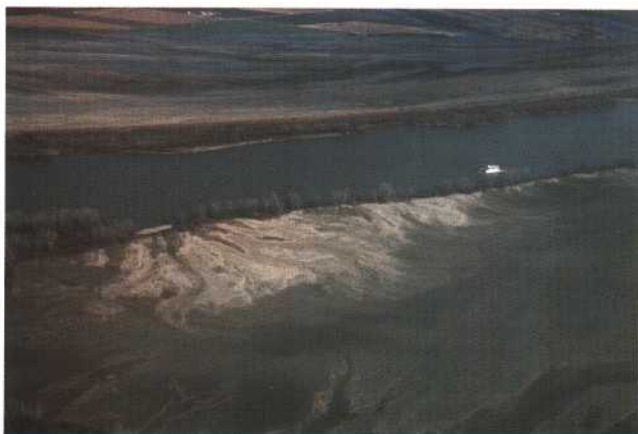
Scour zones and sand deposits in levee-break complexes are by far the most dramatic geomorphic effects of the 1993 flood. In contrast, geomorphic changes in nonleveed areas consisted of minor bank erosion and sedimentation in natural levees and crevasse-splay features (fig. 5). Natural-levee sedimentation was prominent in nonleveed bank areas with dense woody vegetation. Crevasse-splay features, which consist of a scour (crevasse) and associated sand deposits (splay), are similar but much smaller natural analogs for levee-break complexes. Crevasse splays occur where a weakness in the natural levee, or flow concentration, results in erosion of a crevasse channel through which sediment is transported from the channel onto the flood plain (Collinson, 1978).

**Figure 5.** Natural levee and crevasse splays on the Missouri River flood plain between Kansas City and Hermann, Missouri. A, Natural levee; B, Crevasse splay.

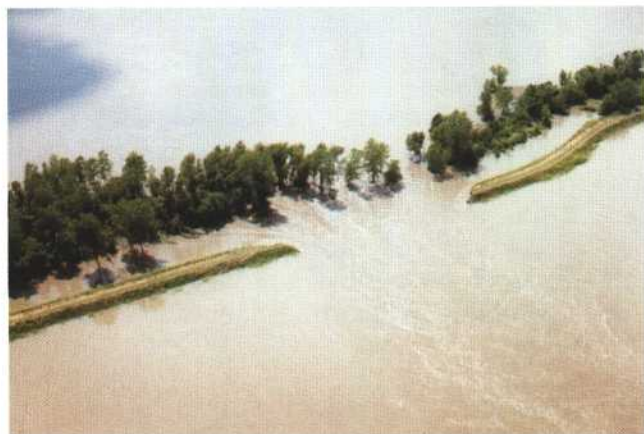
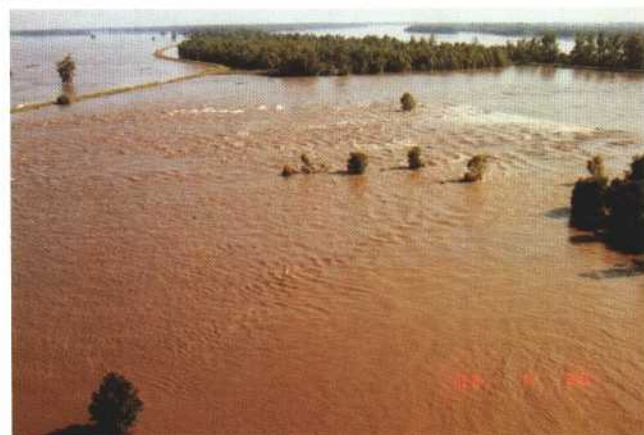
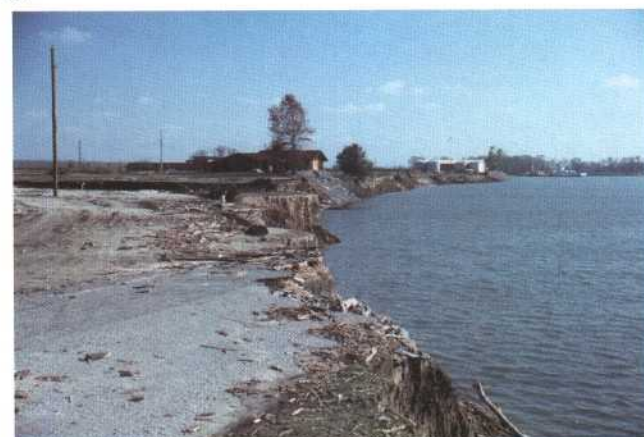
The levee broke on July 15, 1993, at about 1:00 p.m. local time. According to anecdotal evidence from several witnesses, the levee was inspected 15 minutes before the break. At the time of the break, the water level on the channel side of the levee was estimated to be as much as 2 m below the levee crest. [For comparison, at the U.S. Geological Survey (USGS) streamflow-gaging station at Thebes, which is about 16 km upstream, the daily mean stage was 104.68 m on July 15; on July 20 and August 7, the daily mean stage at Thebes peaked at 105.24 m (table 1)]. An eyewitness related that a loud noise drew his attention at 12:50 p.m. When he looked at the levee from a distance of about 500 m, he saw a near-horizontal, 15- to 30-cm-diameter fountain of water gushing out of the side of the levee. The hole quickly enlarged, and a section of the levee failed. As the levee eroded and widened, water began to fill the area between the main levee and a cross levee (fig. 8A). During the first few days after the break, flow through the break was extremely turbulent (fig. 9) with standing waves<sup>1</sup> that were about 1 m high.

**Figure 9.** Miller City, Illinois, levee-break complex. A, Turbulence at northern end (Illinois Department of Transportation); B, Turbulence and vortices in center (Illinois Department of Transportation), and; C, Northern margin of main scour, October 1993.

After the cross levee was breached, flow through the main levee was concentrated in the 1820 channel, and floodwater that moved through the secondary scour immediately downstream of the cross levee (location A, fig. 8A) reversed direction and flowed northeastward. By July 26, flow was 5,570 m<sup>3</sup>/s from the Mississippi River main channel into the break, and 8,000 m<sup>3</sup>/s of flow was measured near the peak discharge on August 7. From July 17 through August 10, the northern (left) bank of the main scour eroded laterally more than 60 m (location B, fig. 8A). In the process, more than 680 m of a county road was removed, as well as a house, a machine shed, and the front yard and front porch of another house (fig. 9).

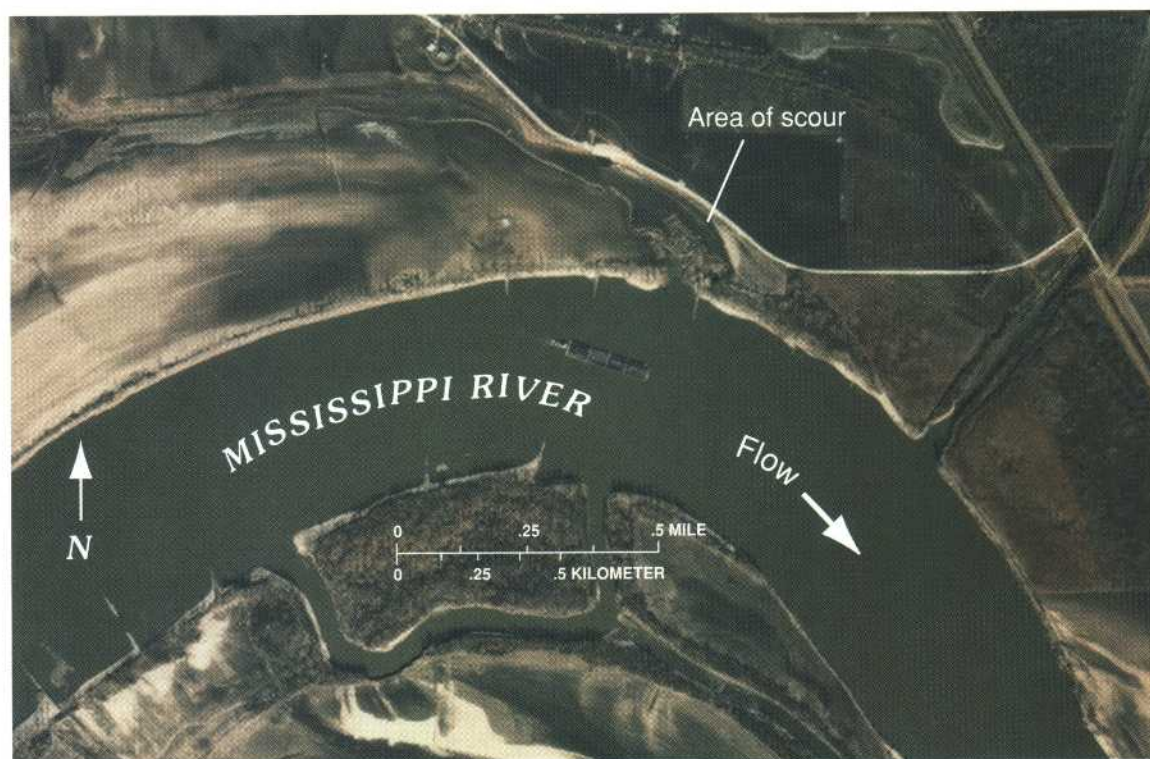
**Figure 11.** Reentry scour east of Roth, Illinois. (Aerial photograph January 8, 1994; U.S. Army Corps of Engineers, St. Louis).

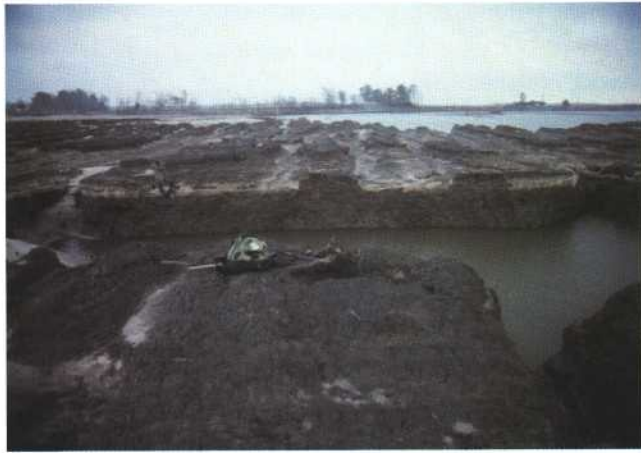
**Figure 17.** Groves and vertical walls at the peninsula, Miller City, Illinois, levee-break complex. View is to the Southeast, downstream along the main scour channel.

Erosion from the 1993 flood created many extensive exposures of preexisting flood-plain sediments (figs. 17, 18). Of the many exposures scattered throughout the Miller City area, none contained thick sand deposits like those that resulted from the 1993 flood. Although the history of channel changes in the Miller City area attests to an extremely dynamic channel system (fig. 10), the apparent lack of thick sand in the stratigraphic record indicates that the geomorphic effects of the 1993 flood were unprecedented during the Holocene. The geomorphic effectiveness of the 1993 flood in the levee-break complex was far greater than would be expected from either the estimated 100-year recurrence interval of the flood at St. Louis (Parrett and others, 1993) or the 75- to 300-year recurrence intervals estimated for the precipitation conditions that created the flood (Interagency Floodplain Management Review Committee, 1994; Kunkel and others, 1994). The large hydraulic head artificially maintained by the levee and the lack of energy dissipation on the dominantly agricultural land probably contributed to much greater geomorphic change in the levee-break complex than would have resulted from a flood of comparable magnitude on wooded, nonleveed bottomland.

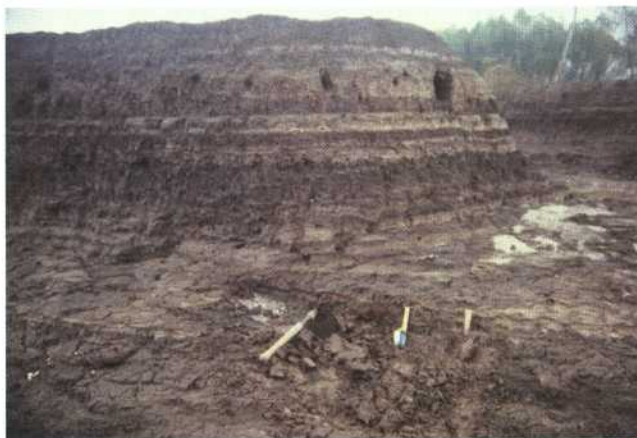
**Figure 18.** Typical pre-1993 flood sediment deposit, Miller City, Illinois, levee-break complex.
