Effects of wildfire on the hydrology of Frijoles and Capulin Canyons in and near Bandelier National Monument, New Mexico

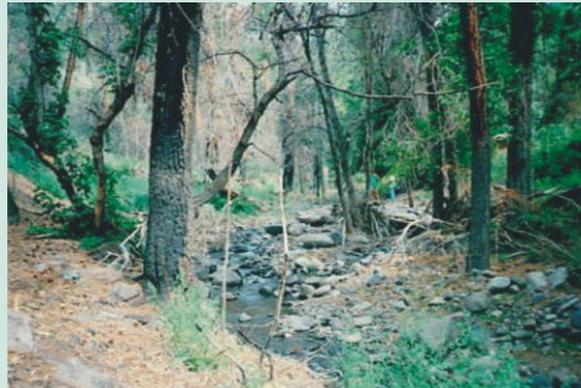
Average flow in Capulin Canyon.

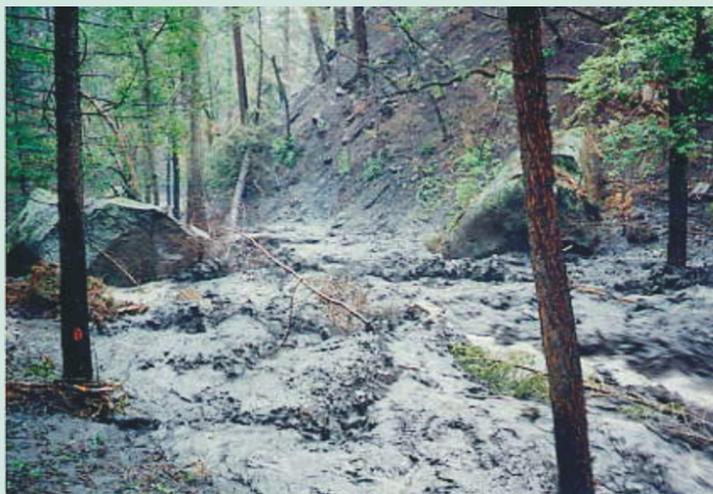
Runoff in Capulin Canyon during a storm on July 10, 1996. Silvery color of water is due to ash.
