EPA/OSHA JOINT CHEMICAL ACCIDENT INVESTIGATION REPORT

**BPS, Inc.
West Helena, Arkansas**

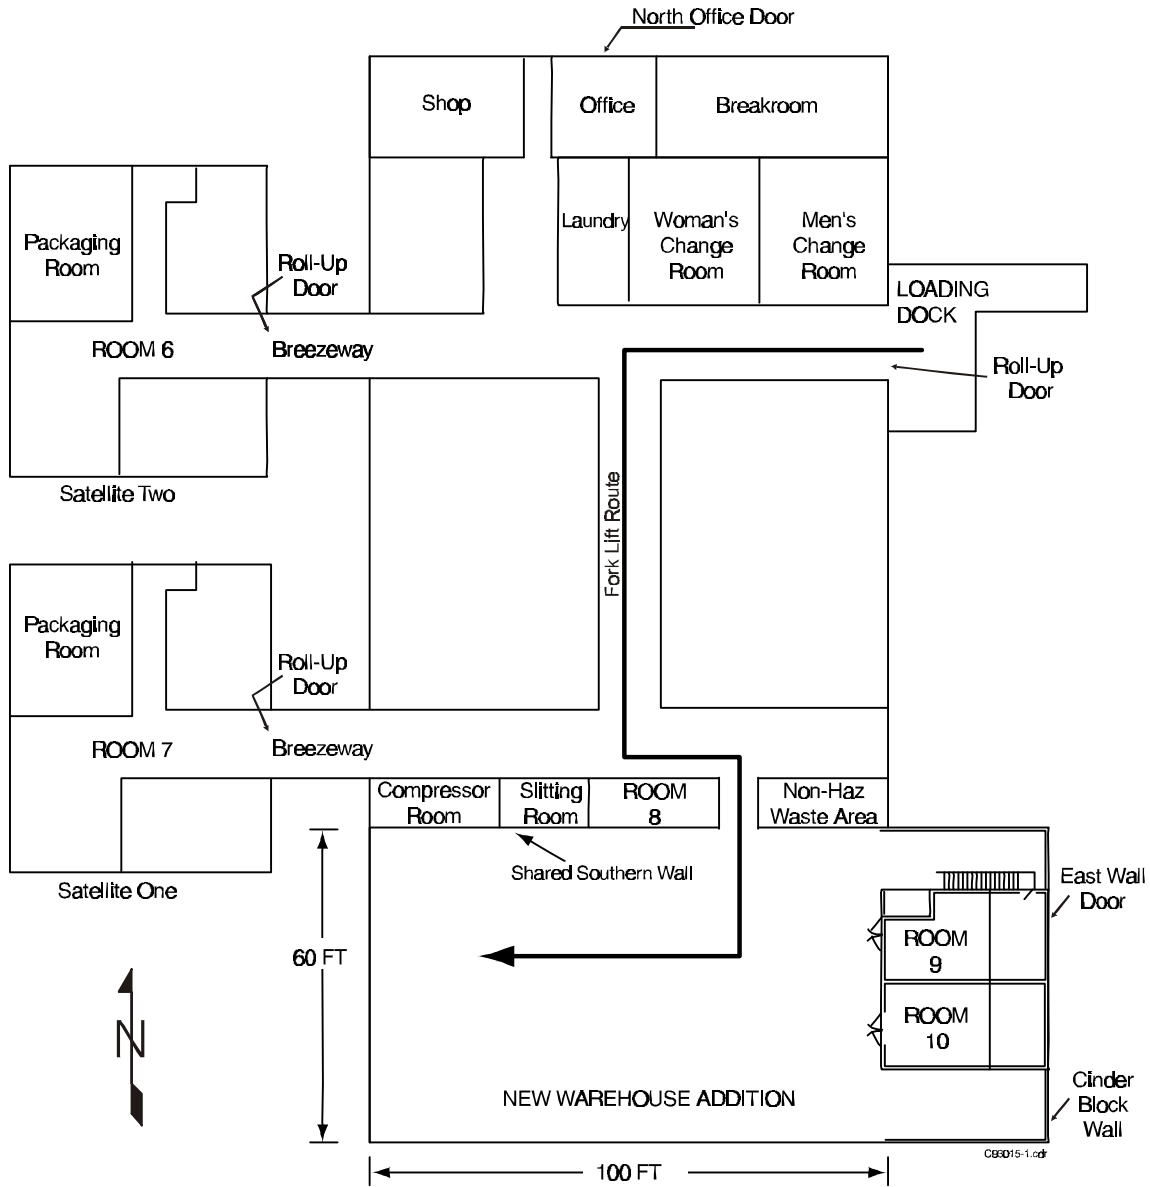
FIGURE 1: FLOOR PLAN - BPS, INC. UNIT #2

The West Helena facility employs approximately 130 workers. At the time of the incident 65 employees were on duty. The facility consists of two production buildings (referred as units One and Two), two satellite buildings, and a Agel@building. The production buildings are constructed of corrugated metal with steel reinforcement. The Unit Two building (Figure 1),

in which the incident occurred, had a 100' x 150' main area, a 16' x 34' loading dock, and two 50' x 60' satellite buildings connected to the main area by breezeways. In October 1995, a warehouse addition was added to the Unit Two building. It shared the southern wall of the original building (referred to as the new warehouse addition north wall). The addition was approximately 7800 square feet. It was also constructed of corrugated metal with the exception of the outside eastern wall. This particular area had two stories with an exterior (eastern) wall constructed of cinder blocks.

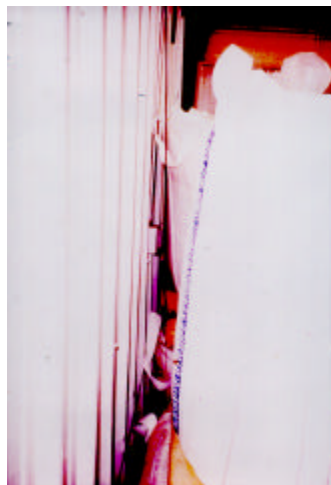
Figure 5. Supersack set-up at BPS Unit One

Shortly after the incident, BPS employees and management identified the decomposing material as an AZM supersack placed against or close to the hot compressor discharge pipe. The JCAIT confirmed that supersacks of materials were being spotted in close proximity or against walls at BPS. After the incident, JCAIT observed supersacks spotted along the wall in the Unit One warehouse. In this case, the supersacks were stacked two-high. The edge of the bottom supersack was within inches of the wall. The top supersack was listing so that it was in contact with the wall (Figure 5).
