UNIT I: HISTORICAL PERSPECTIVE

HISTORICAL PERSPECTIVE

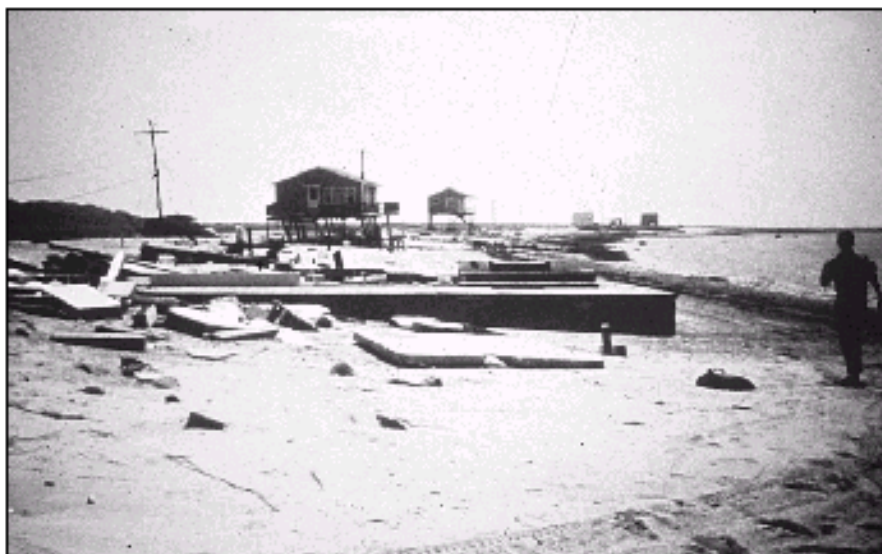
Figure 1-2.
Hurricane Bob (1991) destroyed 29 homes along this reach of Mattapoissett, MA.

A FEMA Flood Damage Assessment Report documented damage in the Buzzards Bay area. The wind speeds during Hurricane Bob were below the design wind speed and the storm tide (corresponding to a 15-year tide) was at least 5 feet below the Base Flood Elevation (BFE). Nevertheless the results of the storm allowed an evaluation of the performance of different foundation types.

Post-hurricane findings regarding foundations included:

- Many buildings in the area had been elevated on a variety of foundations, either in response to Hurricane Carol (1954) or the 1978 northeaster, or as a result of community-enforced National Flood Insurance Program (NFIP) requirements.

- Buildings constructed before the date of the Flood Insurance Rate Map (FIRM) for each community—referred to as *pre-FIRM buildings*—**that had not been elevated, or that had not been elevated sufficiently, suffered major damage or complete destruction; some destroyed buildings appeared to have had insufficient foundation embedment.**

- Post-FIRM buildings (i.e., built after the date of the FIRM) and pre-FIRM **buildings with sufficient elevation performed well** during the storm. Where water was able to pass below buildings unobstructed by enclosed foundations, damage was limited to loss of decks and stairs.

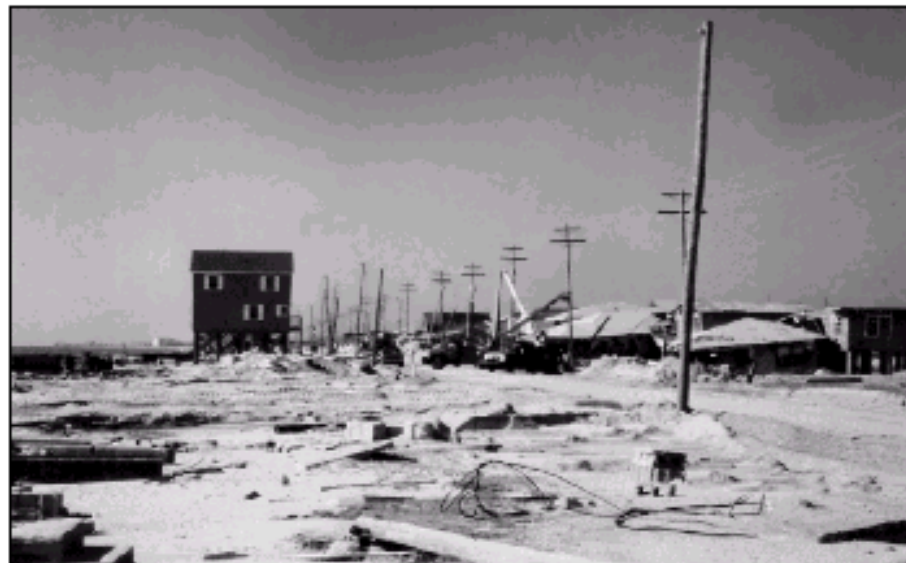
**Figure 1-4.
Hurricane Hugo (1989),
Garden City Beach, SC.
House on pilings survived
while others did not.**

- Post-FIRM buildings that were both properly constructed and elevated survived the storm (see Fig. 1-4). These buildings stood out in sharp contrast to pre-FIRM buildings and to post-FIRM buildings that were poorly designed or constructed.

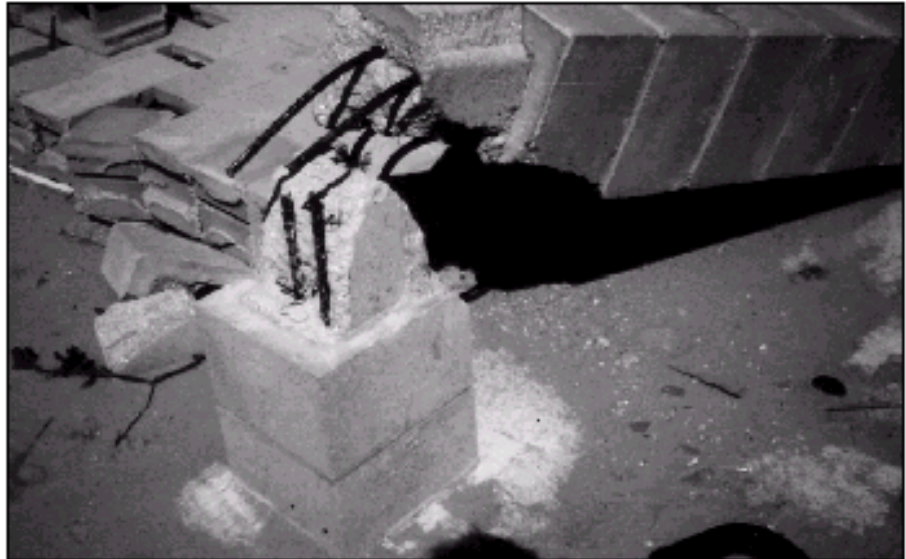
Figure 1-5.
Hurricane Hugo (1989),
South Carolina. Failure of
reinforced masonry
column.

- Many buildings elevated on masonry or reinforced concrete columns supported by shallow footings failed. In some instances, the columns were undermined; in others, the columns failed as a result of poor construction (see Fig. 1-5).

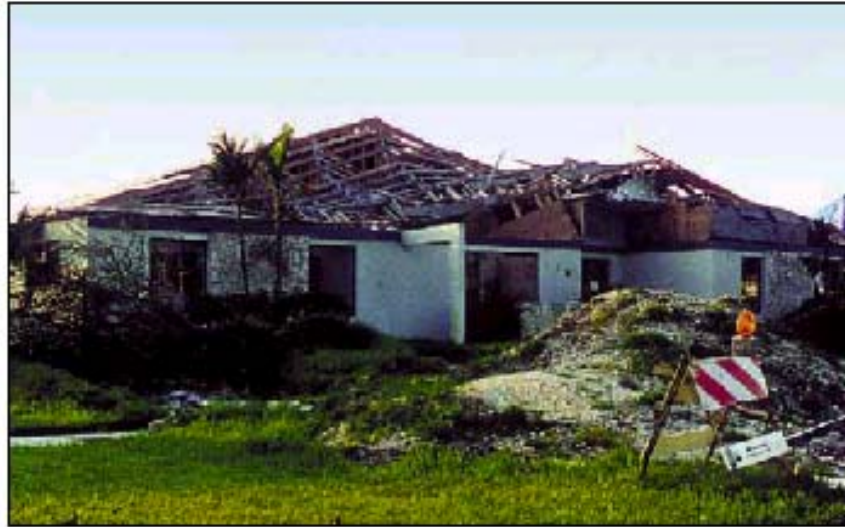
Figure 1-7.
Hurricane Andrew (1992).
Roof structure failure
from inadequate bracing.

- Buildings designed and constructed with components and connections that transferred loads from the envelope to the foundation performed well. When these critical “**load transfer paths**” were not in evidence, damage ranged from considerable to total, depending on the type of architecture and construction.
- Catastrophic **failures of light wood-frame buildings** were observed more frequently than catastrophic failures of other types of buildings constructed on site. Catastrophic failures resulted from a number of factors:
 - Lack of bracing and load path continuity at wood-frame gable ends.
 - Poor fastening and subsequent separation of roof sheathing from roof trusses.
 - Inadequate roof truss bracing or bridging (see Fig. 1-7).
 - Improper sillplate-to-foundation or sillplate-to-masonry connections.

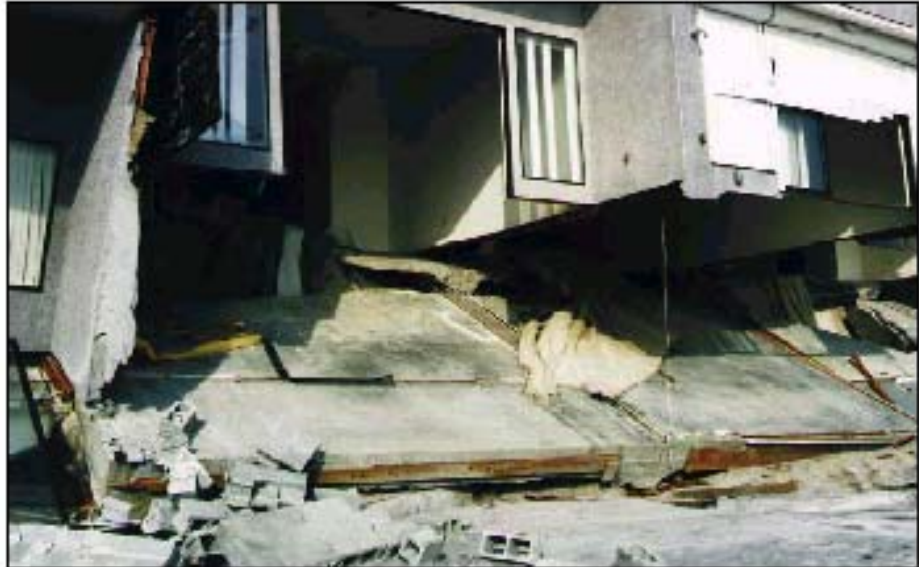
Figure 1-11.
Hurricane Opal (1995),
Bay County, Florida.
Building damage from
erosion and undermining.

- Oceanfront foundations were exposed to 3–7 feet of vertical erosion in many locations (see Figure 1-11). **Lack of foundation embedment**, especially in the case of older elevated buildings, was a significant contributor to building loss.

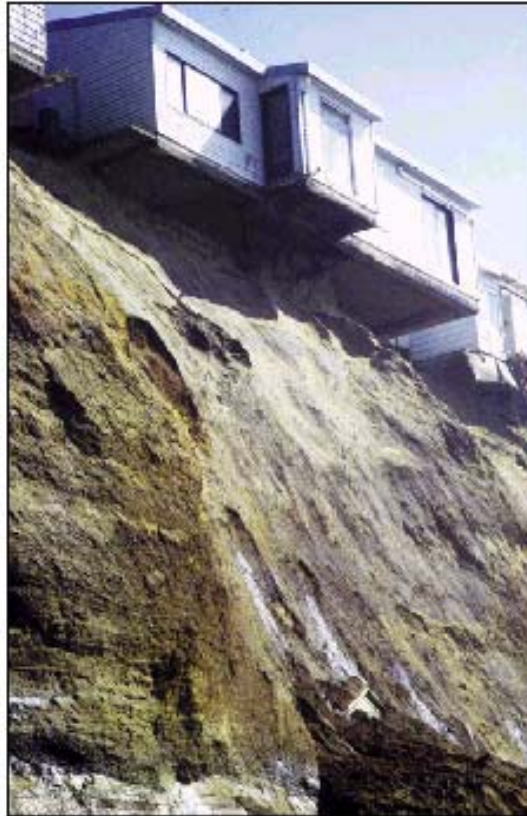
Figure 1-12.
Winter Coastal storms,
California and Oregon
(1997–1998). House in
Pacifica, CA, undermined
by bluff erosion.

Another series of severe El Nino-driven coastal storms battered the Pacific coast. The distinguishing feature of the 1997–98 event was rainfall. The California Coastal Commission reported widespread soil saturation, which resulted in thousands of incidents of debris flows, landslides, and bluff collapse (see Figure 1-12).

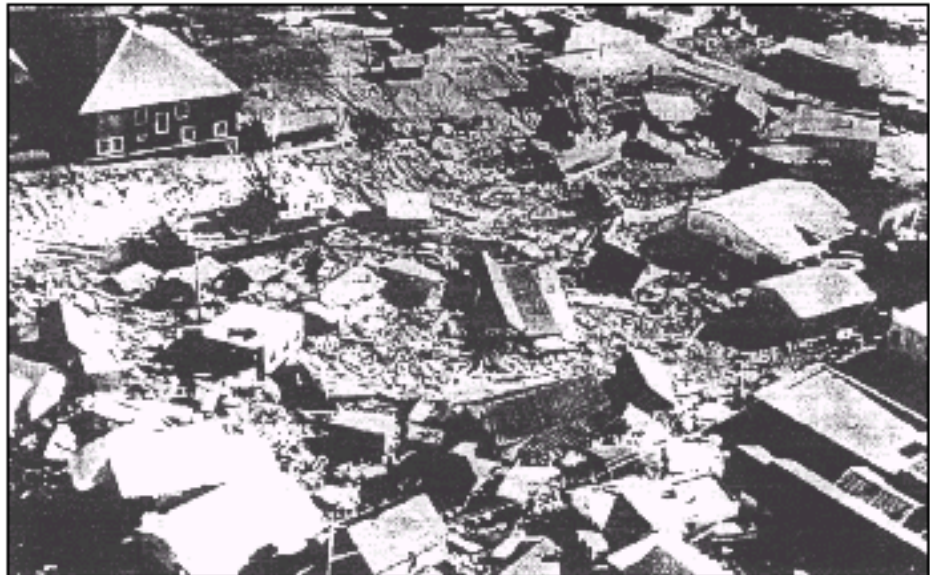
Figure 1-13.
1964 Good Friday
earthquake. Damage in
Kodiak City, Alaska,
caused by the tsunami of
the 1964 Alaskan
earthquake.

The tsunami flooded entire towns and caused extensive damage to waterfront and upland buildings (see Figure 1-13). Tsunami runup reached approximately 20 feet above sea level in places, despite the fact that the main tsunami struck near the time of low tide. Also, liquefaction of coastal bluffs in Anchorage resulted in the loss of buildings.
