## **4.1 INTRODUCTION**

## **4.2 THE NATURE AND PROBABILITY OF EARTHQUAKES**

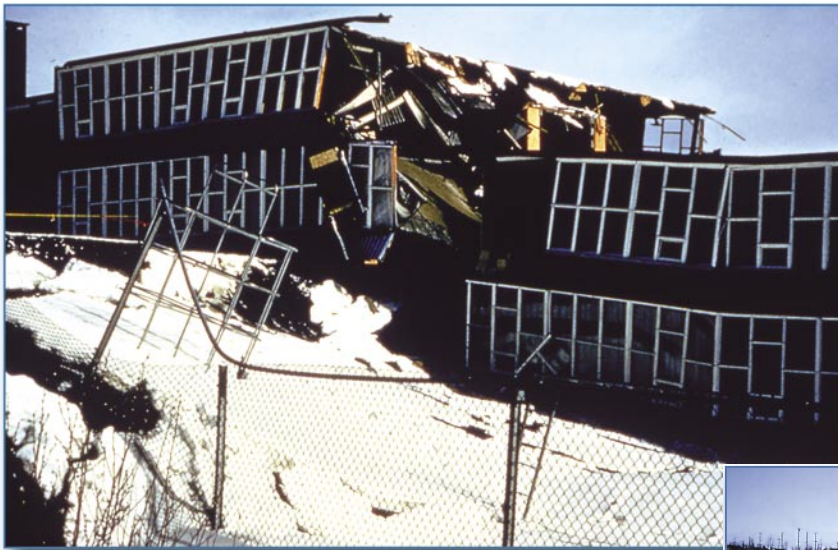
Figure 4-1  
School, Anchorage, AK,  
1964, severely damaged  
by earthquake-induced  
landslide

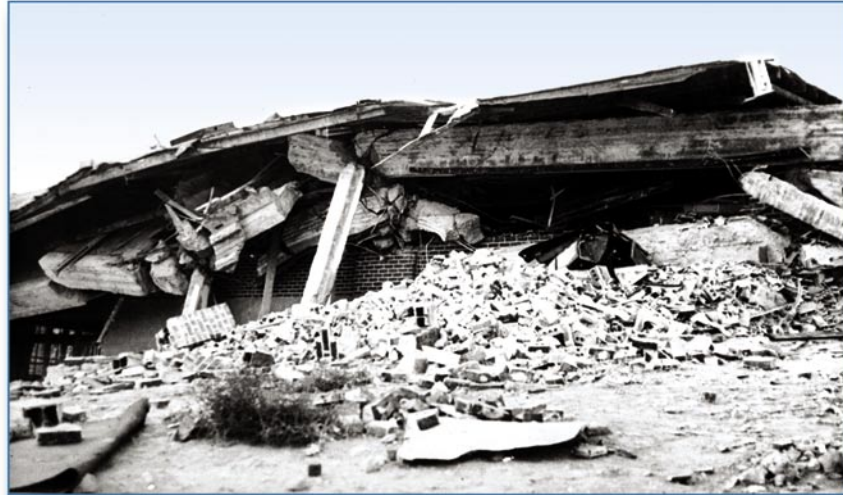
Figure 4-8  
Collapse of portion of  
nonductile concrete frame  
school structure, Helena,  
MT, 1935

Reinforced concrete frames are made ductile by introducing an appropriate, code-specified amount of specifically designed steel reinforcing; unfortunately, the need for this was not recognized in seismic codes until the mid-1970s and so a large inventory of these types of structure exists (see Figure 4-8).

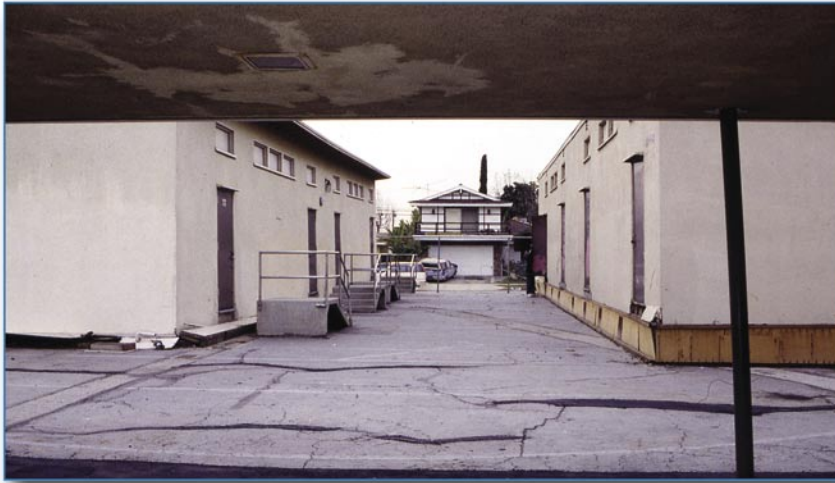
Figure 4-9  
Modular classrooms  
pushed off their  
foundations; note stairs  
at left, Northridge, CA,  
1994.

Modular classrooms are liable to topple off their foundations unless securely attached and braced. This damage is not life-threatening, but makes the building unusable; fractured power, gas, and waste lines may be a hazard (see Figure 4-9).

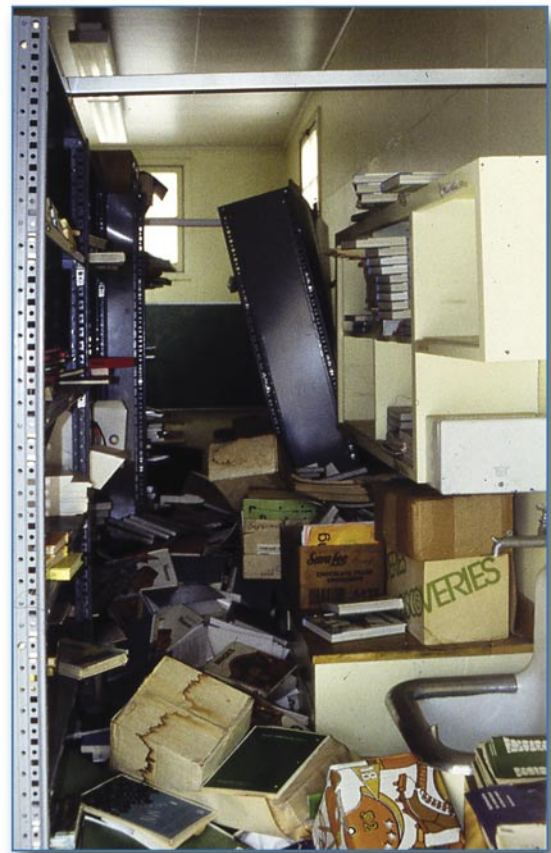
Figure 4-10  
Fallen filing cabinets and shelves, Northridge,  
CA, 1994

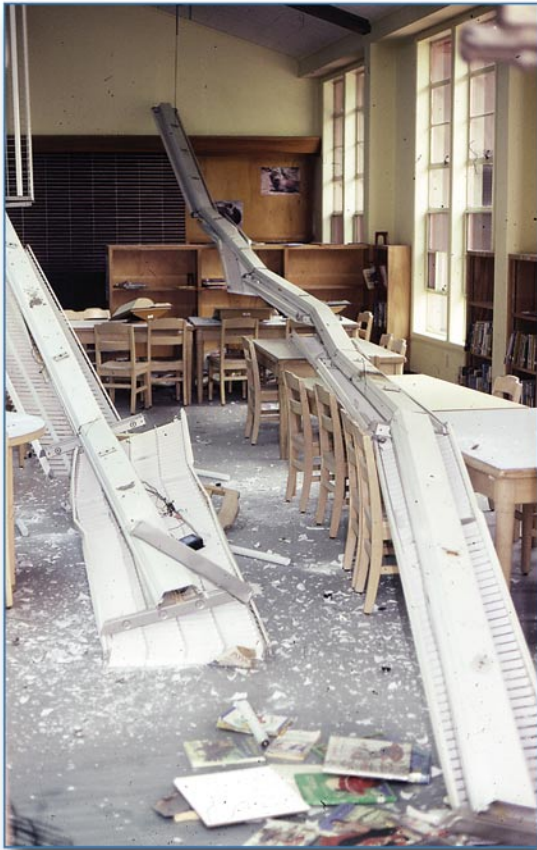
Figure 4-12  
Fallen light fixtures, library, Coalinga, CA, 1983  
SOURCE: GARY MCGAVIN, REDLANDS, CA

Pendant light fixtures have sometimes fallen if they are insecurely attached and not designed to swing freely (see Figure 4-12). Sudden breakage of large glass areas is a specific hazard because of the dense occupancy in many school rooms; design of glazing to resist wind-borne debris and physical attack may also assist in protecting it from earthquake motion. This kind of damage has been significant in California schools that have suffered recent earthquakes.

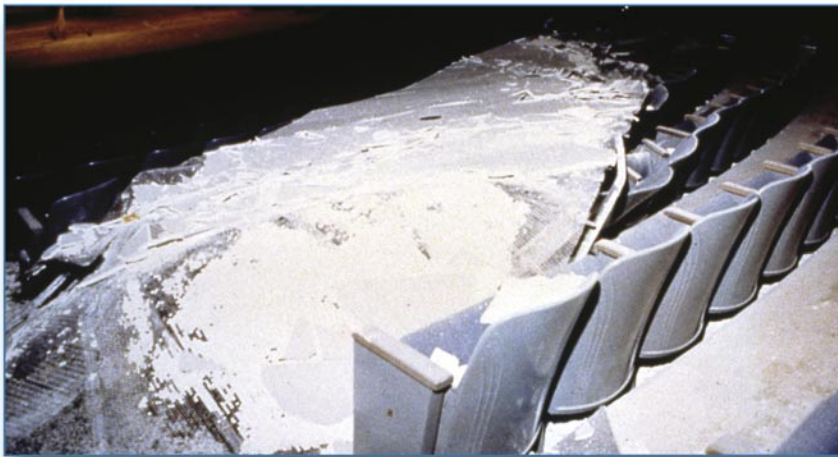
Figure 4-13  
Fallen heavy lath and  
plaster ceiling across  
auditorium seating,  
Northridge, CA, 1994  
SOURCE: GARY MCGAVIN,  
REDLANDS, CA

Heavy hung lath and plaster ceilings in older auditoriums (and assembly buildings) can be dangerous and need careful inspection of their attachment and materials. If deficient in safety, replacement is the only acceptable solution (see Figure 4-13).

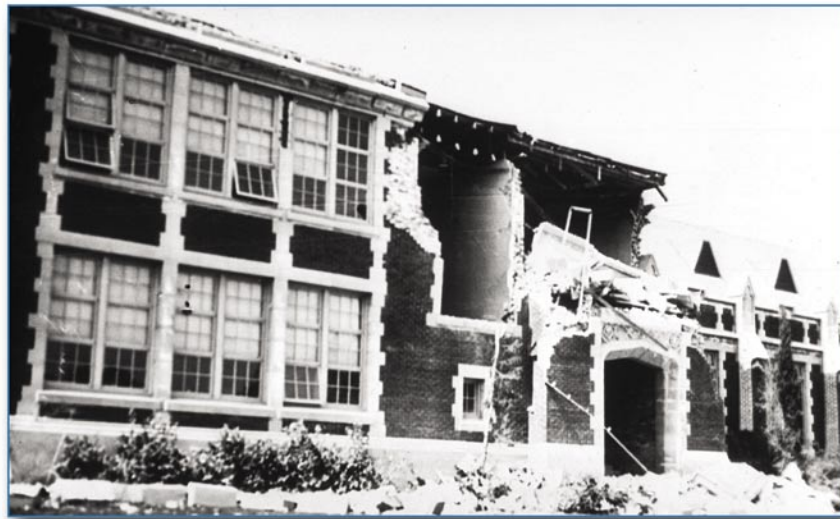
Figure 4-14  
Damage to the John Muir  
School, Long Beach, CA,  
1933

Considering the number of significant earthquakes in California since the early years of the 20th century, there has been remarkably little severe structural damage to schools, except in the Long Beach earthquake of 1933, and there have been very few casualties. In California, no school child has been killed or seriously injured since 1933. This good fortune has been primarily because all major California earthquakes since 1925 have occurred outside school hours (see Figure 4-14).

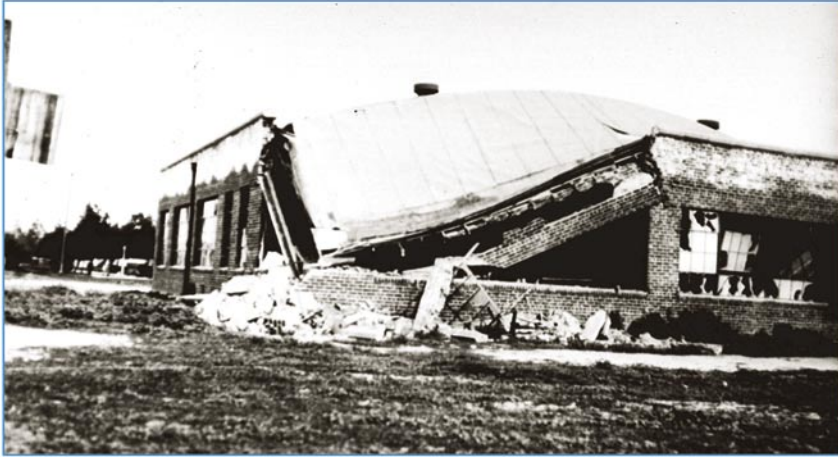
Figure 4-15  
Damage to shop building,  
Compton Junior High  
School, Long Beach, CA,  
1933

In the Long Beach earthquake that occurred at 5:55 p.m. on March 10, 1933, damage to unreinforced masonry school buildings was so severe that there would have been many casualties had they been occupied. As a result, the state passed the Field Act within a month of the earthquake (see Figures 4-15 and 4-16).

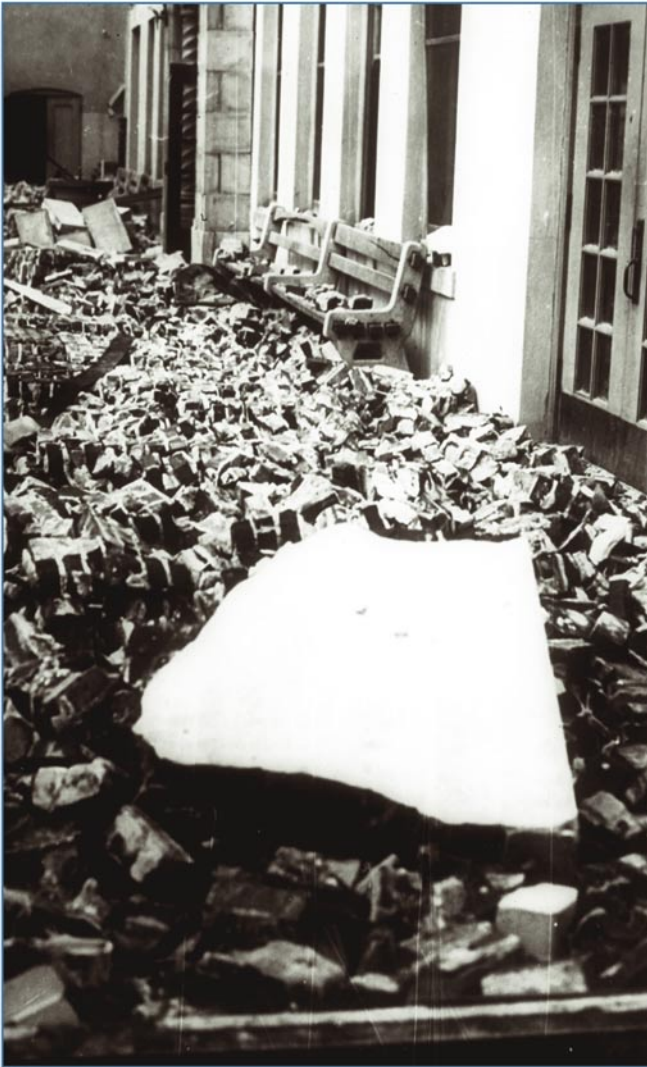
Figure 4-16  
A dangerous passage way between two  
buildings, Polytechnic High School, Long  
Beach, CA, 1933

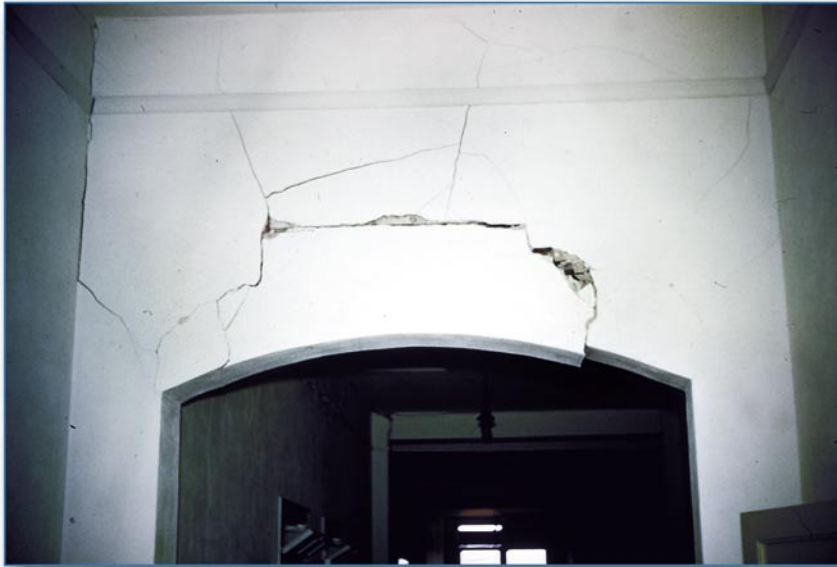
Figure 4-17  
A heavy corridor lintel  
ready to fall, Emerson  
School, Bakersfield, Kern  
County, CA, 1952

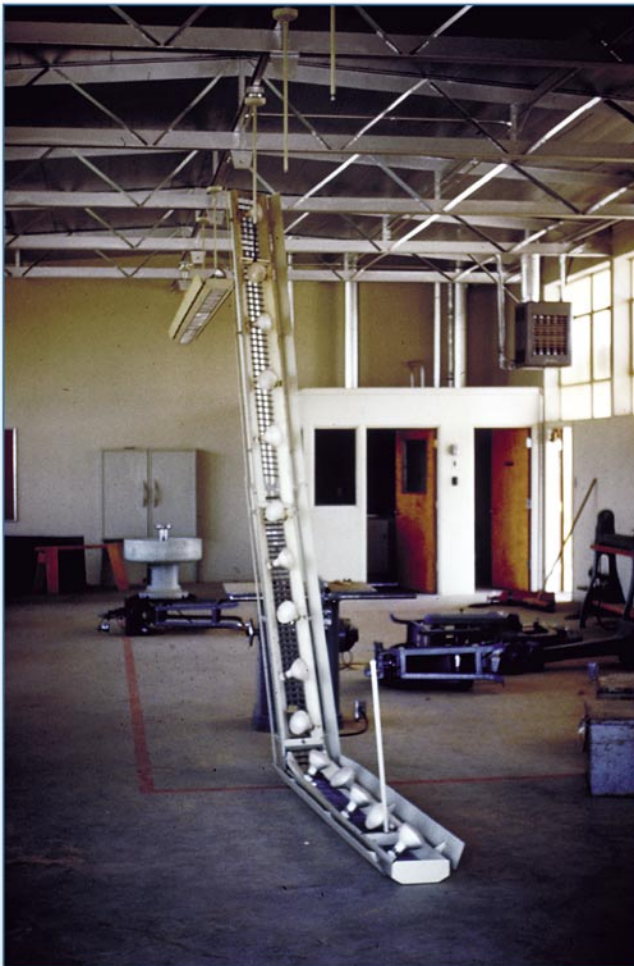
Figure 4-18  
Overturned shop equipment and failed  
light fixtures, Kern County, CA, 1952

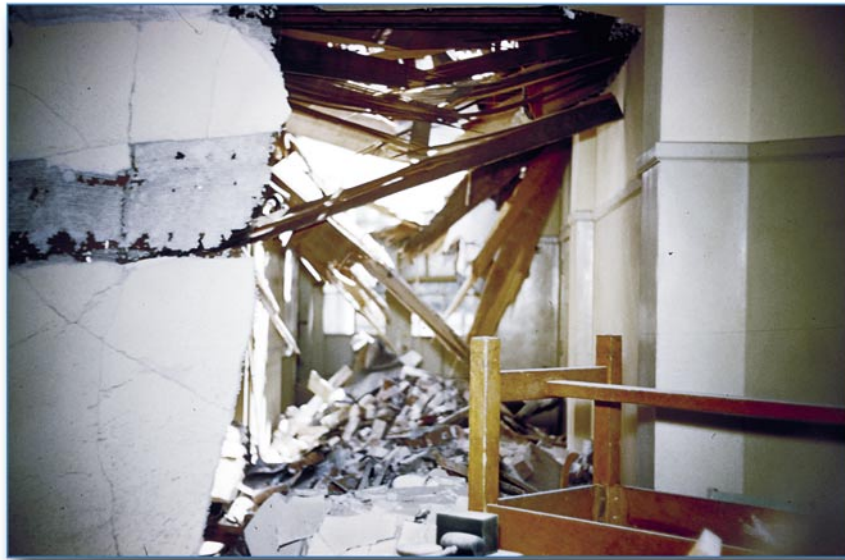
Figure 4-19  
Destroyed exit corridor,  
Bakersfield, Kern County,  
CA, 1952

curred approximately 1 percent damage. Of the 40 non-Field Act schools, 1 collapsed, 15 suffered severe damage, and 14 suffered moderate damage. In the Bakersfield City School District, 175 classrooms and 6,500 students were displaced and only about 10 classrooms could quickly be put back in service. There was considerable nonstructural damage to ceilings and light fixtures.

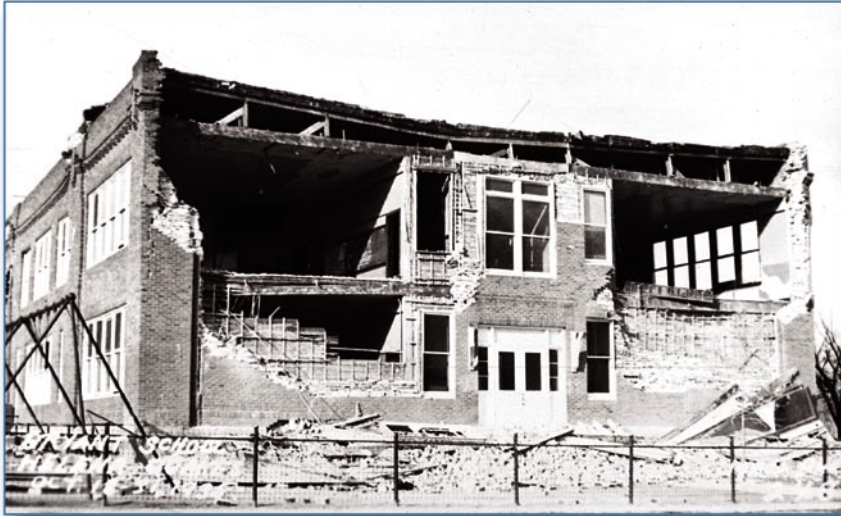
Figure 4-20  
Typical school damage,  
Helena, MT, 1935

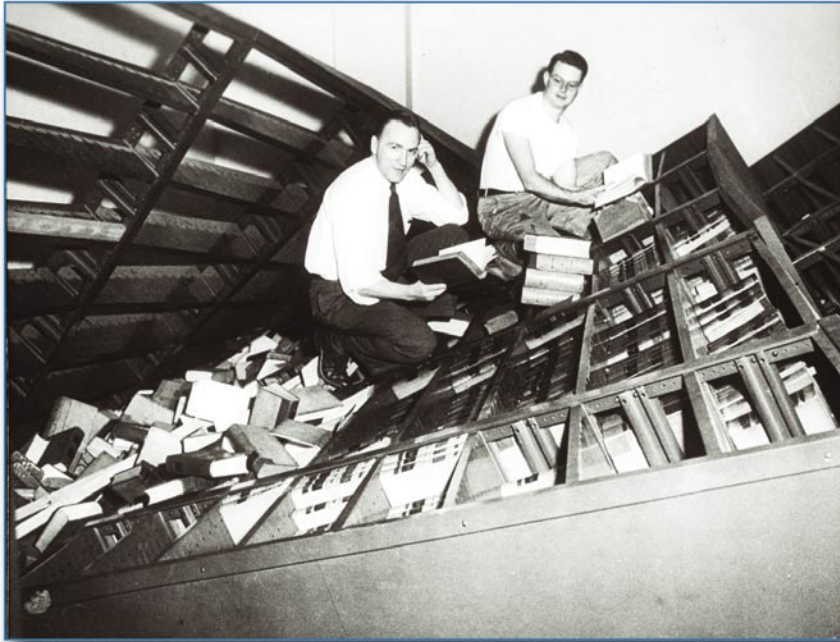
Figure 4-24  
Damage to library shelving,  
Seattle, WA, 1949

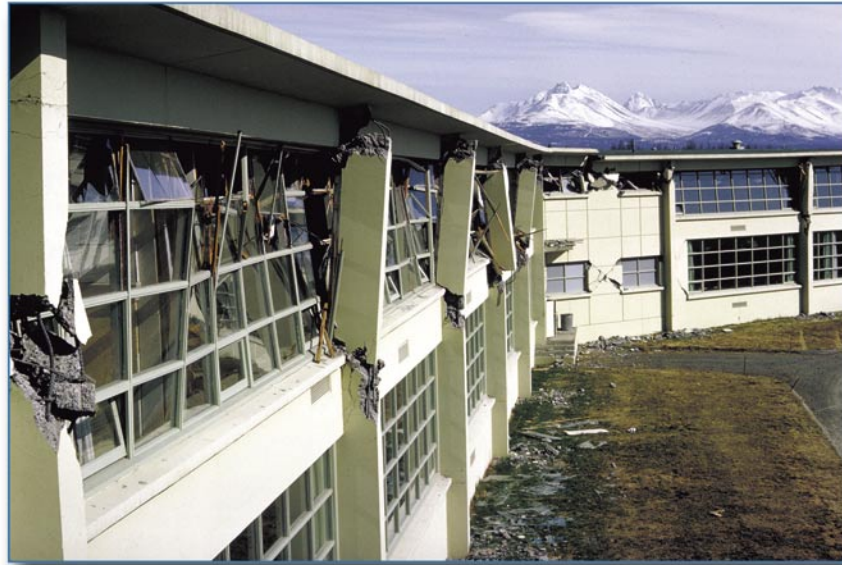
Figure 4-25  
Severe structural damage to  
the West Anchorage High  
School, Anchorage, AK,  
1964

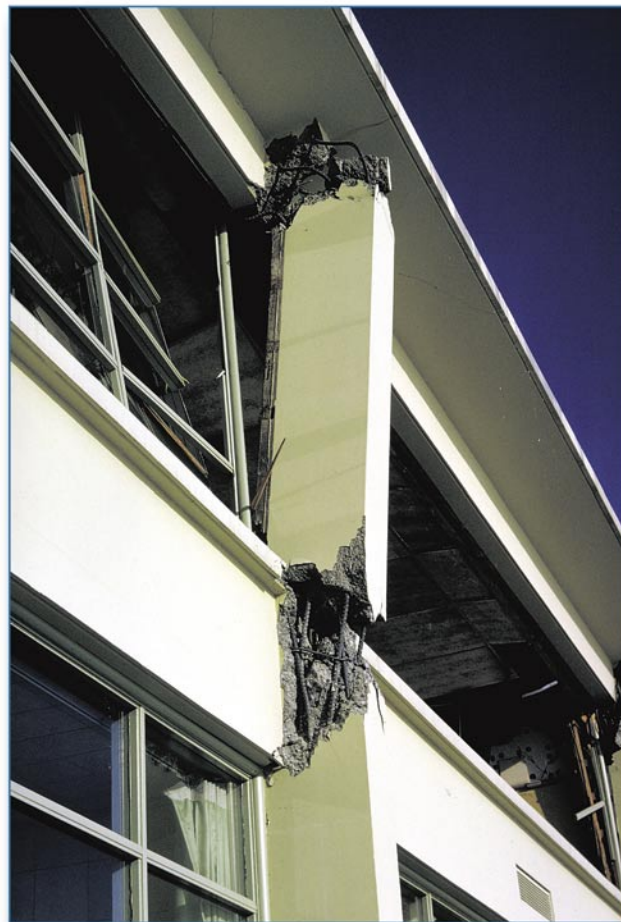
Figure 4-26  
Brittle failure at nonductile concrete column,  
West Anchorage High School, 1964

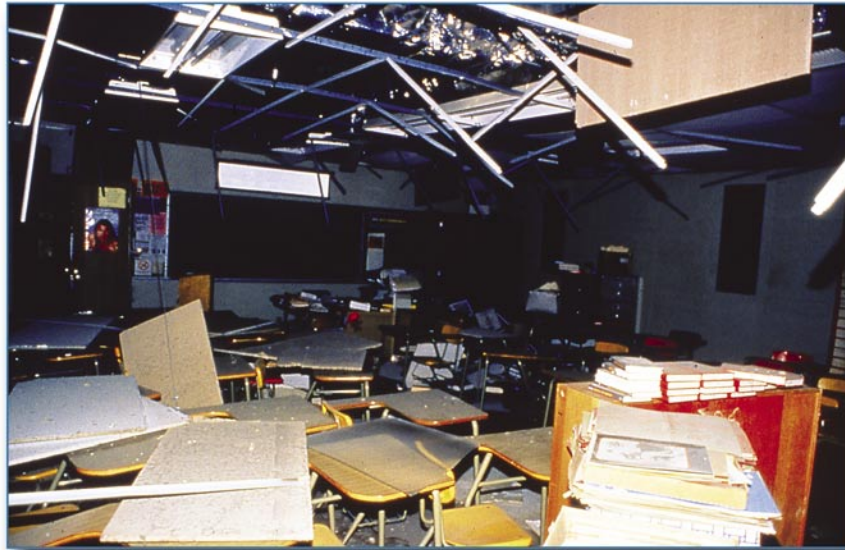
Figure 4-27  
Ceiling damage,  
Northridge, CA, 1994

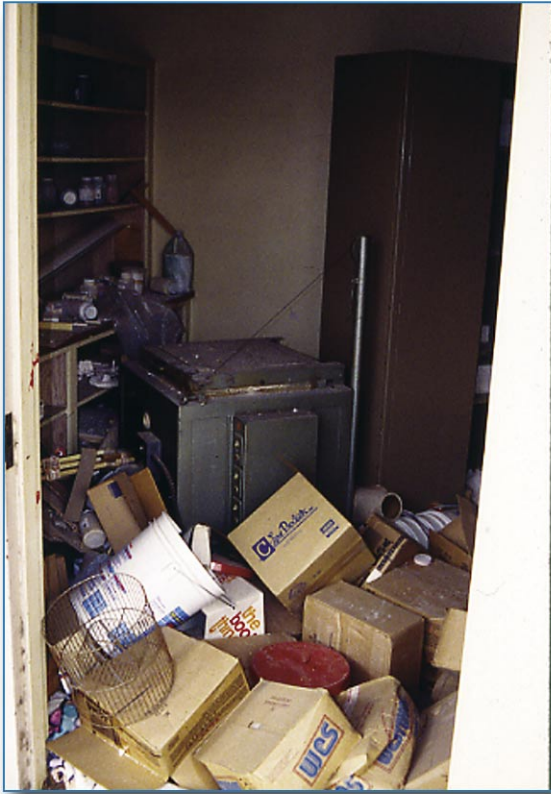
Figure 4-28  
Damage to ceramic kiln, including fractured gas  
line, Northridge, CA, 1994

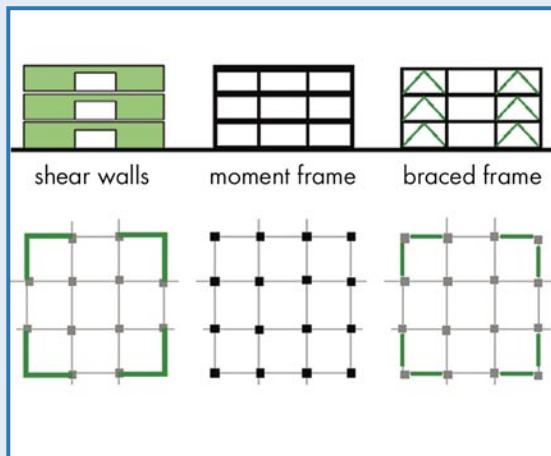
### Lateral Force Resisting Systems – Basic Types

The systems have major architectural implications. Shear walls, which should run uninterrupted from foundation to roof, may impose major planning constraints on a building. Moment frames create unobstructed floors, but, because of their special connection requirements, are expensive. They are subject to more deformation that may result in costly damage to nonstructural components and systems. Braced frames are a common compromise.

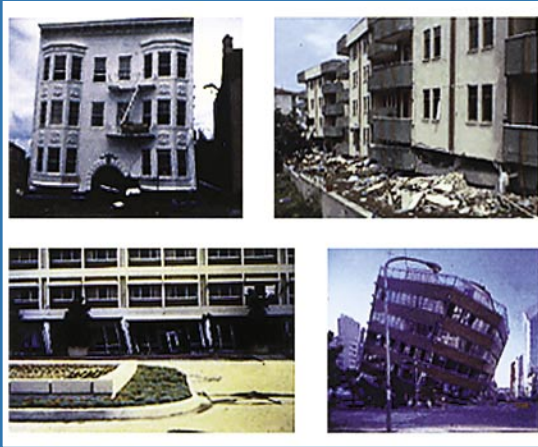
### Soft Stories

Typical examples of soft story-induced damage.

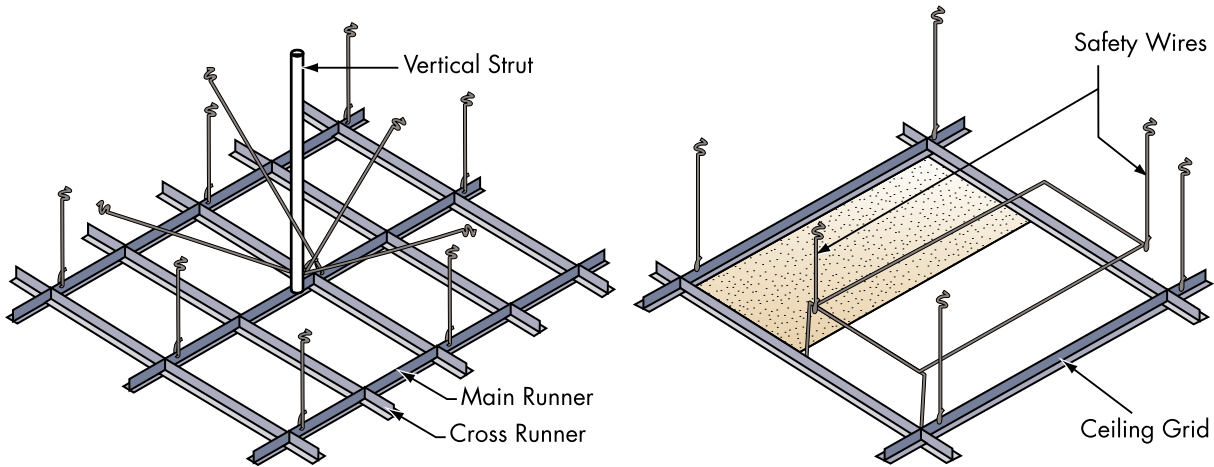
Figure 4-32 Suspended ceiling and light fixture bracing and support

Figure 4-33  
Bracing tall shelving to the structure

Reduction of damage to nonstructural components depends on using methods of supporting and bracing the components to prevent failure (see examples in Figures 4-32, 4-33, 4-34, and 4-35). Seismic codes provide the design force for which the above components must be designed, together with a number of specific design requirements that must be followed.

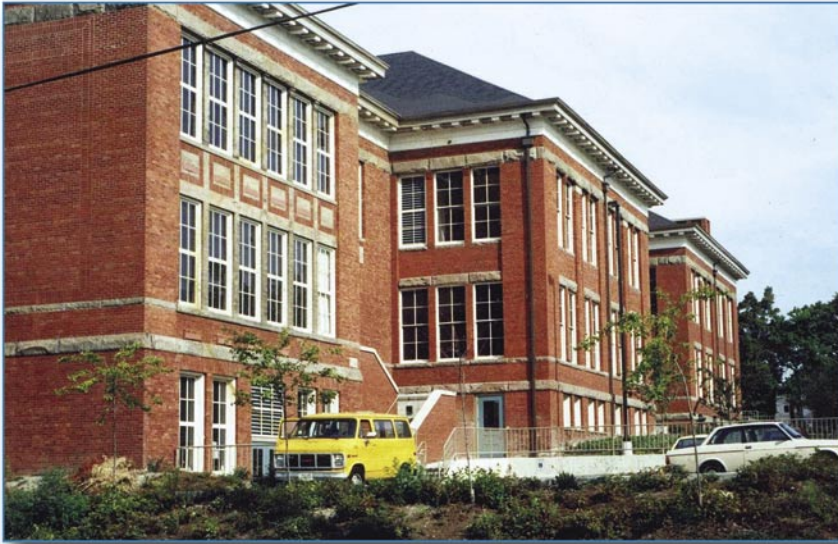
Figure 4-37  
Retrofit of B.F. Day  
Elementary School, Seattle,  
WA

Seismic retrofit at any large scale is expensive, both in design and construction, because of the more complex analyses that must be conducted and the construction constraints that must be overcome. In addition, closure of a school for an extended period (beyond that of the normal summer break) is usually unacceptable. Major seismic retrofit is rare, although some successful projects have been done, primarily with the goal of saving a building that is not only a place of learning, but a historic community resource as well. The retrofitting of the B.F. Day School in Seattle was one such project (see Figures 4-37 and 4-38).
