DESIGN AND PERFORMANCE ISSUES RELATING TO COMMERCIAL OFFICE BUILDINGS

6.1 INTRODUCTION

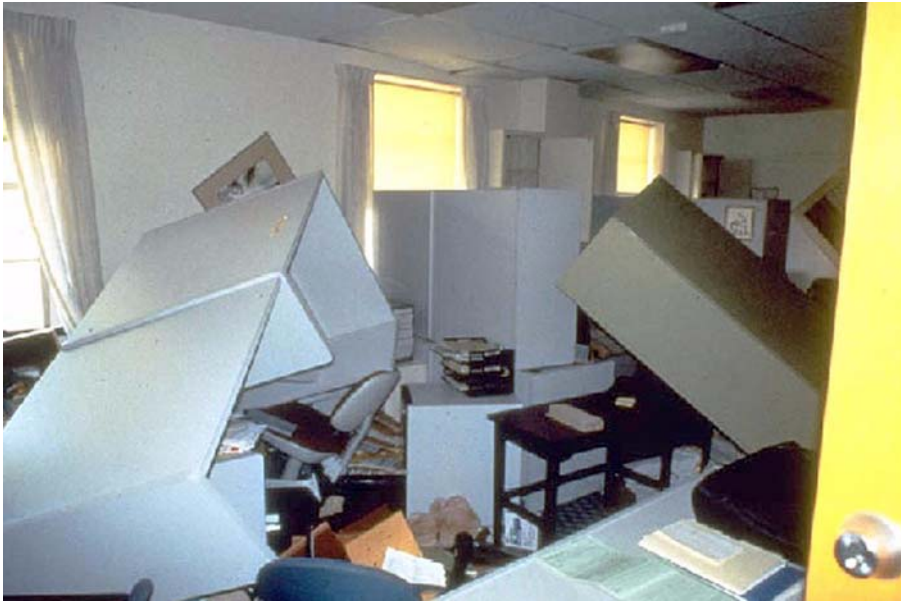
Figure 6-1 Typical earthquake damage to contents and nonstructural components in a modern office building. (photo courtesy of the Earthquake Engineering Research Institute)

The seismic performance of modern office buildings designed to recent codes (adopted since the late 1970s) has been good as far as providing life safety. However, the recognition by building owners that satisfactory life-safety code-level performance may still encompass considerable damage (see Figure 6-1), along with repair costs and possible business interruption of the building for weeks or even months, even in a moderate earthquake, suggests that some performance-based design strategies may be useful.

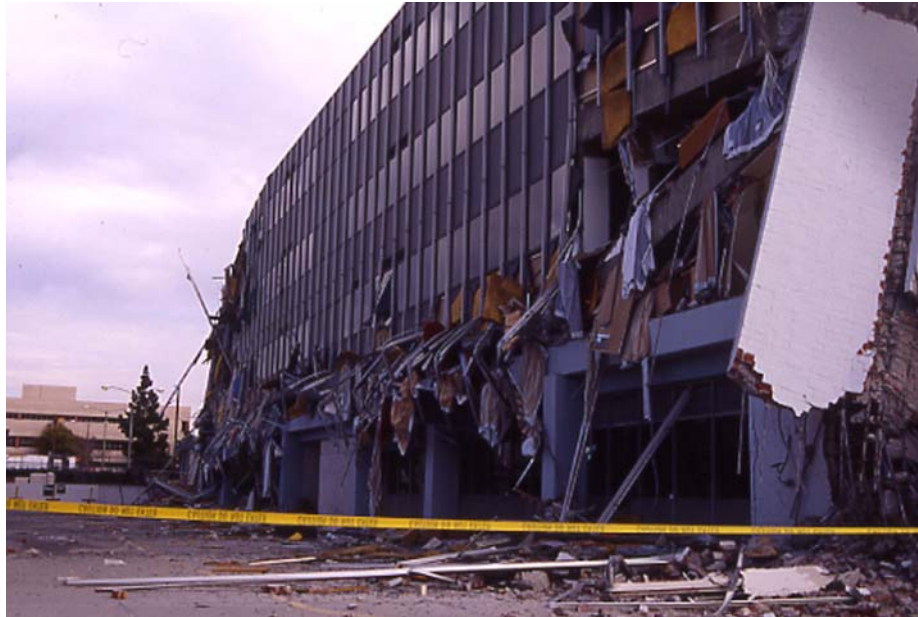
Figure 6-2 Exterior view of medical office building severely damaged by the 1994 Northridge earthquake. (C. Arnold photo)

Where severe structural damage has occurred in commercial office buildings, it has generally been to older buildings, often the result of configuration irregularities. Figure 6-2 shows an older medical office building, which had a vertical irregularity that caused one floor to pancake during the 1994 Northridge earthquake in Southern California; a failure resulting from inadequate attachment of heavy nonstructural walls in an older 5-story office building is shown in Figure 6-3.

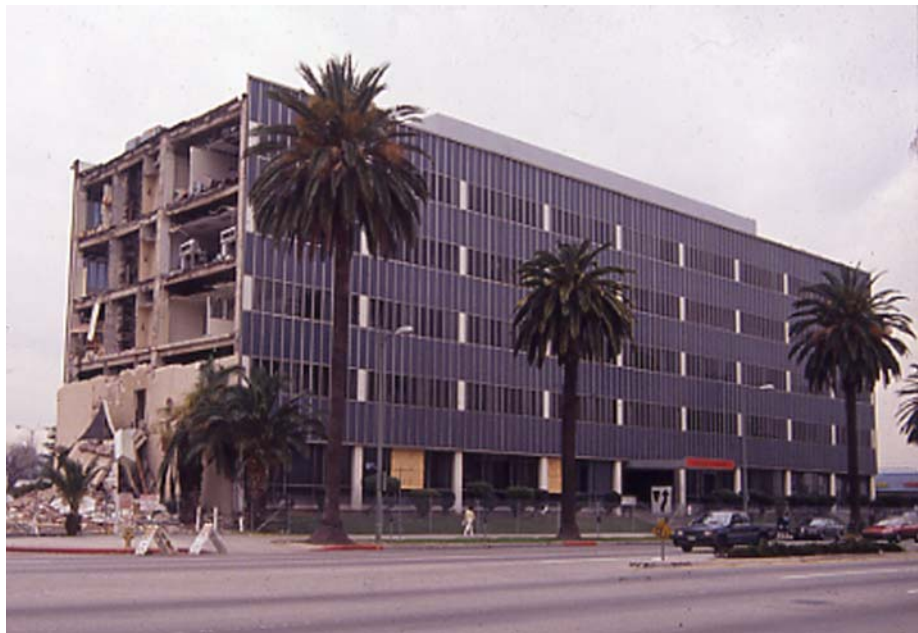
Figure 6-3 Partially collapsed end-wall in 5-story office building caused by severe earthquake ground shaking. (C. Arnold photo)
