1.1 INTRODUCTION

1.2 THE EVOLUTION OF SITE SECURITY DESIGN

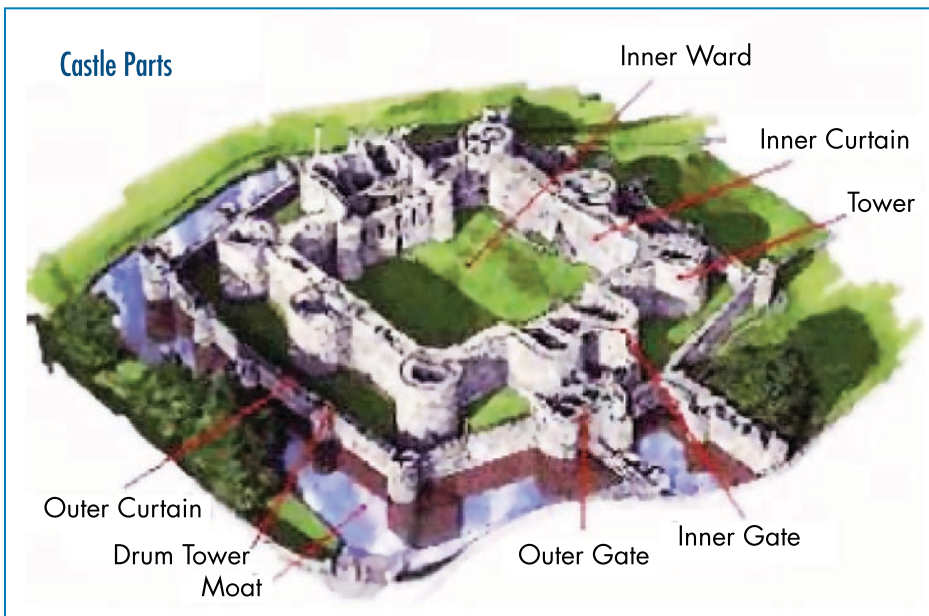
Figure 1-1:
Mediaeval castle
elements.

The design of buildings to protect occupants from attack is as old as the history of architecture itself. The development of gunpowder and cannon in the middle ages forced walls to become lower and thicker in protection against cannon balls. The eventual result was the bastioned fort, which was developed in increasingly elaborate forms. With a broad open space in front of the moats; the drawbridge, inner and outer entries, the high walls with slit openings and the well guarded towers, the complex, in its mature form, shows all the elements that are present in today's doctrine of the three layers of defense against attack (Figure 1-1).

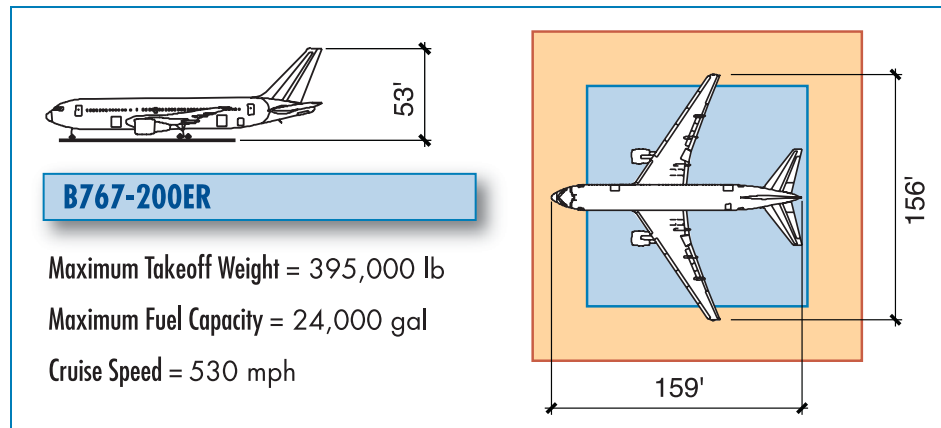
Figure 1-2:
The extraordinary weapon. The figure shows the relative size of the Boeing 767 and the World Trade Center towers, the weight of the airplane, and its fuel load.

Some of the characteristics of the September 11, 2001, attack on the WTC are described below. The attacks used an extraordinary weapon (Figure 1-2). The figure shows a Boeing 767 superimposed to scale against the floor plan of a WTC tower.

The WTC towers had been designed to withstand the accidental impact of a Boeing 707 seeking to land at a nearby airport; the airplane was estimated to have a gross weight of 263,000 pounds and a flight speed of 180 mph with a modest fuel load. The Boeing 767-ER type aircrafts that hit

both towers on September 11 had estimated gross weights of 274,000 pounds and flight speeds of 470 to 590 mph on impact with near-full loads of fuel. The burning fuel proved to be the deciding factor in the collapse of the towers. These differences in the design threat and the actual attack illustrate the critical importance of establishing the design basis threat, as described in the risk assessment process outlined in the next chapter. The nature of the design, the assets (consequences), and the building vulnerabilities lead to the overall risk assessment that drives the consideration of alternative protection strategies.

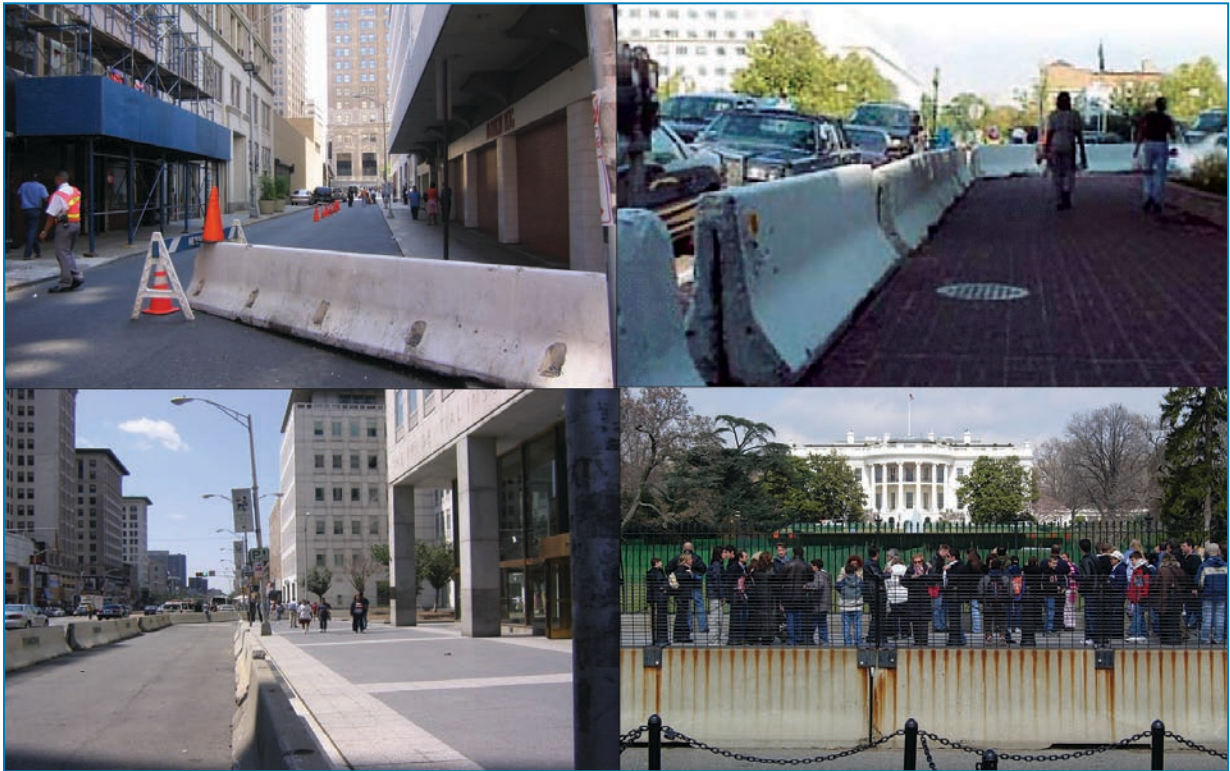
Figure 1-4:
Jersey barriers installed in New York City and Washington D.C. after 9/11.

The impact of 9/11, particularly in Washington and New York, was so traumatic that many security measures were quickly applied on an ad hoc basis. For example, the ubiquitous Jersey barrier is one of many devices used as perimeter security that, if not properly located, can degrade the quality and character of public space and severely detract from the sense of openness and accessibility that are features of an attractive and functional urban environment (Figure 1-4).

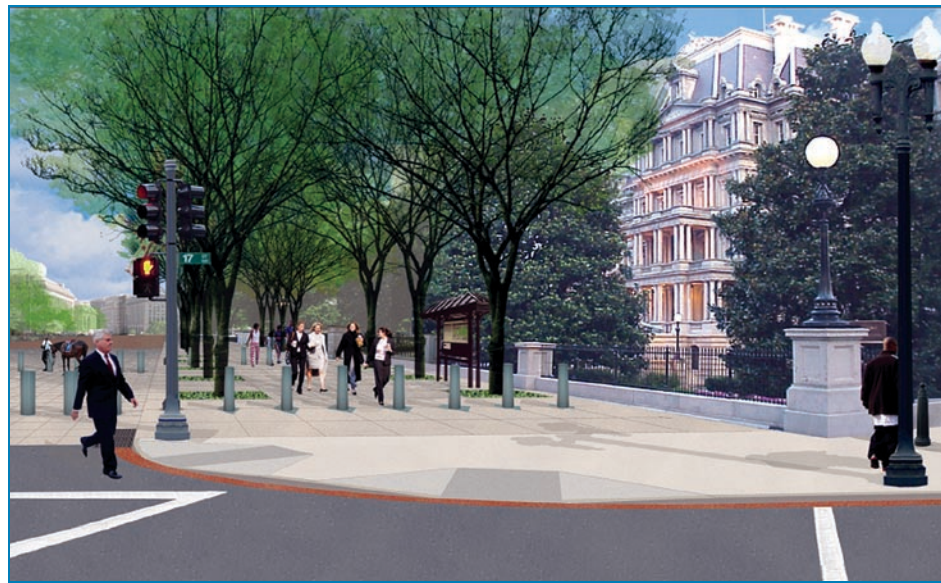
Figure 1-5:
Streetscape, corner
of 17th Street and
Pennsylvania Avenue,
Washington, D.C.
SOURCE: NCPC

In the following year, the National Capital Planning Commission (NCPC), an influential public agency entered the discussion. NCPC is the federal government planning agency in the capital region. Concerned by the number of hodge-podge security solutions being installed by individual federal agencies after the Oklahoma City bombing and the attacks of September 11, 2001, NCPC convened a task force to address and report on the impacts, including street and sidewalk closures, and the detrimental physical, visual and psychological consequences that unplanned and uncoordinated perimeter security was causing the city and its historic resources. This was published as the *National Capital Urban Design and Security Plan* in October 2002. Figure 1-5 shows a typical proposal from the plan.

The NCPC Plan focuses exclusively on perimeter building security designed to protect employees, visitors, and federal functions and property from threats generated by unauthorized vehicles approaching or entering sensitive buildings. It does not address other kinds of security measures such as building hardening, operational procedures, or surveillance. The goal of the plan is to restore the beauty of the nation's capital by integrating building perimeter security into an attractive streetscape and by coordinating the design and installation of streetscape products.

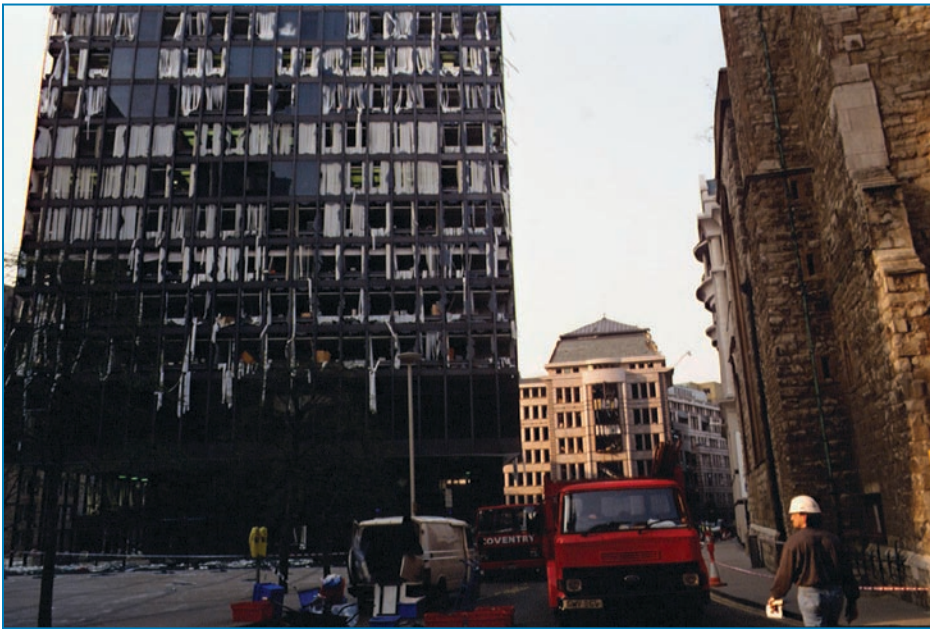
Figure 1-7:
Damage to
surrounding buildings
© MATTHEW POLAK/CORBIS

In April 1992, at 9:20 p.m., the offices of the Baltic Exchange at 30 St. Mary Axe in the City of London were virtually destroyed in an Irish Republican Army (IRA) bomb attack. A small truck pulled up in St. Mary Axe, a narrow street in the heart of London's financial district. Inside the truck was the first large fertilizer-based home-made explosive device ever to be exploded: the bomb's power was enhanced by a Semtex-based detonating cord wrapped around the explosives. Although most of the office workers had gone home, the bomb killed three people, all by flying glass, and injured 91. The damage was estimated at about \$1.2 billion (Figure 1-7).

“The area that had been damaged not only extended well beyond what anyone would have believed knowing the location of the bomb: damage done to this area was phenomenal. The impact of the explosion had showered the direct area with endless mountains of glass, and nearly all of the windows of the adjoining Commercial Union skyscraper were knocked to smithereens. The force had also damaged many other buildings and destroyed windows over a vast area and damaged cars.”

- Nonreinforced masonry-bearing walls have high vulnerability rating.
- Glazing can cause immense damage if not properly designed.

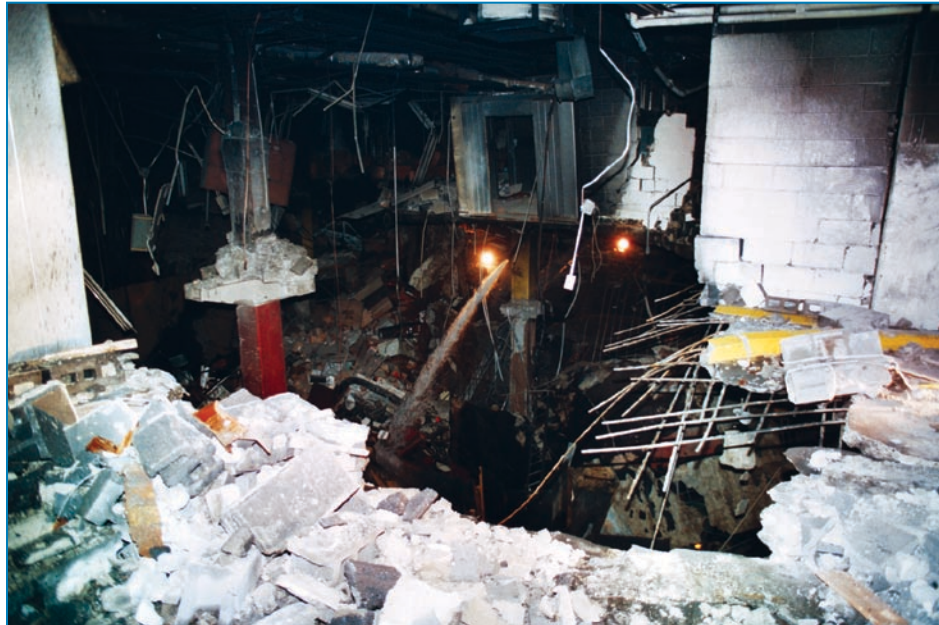
Figure 1-9:
Damage in WTC
garage caused by the
1993 bomb attack.

The explosion was caused by a 1,500-pound urea-nitrate bomb (equivalent to about 900 pounds of TNT) packed in a rented Ford van, detonated by a timer after the van had been parked in the basement parking garage. The explosion created a crater 200 feet by 100 feet and several stories deep. The towers' power and emergency systems were wrecked. Most of the injuries were due to smoke inhalation (Figure 1-9).

- Strong columns at base of tall building prevented major structural damage.
- Loss of large floor areas, while the supporting column remained standing showed importance of hardened floors in vulnerable conditions.
- Loss of power and emergency systems showed importance of redundant, hardened and reliable utility and emergency service design.
- Importance of multidisciplinary design.

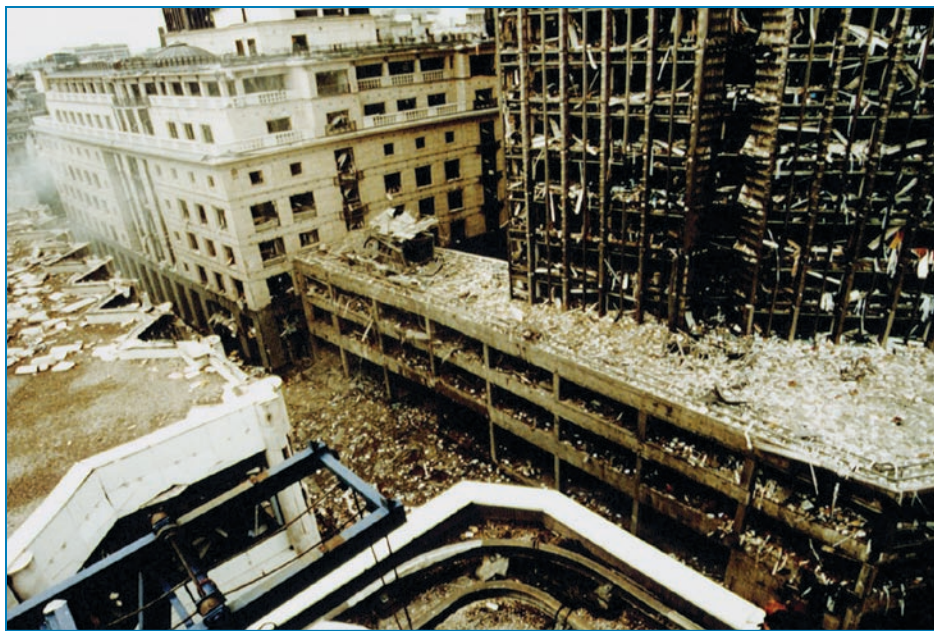
Figure 1-10:
Damage to
surrounding buildings
SOURCE: © CORBIS

A bomb hidden in the back of a large truck exploded in a narrow street, killing one person and injuring more than 40. The bomb was home-made with about one ton of fertilizer and was similar to the bomb that devastated the nearby Baltic Exchange, noted in Section 1.5.2.3. The explosion shook buildings and shattered hundreds of windows, sending glass showering down into the streets below. A mediaeval church, St. Ethelburga's, collapsed. Another church and the Liverpool Street underground station were also wrecked.

The cost of repairing the damage was estimated at more than \$1.5 billion. Repairs to the Baltic Exchange had just been completed and the building re-opened, when the same bank was damaged in the April Bishopsgate blast. Huge payouts by insurance companies contributed to a crisis in the industry, including the near financial collapse of the world's leading insurance market, Lloyds of London (Figure 1-10).

- Large collateral damage to surrounding buildings in a dense urban setting caused crises in the insurance industry.

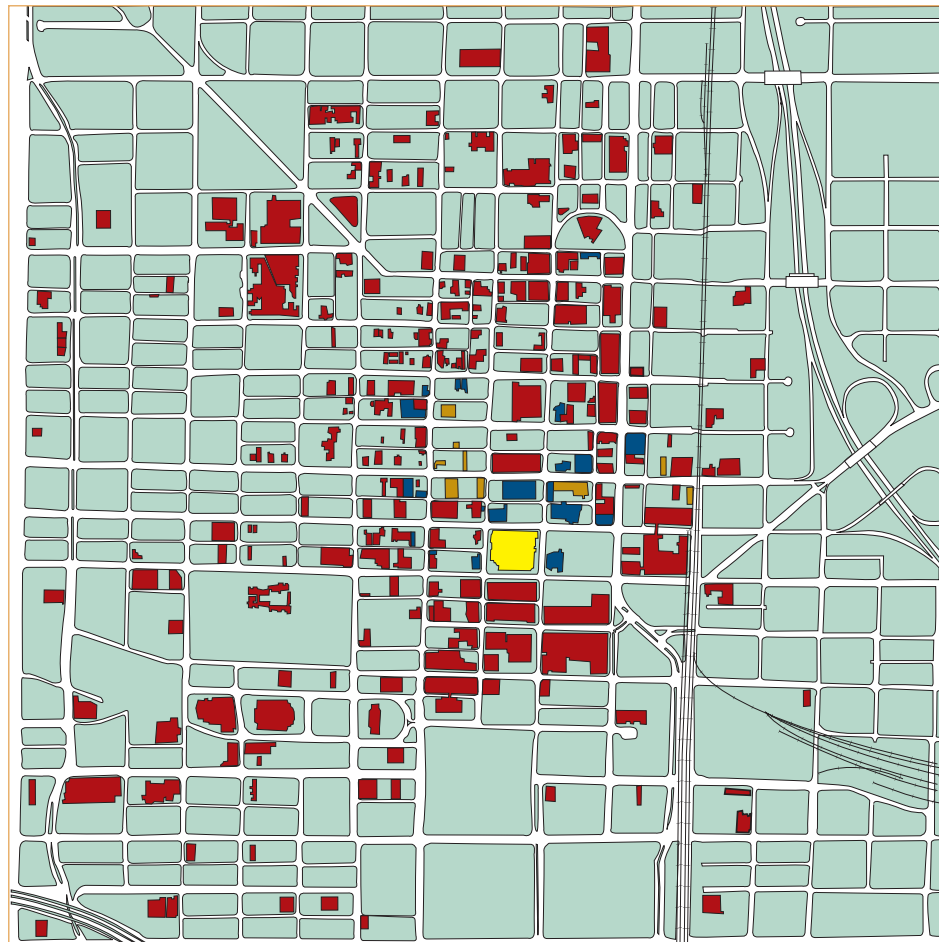
Of the 361 building occupants, 118 workers, 15 children in day care, 4 children visitors, and 26 adult visitors were killed. One hundred sixty-six people were injured. Two people were killed and 39 injured in the adjoining Water Resources Board Building, and one person was killed and four injured in the adjoining Athenian Building. One person was killed and 60 were injured outside, and 167 injuries occurred in other buildings near the blast. Over 300 buildings were damaged or destroyed (Figure 1-11).

This figure shows the site layout and impact location of the Murrah Federal Building after the bombing of 1995. Collateral damage in adjacent sites and buildings was substantial.

- High collateral damage even at long distances from ground zero.
- Importance of community context design strategies for high-value targets in an urban setting.

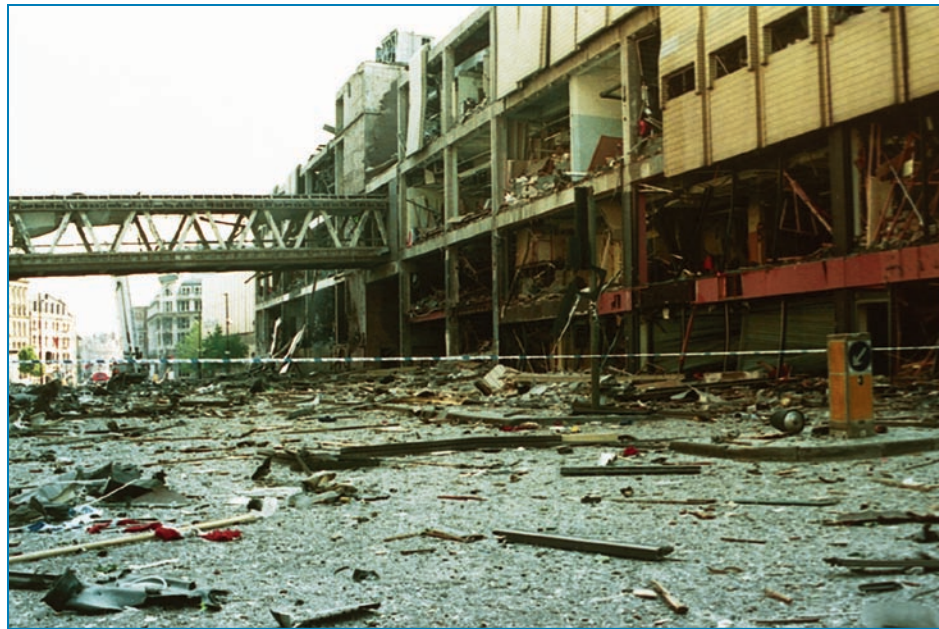
Figure 1-12:
Manchester shopping
center damage.

Most injuries were sustained from falling glass and building debris. The main railroad stations were closed for several hours, and the city center was sealed off. The evacuation of shoppers took place from the Marks and Spencer Department Store at the center of the site, outside which the truck bomb was parked.

- The tower was spared from major damage due to setback offered by lower floors.
- No major structural failure due to the relatively small bomb size and the width of the sidewalk.
- Most of the severe damage and injuries were caused by failure of the building envelope and shattered glazing.

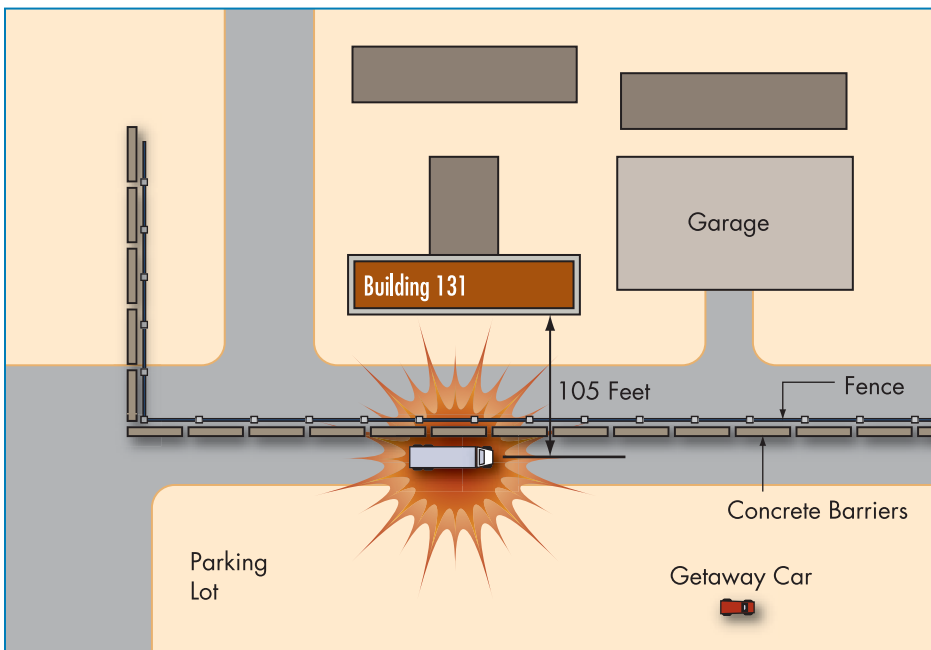
Figure 1-15:
Location of truck bomb
and getaway car.

On the evening of June 25, a security policeman went to the top of Building 131 to check on two sentries posted there. From the roof they observed a sewage tanker truck and a white car enter the parking lot. They watched the truck drive to the second to last row, turn left as if leaving the lot, slow down, stop and then back up towards the fence line. It stopped directly in front of the center of the north façade of Building 131. The truck's driver and a passenger jumped out and hurried to a waiting car, which sped out of the parking lot. The security police acted rapidly: they radioed in an alert and started the evacuation plan to notify each floor of the building. Many of the evacuees were in the stairwell when the bomb went off. The stairwell was on the other side of the building away from the bomb, perhaps the safest location in the building. The actions of the guards saved many lives (Figure 1-15).

As the blast waves hit the building, they propelled pieces of Jersey barriers into the first floor. The outer walls of the bottom floors were blown into rooms, and the facades of the floors peeled off and fell into a pile of rubble. The building did not collapse because it had been built to British code standards and was made of prefabricated concrete cubicles that were bolted together. The bomb blasted a crater 35 feet deep and 85 feet across.

- Showed importance of adequate setback: a shorter setback would have resulted in much more structural damage.

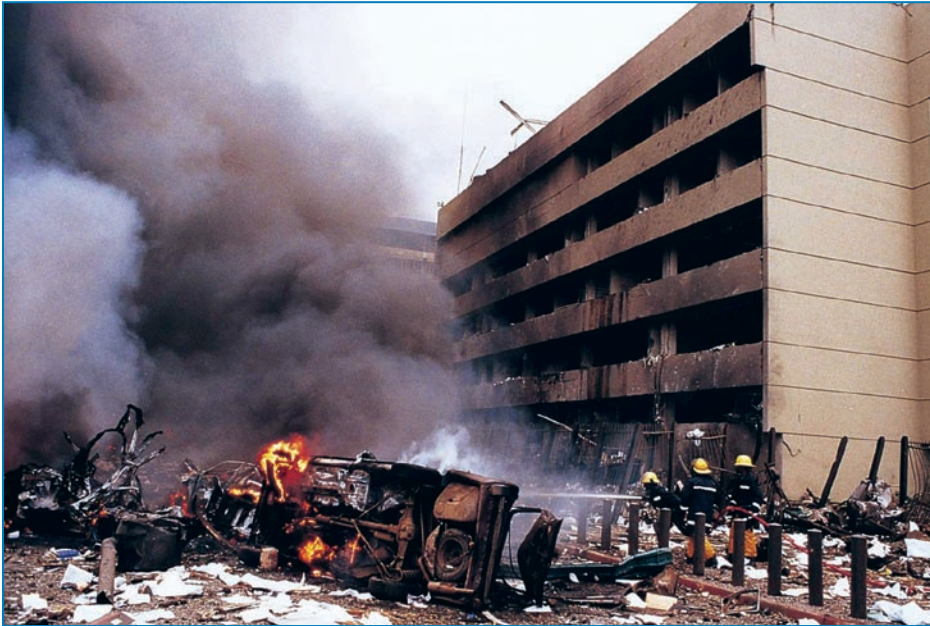
Figure 1-16:
U.S. Embassy,
Nairobi, Kenya.

The United States Embassy in Nairobi, Kenya, was attacked on August 7, 1998, at 10:30 a.m. local time, five minutes after an attack on the U.S. Embassy in Dar es Salaam, Tanzania. The building was a five-story reinforced concrete structure, constructed under the supervision of the Foreign Buildings Operations in the early 1980s before the Inman Committee security standards were produced (Figure 1-16).

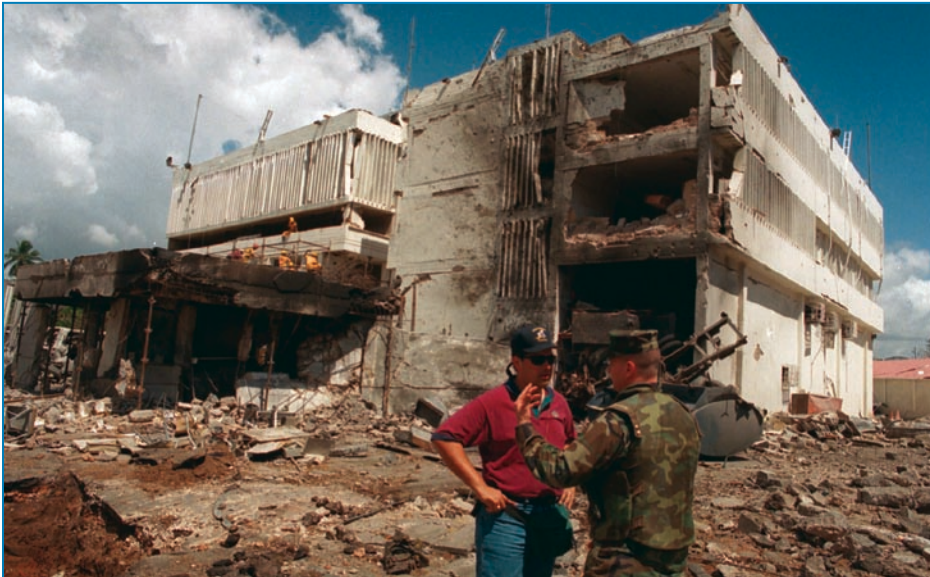
Figure 1-17:
Damage to the U.S
Embassy, Tanzania

The truck bomber drove to one of the two vehicular gates of the U.S. Embassy. Apparently unable to penetrate the perimeter because it was blocked by an embassy water tanker, the suicide bomber detonated his charge at 10:39 a.m. at a distance of about 35 feet from the outer wall of the chancery (Figure 1-17)

The chancery suffered major structural damage and was rendered unusable, but did not collapse. No one inside the chancery was killed, in part due to the strength of the structure and in part to simple luck. Several American Embassy residences were destroyed as were dozens of vehicles. The Ambassador's residence, a thousand yards distant and vacant at the time, suffered roof damage and collapsed ceilings.

- The 35-foot setback outside the chancery wall proved to be adequate to protect the building from major collapse even though the structure was severely damaged.

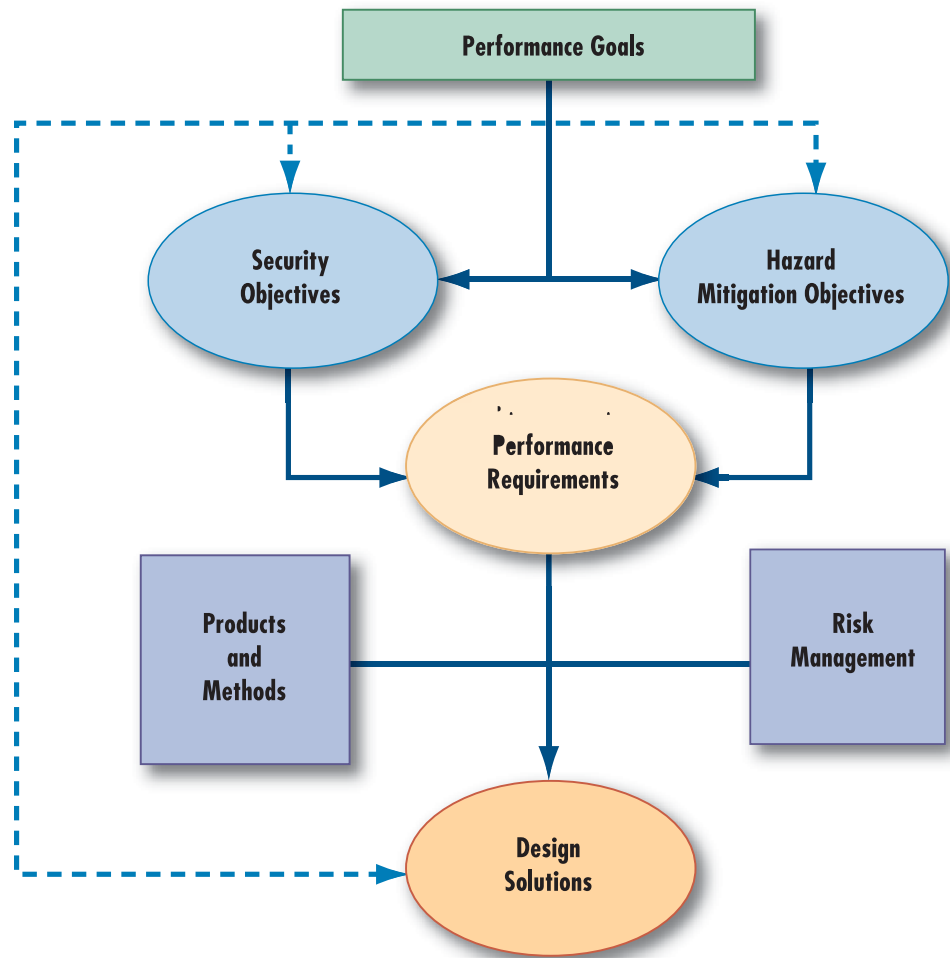
Figure 1-18:
A performance-based
multi-hazard model.

Figure 1-18 is a model of a performance-based design process that integrates security and natural hazard objectives and performance requirements, while allowing the input of existing and new technologies related to risk management principles. The consideration of cost issues enables design solutions appropriate to the individual project to be achieved. Some broad considerations for achieving the maximum risk reduction for the minimum amount of money are presented in Section 2.8.
