# From Landslides to Levees

Important Links Among Episodic Sediment Movement,  
Fluvial Landforms, Geologic Setting, and Aquatic Habitat

By Faith Fitzpatrick

USGS Wisconsin Water Science Center

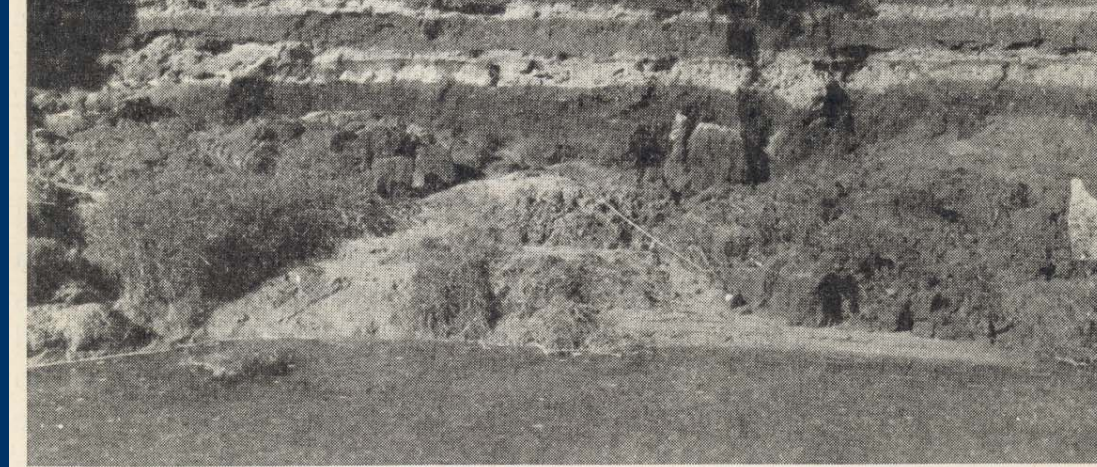
FIG. 4.—Cut-bank exposure showing 3 feet of stratified modern sand and silt overlying the topsoil horizon. This picture was taken on the alluvial fan of Sand Creek, a tributary of the Kickapoo River. The exposure shows more sand (light-colored layers) in the modern alluvium than is common on the main Kickapoo River flood plain.

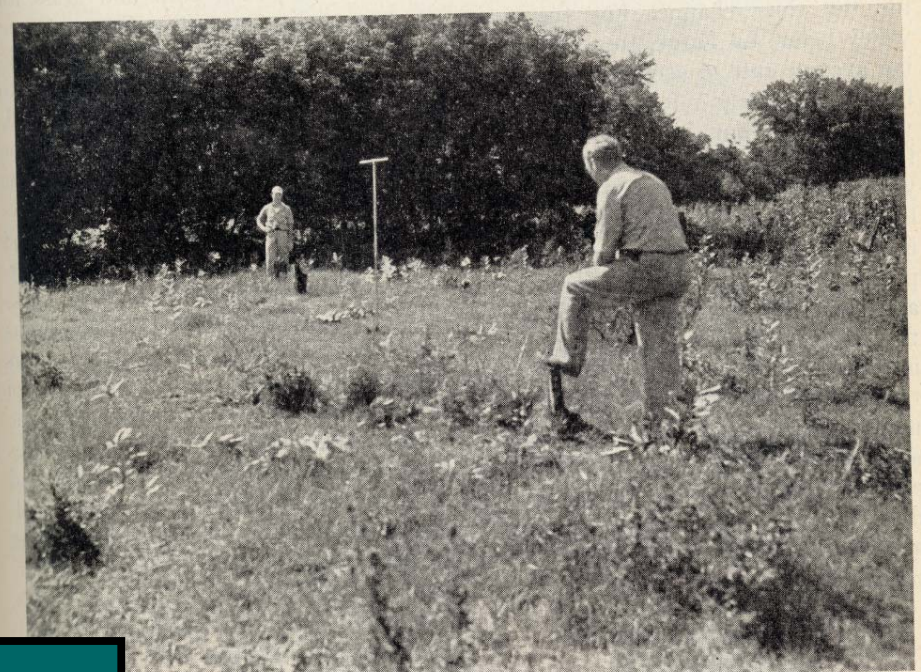
...ence posts, with woven wire still attached, partially buried on the Kickapoo River flood plain southwest of La Farge. The soil auger stands at the site of a post that has been recently buried. The posts beside which the men stand have been buried to within about 15 inches of their original position.

Kickapoo River, WI;  
Studies by Stafford Happ, 1940

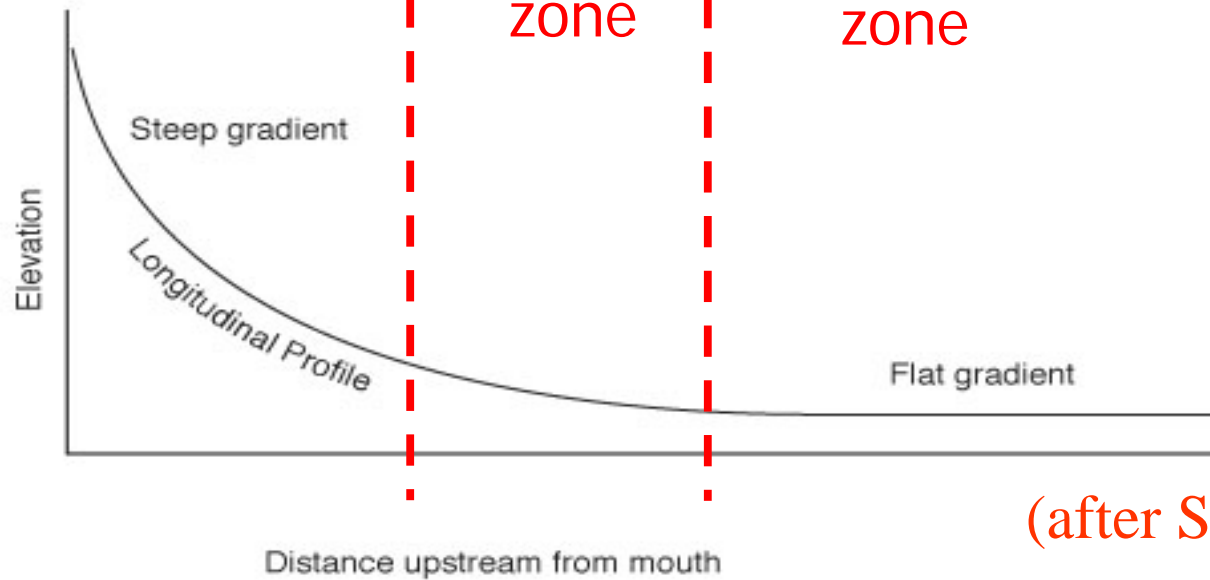
Erosion zone Transition zone Deposition zone

Elevation profile

(after Schumm, 1977)

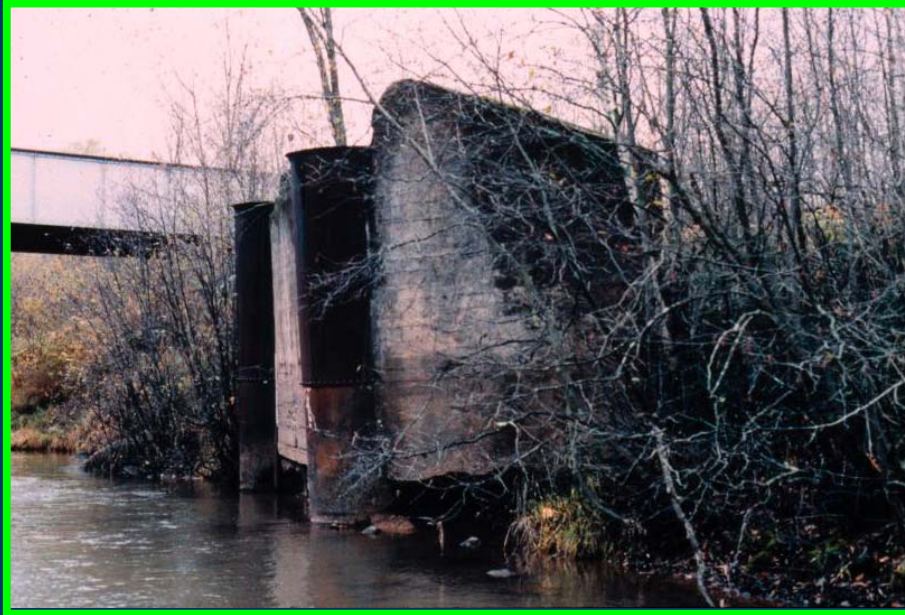
Transitional main stem

14,000 metric tons/year  
140 tons/km<sup>2</sup>/yr

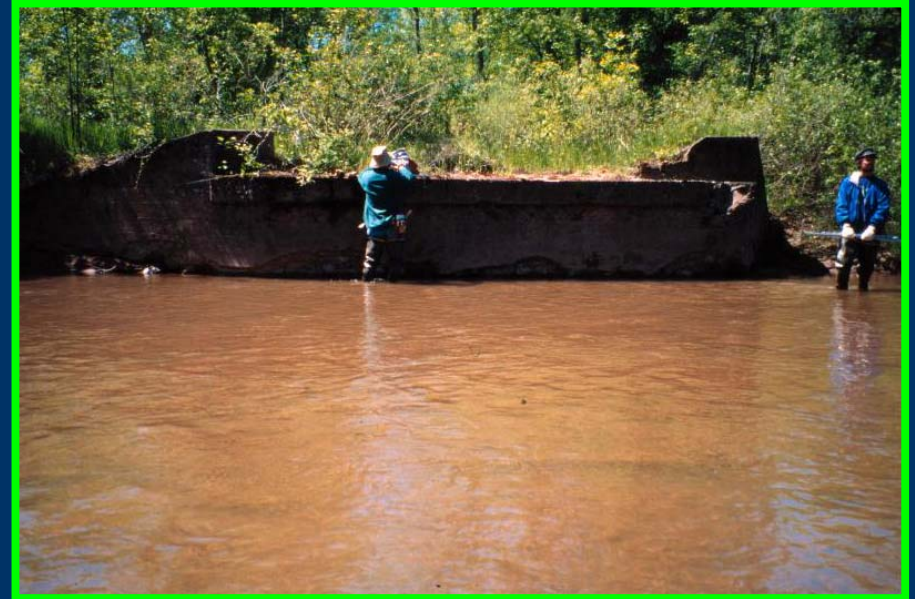
Lower main stem

24,440 metric tons/year  
200 tons/km<sup>2</sup>/yr
