**Attachment 2 – Project Location  
Photographs**

**ASSUNPINK CREEK - BROAD STREET CULVERT REMOVAL**

## Clean Water Act Section 404(b)(1) Evaluation

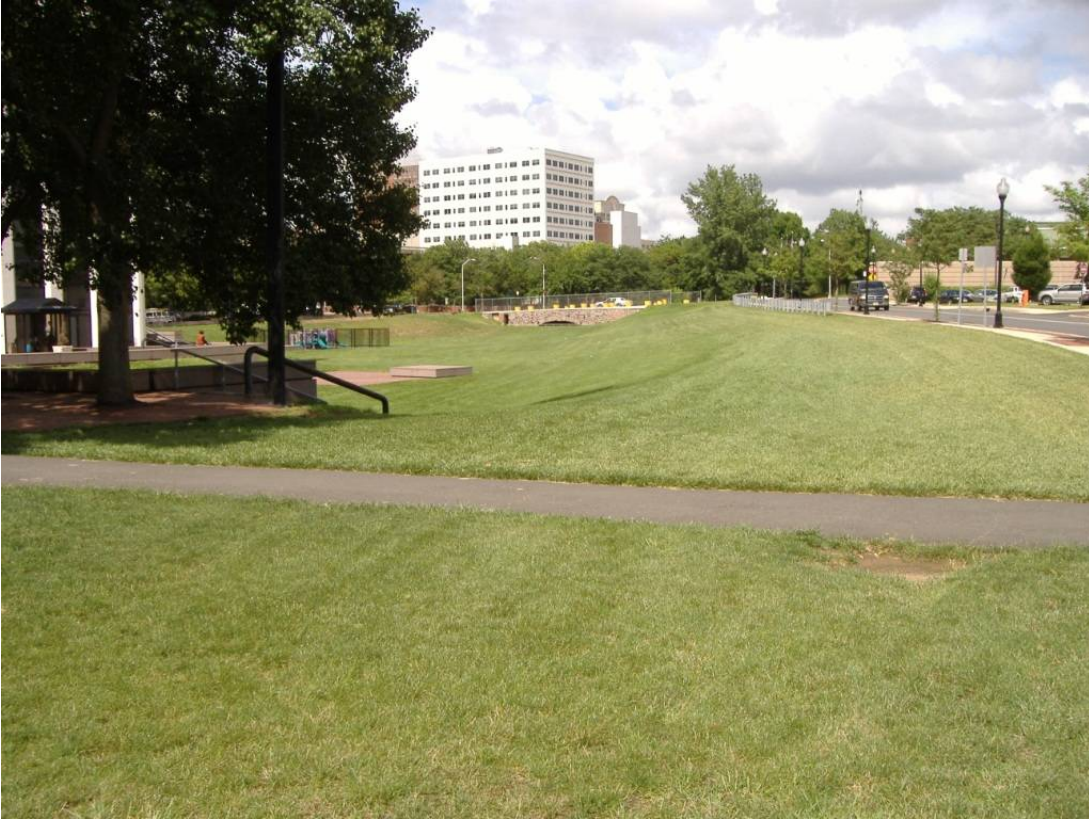
**Plate 1.** View upstream of turf and fill covering the Broad Street culvert.

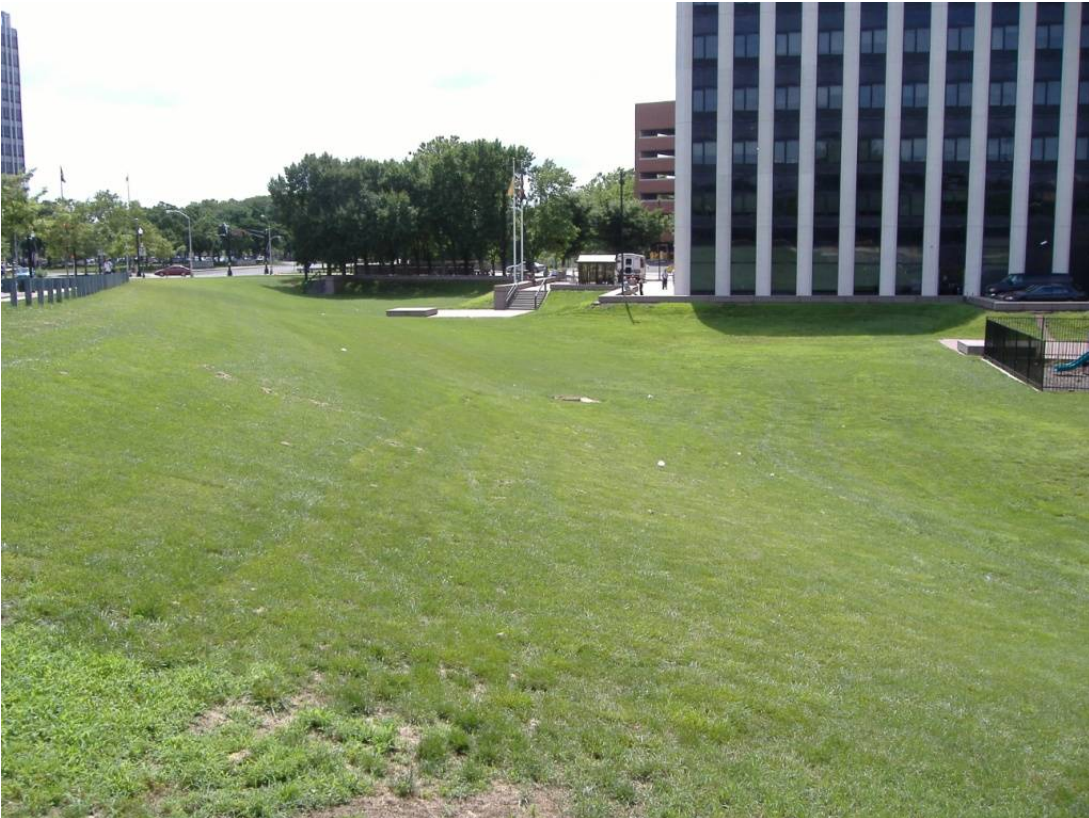
**Plate 2.** View downstream of turf and fill covering the Broad Street culvert.

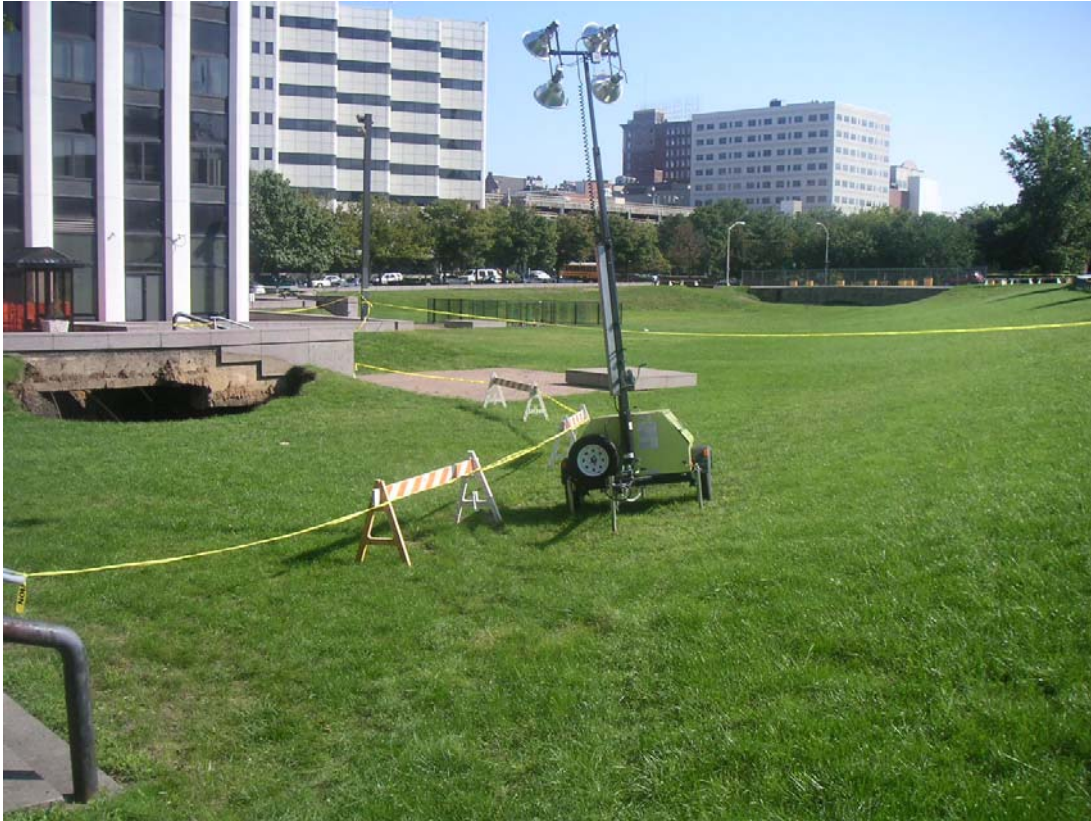
**Plate 3.** View upstream showing the collapsed culvert roof section.

The roof deck slabs over the northern flume of the culvert collapsed into the culvert. The collapse of the deck slabs removed support for the soil and structure above, which in turn collapsed into the culvert. Sections of the wall and stair structure above the roof collapse still remain in place, however these sections are extremely unstable and could collapse into the culvert at any time. The use of precast hollow-core slabs in a buried condition is a very questionable application and the failure of the deck slabs can most likely be attributed to some combination of the following three conditions.

Hollow-core slabs contain large voids inside the slabs and gain their strength from high-strength strands of steel that are located in the bottom segments of the deck slab. In an exterior application, especially a buried application, the deck slab is exposed to continual moisture and water infiltration. In this application, the slabs are exposed to the creek below and continual water seepage through joints from the soil above. Evidence of water seepage was seen on the exposed walls in the collapsed area. The steel strands usually contain only about 1 1/4" of concrete cover and when exposed to such moist conditions, the possibility of eventual corrosion of the strands is great. When the strands corrode, they expand and cause the concrete to spall, only accelerating the corrosion process and reducing the bonding strength of the strand to the deck slab. Both of these conditions can eventually lead to sudden collapse. Secondly, when hollow-core deck slabs are not properly installed with weep holes and are then exposed to freezing, the cores which inevitably collect water are subject to freezing which can also cause catastrophic damage to the structural integrity of the deck slabs. Finally, 8" deck slabs spanning approximately 22' have allowable load carrying capacities that are lower than the conditions that appear to exist at this site. The load of three feet of soil alone is on the order of 350 pounds per square foot, which is beyond the traditional carrying capacities for 8" decks. This load only rises at the areas of the raised patios and walls, and also does not include the load of the reported ponds of water that collect in the open field during heavy rains.

From our visual inspection, we have determined that the collapse is from the failure of the culvert roof deck slabs. Further, based on the reasons outlined above, we have concern that other sections of the culvert roof may contain highly questionable structural integrity with the potential for sudden collapse. While walking the open field over the culvert, one section of grass appeared to have settled over the culvert roof only strengthening our concern of the roof's integrity. **BEI highly recommends that the entire culvert roof area including a minimum buffer of 10 feet on each side of the culvert be cordoned off to any access. No access should be allowed on top of the culvert until the entire culvert roof structure can be inspected and properly repaired.** Our inspection was limited to visual observations as made from the ground surface and did not include any inspection of the actual roof of the culvert, which will require access into the culvert to perform. It is our understanding that the actual culvert belongs to the City of Trenton. This letter assumes that further inspection of the culvert will be the responsibility of the City of Trenton including investigation into the items mentioned above.

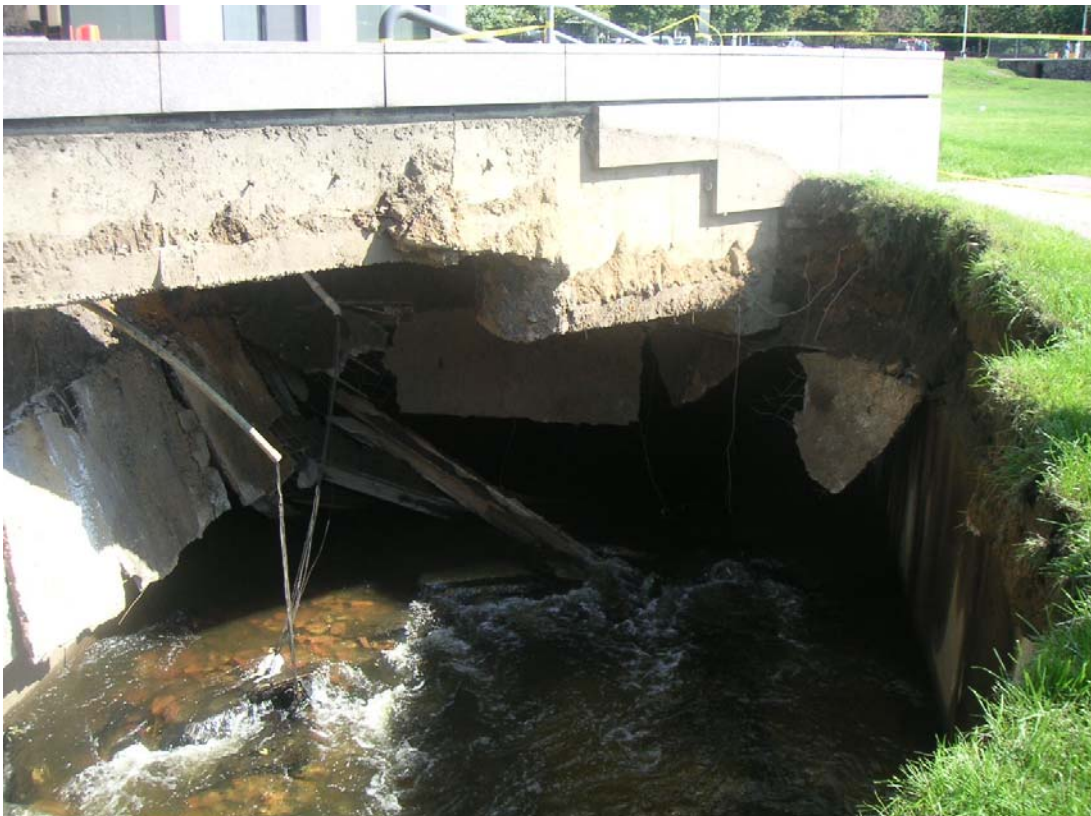
**Plate 4.** Location of the collapsed culvert roof section.

Inspection revealed that the structural failure consisted of the culvert roof structure in an approximately 24' by 35' area directly at the patio and stairs to the South of Capital Place One.

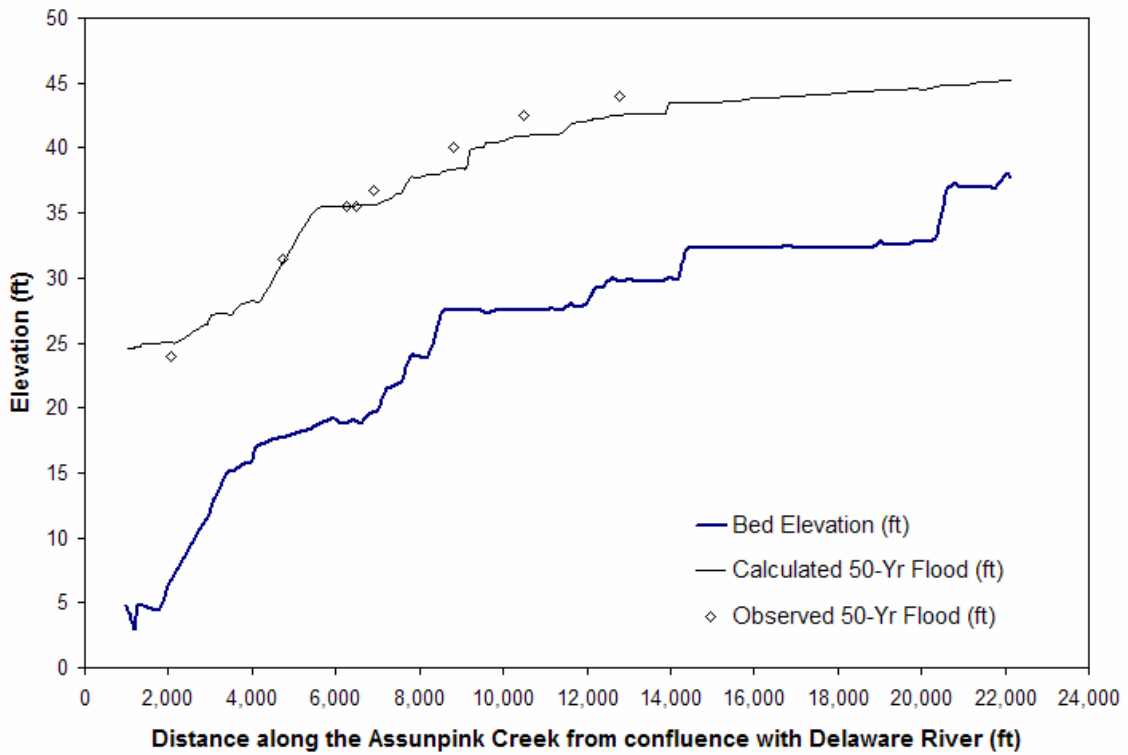
Figure 7: Lower Assumpink Creek Hydraulic Modeling, Model Verification Run: 50-year Event

The calibrated Manning's  $n$  values were used to calculate water surface profiles for the 10-, 50-, and 500-year storms and the July 1975 event as shown in Figures 6 to 9.

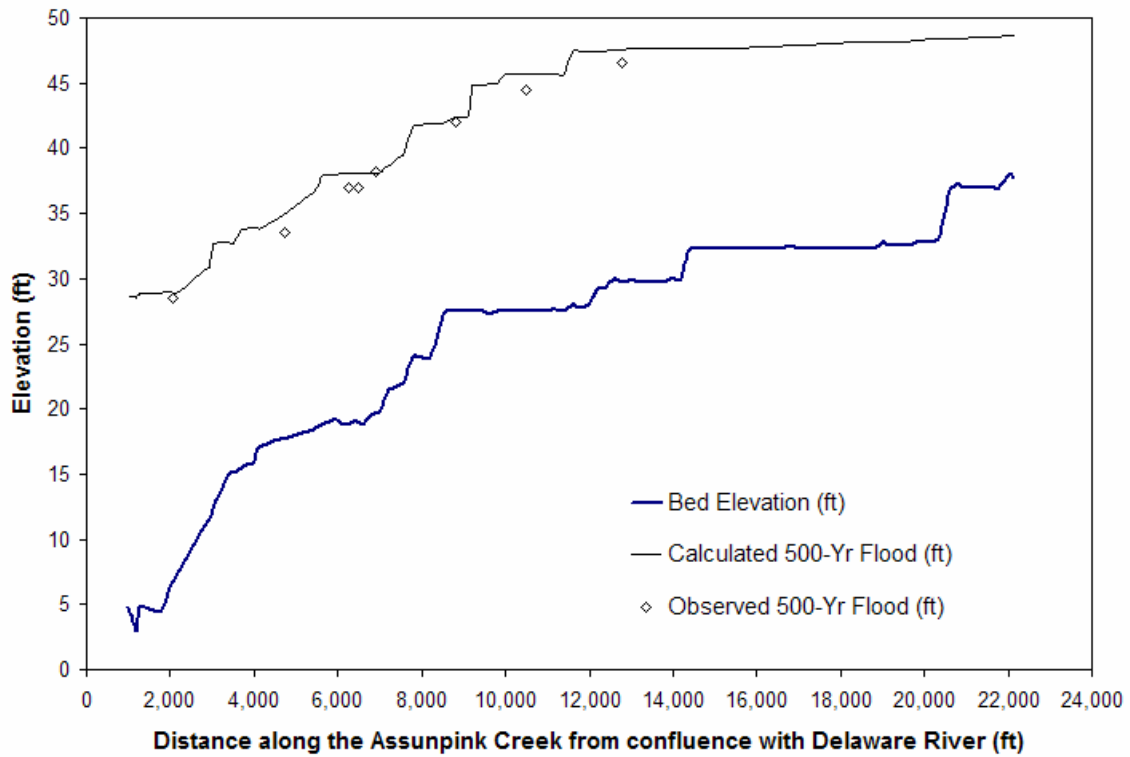
Figure 8: Lower Assunpink Creek Hydraulic Modeling, Model Verification Run: 500-year Event

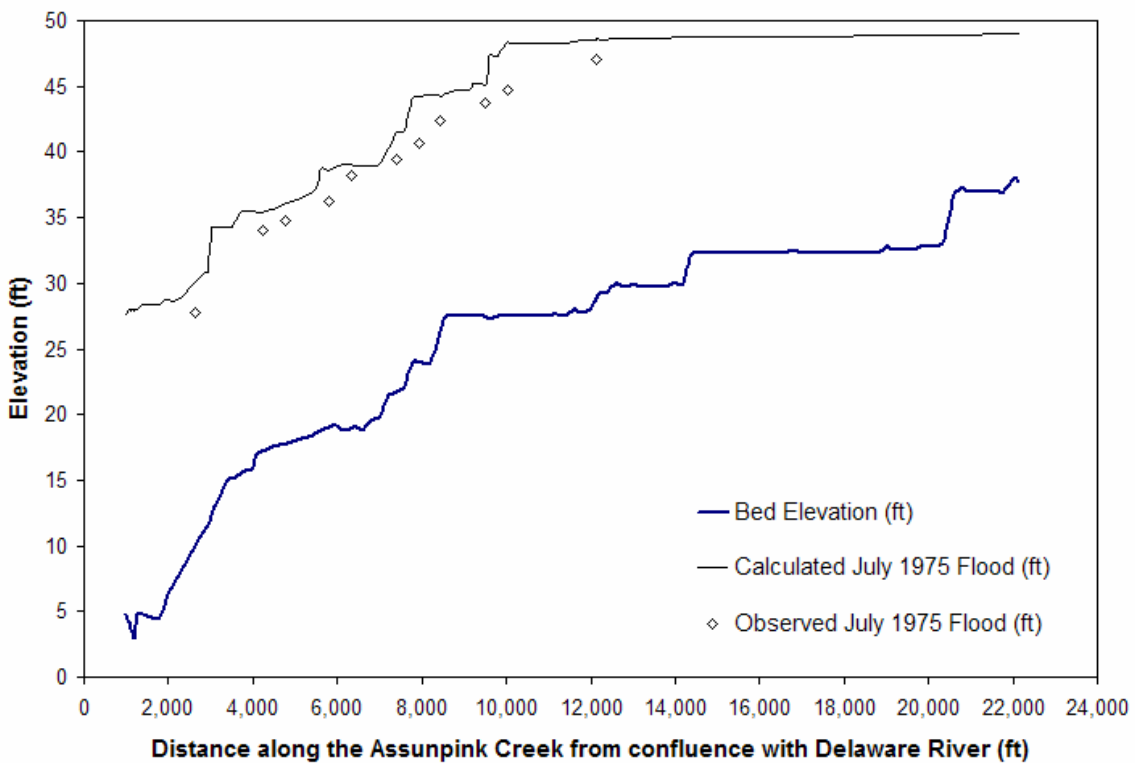
Figure 9: Lower Assunpink Creek Hydraulic Modeling, Model Verification Run: July 1975 Event
