Holding Down the Forts

The Army, Adobe, and Preservation

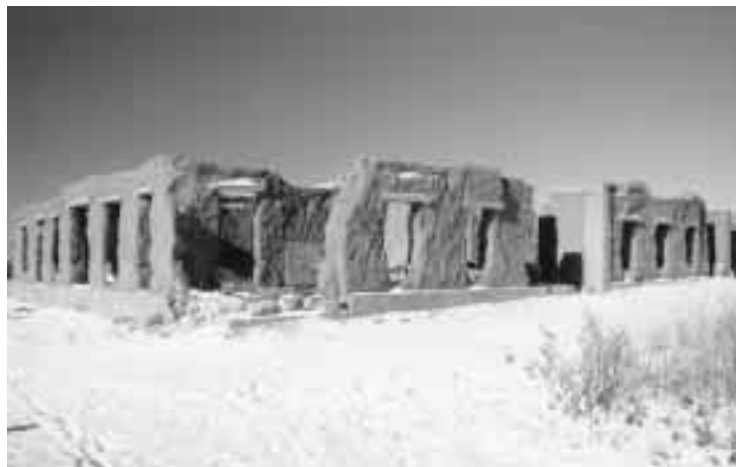
Fort Union, New Mexico, post hospital in winter.

Indeed, from the moment they were completed until their abandonment in 1891, the fort's adobe structures were in an almost constant state of unremitting deterioration. The territorial style of architecture [at Fort Union] proved to be lamentably inadequate on the exposed plains of eastern New Mexico. The flat, tin-covered roofs were unable to provide sufficient protection from the wind-driven rain and hail storms which plagued that level open country. As a result, cracks developed, water seeped through the roofs and walls into the adobe, walls separated from the roofs and threatened to collapse, and floors and foundations rotted. The physical decline of the structures was hastened by two additional factors: the inability of the troops to perform the necessary repairs at a time when strict economy measures prohibited the employment of citizen craftsmen and a pronounced unwillingness on the part of Army officialdom to appropriate sufficient funds for annual maintenance.*

adobe caps were placed on nearly all the walls, and tall unstable walls were braced with internal armatures of iron. Soil-cement adobes were used to rebuild missing corners and fill eroded wall bases. Almost every chemical in the NPS arsenal was at one time or another sprayed on a wall at Fort Union, but preservation today relies primarily on unamended mud shelter coats and adobes.

In 1995 Fort Union commissioned a study of adobe deterioration to determine the patterns and causes of deterioration and suggest treatments. As a result, most of the walls at Fort Union were recently recapped with new soil-cement adobes, and certain deteriorating architectural features, eroded corners and lintels for example, are augmented with unamended adobes immediately.

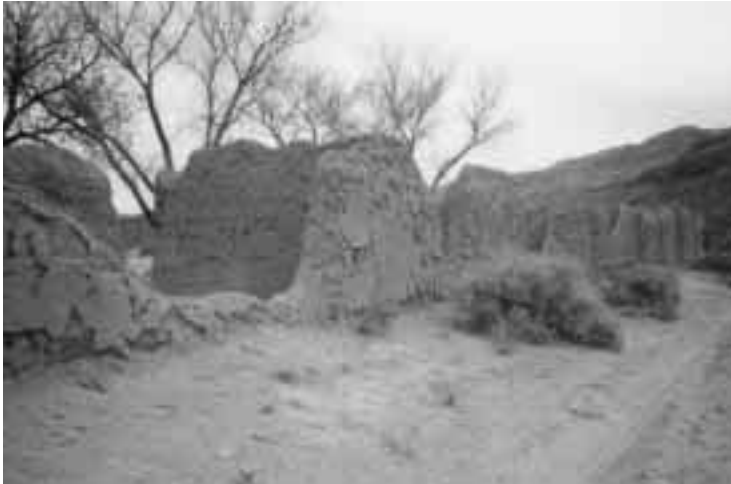
Wall fragments
at Ft. Selden,
New Mexico
State
Monument.

Fort Selden was abandoned in 1878, but it was reoccupied three years later and reconstruction began, completed in 1885. In 1891, the troops left Fort Selden again, for the last time. The site passed into private ownership in 1892, and remained so until 1963 when it was donated to the State of New Mexico. In 1974, Fort Selden was declared a New Mexico State Monument. Initial stabilization consisted of clearing away the wall falls and fill, and compacting the soil at the wall bases. Most of the walls were initially capped with urethane-modified adobes, but these were removed two years later because of concern about erosion associated with the caps. Some low eroded walls at Fort Selden were covered with geotextile fabric and covered with fill, an effective technique for preserving these ephemeral fragments.

Fort Selden has been the site of an extensive experimentation in adobe preservation. A test wall program—trials of wall coatings, foundations, and capping—was begun in 1985, and the Getty Conservation Institute used the site for consolidation-amended-shelter coat trials beginning in 1993. For awhile, selected wall fragments were wrapped in aerotextiles to protect them from rain and wind.

In 1997, New Mexico State Monuments commissioned a new preservation plan for Fort Selden, and it is investigating the options for constructing free-standing shelters over some of the ruins. Adobe treatments are now limited to unamended shelter coats, and veneer infills and capping with unmodified adobes.

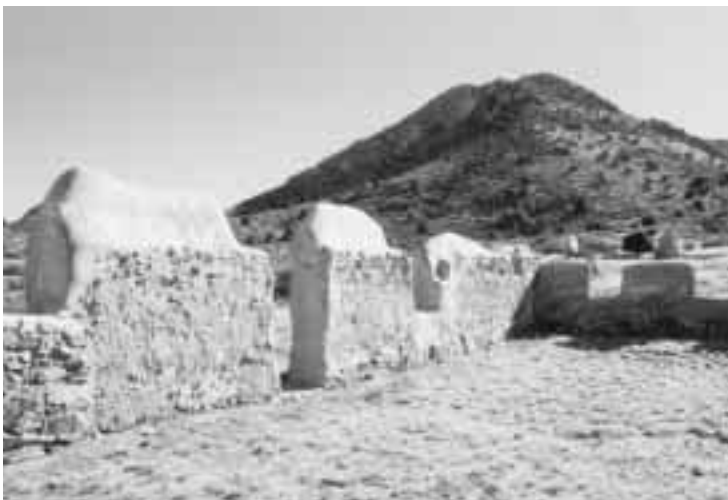
Lime plaster shelter coats over adobe and lime concrete foundation walls of the Cavalry Barracks, Ft. Bowie NHS.

Alarmed by rapid erosion of the adobe at the site following the removal of the soil-cement bricks, the NPS covered the adobe fragments with lime plaster shelter coats in 1988 and 1989. With each change in treatment, more historic adobe was lost. Although the lime plaster will remain and be maintained, the Fort is developing a new preservation guide to shelter the adobe.

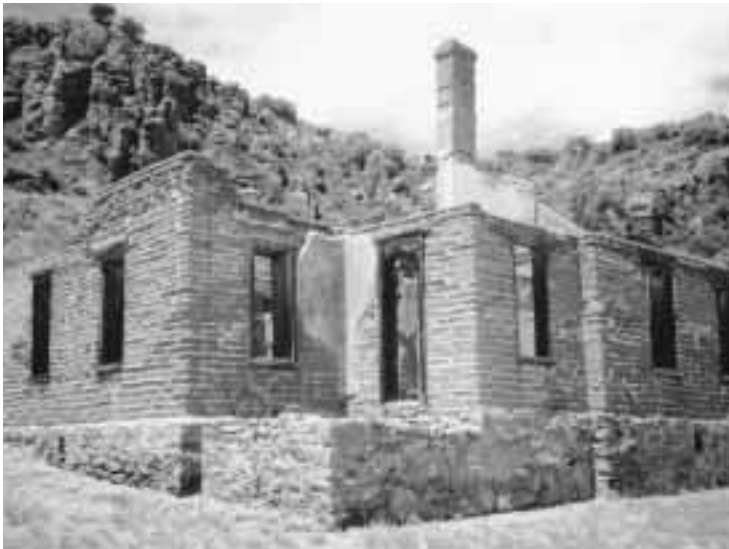
Non-commissioned Officers' Quarters, Ft. Davis National Historic Site.

The Park Service made a bold decision to reconstruct missing portions of the adobe buildings that were at least 70% intact and to replace missing roofs. Concrete bond beams were installed around adobe perimeter walls, and the porches were reconstructed. Exterior plasters were renewed on the structures on officers' row.

Sheltering the structures with new roofs has slowed deterioration significantly. Consolidating chemicals also appeared at Fort Davis, but today the unroofed adobe ruins are treated with unamended adobe caps and veneers. Some water repellants are used on modern adobe veneers to lengthen their life.
