Suspect/Counterfeit Items Awareness Training

U.S. Department of Energy Health, Safety and Security Office of Corporate Safety Analysis

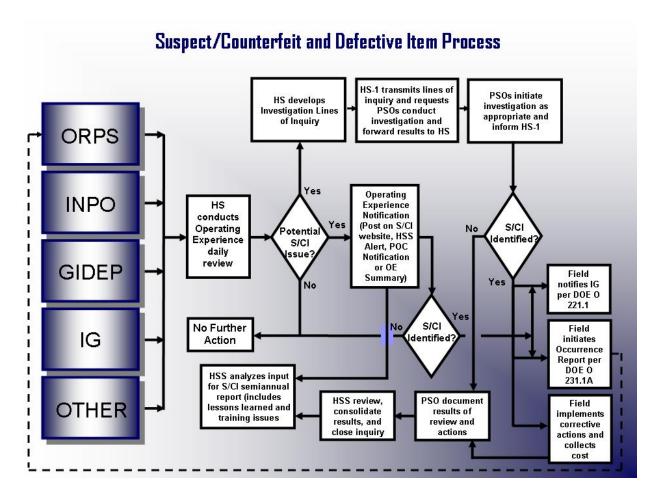
The S/CI process flow chart is included in the *Office of the Environment, Safety and Health Process Guide for the Identification and Disposition of Suspect/Counterfeit Items at Department of Energy Facilities*. The detailed Process Guide can be found on the Office of Corporate Safety Analysis Suspect/Counterfeit-Defective Items website at http://www.hss.energy.gov/csa/csp/sci/ that includes S/CI-related information and links to other related websites.

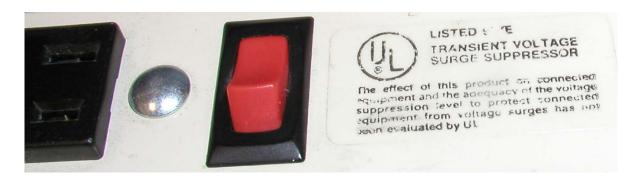
Found at DOE Headquarters in Germantown, MD

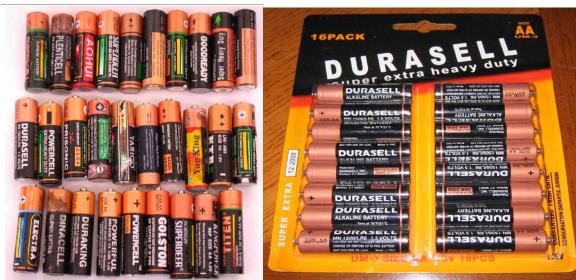
On the left - Examples of DURACELL clones simulating trademarked DURACELL colors (note several are leaking). Some have flimsy casings that crush easily under pressure by hand. The counterfeit batteries on the right the batteries are spelled differently but constitute trademark infringement (black and gold copper top).

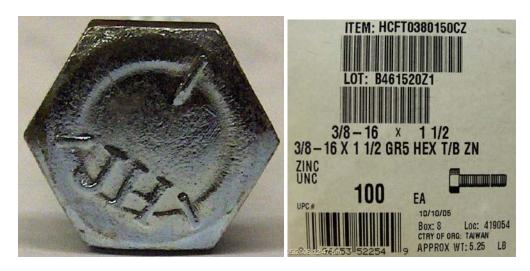
This Jinn Her "JH" Grade 5 Hex Bolt from the West Valley Demonstration Project (WVDP) was received in December 2005. Jinn Her "J" headmarks on grade 5 and grade 8 high-carbon steel fasteners are deemed counterfeit. However, Jinn Her has the "JH" insignia currently registered in the U.S. through the U.S. Patent and Trademark Office. The fasteners were ordered as domestic, yet the supplier provided the foreign-made Jinn Her fasteners from Taiwan. The fasteners were tested and found to meet WVDP specifications. WVDP has chosen to use these fasteners. This insignia (headmark) appears on the FQA Register of Active Fastener Insignias at http://www.uspto.gov/web/offices/tac/fga/fga.htm.

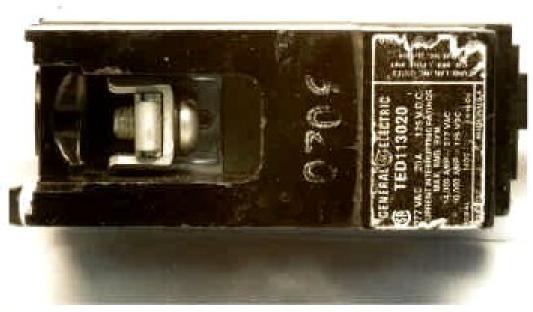
Manufacturer stopped marking with both indicators over 20 years ago Label very worn

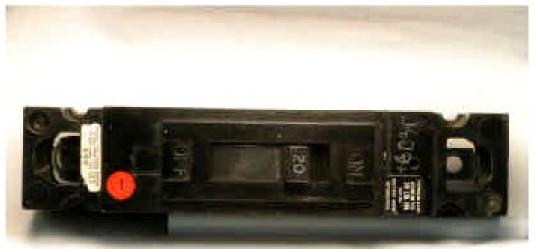
GE Molded Case Circuit Breaker

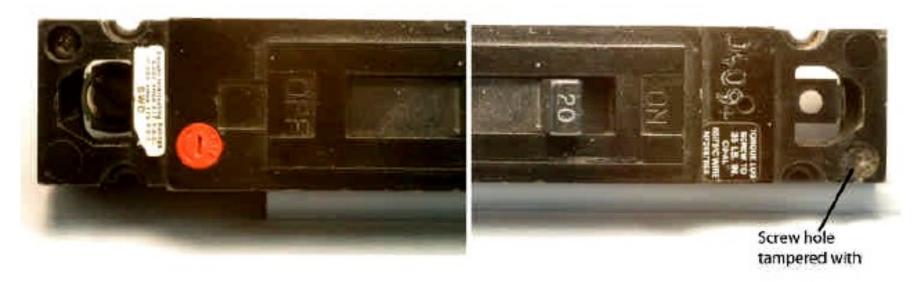
Sold as new by supplier Indications of being used or refurbished Label worn and torn

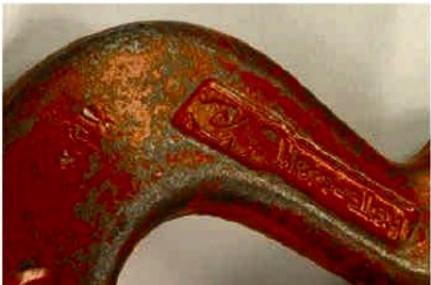
Represented as being new in condition shown above Appearance very worn Are correct manufacturer markings for orange hook

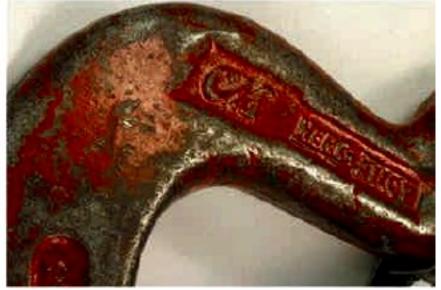
Red color is the Crosby Group, Inc. trademark-patented color Represented as being new in condition shown above Appearance very worn

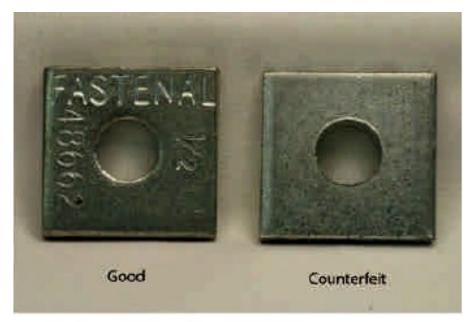
Grind marks where information was removed New information stamped on
