DOT/FAA/AR-02/128

Paint and Bead Durability Study

March 2003

Final Report

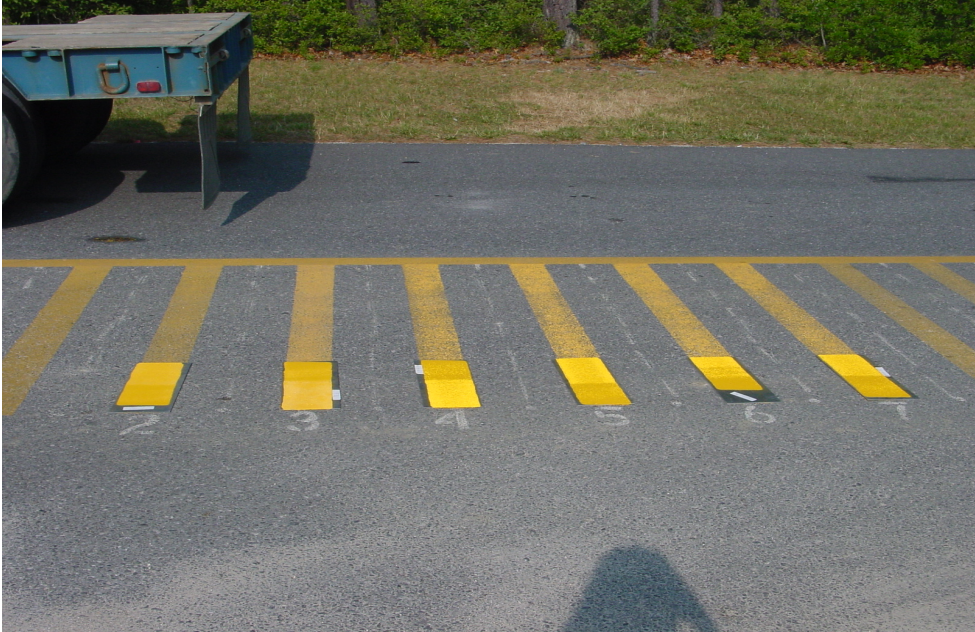
FIGURE 1. YELLOW PAINT WITH Q-PANELS

at the same time of application to compare wear and aging over time. The differences between the appearance of the Q-Panel and pavement markings are due to time. The Q-panels were made at the time of application, June 2001, and the pavement markings are shown in July 2002 (see figures 1, 2, and 3).

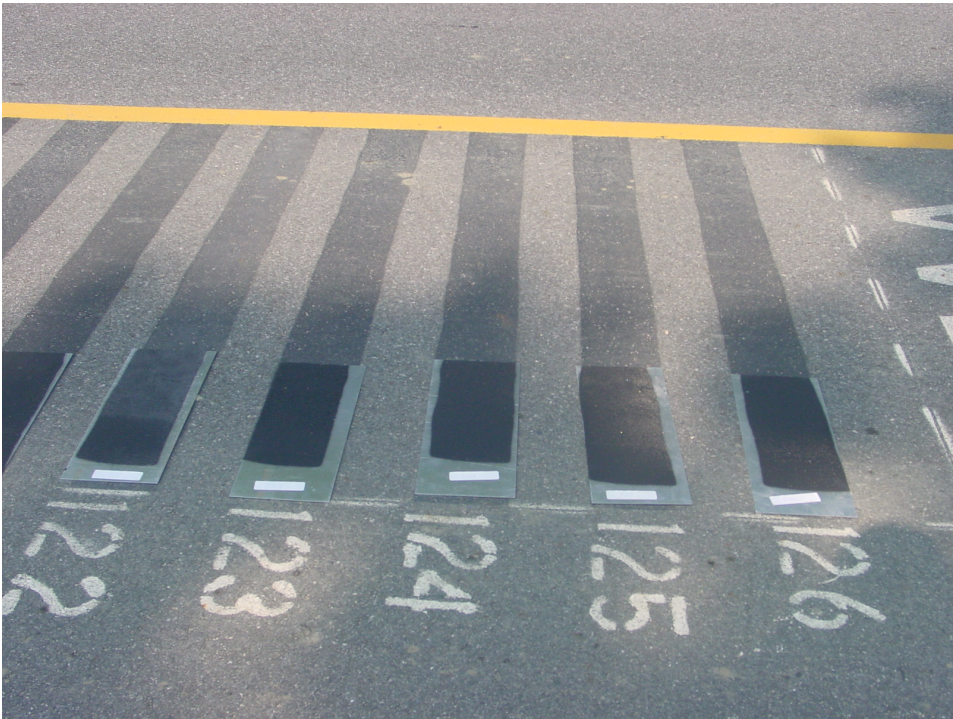
FIGURE 2. BLACK PAINT WITH Q-PANELS

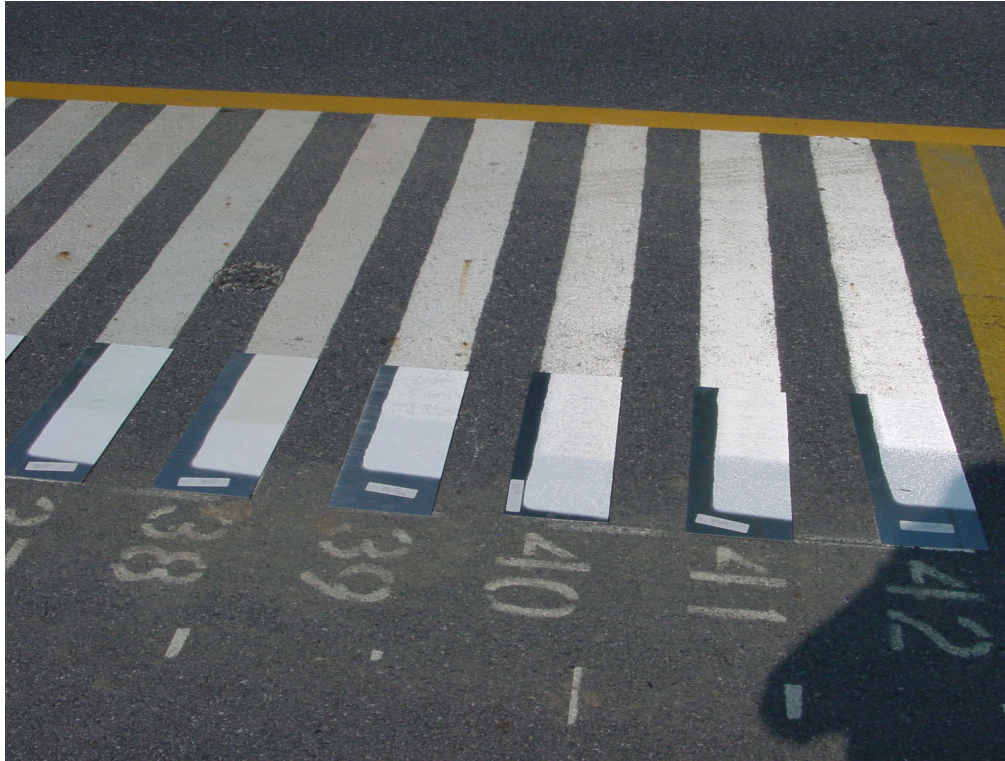
FIGURE 3. WHITE PAINT WITH Q-PANELS

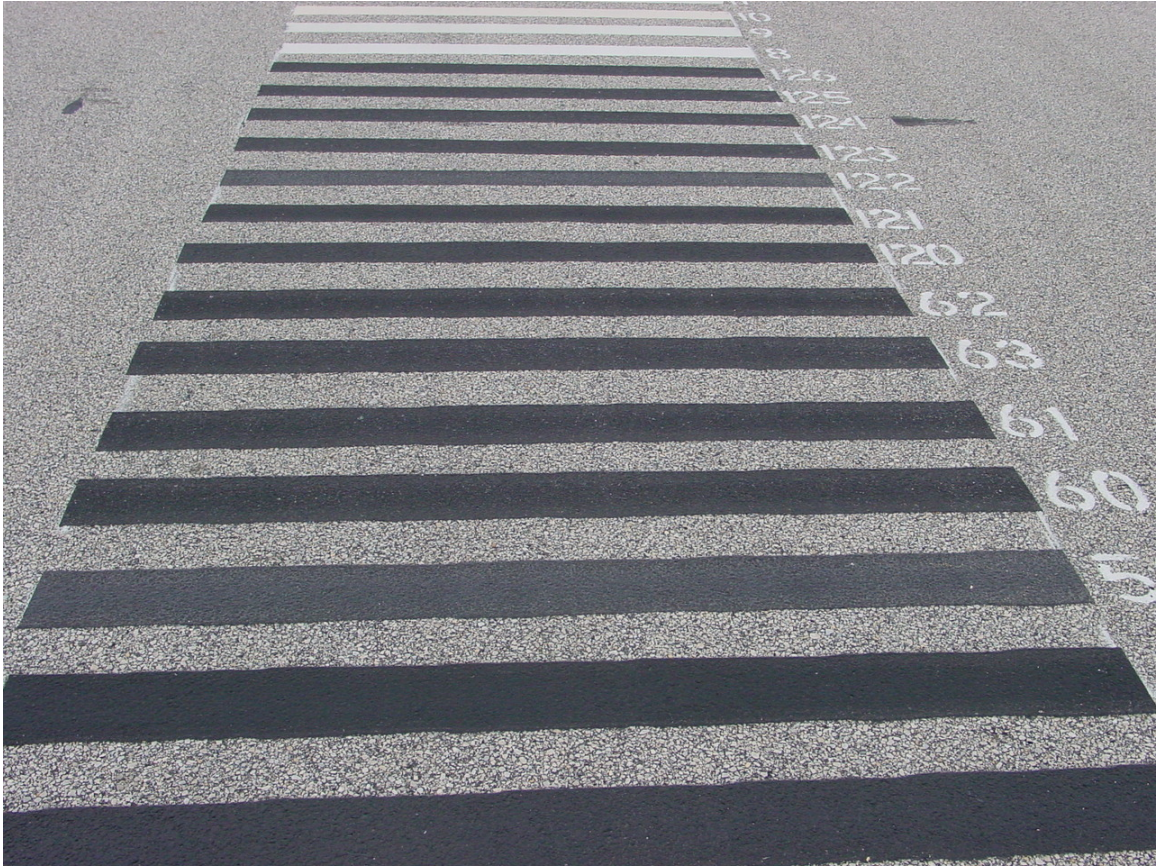
Black paint with beads was applied to simulate accidental application of beads. It was evaluated by painting black markings with and without beads to determine the effects. Figure 4 shows black paint with beads.

FIGURE 4. BLACK PAINT WITH BEADS

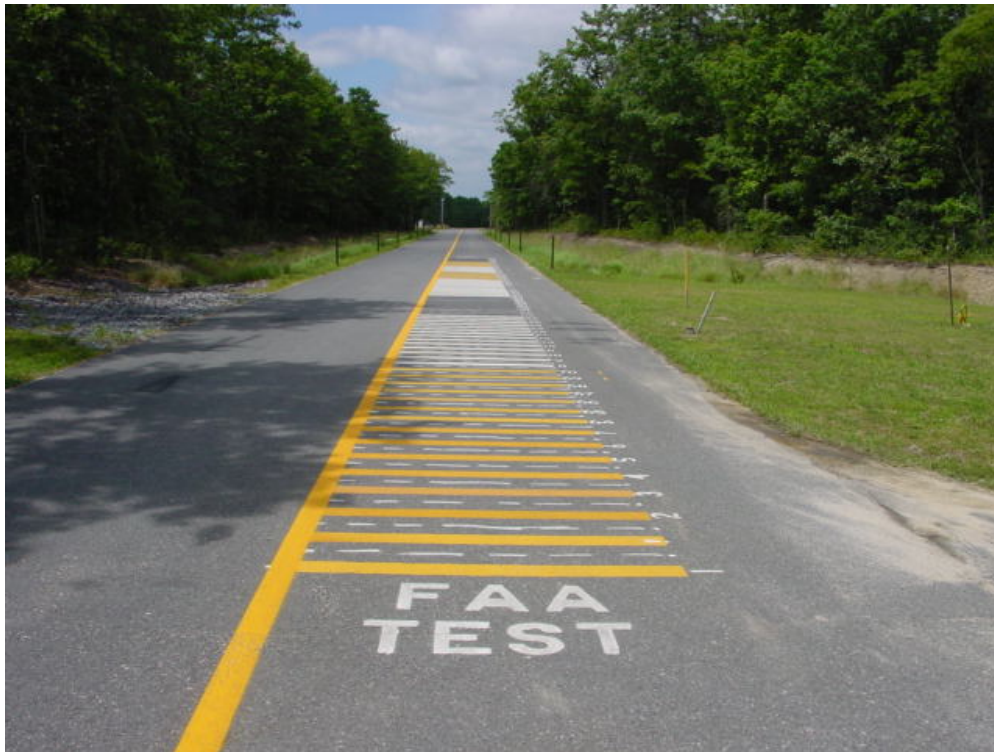
FIGURE 5. LINES AT NEWER HOT-MIX ASPHALT TEST SITE
(Pavement Placed 1999)

The project team took readings with a retro-reflectometer and spectrophotometer every month at the three test marking locations. At the newer hot-mix asphalt test site (pavement placed 1999) located adjacent to building 296 along Pangborn Road, six readings were taken on each line at the beginning, middle, and end of the line and then in the opposite direction at the beginning, middle, and end of the line. Prior to September 11, 2001, the readings at taxiways Hotel and Delta were handled in the same manner. Post September 11, 2001, one reading per line was allowed due to heightened security at the airport. Figures 5, 6, and 7 show the lines at the newer hot-mix asphalt test site, taxiway Hotel, and taxiway Delta.

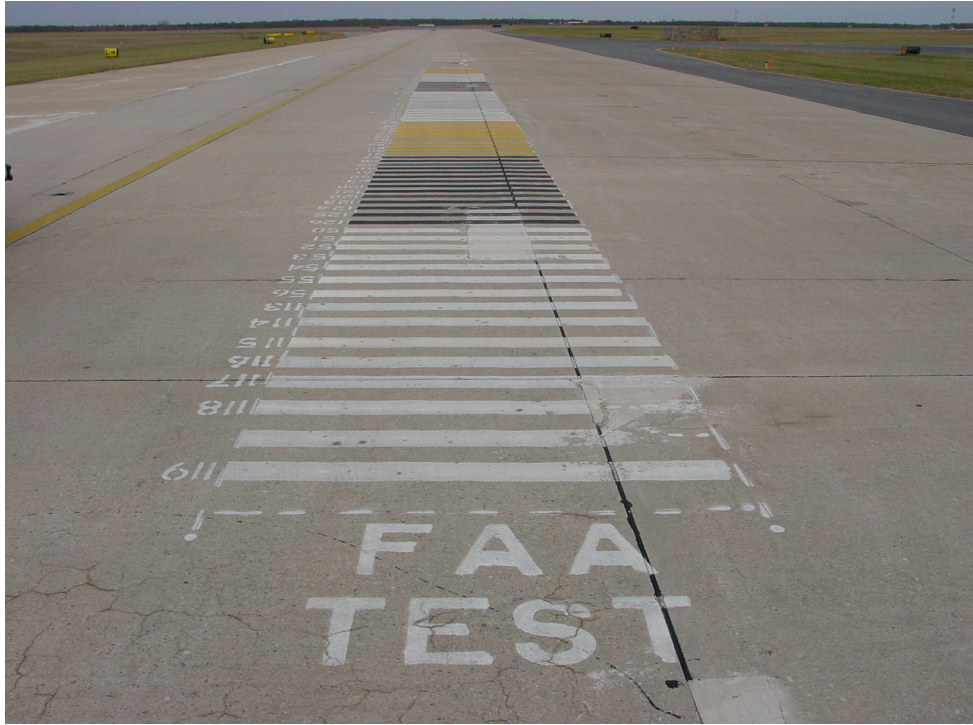
FIGURE 6. LINES AT TAXIWAY HOTEL ON PORTLAND CEMENT CONCRETE

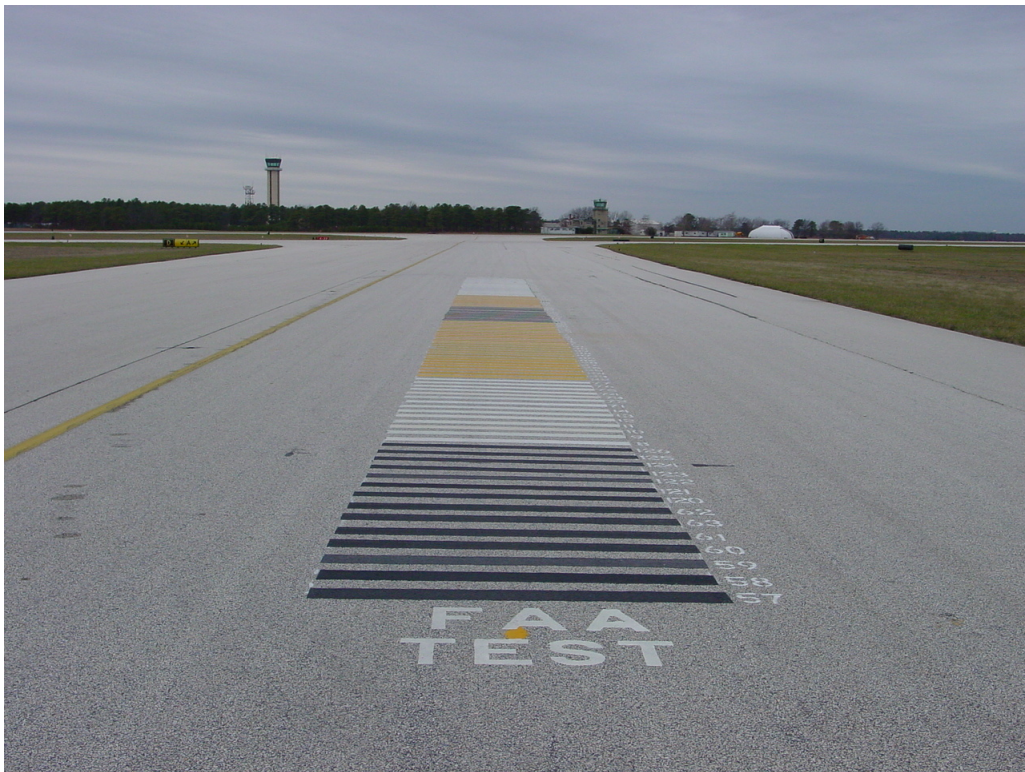
FIGURE 7. LINES AT TAXIWAY DELTA ON OLD HOT-MIX ASPHALT

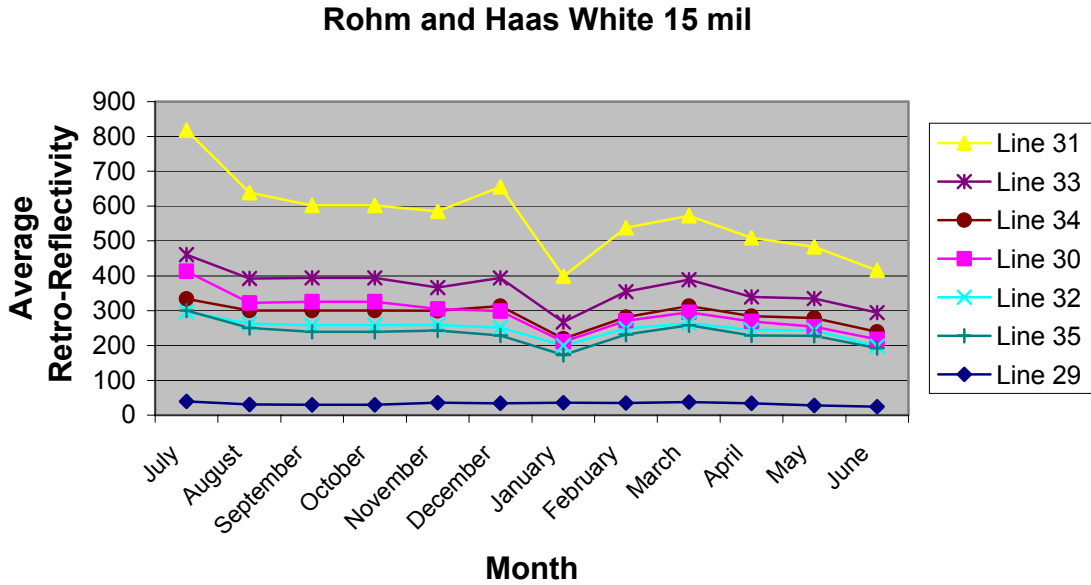
The paint applied at 15 mil (see figure 8) has higher retro-reflectivity than the 7.5 mil by approximately 100 mcd/m²/lx (Lines 30, 31, 32, 33, 34, and 35). It was found that paint at 15-mil wet film thickness provides the highest retro-reflectivity for each type of bead.

FIGURE 8. APPLICATION OF 15-mil WET FILM THICKNESS

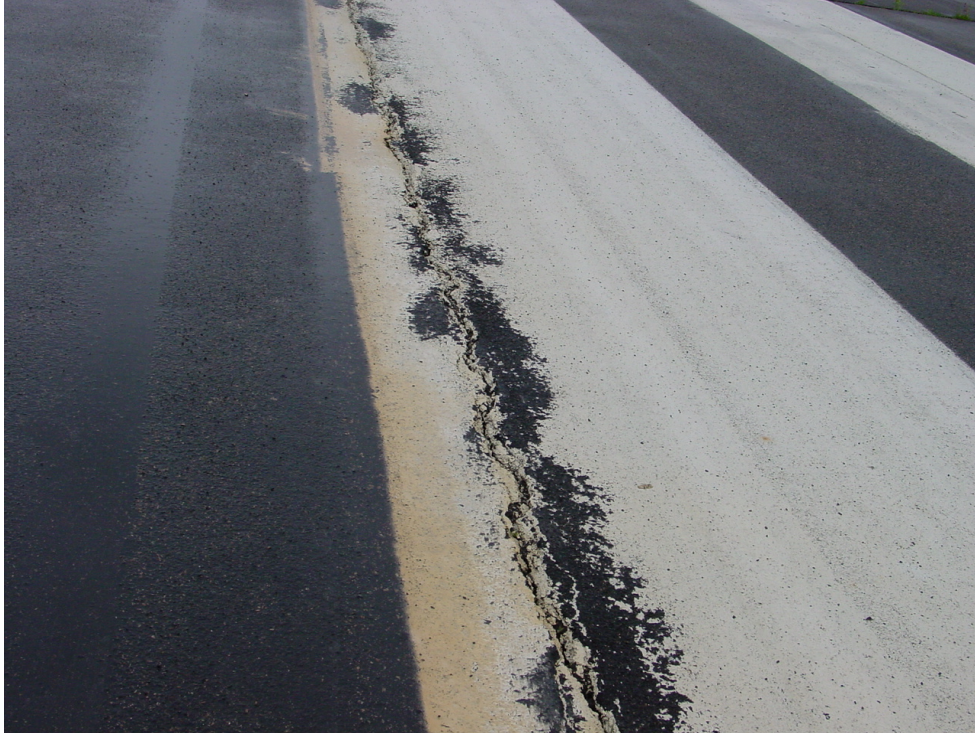
The discoloration of the paint due to oil from the asphalt washing over the surface and acid rain was observed at New Bedford Airport in New Bedford, Massachusetts; Worcester Airport in Worcester, Massachusetts; and Lawrence Airport in Lawrence, Massachusetts (see figure 10). At all three locations, the white paint was turning yellow. The paint was also coming up in big sheets because there were at least eight layers of paint already applied at the time of repainting.

FIGURE 10. YELLOWING OF THE WHITE PAINT AT NEW BEDFORD AIRPORT, NEW BEDFORD, MASSACHUSETTS

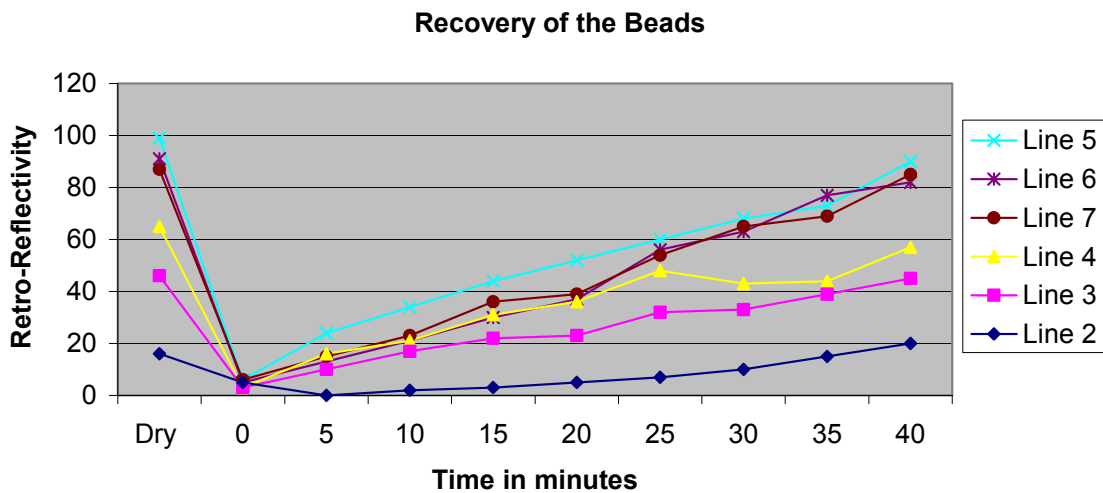
A 2-liter, ASTM-E-2177 water test was performed on the lines to determine whether the new Visibead and Megalux beads reflect better than the highway and airport beads in wet-weather conditions. The wet retro-reflectivity readings were documented, analyzed, and graphed (see figures 11 and 12).

FIGURE 11. ASTM-E-2177/01 WATER TEST (Lines 2 through 7)

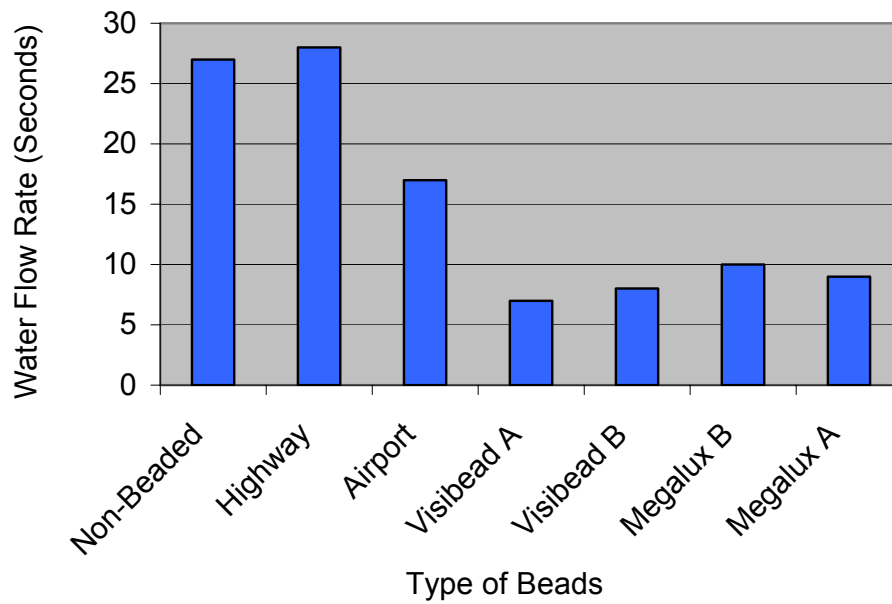
FIGURE A-10. AVERAGE WATER FLOW METER TEST

The Skidabrader Outflow meter tests have been performed on all of the lines at the newer hot-mix asphalt test site (see appendix A, figure A-10). The Outflow meter tests were taken for each line to see how fast the water sheets off the paint lines with beads. A 2-liter water test (ASTM-E-2177) was performed on the lines to determine whether the new Visibead and Megalux beads reflect better than the highway and airport beads in wet-weather conditions. The two graphs show that the greater the slope of the line, the faster the retro-reflectivity recovers. Since ASTM-E-2177 was not approved until February 2002, the test was not performed until July 2002. Also, Dyna-meter test plugs were performed before the end of testing. This test determined whether there is an internal failure, which is cohesive, or an external failure, which is adhesive. With a cohesive failure, the paint fails; with an adhesive failure, the asphalt or concrete fails. The Dyna-meter provides a tensile strength reading at failure when a test plug is pulled from the asphalt. The test was performed to determine if the paint is stronger than the asphalt (see appendix A, figure A-11).
