IV - WATERSHED CHARACTERISTICS

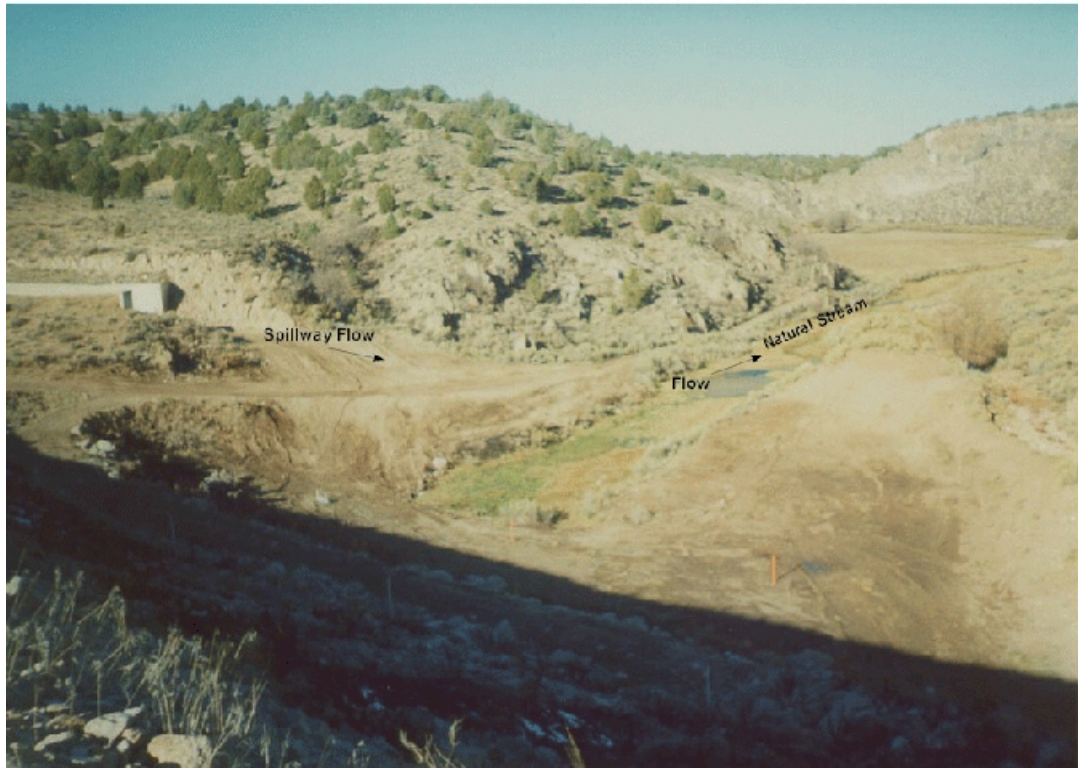
Photo 4-1. Looking downstream below spillway

4-09 Channel and Floodway Characteristics. Discharge from the outlet works enters a short open channel that leads to the natural streambed of Mathews Canyon. Discharge from the spillway enters the natural stream about 200 feet below the toe of the dam. This is shown on Photo 4-1. The spillway discharge curve is shown on Plate 4-07. There exists a continuous stage-recording gage downstream from the dam which is housed in a corrugated metal pipe. The discharge rating curve for stream flow at this station is shown on Plate 4-08.
