## Dollars Well Spent

The dust has settled for now at the John Muir National Historic Site. However, if you had driven by the Martinez, California site last fall, you would have noticed scaffolding around the historic home.

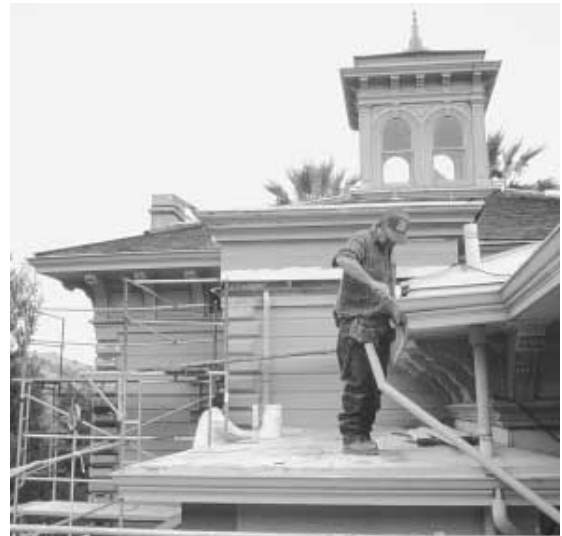
*Bernie George, Historic Preservation Training Center, repairing rain gutters. Randy Mitchell, John Muir NHS, is in the back. Photo courtesy the author.*

Present-day technologies were called upon frequently. About half of the weathered window sills and rotted soffits have been cleaned and then patched with a space-age epoxy-filler compound. Silvery-white fiberglass fabric impregnated with a resin slurry now serves as a durable and nearly invisible patch across leaking redwood rain gutter joints. And then there were the “cut nails.”
