# **Ice Jam Flood Assessment for the St. John River Basin, Aroostook County, Maine**

# Special Report 95-15

Cold Regions Research &  
Engineering Laboratory

Prepared for  
U.S ARMY ENGINEER DIVISION, NEW ENGLAND

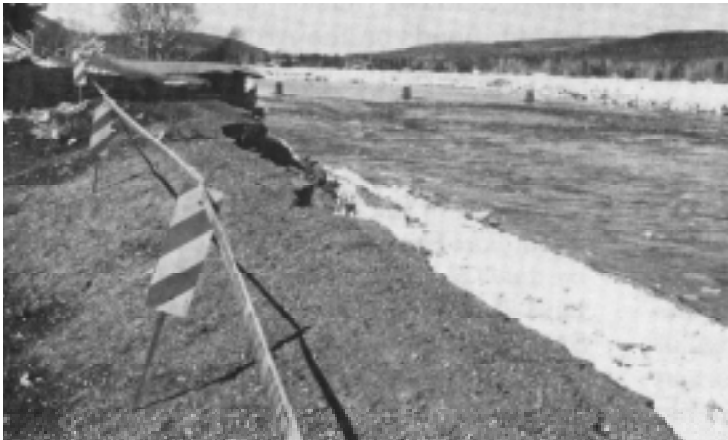
*a. Bridge and road section destroyed.*

**Figure 1. Ice jam damage in the town of Allagash, Maine, April 1991.**

(1973–1992) (Table 1). Most recently, in the spring of 1991, devastating ice jam floods on the St. John River caused damage estimated at \$14,000,000. On 9 and 10 April 1991, the two bridges in the village of Dickey, located in the town of Allagash, 1000 ft of state highway and 11 houses were destroyed (Fig. 1) and an additional 22 houses were damaged. On 13–14 April, ice jam floods on the Aroostook River caused damage to shoreline, roads, 16 houses in the town of Fort Fairfield and properties in the village of Crouseville located in the town of Washburn.

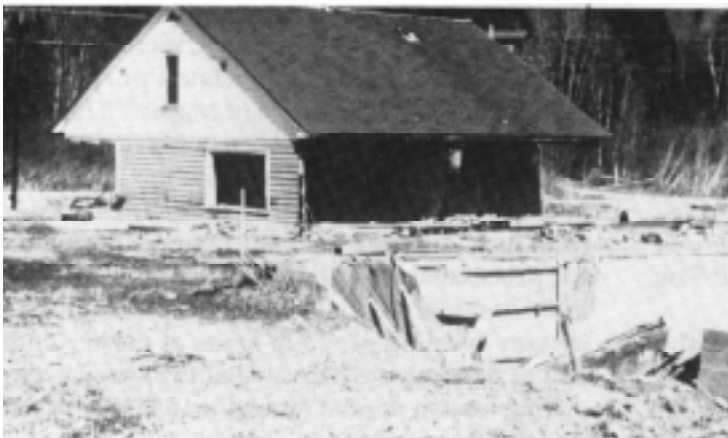
*b. Private home moved from foundation.*

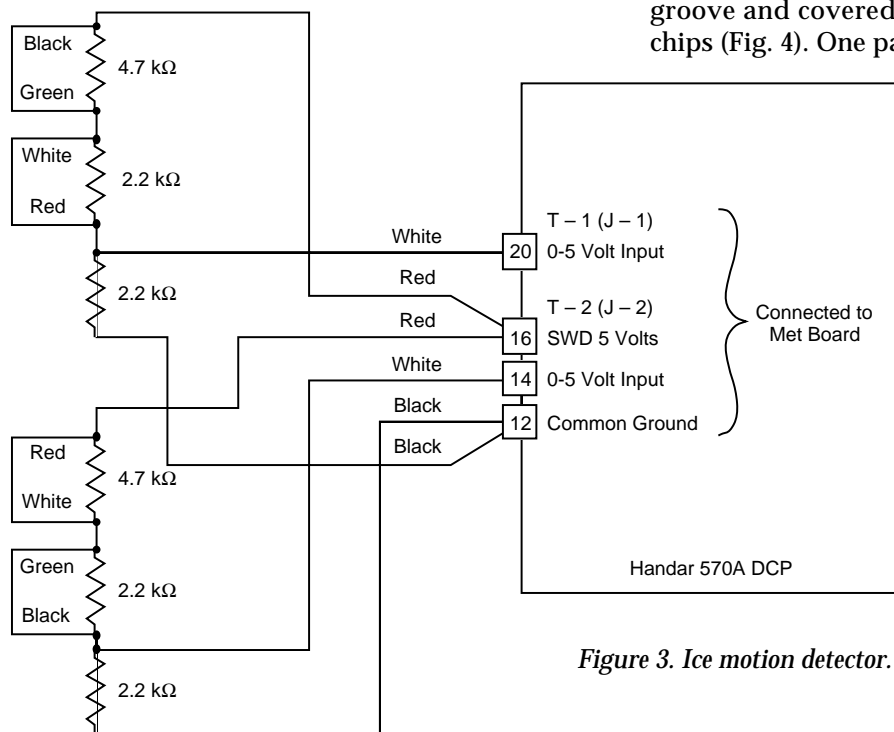
Figure 3. Ice motion detector.

bridge on the upper St. John River. Each sensor consisted of two pairs of electrical wires. Each pair, of different length, is joined at one end by a waterproof connection and at the other end is connected to a series of resistors, which in turn are connected to the USGS Nine Mile stream gaging station’s Data Collection Platform (DCP). An electrical diagram for the system is shown in Figure 3. The voltage measured by the DCP determines if both pairs of wires are intact, if one or the other pair has broken, or if both pairs have broken.

the other 175 ft. This difference in length was introduced to account for the possibility that the ice may not break up simultaneously across the whole river width. We also felt that two pairs of wires per detector would improve their reliability, since there is always the possibility that one pair may be damaged by chafing of the protective insulation because of minor ice motion, or other causes.

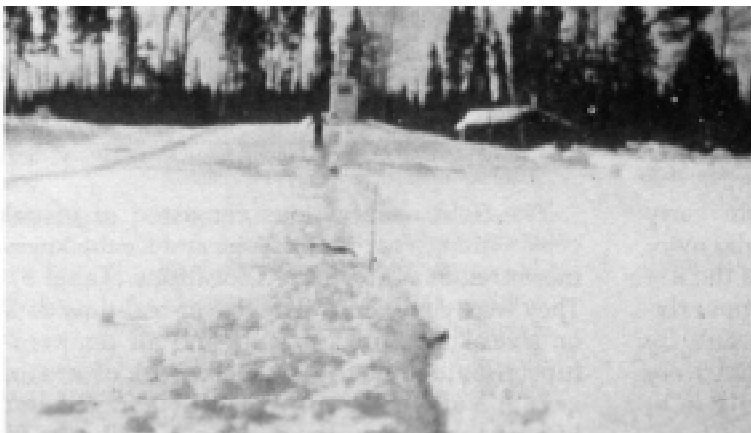
A 4- to 6-in. deep groove was cut into the ice cover from the bank perpendicular to the river flow. Both pairs of wires were laid into the groove and covered with packed snow and ice chips (Fig. 4). One pair extended 100 ft outward,

Figure 4. Installation of ice motion detector at Nine Mile, St. John River, Maine.

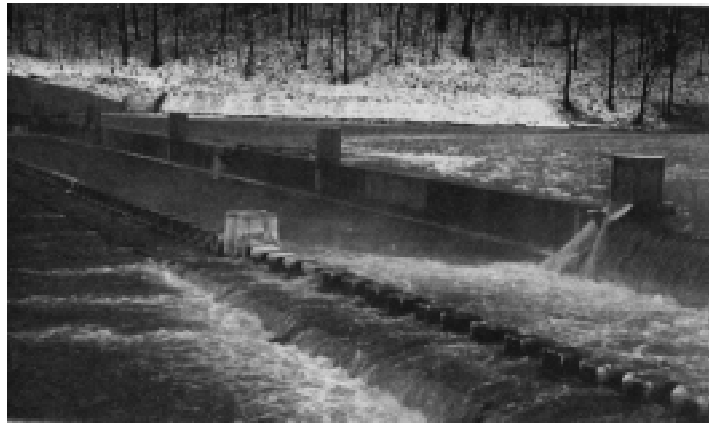
Figure 6. Examples of weirs or small dams.

Approximately 6 to 8 ft high, weirs either stabilize a naturally forming ice sheet or create a low velocity pool where an ice sheet will form. They also provide a local storage area to temporarily hold incoming brash ice during an upstream breakup. They can be equipped with ice-holding piers to enhance their ice-holding capacity, and with bascule gates to allow recreational navigation during the ice free seasons. Examples are the ICS on the Oil Creek, near Oil City, Pennsylvania, and a proposed ICS for Cazenovia Creek, near Buffalo, New York (Fig. 6).

a. General plan of Oil Creek ICS, Pennsylvania.

b. Oil Creek ICS in operation.

c. Concept of Cazenovia Creek ICS.

d. Hydraulic model of Cazenovia Creek ICS.

around an existing ice jam site, thereby reducing the water level behind the jam and consequent flooding. It, therefore, also reduces the water pressure head exerted on the jam, and delays jam failure. A bypass channel can be used alone, as was proposed at Port Jervis, New York, or in conjunction with an ice control structure (e.g., Cazenovia Creek structure, Fig. 6c and d).

2. Ice control structures downstream of the Priestly bridge. Either a 6- to 8-ft high weir similar to the Oil Creek or Cazenovia Creek ICS, or a series of rock-filled cribs connected by modified ice booms could be built. It is estimated that such an ICS would alleviate all ice damage from the 500-year event at all locations downstream from the structure.

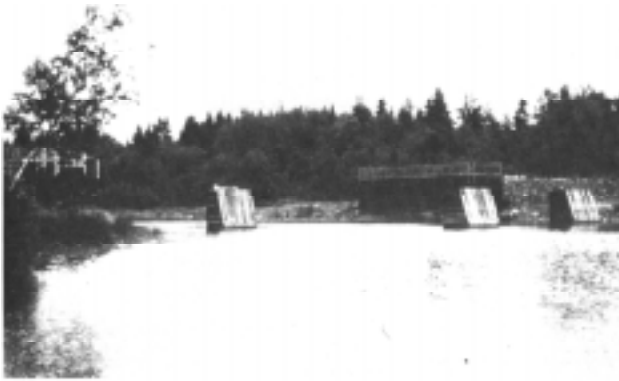
Figure 7. Example of rock-filled crib, Cherryfield, Maine.

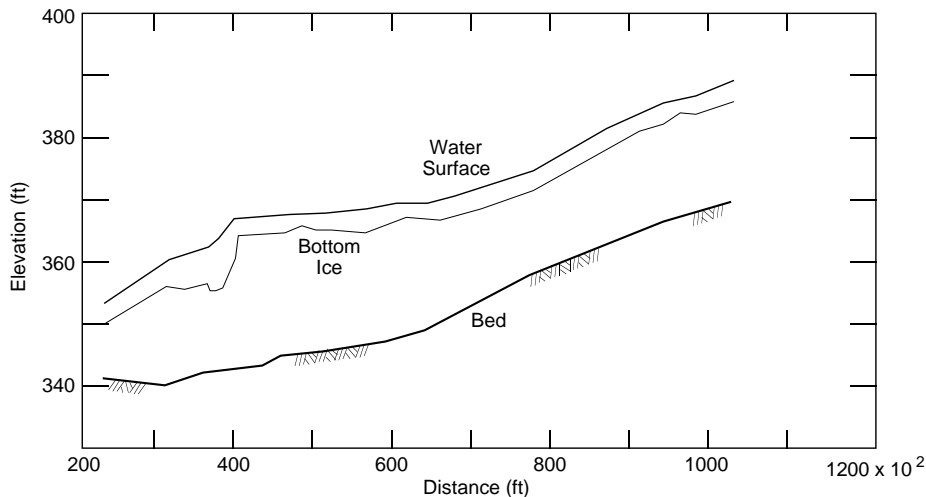
Figure 11. Water surface profile for an equilibrium ice jam on the Aroostook River between Fort Fairfield and Caribou dam.

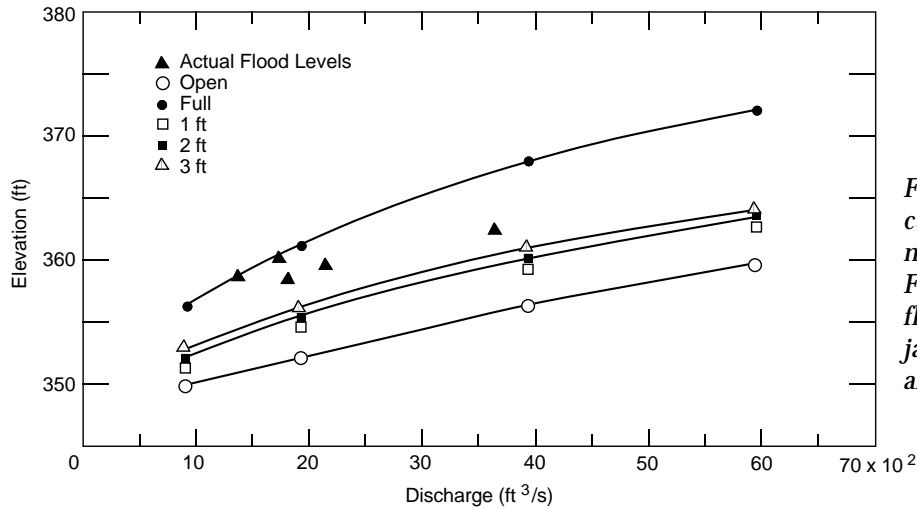
Figure 12 shows an ice-affected rating curve

Figure 12. Ice-affected rating curves of the Aroostook River, near Limestone Road bridge, Fort Fairfield. Shown are the flood levels reached during ice jams in 1932, 1936, 1940, 1973 and 1976.

developed for river station 402+84, which corresponds to the Limestone Road bridge. The curves represent open water, ice-covered and ice-jammed conditions in order of increasing stage. The figure shows the calculated ice-affected water levels for discharges up to a 25-year open water flood (60,000 ft<sup>3</sup>/s). It is unlikely, however, that an ice cover would remain intact for discharges much greater than 10,000 ft<sup>3</sup>/s or that a jam would remain stable for discharges as large as a 5-year open water flood (43,000 ft<sup>3</sup>/s). For the major ice-related floods reviewed in Table 3, peak stages for all but one were reached at discharges of no more than 23,000 ft<sup>3</sup>/s. The remaining flood, in 1976, had a discharge on the order of 37,000 ft<sup>3</sup>/s. A 2-year flood is on the order of 31,000 ft<sup>3</sup>/s. Prior to reaching a 5-year recurrence interval discharge, it is likely that any ice jam would release, and water levels would return to open water levels. Thus, the true rating curve would likely follow the curve for an ice cover of appropriate thickness up to a discharge

of 10,000 to 15,000 ft<sup>3</sup>/s, and would then increase to levels no greater than the equilibrium jam curve (depending on ice conditions and supply).

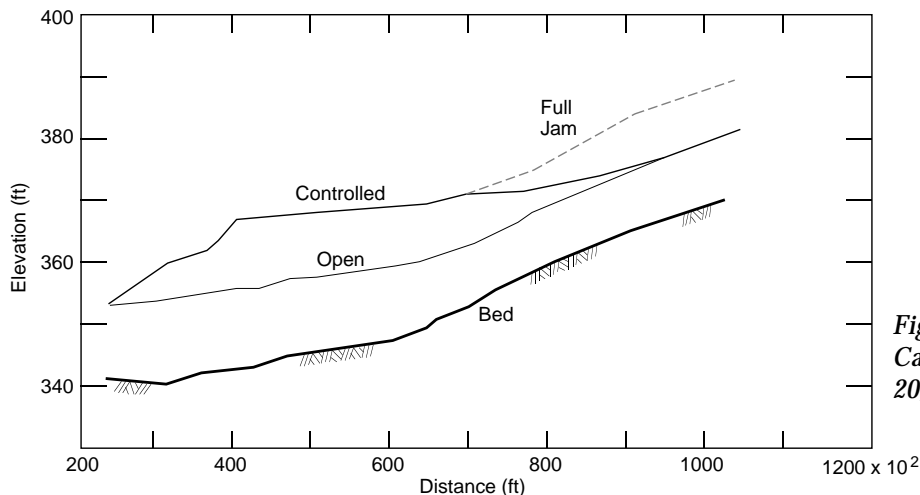
Figure 13. Possible effect of the Caribou dam as an ICS ( $Q = 20,000 \text{ ft}^3/\text{s}$ ;  $h_i = 28 \text{ in.}$ ).

would be limited to that ice present in the river between Fort Fairfield and the dam. The HEC-2 program with ice option was run for this case, for the same discharge of 20,000 ft<sup>3</sup>/s and with the additional assumption, supported by the field measurements and the calculations in Table 2, that the ice thickness averaged 28 in. The results of the computations are presented in Figure 13. With ice supply limited by the dam, we found that the jam should extend up to station 680, approximately, and that the jam backwater should merge with the open water surface profile at about station 950. Therefore, improvements to the dam to ensure that it acts as an ice-control structure would not be sufficient to alleviate ice jam flooding at Fort Fairfield. Additional mitigation means, upstream of Fort Fairfield and below the dam, would be required.

We again emphasize that in developing Figures 13 through 16 we assumed that the jams would be fully developed, a conservative assumption, and that ice volumes would correspond to a before-breakup ice cover thickness of 28 in. Depending on the actual thickness of ice formed in a given year and, especially, the extent of ice decay before breakup, the actual ice volumes, ice jam length and resulting water levels may be less.

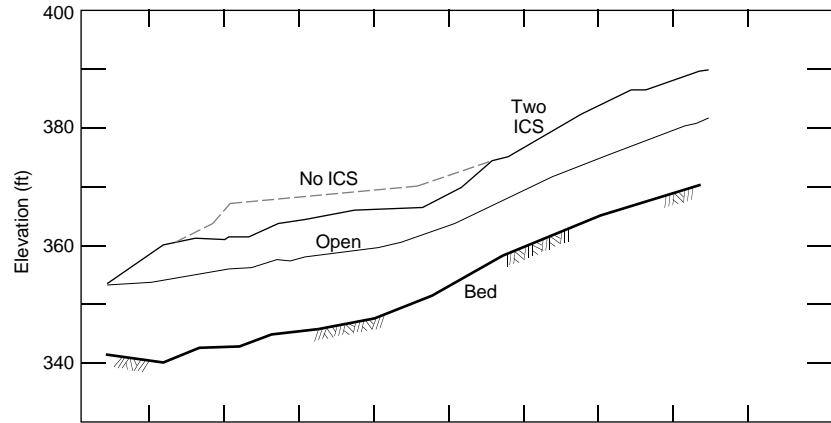
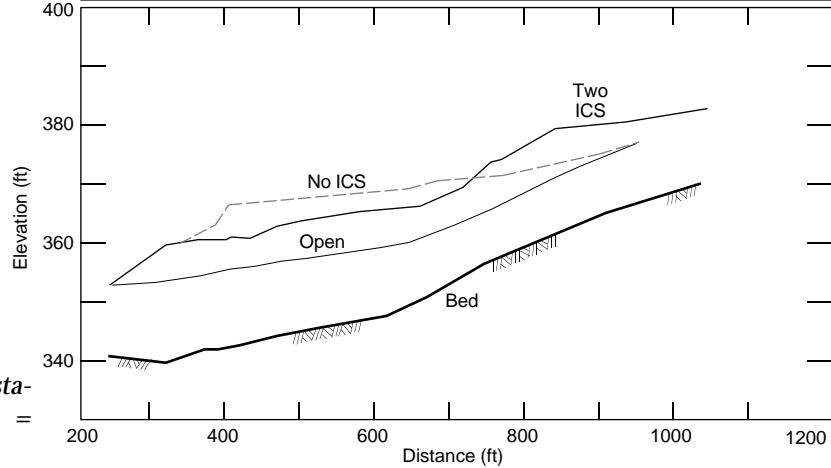
a. Unlimited ice supply.

b. Ice supply limited by Caribou dam ( $h_j = 28$  in.).

Figure 16. Effects of ICSs at both station 423 and Haley Island ( $Q = 20,000 \text{ ft}^3/\text{s}$ ).
