## Assessment of the Effectiveness of the Israel River Ice Control Structure, Lancaster, NH

Carrie M. Vuyovich and Kathleen D. White

January 2006

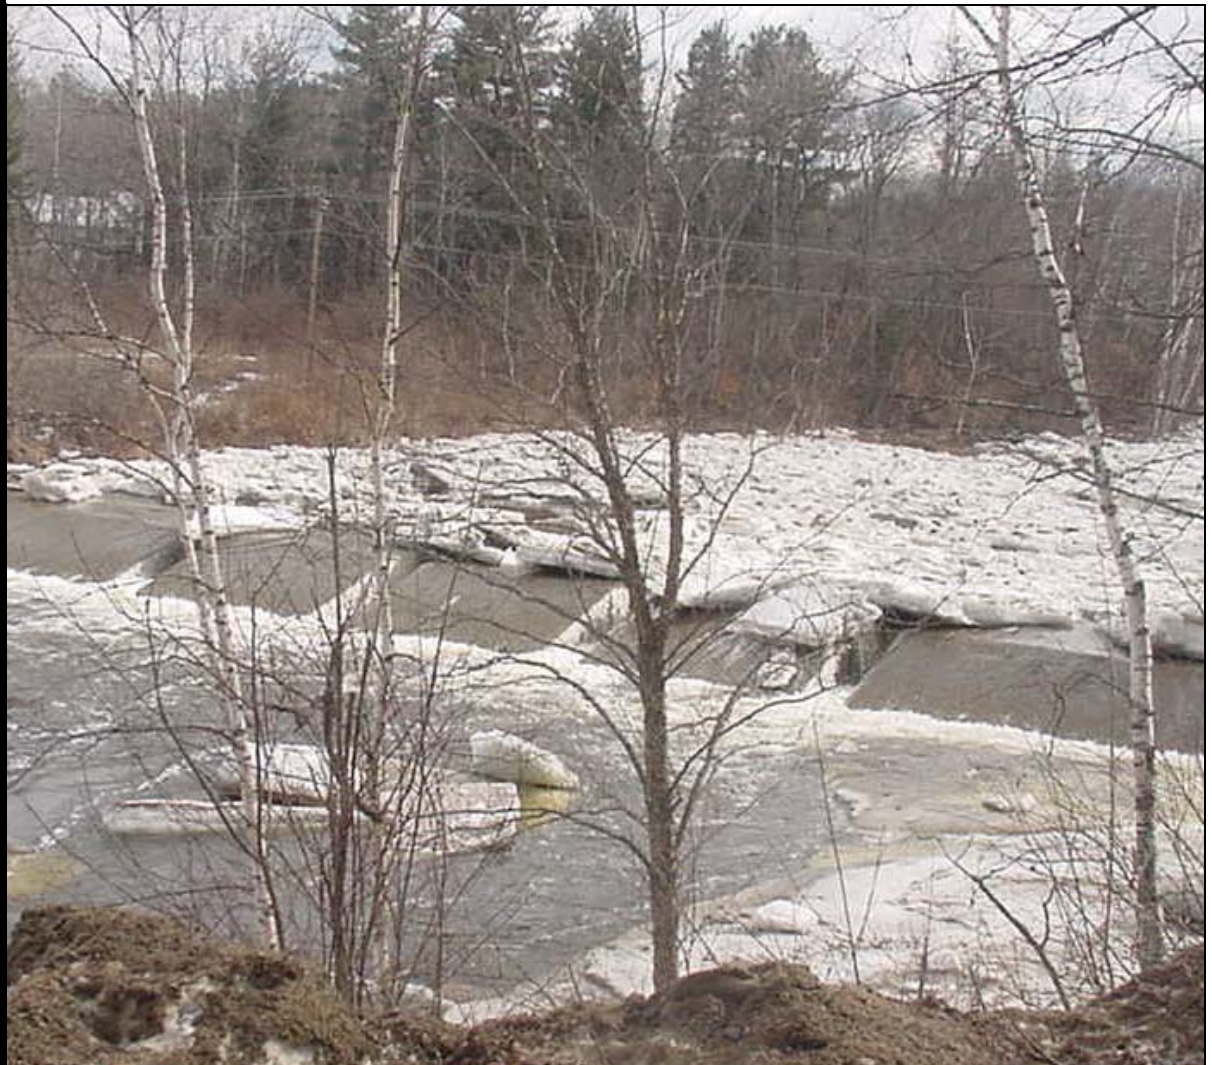
Cover: Ice cover retained upstream of the ICS during the 24 March 2003 ice event.

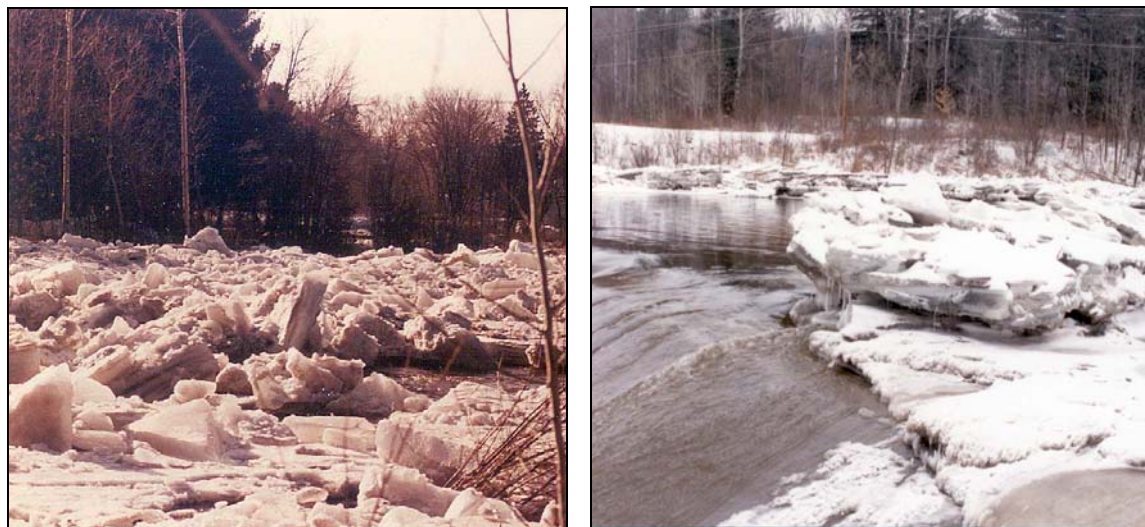
**a. Ice jam in the ICS pool, February 1985.**

**b. Ice above the weir, March 12, 1992.**

**Figure 3. Ice retention upstream from the ICS during ice jams.**

large enough to break up the ice and lift it over the ICS. Figure 3 shows the February 1985 and March 1992 jamming upstream from the ICS.

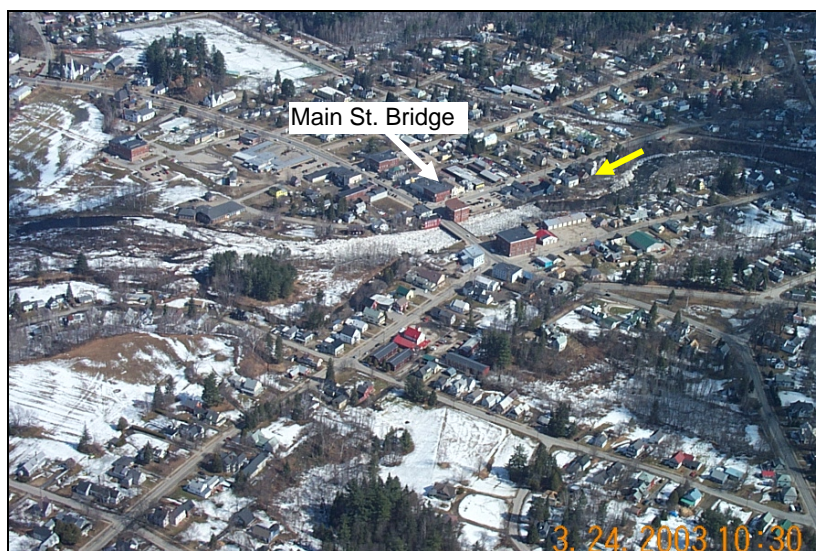
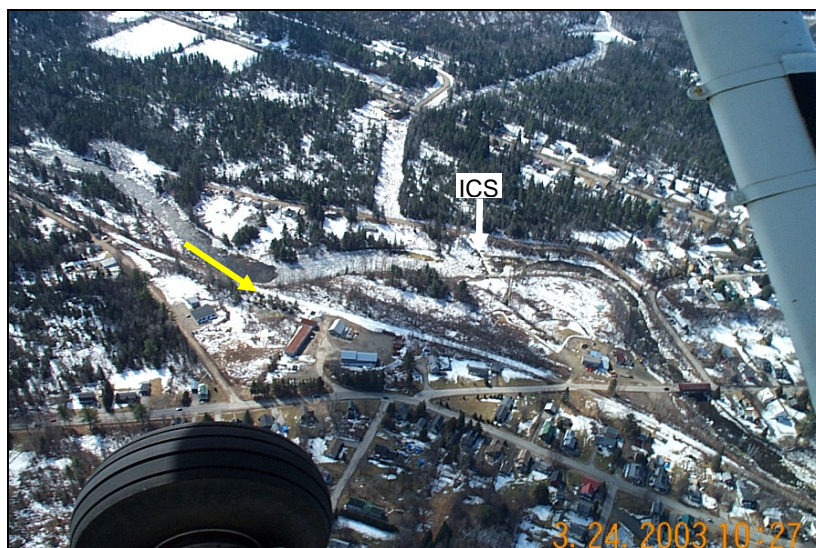
a. Ice jam in town.

b. Ice held above the ice control structure.

**Figure 6. Aerial photos of the 24 March 2003 ice event. The yellow arrows indicate the flow direction.**

The key to ice control in the Israel River is to retain the ice cover on the ICS pool or to otherwise delay the movement of ice from upstream until the discharge has reached the point where the jam downstream in Lancaster fails due to ice forces, deterioration of ice strength caused by increased flow, or some combination of the two. In several events the ice cover is known to have remained above the ICS until the jam in town failed, including during 2003, when the pictures on the cover of this report and in Figure 6 were taken. Anecdotal reports of the

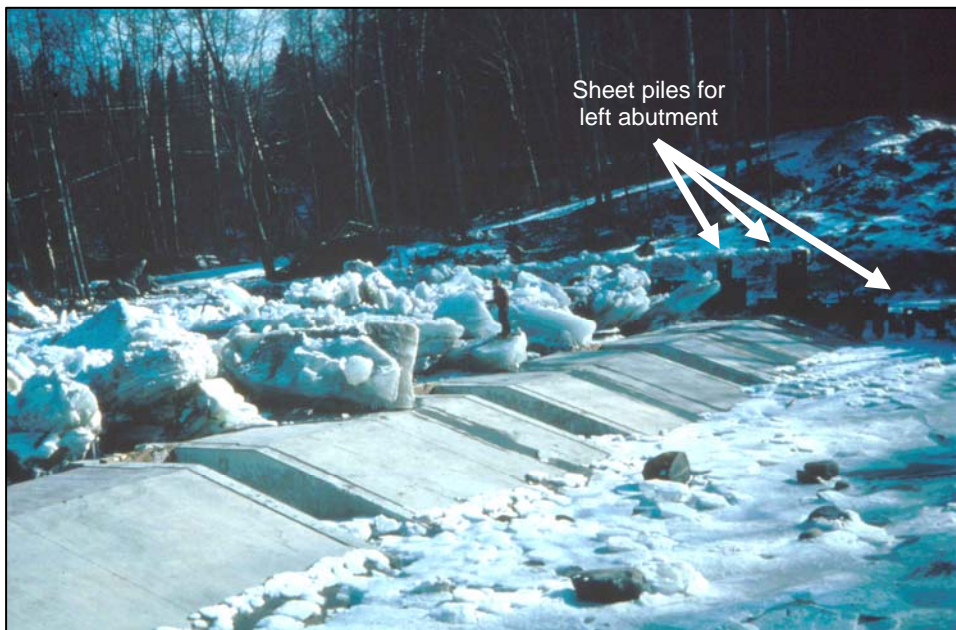
**Figure 10. Ice retention upstream from the ICS during construction, winter 1980-81.**

During this period, which spans 1981 through 1990, Table 3 predicts three severe ice jams: in 1981, 1989, and 1990. In 1981, significant amounts of ice were retained upstream from the ICS (Fig. 10). As noted previously, field notes report significant volumes of jammed ice in the river extending as far up as the covered bridge. At the same time, the ICS retained ice from upstream. If this ice had not been retained, it would have pushed downstream and added to the volume of ice already jammed, thickening the jam, possibly to similar proportions as in 1968, 1950, and 1970. Ice was reported jammed up to the covered bridge in the 1989 event, and that upstream ice was held above the ICS. In 1990

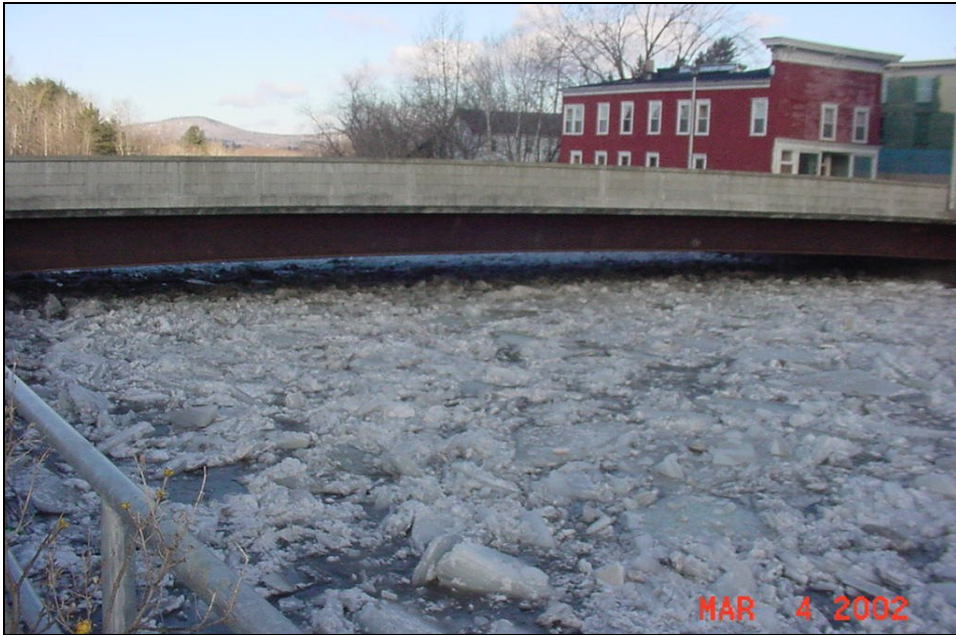
**Figure 11. Ice jam of 4 March 2002 (looking downstream toward the Main Street Bridge).**

Two jams were identified as being potentially severe after the ICS was in place, but were not. In 2002, an ice jam occurred on 4 March, about a week before the predicted jam shown in Table 3. Ice was retained above the ICS. That year, the ice was thought to be weaker and thinner than predicted by the Stefan equation because of a melt event recorded on 12 February. This allowed breakup to occur at a lower discharge than normal, and, while causing a relatively high stage (Fig. 11), the jam remained in place only for a matter of hours. Thus, the larger flow identified in Table 3 occurred during open-water conditions on the Israel River in Lancaster. In the spring of 2004, a smaller jam was recorded by the monitoring equipment on 27 March, about a week prior to the event predicted by the threshold criteria. The jam caused a stage increase of about 4 ft at the measuring site, and it remained in place until 30 March, with a little shove on 29 March.

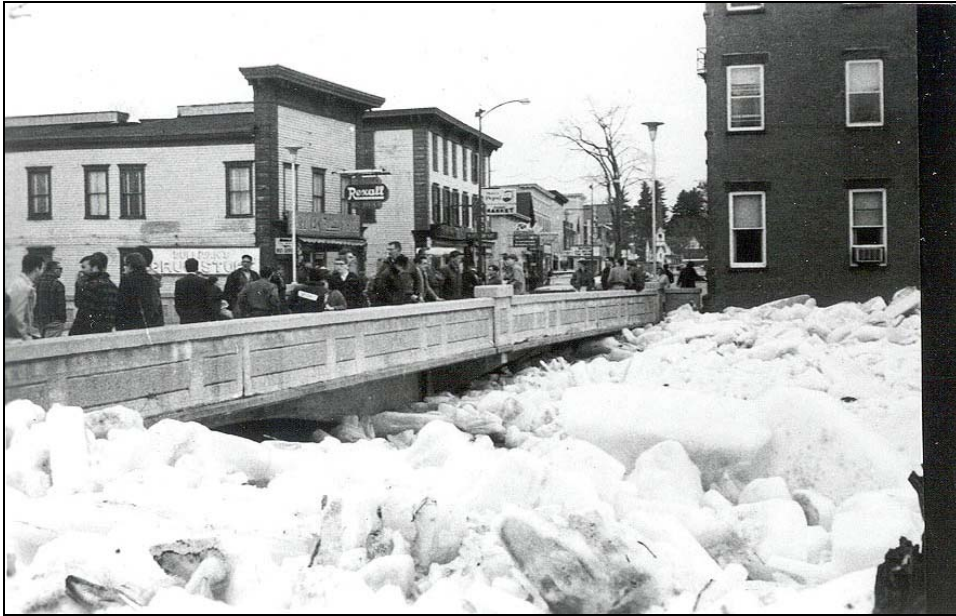
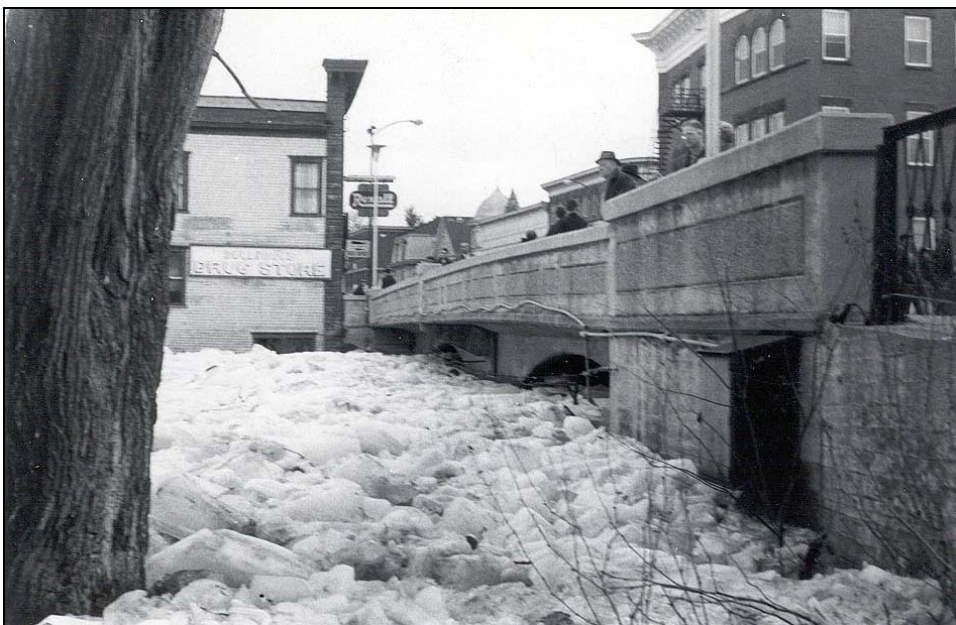
**a. Upstream face.**

**b. Downstream face.**

**Figure 13. The Main Street Bridge during the March 1968 ice jam.**

The current Main Street Bridge in Lancaster is the latest in a series of bridges in about the same location. All of the bridges impact conveyance in some manner or another as the jamming ice fills the bridge openings. As noted earlier, two previous bridges at the same location—a covered bridge in 1886 and an iron bridge in 1895—were destroyed by ice events (W.A. Fergusson and Co. 1888). As ice jams progressed up through the double-arch Main Street Bridge, they often reached nearly to the top of the arches. Figure 13, taken during the March 1968 ice event, shows that ice was within a foot or so of the top of the arch on the

downstream side of the bridge and was piling up against the upstream side of the bridge. The same process occurs with the single-span bridge, and similar pileups occur at the upstream face of this bridge (e.g., Fig. 14 and 15). Local residents reported standing on the bridge and reaching out to touch the ice (even with the handrail) on the upstream side of the bridge.

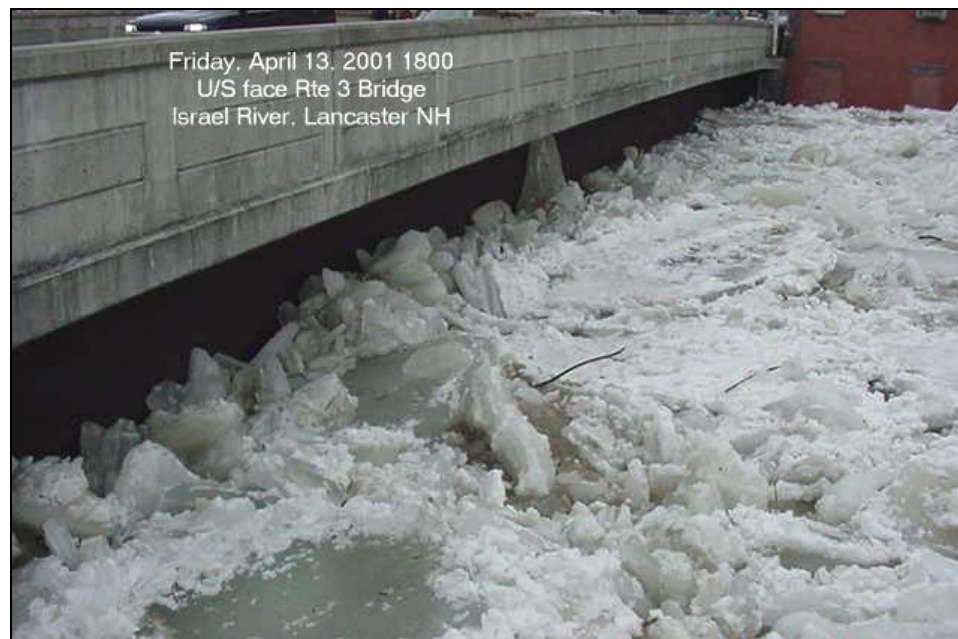
**Figure 14. Ice building up on the upstream face of the single-span Main Street Bridge in April 2001. (From USA CRREL Ice Jam Database.)**

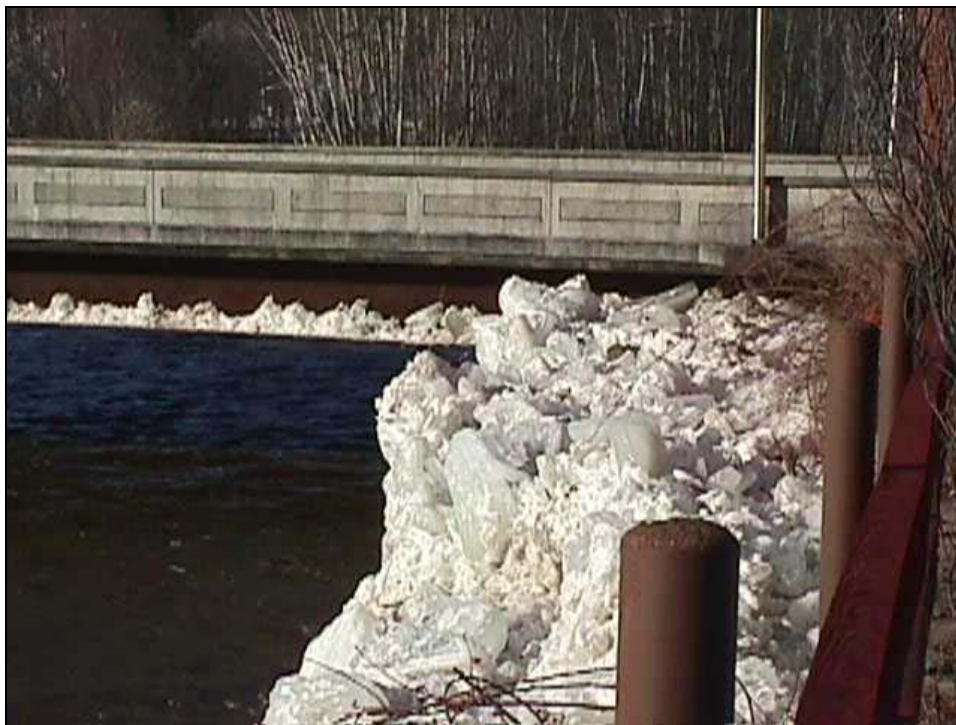
**Figure 15. Upstream view of the Main Street Bridge after the ice jam of January 1999. (Photo courtesy of Greatnorthwoods.org, <http://www.greatnorthwoods.org/lancaster/icejam19990124/1/>.)**
