Reevaluating Success

The First Bank of the United States

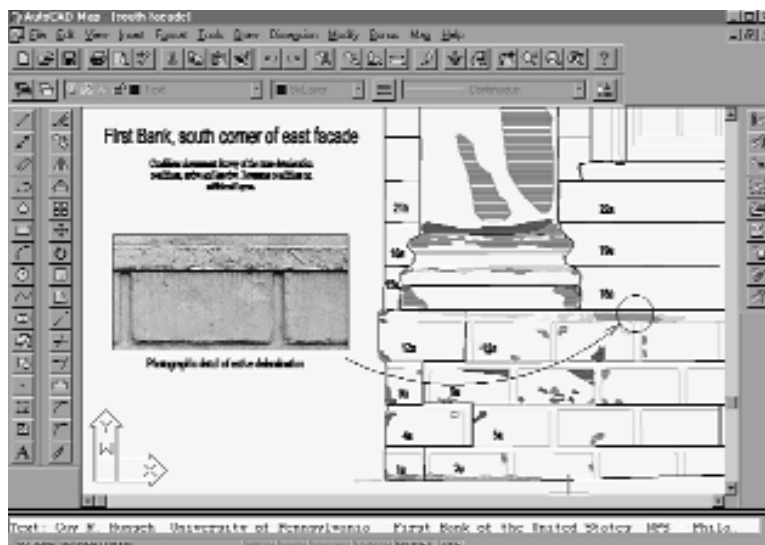
By combining the rendering capabilities of an architectural CAD program with GIS database analysis and photographic images, the digitized survey can be interpreted visually and quantitatively. Screen capture by the author.

Two key areas in the study of the First Bank have benefited from these technologies. First is the execution of a complete Conditions Assessment Survey of the façade to document the stone's condition and treatments at a given point in time and to allow precise monitoring of critical areas. Scaled, rectified 35mm photographs were taken of all surfaces of the façade, portico, and columns. Deterioration conditions for the marble and for the treatments in evidence were defined and recorded with a predetermined graphic lexicon of lines, symbols, and colors. This information was then transferred into a computer rendering program (AutoCAD® Release 14); the conditions were separated on different layers for the purpose of adapting the final drawings for specific analytical questions. Recently, GIS applications (AutoCAD® Map Release 2) have been tested which allow each stone or architectural element to be assigned to a database table enabling the researcher to query specific deterioration condition relationships while re-imaging the drawing.
