# OPERATING EXPERIENCE SUMMARY

U.S. Department of Energy  
Office of Health, Safety and Security  
OE Summary 2008-10  
November 10, 2008

## Three Recent Events Involved Failed Rigging and Lifting Hardware

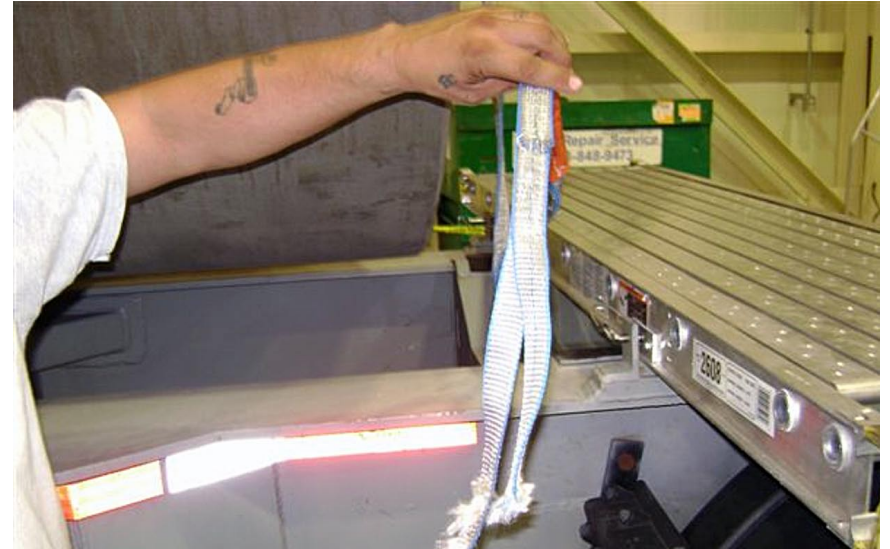
On September 24, 2008, at the Waste Isolation Pilot Plant, an overloaded synthetic sling failed (Figure 1-1) and struck a waste handling technician across the hand, forearm, and chest. The technician received a minor injury (redness of the skin). (ORPS Report EM-CAFO--WTS-WIPP-2008-0012)

**Figure 1-1. Worker holding failed synthetic sling**

Initial investigation revealed that this event could have been attributed to inattention to detail by the crane operator, an improperly positioned load cell, or the lack of sufficient engineered barriers. The exact causes will not be known until the Root Cause Analysis has been completed.

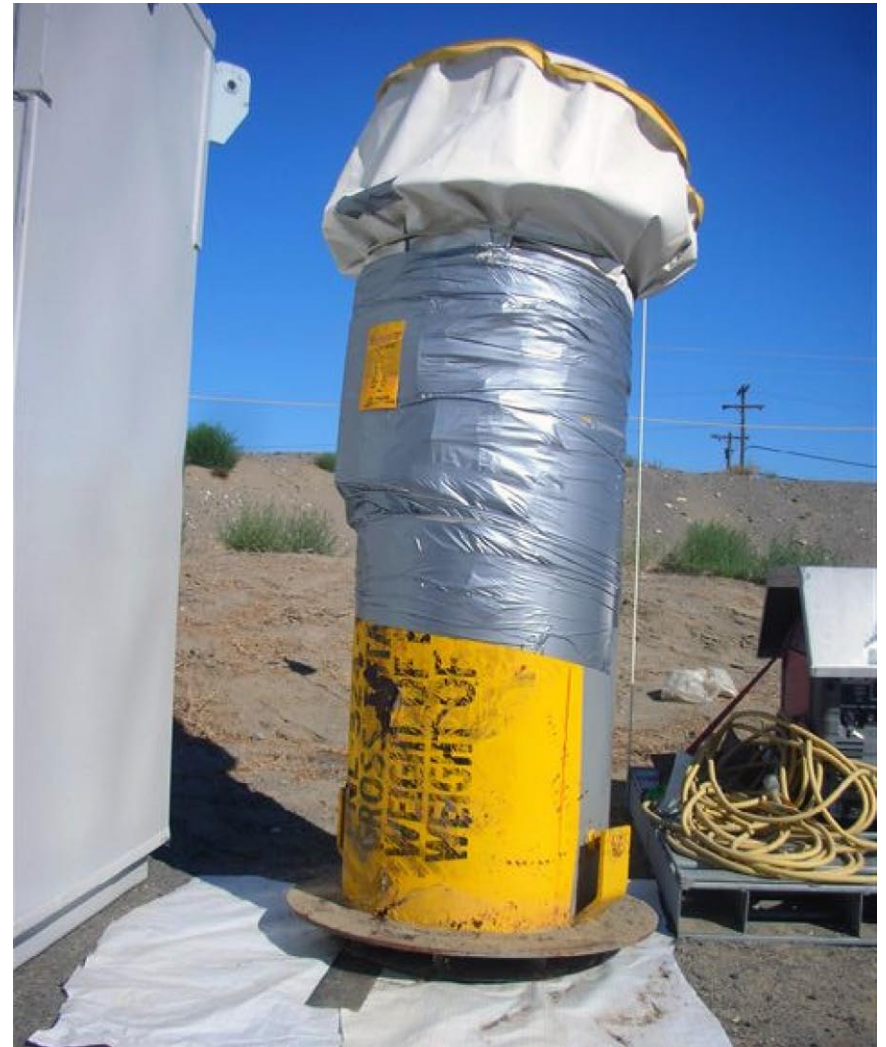
On September 15, 2008, at the Hanford Solid Waste Facility, a crane was lifting a retrieved waste cask when the slings used to rig the cask to the crane broke. The waste cask dropped approximately 4 inches and landed in an upright position (Figure 1-3). No one was injured, and the cask was not damaged. (ORPS Report EM-RL--PHMC-SOLIDWASTE-2008-0008)

**Figure 1-3. The dropped waste cask**

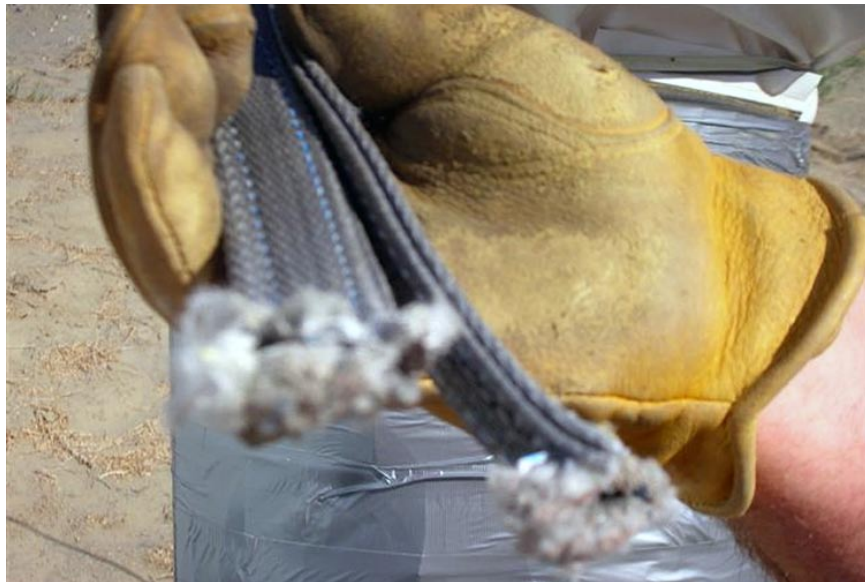
Investigators determined that the synthetic slings selected (Figure 1-4) were inappropriate for the rigging configuration, and softeners had not been used to cushion them. Both conditions increased the potential for the slings to fail.

Investigators determined that the riggers looked at the safe working capacity of the slings in the basket configuration (6,400 pounds), not the choked configuration (2,400 pounds). However, they rigged them in the choked configuration, with

**Figure 1-4. The cut sling**

a total capacity of 4,800 pounds, even though the cask weighed approximately 6,000 pounds. They did not make a second check of the working capacity of the rigging. In addition, the slings were not protected by softeners at the flange interface, which created a sharp corner.

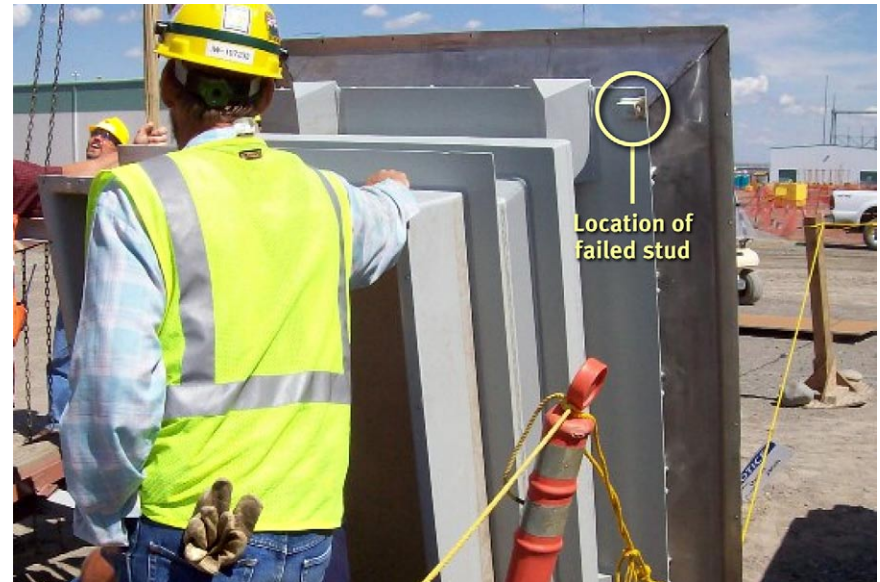
On August 19, 2008, at the Hanford High Level Waste Facility, a 6,000-pound shield window liner toppled 3 feet to the ground after two lifting eye nut assemblies sheared off from the top of the window liner because of excessive side loading stresses. Iron workers were attempting to lay the liner on its side when the rigging hardware failed (Figure 1-5). (ORPS Report EM-RP--BNRP-RPPWTP-2008-0016; final report issued September 30, 2008)

The shield window liner had to be placed on its side to shorten the legs and jacking bolts had to be added to help with its final positioning in a wall. The drop-forged, heavy-duty eye nuts

**Figure 1-5. Window liner on its side after eye nut stud failure**

(10,600-pound workload rating vertical pull) and threaded studs (116,000 psi tensile strength) were installed according to the manufacturer's drawings and shipping instructions. The lifting eye nut was threaded onto a metal stud that was threaded into a welded flange on the liner.

The rigging for the eye nuts was positioned at approximately a 45-degree angle, and the rigger was using a chain hoist to raise the legs off the ground when the shearing of the two studs occurred. The riggers had successfully performed these side loading lifts in the past on a similar sized window liner with no incident.

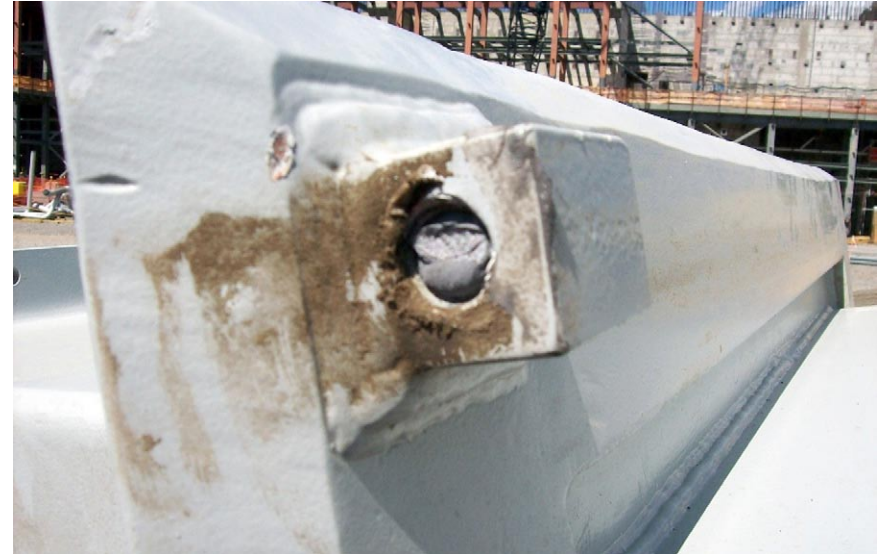
Investigators learned that the drawings and specifications provided by Bechtel to the manufacturer lacked the correct rigging configurations and requirements. The drawings did not require the eye nut shoulder to be flush or seated with the flange of the shield window liner. The drawings left a  $\frac{5}{8}$ -inch exposed neck (reveal) on the studs, reducing the overall strength of the eye bolt assembly (Figure 1-6). Figure 1-7 shows one of the failed studs.

**Figure 1-6. Installed eye nut not shouldered to the flange**

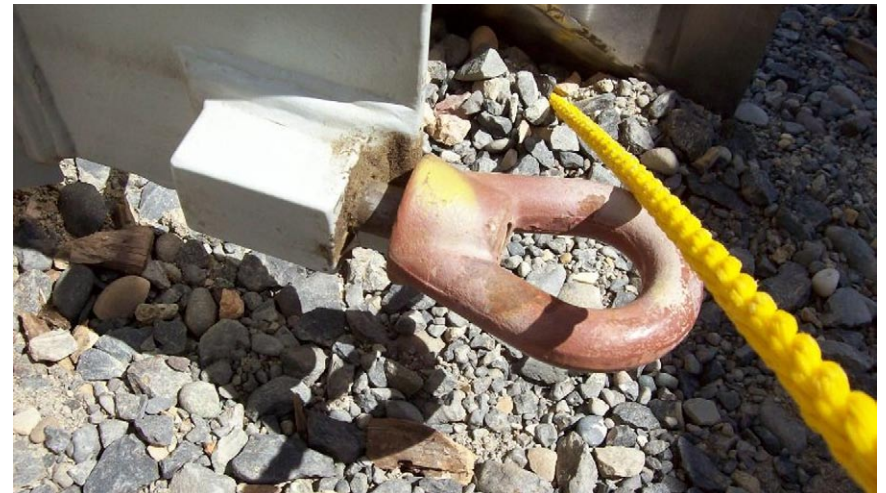
Investigators determined that there were no specifications for shear ratings for the studs and that a document review would have identified the lack of lifting or rigging instructions and restrictions. They also determined that there were no material handling directions for the window liners.

**Figure 1-7. One of the four lifting flanges on the liner with a broken stud**
