# OPERATING EXPERIENCE SUMMARY

**U.S. Department of Energy**  
**Office of Environment, Safety and Health**  
OE Summary 2004-15  
July 26, 2004

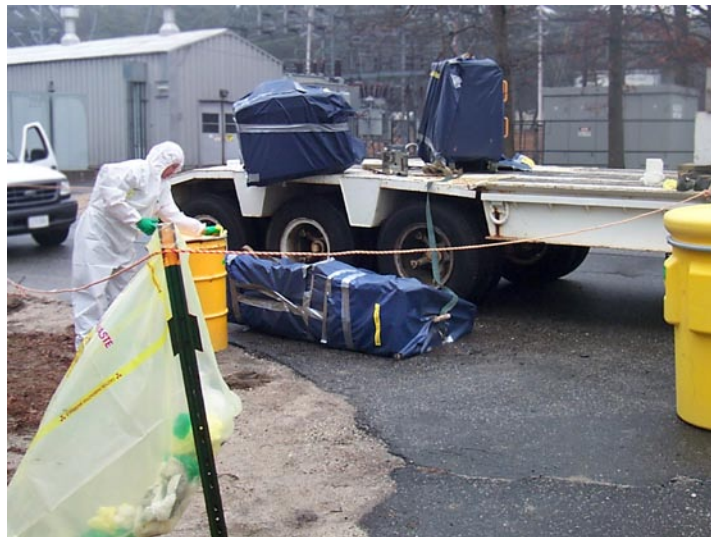
**Figure 2-2. Failed wire-rope sling and shackle**

The dynamic load placed on the sling exceeded its 2.2-ton rating and caused it to fail in the

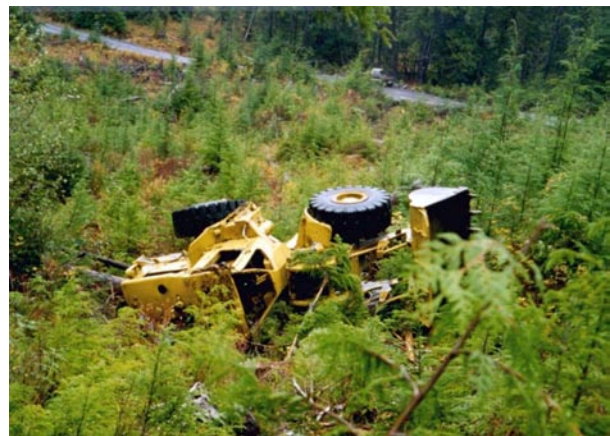
*Figure 1-1. View of front-end loader from top of slope*

The 58-yr-old operator was driving to a logging camp site from a work site when the loader went off the road, rolled down the slope, then rolled over and ejected him. The operator was found about 100 feet down the slope, crushed beneath the loader, and was declared dead at the scene. Figure 1-1 shows the accident scene.

The front-end loader was equipped with a rollover protection system (ROPS) that was incorporated into the operator's compartment. Seat belts are an important component of ROPS because they hold operators in place and keep them from being thrown from the equipment. Investigators learned that the operator of the front-end loader lacked this protection because his seat belt was defective and could not be used.

*These events illustrate the importance of using seat belts while maneuvering powered industrial trucks and heavy equipment. Managers should ensure that seat belts and harnesses are in good condition and should require workers to wear them whenever motorized vehicles are operated. Vehicles that are not equipped with seat belts should have them installed when feasible.*

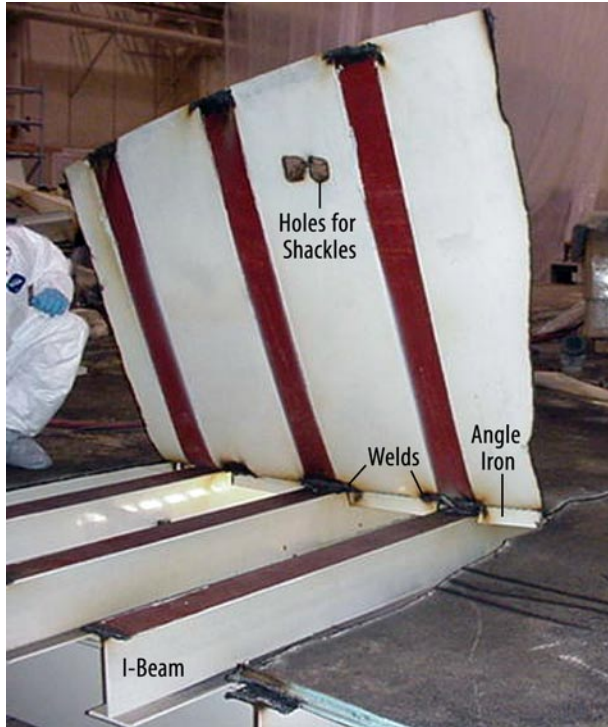
**Figure 2-1. Steel plate section of tank floor**

The demolition crew (site supervisor, equipment operator, and three environmental technicians) was removing a large steel tank by cutting it into sections with a plasma torch and lifting the sections out with the bridge crane. The top and sides of the tank had been removed, and work progressed on removing the carbon steel tank bottom, which was attached to structural I-beams every 1½ feet. Work planners believed the plate was tack welded to the outside edge of the I-beams; however, investigators determined that a continuous weld bead was used instead.

After workers cut a 6-foot by 12-foot section of plate from the I-beam at the edge of the tank, they cut two circular holes (Figure 2-1) in the plate to attach a shackle for lifting. They planned to attach two ends of a 4-foot-long, ½-inch-thick wire rope sling to the shackle and loop it over the crane hook. The overhead bridge crane would then be used to bend the steel plate to allow better worker access to cut the welds and separate the plate from the I-beam and sections of angle iron.

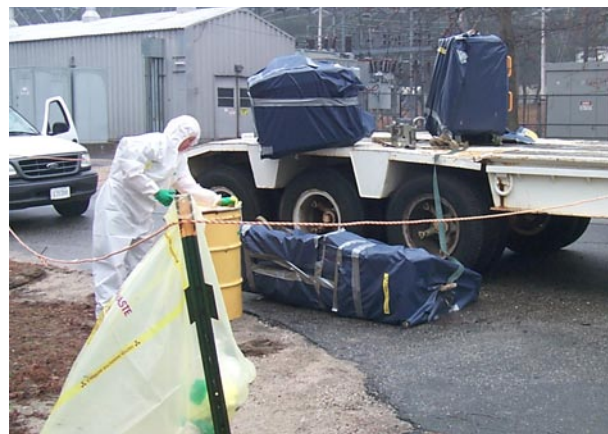
**Figure 3-1. Dropped load**

clear the line; a lifting magnet device released and dropped a 1,600-pound steel plate that exceeded the magnet's 1,210-pound lift limit; a restraining strap broke, dumping the load, while a truck was transporting a package whose weight had been underestimated by half. Figure 3-1 shows the results of this incident. Thorough planning would have helped to ensure that load height and weight measurements were taken before the work started, enabling projects to be completed without incident. (ORPS Report CH--BH-BNL-BNL-2004-0005)

*These events demonstrate the importance of thorough pre-job planning with specific, not generic, work packages and the need for mandatory pre-work walkdowns that include task-specific "what-if" scenarios. Careful planning can also be augmented by using equipment with fail-safe design and by operators who react quickly to changing conditions.*
