REDUCING EARTHQUAKE LOSSES THROUGHOUT THE UNITED STATES

# Monitoring Earthquake Shaking in Buildings to Reduce Loss of Life and Property

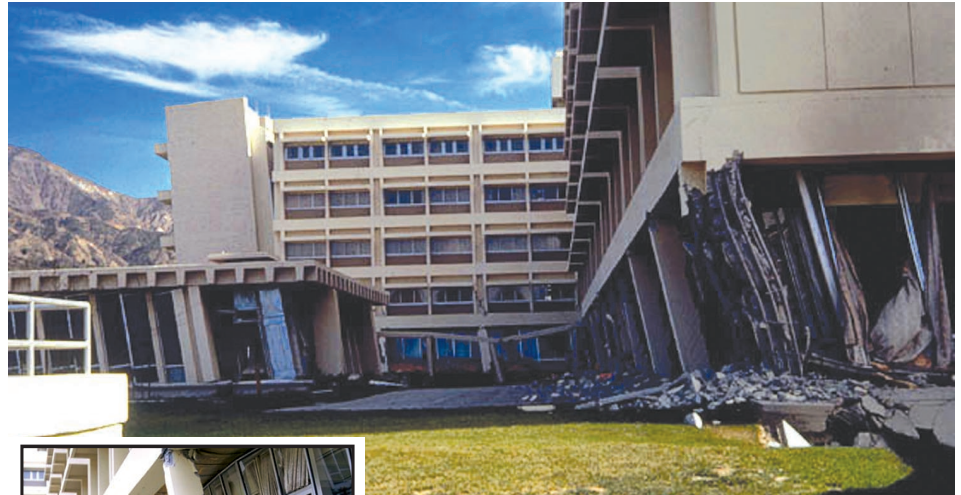
The 1971 San Fernando, California, earthquake (magnitude 6.7) severely damaged the recently built Olive View Hospital. This building was not instrumented with seismic sensors. Accordingly, no data were obtained to understand how the damage initiated and progressed during the intense shaking. The building was razed and replaced with a stronger structure that survived the 1994 Northridge earthquake (see back page).

The 1994 Northridge earthquake (magnitude 6.7) in southern California tested the structure that replaced the Olive View Hospital, which was heavily damaged by the 1971 San Fernando shock (see front page) and later razed. The replacement building was designed to be stronger than its predecessor and was instrumented by the California Geological Survey.

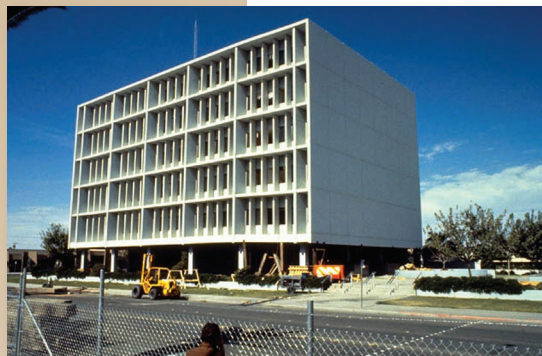
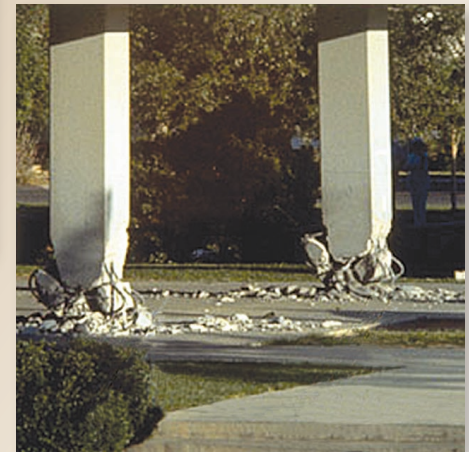
Recordings of earthquake shaking within a heavily damaged building are rare—even today. The first set of such records was obtained in 1979 from southern California when a magnitude 6.4 earthquake seriously damaged this modern office building in the Imperial Valley. The estimated cost to repair the reinforced-concrete frame and shear-wall building was so large that the building was razed. The photo at far right shows the evolving failure of columns at one end of the building.

The California Geological Survey (formerly the California Division of Mines and Geology) had installed 13 motion sensors at various points throughout the structure to document its swaying and twisting in an earthquake. Shown above the building is the roof-level record of horizontal acceleration parallel to the long axis of the structure. The sudden lengthening of vibrations at *A* (7 seconds after

shaking begins) marks the onset of structural damage. About 4 seconds later (at *B*), faint high-frequency vibrations (rapid small pulses), superimposed on the slower vibrations, signal the collapse of columns.

Such records from buildings that suffer earthquake damage enable engineers to document and investi-

gate failure processes and to devise and improve methods for minimizing structural damage in future shocks.
