**2007/2008 STATUS REPORT ON MITIGATION ACTIVITIES FOR CWA 404 PERMITS
CONDUCTED BY TUCSON AUDUBON SOCIETY
September 2008**

2. MARTIN FARM PROJECT SITE—HABITAT MITIGATION ACTIVITIES

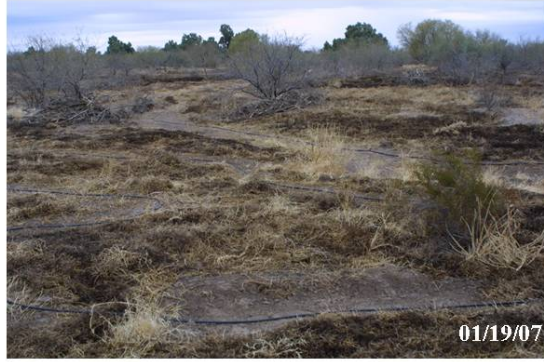
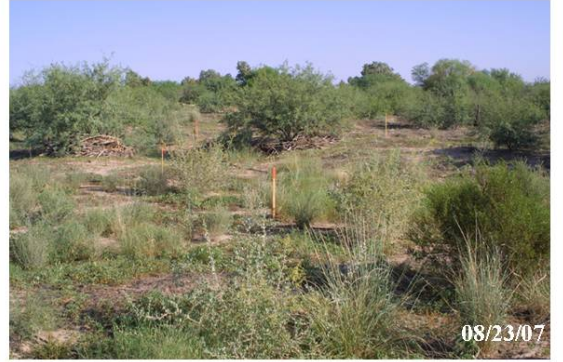
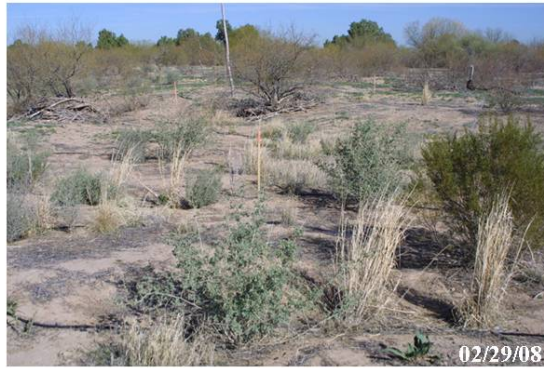
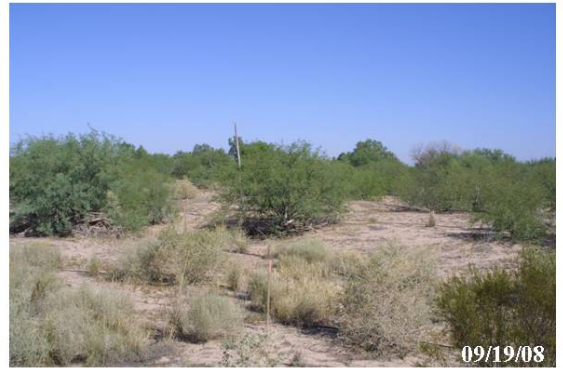
Figure 1. Repeat photo M8b

Photo monitoring shows that in some areas we have strongly augmented vegetative density and diversity. Photos are taken semiannually, once in winter and once in late summer near the end of the growing season. Results appear most striking on the upper floodplain area where plant survival has been good and plants were installed densely along drip irrigation lines. Figure 1 shows one such area. The first photo shows dried annual vegetation with planned planting areas indicated by the black irrigation lines. The photo from August 2007 shows extensive new growth both from planted perennials and annuals that grew from heavy summer rains that year. In the final two photos, the perennials continue to grow although less summer precipitation led to a decrease in annuals. While the perennials in the final photo appear drier, casual observation by crew members indicates they are all still alive..
