Fort Davis National Historic Site, Texas

CULTURAL LANDSCAPE STUDY

Landscape History, Statement of Significance,
Documentation Package

November 2000

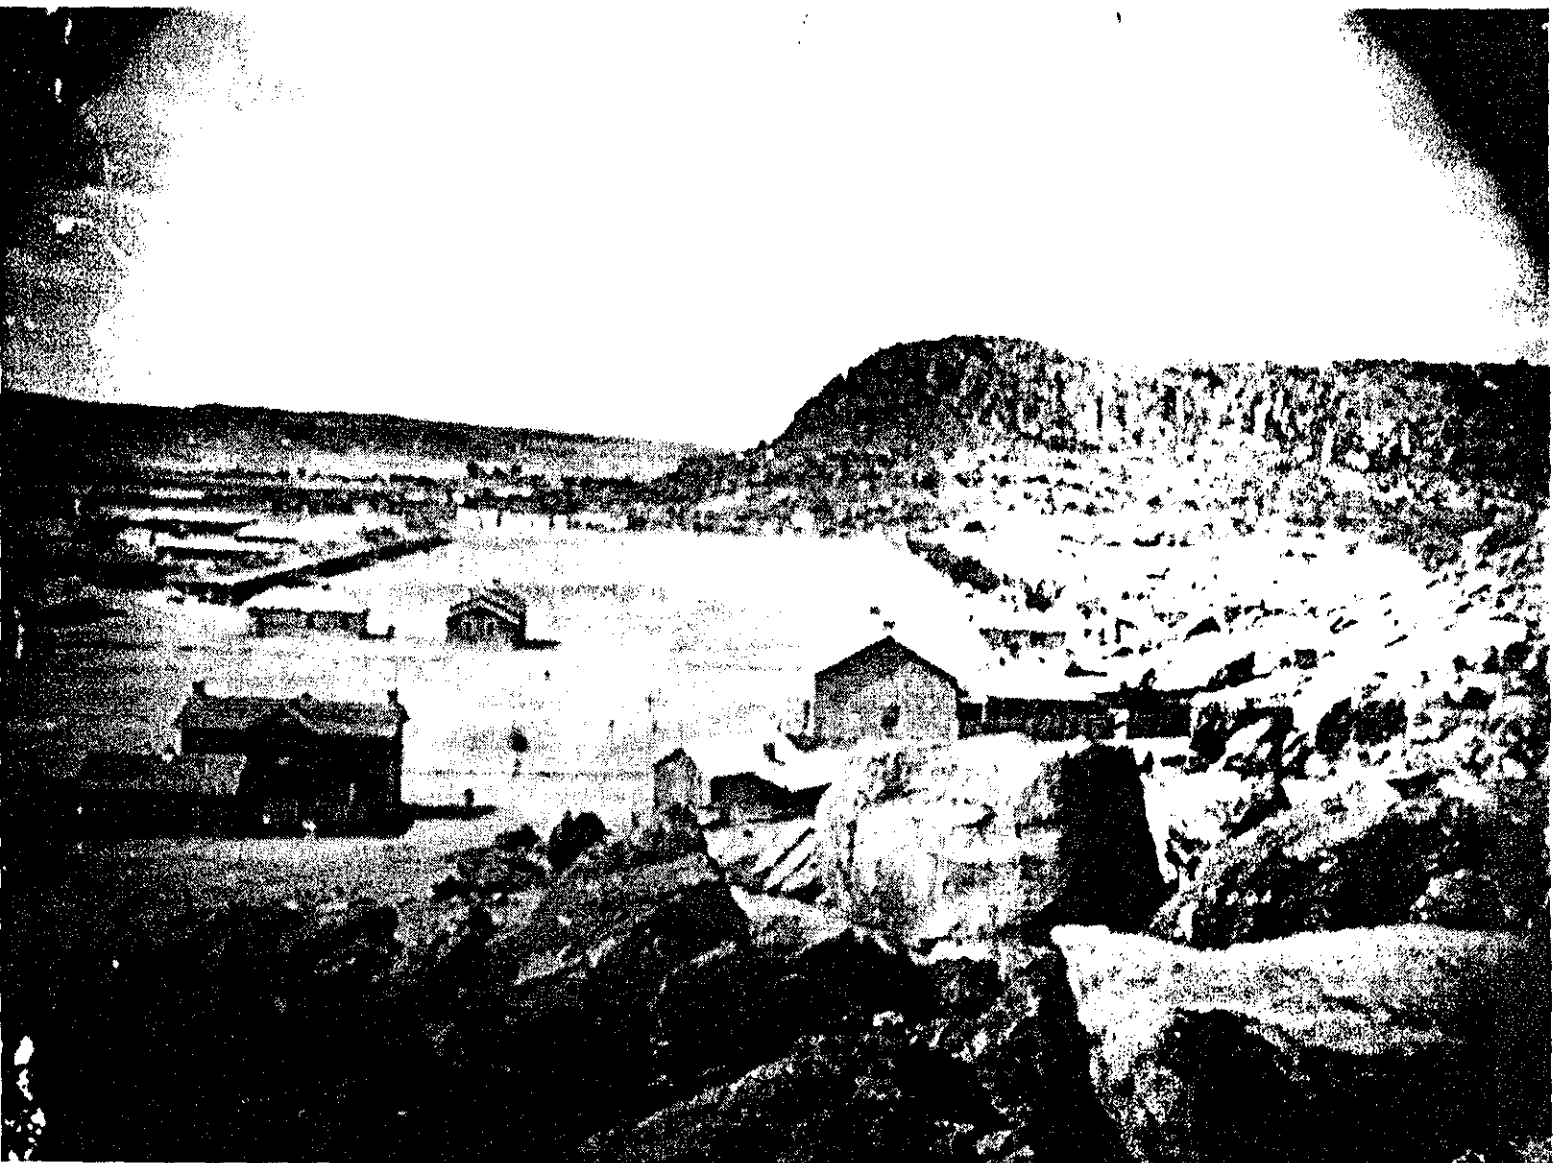
Figure 1. Photograph, Second Fort Davis from north, ca. 1886 (Source: Fort Davis NHS Archives, Photo HG-14)

during the second fort period, mainly due to the fact that goats browsed these areas then (compare Figure 1 to Figure 17 and Figure 10 to Figure 16). The numbers of trees in these areas have increased somewhat as well.¹⁹⁰

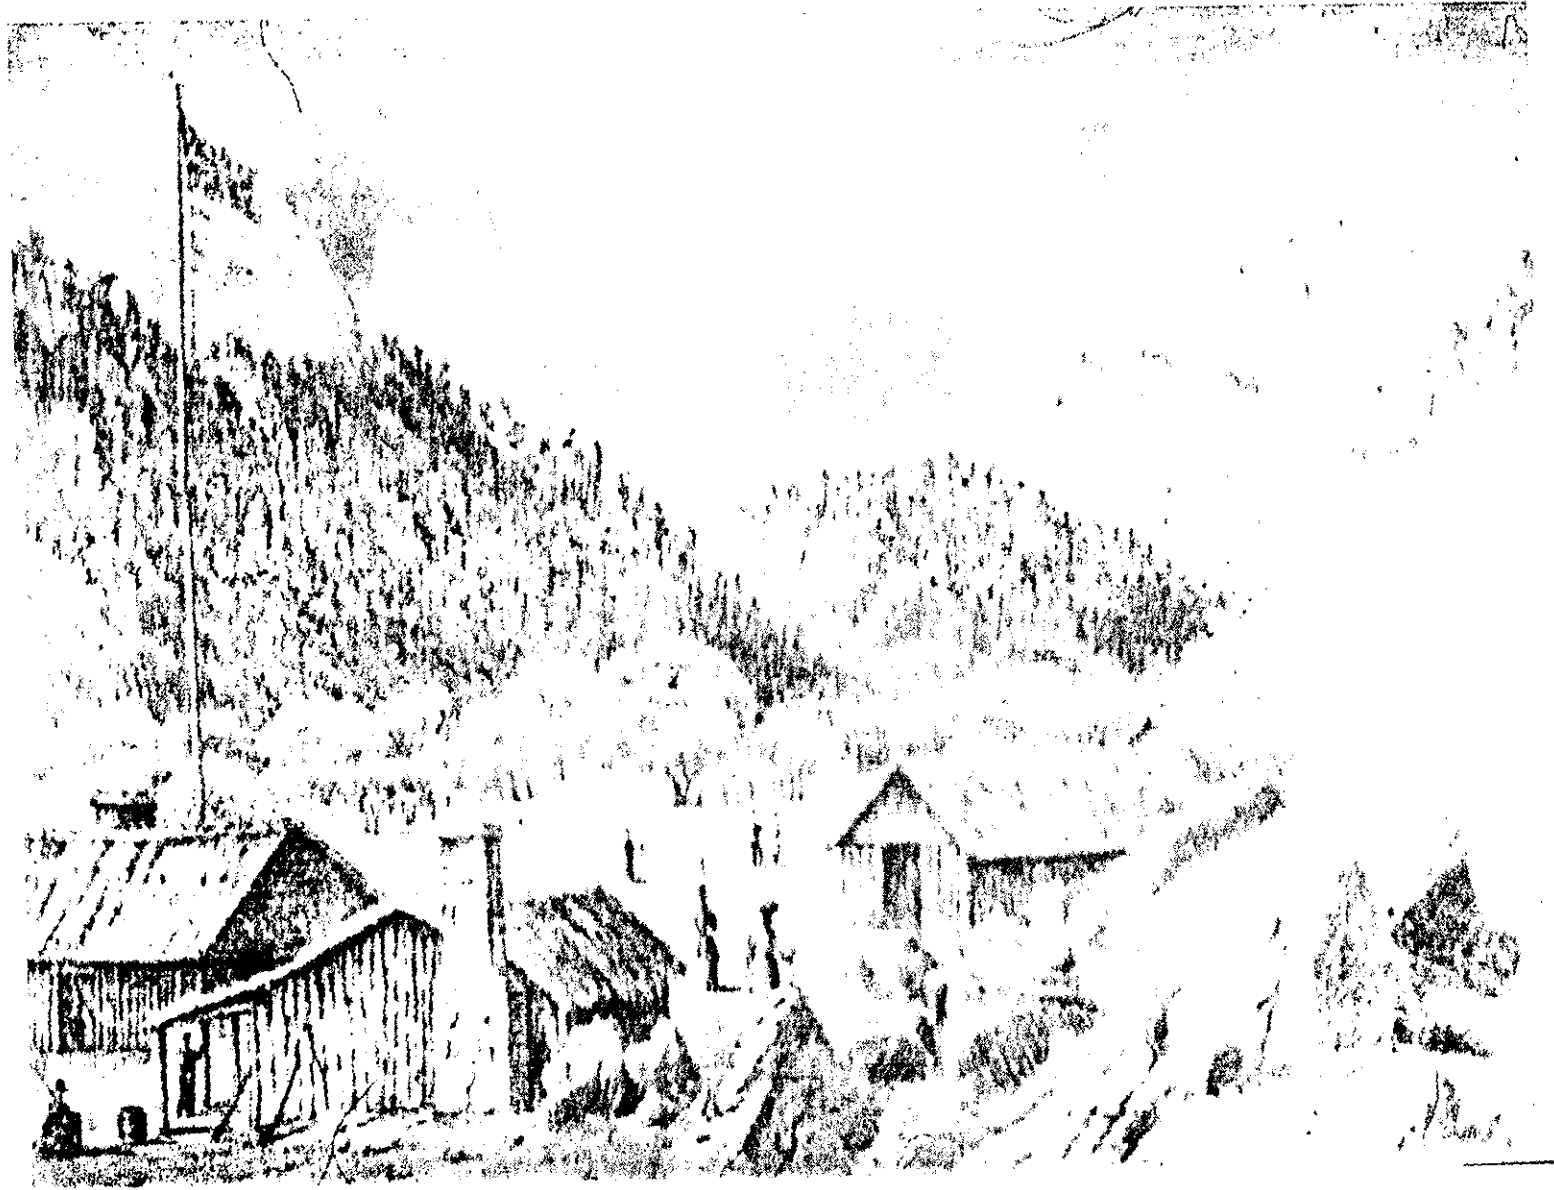
Figure 7. Illustration. First Fort Davis by Arthur T. Lee, ca. 1854-1858 (Source: Greene, p. 451)

In Nelson's "The Historical Vegetative Aspect of Fort Davis National Historic Site," he identifies vegetative types present in Lee's paintings and sketches, which were composed at Fort Davis during the 1850s (see Figure 7). From these sources, Nelson notes the presence of cottonwood trees along Limpia Creek, patches of brush and grass on slopes and hills, shrubs and trees amid rocks and cliffs, and what he characterizes as a "very definite oak savannah" in the Hospital Canyon area. Nelson adds that it is difficult to ascertain the accuracy of these sources because Lee may have taken a good degree of artistic license, but Nelson does state that the patterns mentioned tend to correspond with information in historic photographs from the period of the second fort.⁵⁷

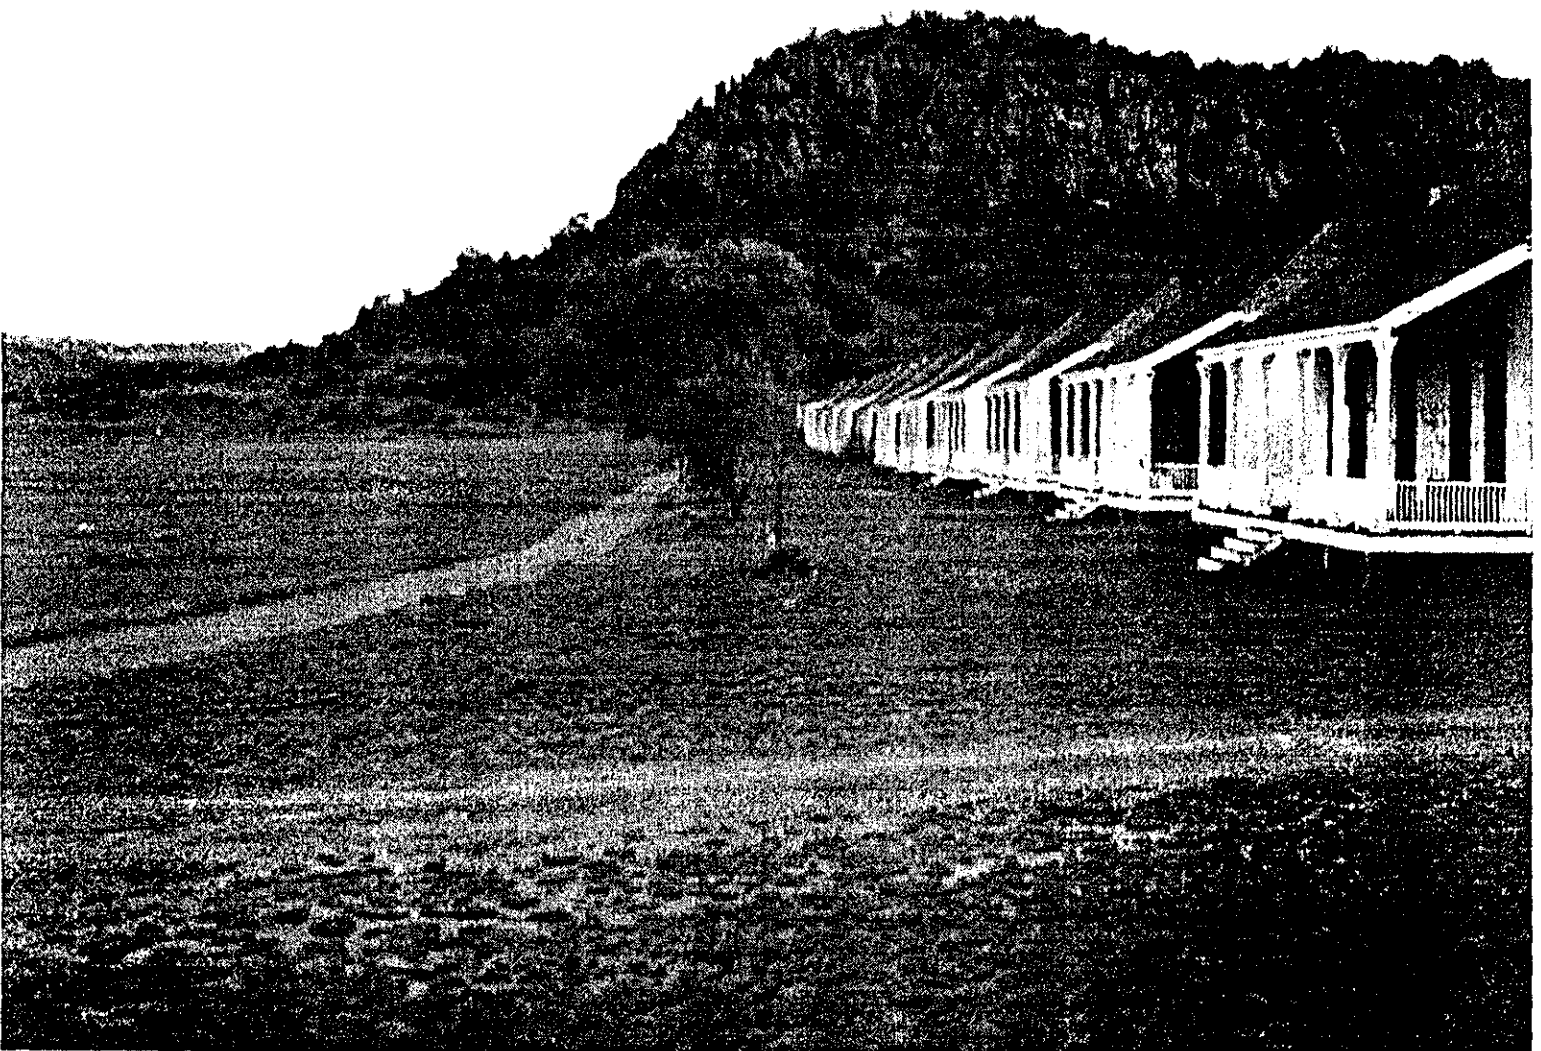
Figure 15. Photograph. Second Fort Davis officers' row. 1999 (Source: Author)

In terms of the management of other landscape features, buildings and structures have been maintained, footprints of ruins have been marked with either wooden stakes or soil cement adobes (for first fort buildings) and soil cement adobes (for second fort buildings) (see Figures 14 and 19). Trees have been both planted and maintained at the cottonwood grove near the spring and in front of officers' row (see Figures 15, 18, and 21). A trail for visitors also was built on Sleeping Lion Mountain in the 1970s.¹⁷⁵

1 and 11 to Figure 15). On officers' row, one historic tree remained as of July 1988 (in front of HB-2), and other trees (cottonwood and desert willow) have been planted and maintained in front of other buildings there since the establishment of the park (see Figures 15, 17, and 18). The park also has adopted a policy to attempt to limit the size of the trees in front of officers' row to the approximate size of trees there in the 1880s.¹⁸⁷

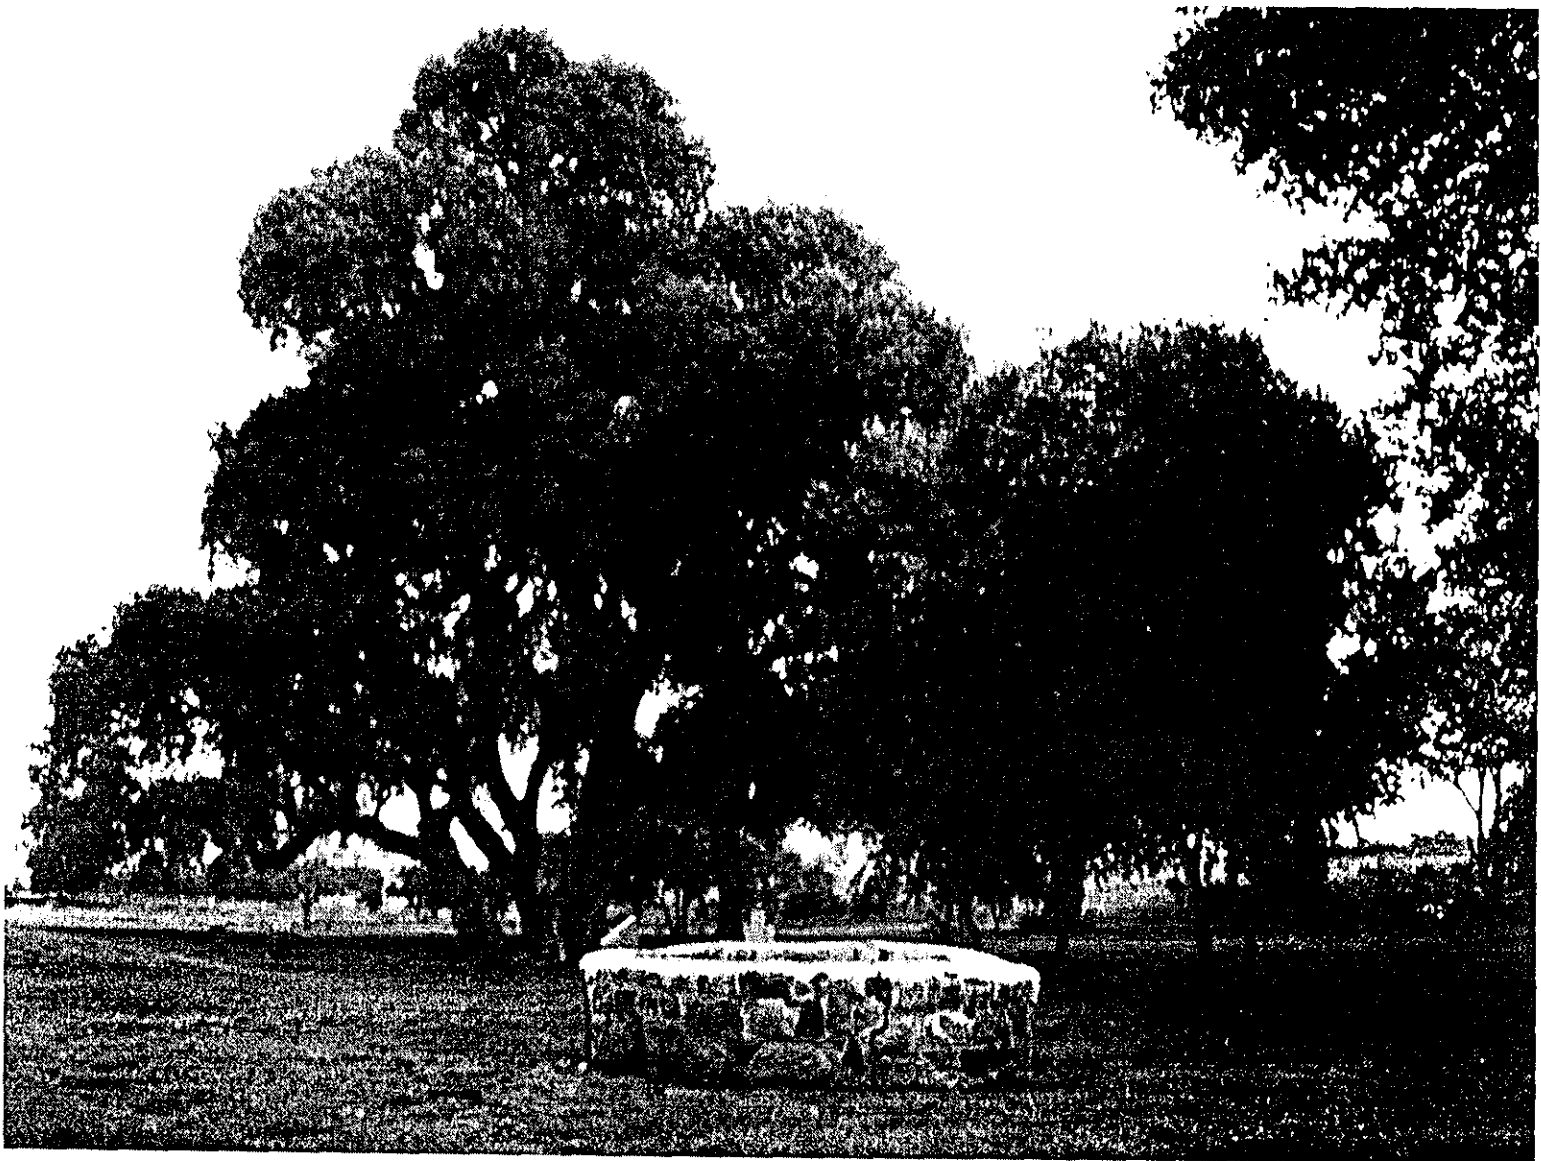
Figure 21. Photograph. Cottonwood grove and spring enclosure. 1999 (Source: Author)

In the area of the spring and historic cottonwoods, remnants from the second fort period include irrigation ditches and a circular masonry wall around what was the spring (see Figure 21). The Park Service has added modern picnic benches to this cluster of features.
