FORT LARNED

NATIONAL HISTORIC SITE • KANSAS
NATIONAL PARK SERVICE

Cultural Landscape Report

MAY 1999

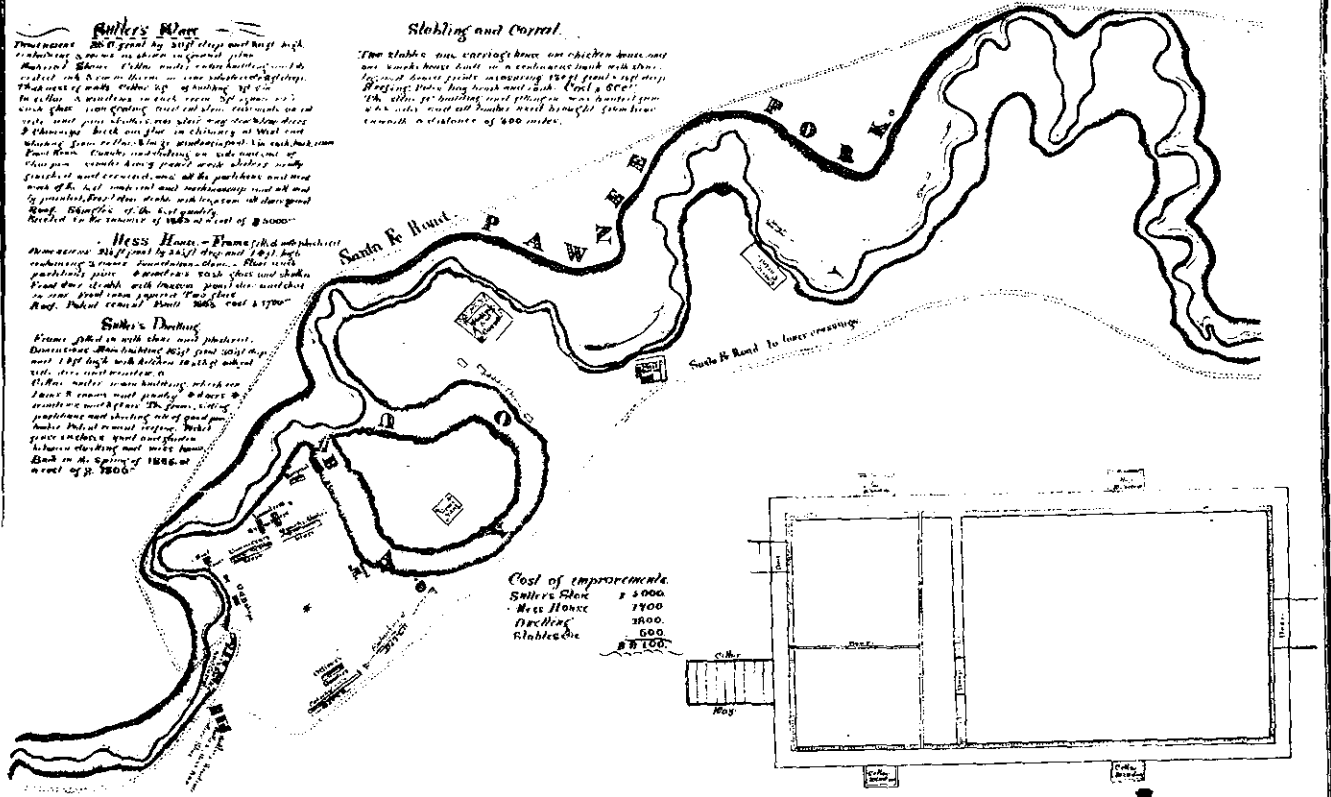
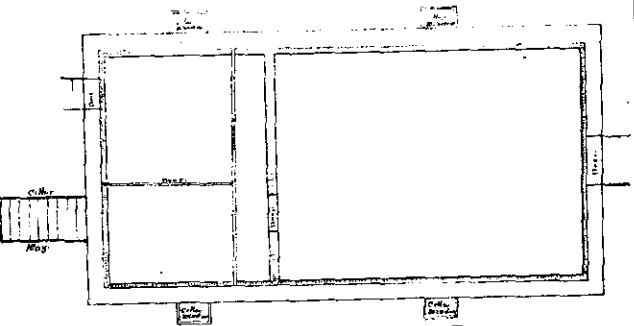
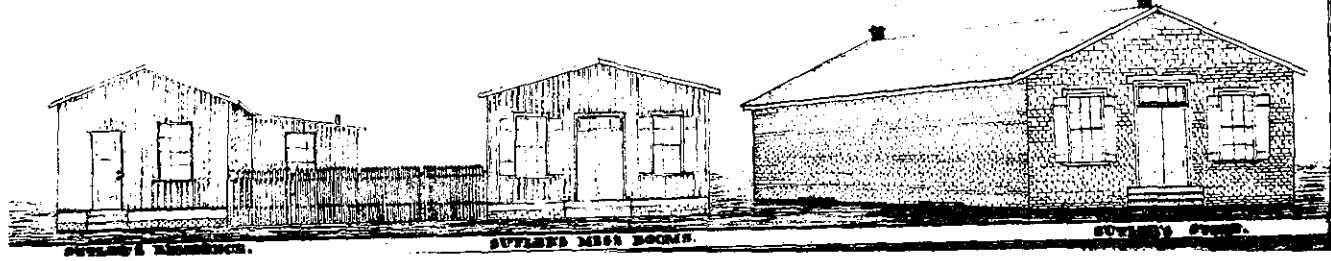
Map 3. 1866 Map of Fort Larned, Kansas, showing the sutler's complex. [Fort Larned National Historic Site]

By 1867 the sutler was operating a diverse operation that consisted of a sutler's house, a mess hall and icehouse, a carriage house, a chicken house, a smokehouse, and two stables.³⁵ Map 3 provides the best indication of the layout and character of the sutler's complex. A *circa* 1878 photograph of the sutler's store, however, gives no indication of this complex (*Figure 9*). The photograph indicates an untidy environment with a missing window, and a stove, table, and other items stored or discarded near the entry door and makeshift entry stairs. The exterior condition may well indicate that the photograph dates from the deactivation period. A sign located on the north facade above a window identified the store and would have been visible from the parade and the portion of the trail that crossed the river. The sign appears to have been a simple one of wooden construction with painted lettering. It is not known if there were signs on the other facades but there was none on the west facade. The one-story, sandstone sutler's store resembled the other buildings of the fort complex, but was located outside the main cluster of the quadrangle. The sutler's store served as the fort's recreational center and major focus of social activity.

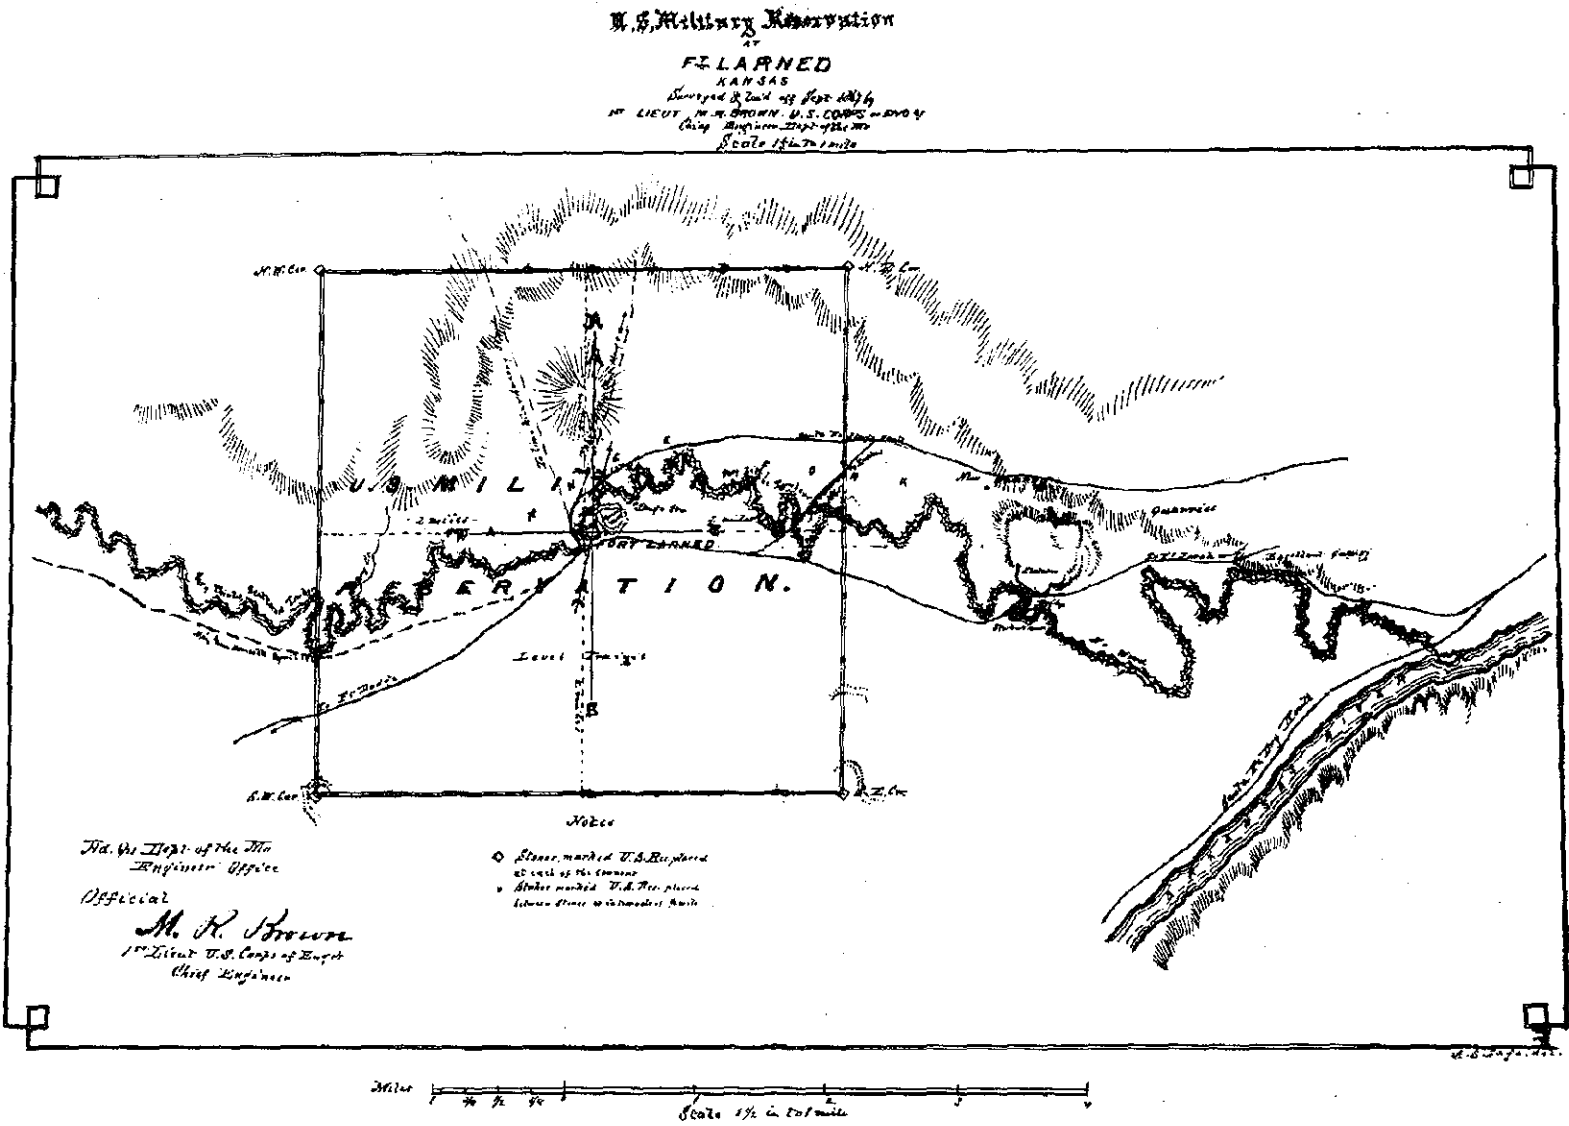
Map 4. U.S. Military Reservation at Ft. Larned, Kansas, Surveyed and Laid off Sept. 1867 by 1st Lieut. M.R. Brown, U.S. Corps of Engrs. [Fort Larned National Historic Site]

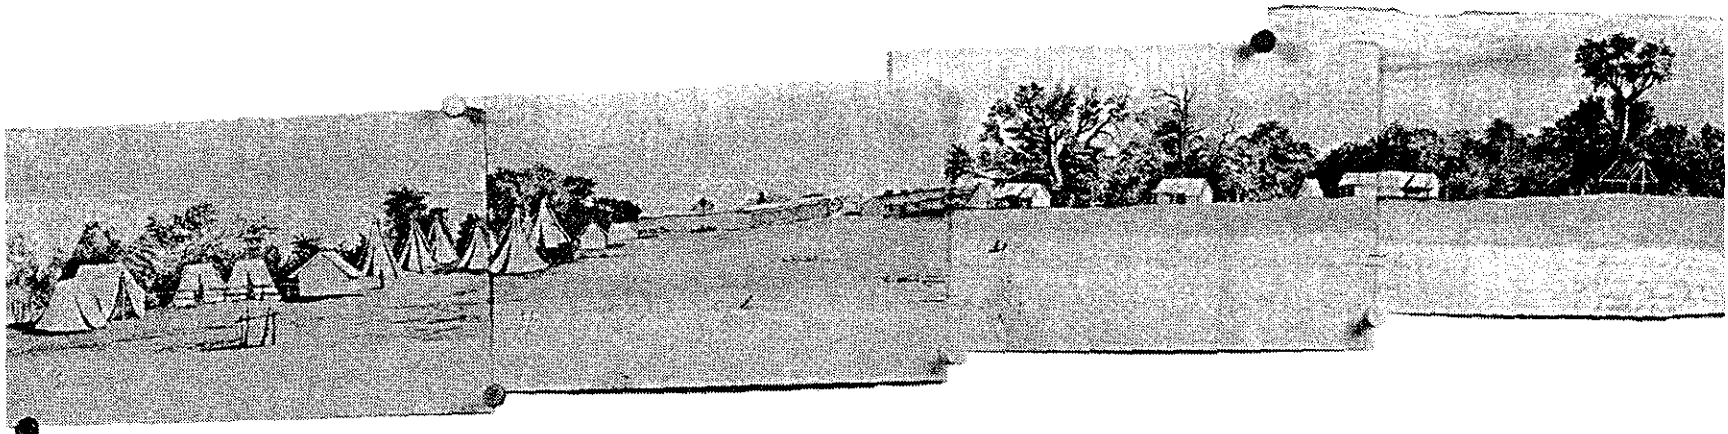
Figure 1. Four sketches giving a panoramic view of Fort Larned, drawn by Pvt. F. Roche, 1860. [Fort Larned National Historic Site]

Four sketches by Private Robert F. Roche, Co. G, 2nd infantry, drawn between May and November 1860 provide the earliest known depiction of the fort in this period (*Figure 1*). Viewed together, the sketches provide a panoramic view of the fort. The sketches show considerable tree cover with a number of dense clumps of deciduous trees in the fort vicinity. Tents and small modest structures, of both wood and adobe, are shown in informal but largely linear groupings. Comparisons with later views of the site indicate that this deciduous vegetation would decline steadily as a result of cutting to provide firewood for the fort.

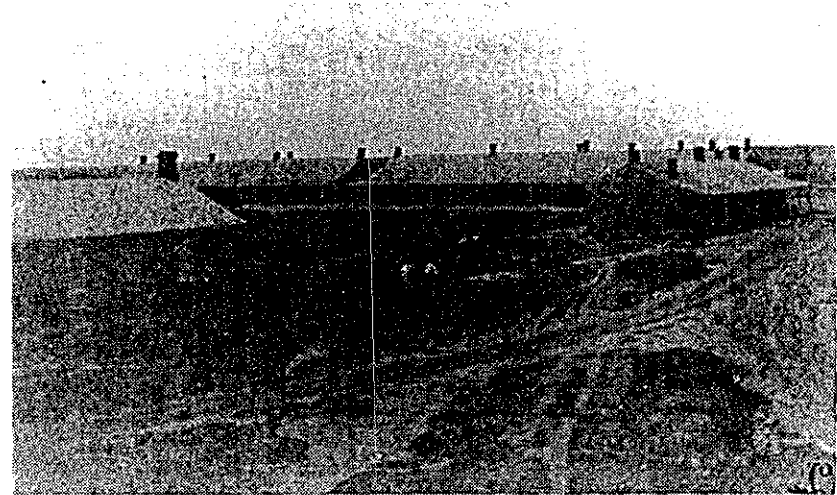
Figure 7. Overall view of Fort Larned from the southeast, late 1870s. [Fort Larned National Historic Site]

A bridge was built across the Pawnee about a hundred yards above the fort in 1868. The bridge was described as a “good substantial bridge.”¹⁰⁰ An 1878 view of the fort shows wagon ruts that indicate a portion of the fort's interior circulation. No trees are visible in this view from the southeast corner of the parade. Patches of both grass and bare earth are visible on the ground plane (*Figure 7*).

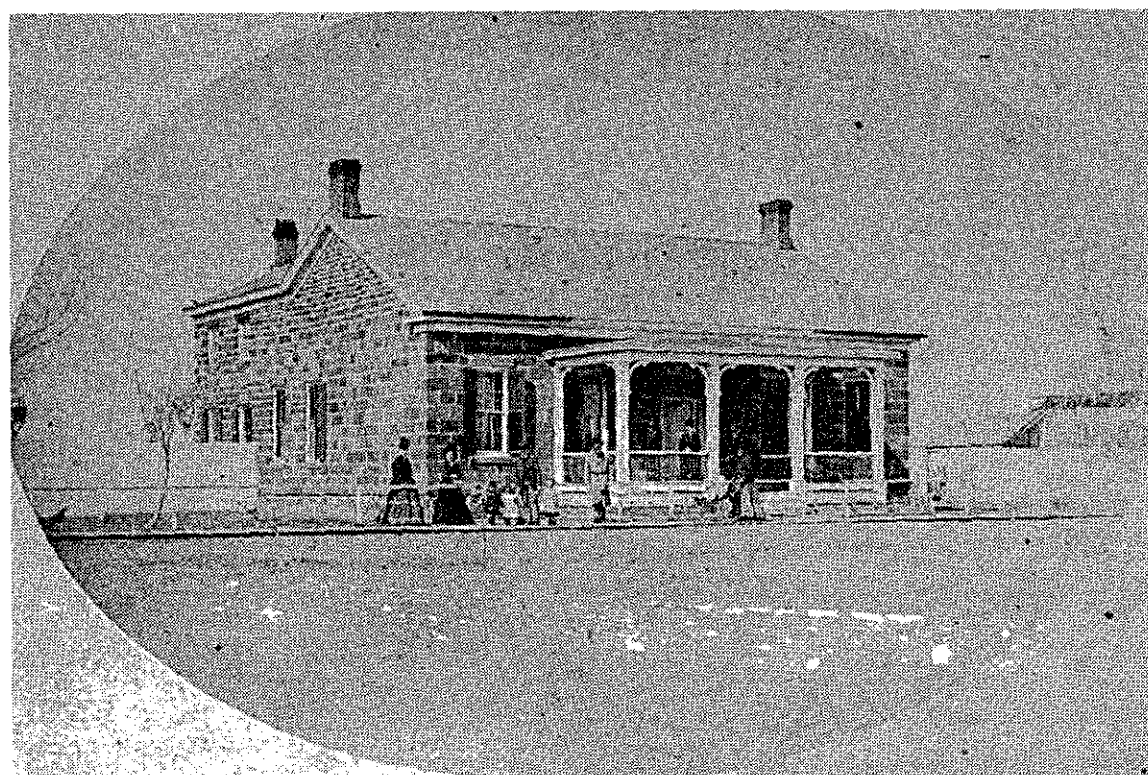
Figure 6. Commanding Officer's Quarters (HS-8), circa 1875. [Fort Larned National Historic Site]

By the 1870s photographs indicate that Officers' Row was a well-developed residential sector within the quadrangle. There are several photographs of the row during that period, including a *circa* 1875 photograph of the Commanding Officer's Quarters (*Figure 6*) and an April 1879 photograph of the south Officers' Quarters (*Figure 11*). Tall wooden fences defined the rear and side yards and a wooden boardwalk extended along the front of the three officers' quarters. The rear yards were described as "large" with "high fences."⁵⁴ The backyards accommodated the typical domestic needs of the period; privies, water barrels, and stables were developed west of the quarters to the rear.⁵⁵ The surgeon's report describes each of the officers' quarters as opening "into a yard common to all the occupants on that side of the building ..."⁵⁶ Each had a small porch to the rear and to the side of the kitchen.⁵⁷

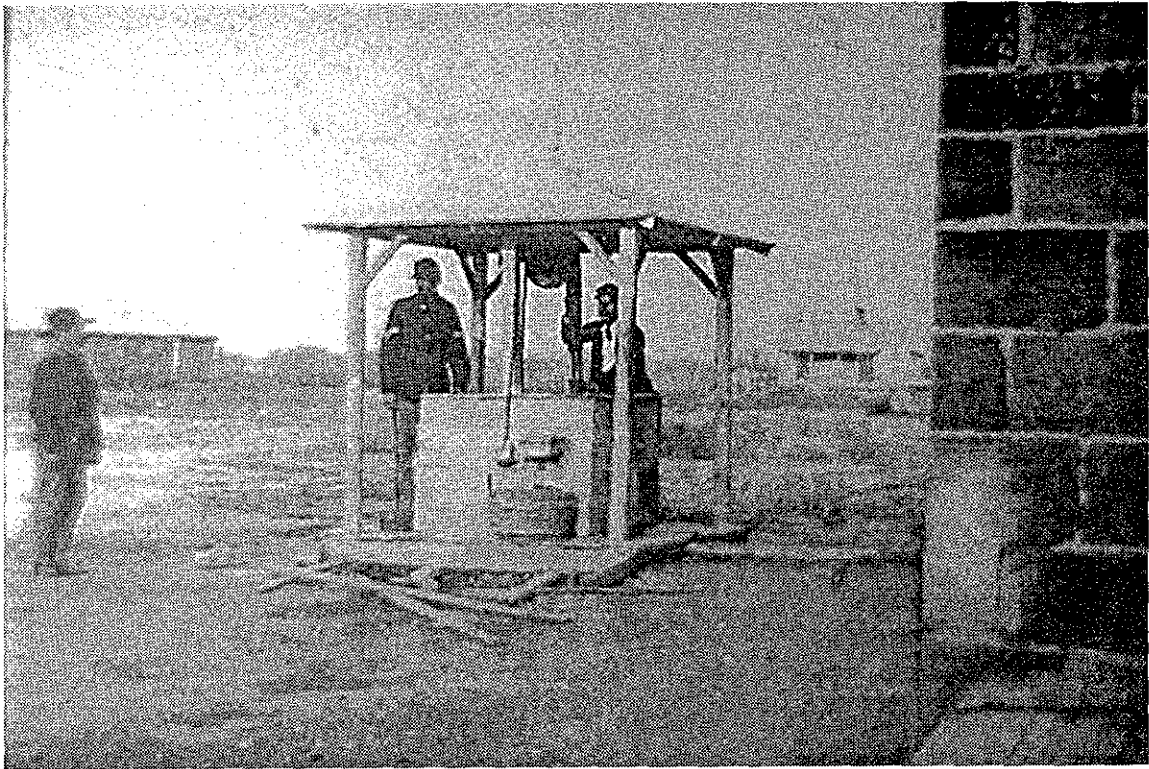
Figure 8. Well house behind infantry barracks (HS-1), with old adobe hospital, *left*, and hospital steward's quarters, *right*, in background, 1878. [Santa Fe Trail Center, Larned KS]

wooden bucket standing next to the well (*Figure 8*). Visible in the background is the old adobe hospital at the left and the hospital steward's quarters to the right.

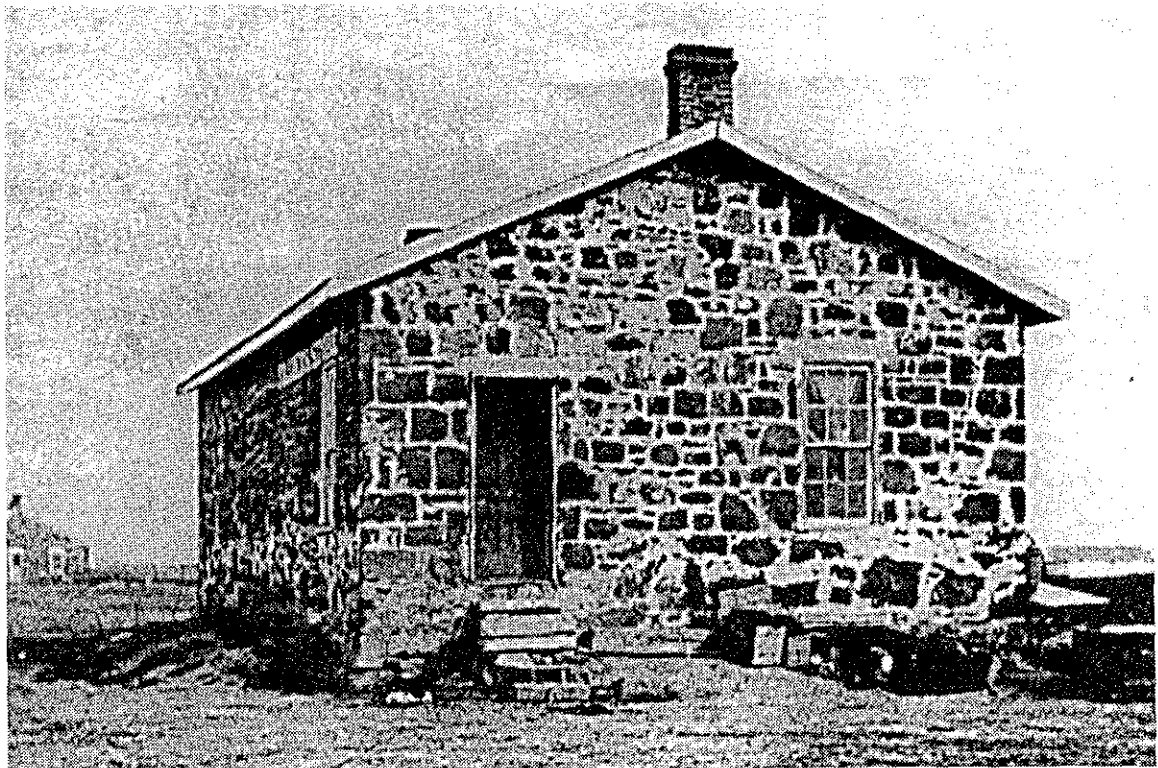
Figure 9. Sutler's store, with Quartermaster Storehouse in background, *circa* 1878. [Fort Larned National Historic Site]

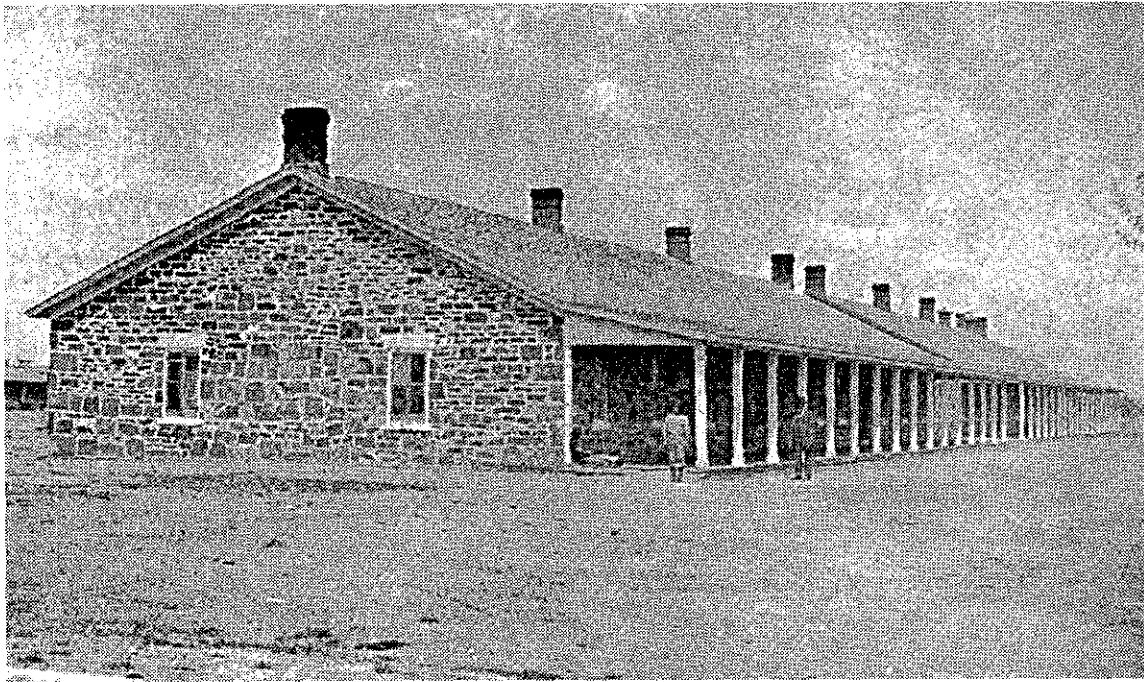
Figure 10. Barracks (HS-1, HS-2), April 29, 1879. [Kansas State Historical Society]

The fort complex included nine buildings arranged around a 400'-square parade ground. The principal facade of each building, except the utilitarian trade shops to the east, oriented inward toward the parade. Despite its remote location, the fort was a formal and regularly-arranged quadrangle befitting an impressive military installation. Covered porches and verandahs attached to the barracks and officers' quarters provided protected transitional areas between the fort's residential areas and the more public area of the parade. The officers' quarters were located on the west side of the parade; the commanding officer's quarters, the first of the officers' quarters to be completed, occupied the central location of Officers' Row and was flanked by two identical duplex structures for other officers. During the peak period of operation, existing officers' housing was insufficient. Some officers lived in crowded conditions while others even lived in tents. Barracks for enlisted men were on the north side of the parade (*Figure 10*).

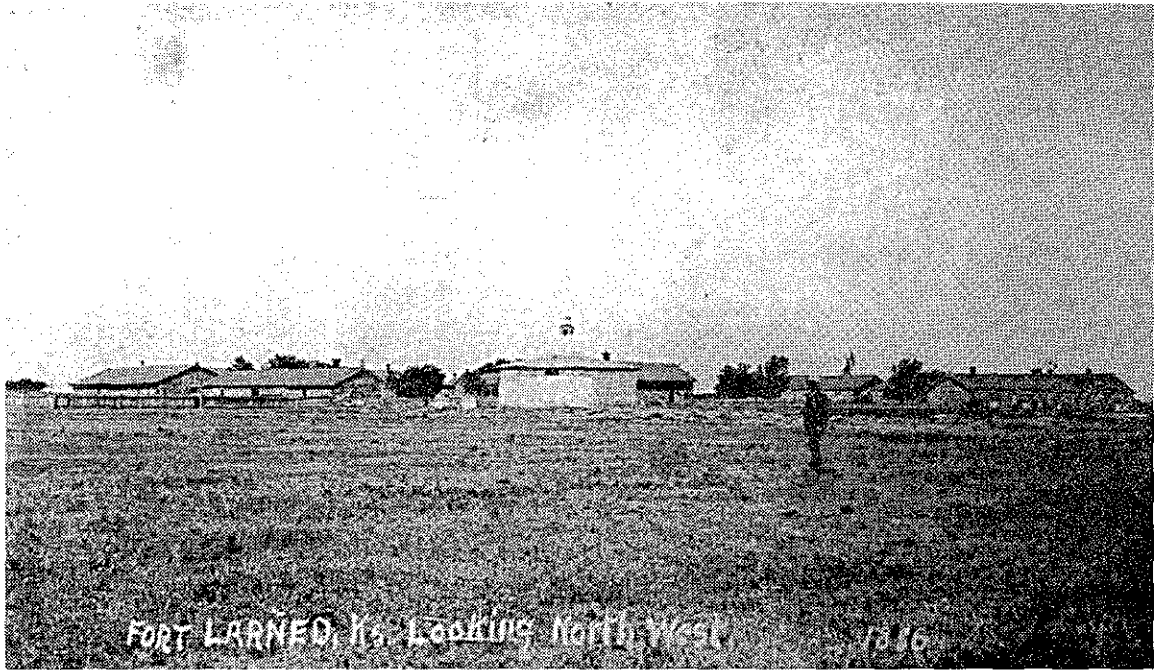
Figure 12. General view of Fort Larned from the southeast, 1886. [Kansas State Historical Society]

An 1886 photograph documents the appearance and condition of the former fort during the Pawnee Valley Stockbreeders Association ownership (*Figure 12*). The photograph indicates use of some storehouses as barns, some fencing, and at least two windmills for pumping water. A sketch, which was published in *The Official Atlas of Kansas 1887*, clearly delineates the extent of the adapted fort with its new corrals built to accommodate livestock, a race track, and the windmills described in the *Chronoscope* (*Figure 15*). A few shade trees are evident, particularly in the residential area of the ranch along the former Officers' Row. The intersecting walks of the former parade have been retained. Following the Pawnee Valley Stockbreeders Association's default on its mortgage, one of its members, Charles Wilbur, purchased the fort property in 1891, and sold it to Johanna Frorer of Illinois in 1893.

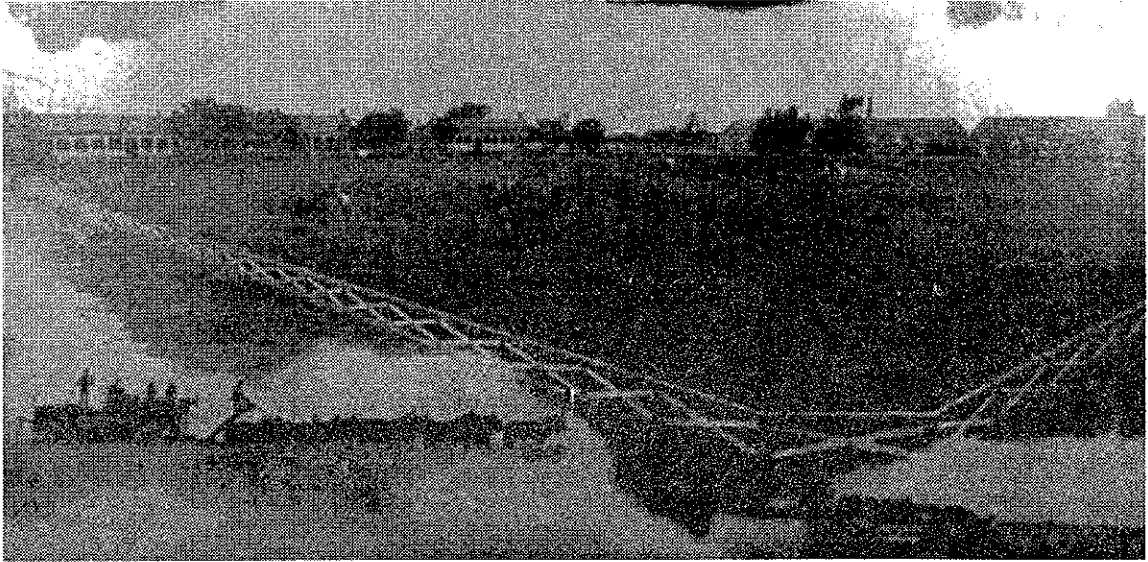
Figure 16. Detail of photomontage, Fort Larned Ranch, *circa* 1900. [Santa Fe Trail Center, Larned KS]

Sometime after 1886, the blockhouse was demolished as were some of the auxiliary buildings. A circa 1900 photographic montage gives an indication of the ranching activity that was the new land use for the fort (*Figure 16*). The evidence of fencing, shade trees, and pastures for grazing mark the complete transition from the fort period with its sparse and utilitarian landscape to the more lush and developed stockbreeding ranch.

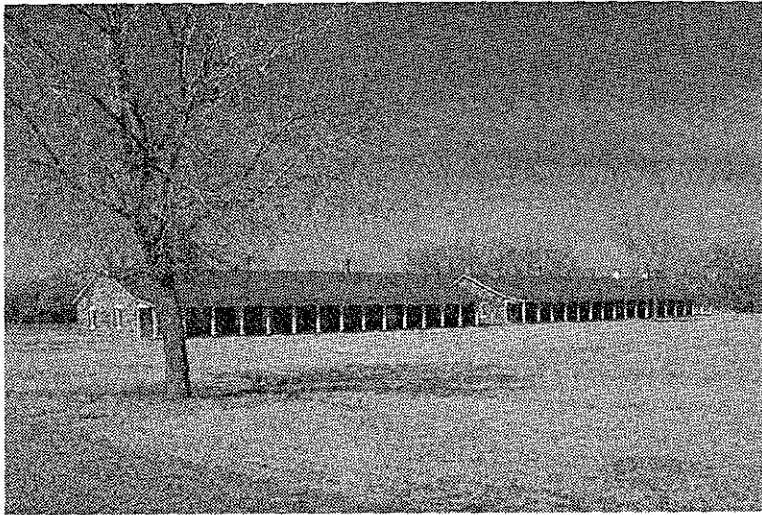
Figure 41. HS-1 and HS-2.  
[LCA, 4/96]

The north-northwest side of the quadrangle is reinforced by the fort's two largest buildings, the Barracks / Visitor Center (HS-1) and the Barracks / Post Hospital (HS-2) (*Figure 41*). On the east-northeast are the Shops Building (HS-3) and New Commissary (HS-4), and on the south-southeast the Old Commissary (HS-5) and Quartermaster Storehouse (HS-6); all four buildings are located directly adjacent to the perimeter walk (*Figures 42, 43*). On the west-southwest, two Officers' Quarters (HS-7, HS-9) flank the central Commanding Officer's Quarters (HS-8); all three buildings are set back from the perimeter gravel walk by an intervening linear boardwalk (*Figure 44*). The spaces between HS-1 / HS-2 and HS-5 / HS-6 align with the ends of the north-northwest – south-southeast crosswalk, and direct views into the prairie and agricultural areas south of the fort (*Figure 45*). HS-8 is sited on axis with the fort's flagstaff along the alignment of the west-southwest – east-northeast crosswalk (*Figure 46*).

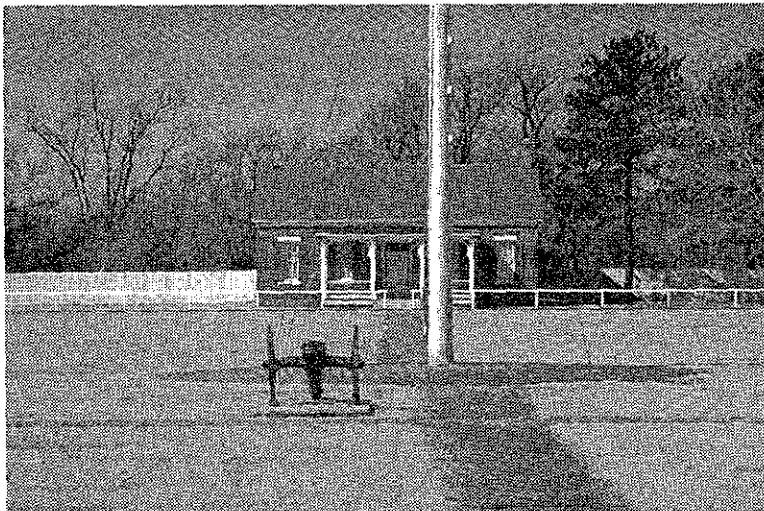
Figure 46. Howitzer and flagstaff, with HS-8 in background. [LCA, 4/96]

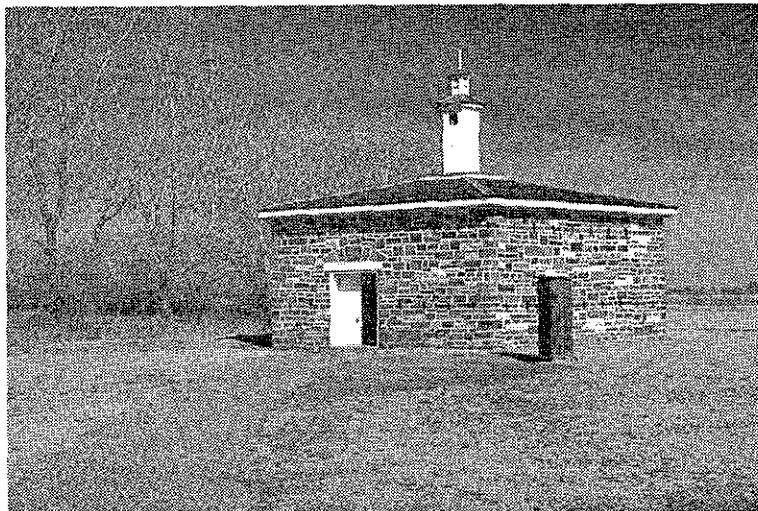
Figure 49. Blockhouse and sweatbox. [LCA, 4/96]

The blockhouse (HS-10) and the fort's present outbuildings are located in the zone between the quadrangle of historic buildings and the Pawnee River / oxbow. Historically, a number of earlier fort buildings and other support facilities were located in this vicinity. Most of the present outbuildings are associated with the fort's residential structures. Four reconstructed wells, each with a raised platform and post-supported roof, are located on axis with and at the rear of HS-1, HS-2, HS-7, and HS-9 (*Figure 47*). Further to the west along their central axes, HS-7 and HS-9 also each have a reconstructed privy (*Figure 48*). A modern carport is located in the rear yard of HS-8. The reconstructed blockhouse is located just east of the quadrangle's eastern corner; adjacent to it on the south is a reconstructed sweatbox (*Figure 49*).

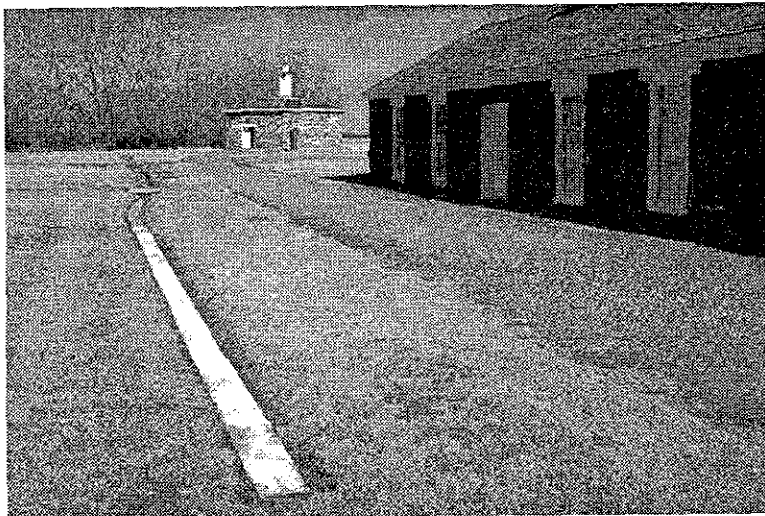
Figure 50. Drainage ditch at east end of parade ground. [LCA, 4/96]

Site drainage was also an important concern at the fort. Drainage ditches were constructed throughout the fort precinct to conduct stormwater from the nearly level parade ground. A remnant of this system located at the eastern corner of the quadrangle empties into the oxbow near the reconstructed blockhouse (*Figure 50*).

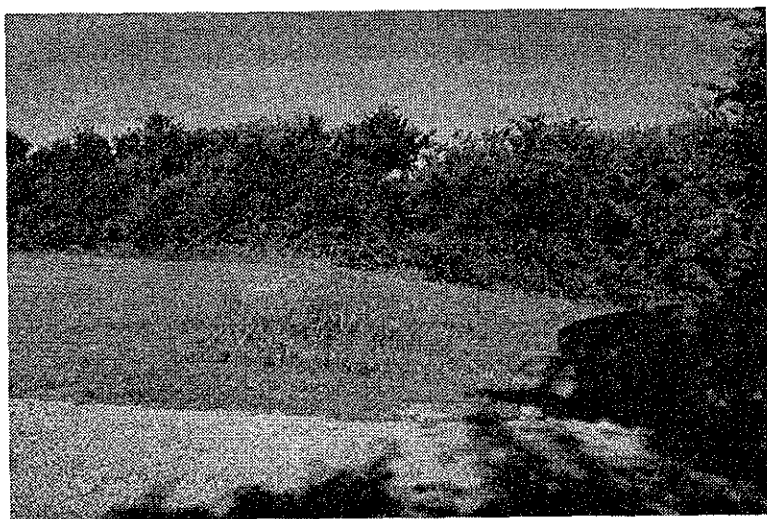
Figure 52. Berm along south bank of the Pawnee River. [LCA, 7/97]

Subsequent owners and occupants of the fort property also have modified the site in response to its natural features and conditions. During the ranching period, the Frizell family constructed berms along the south bank of the Pawnee River to assist in flood control (*Figure 52*). Berms along irrigation ditches south of the fort may also protect the fort from backwash flooding. The more recent construction to state highway standards of the entrance road bridge across the Pawnee River also is a reflection of concern about the potentially damaging effects of flooding. The river's presence and its periodic, albeit less frequent, flooding continue to influence the site and its surroundings today. The fertility of the soil, resulting at least in part from the river's history of siltation and flooding, continues to make agriculture a prime economic activity in Pawnee County.

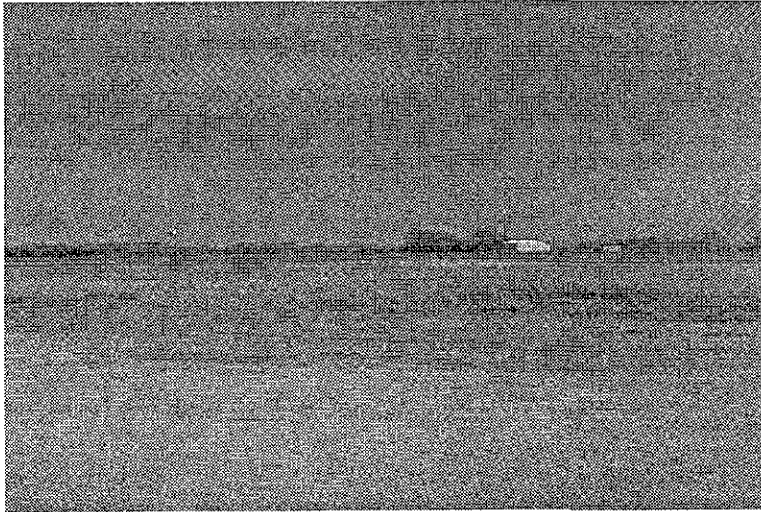
Figure 53. View from the fort to the southeast, showing water tower at state hospital, pole barn, and trees on the horizon. [LCA, 4/96]

Views from the fort are more problematic. The expansive, nineteenth-century vistas of the prairie are no longer present, replaced by a landscape that includes not only signs of development such as agricultural fields and structures, utility lines, and industrial equipment, but also the growth of woodlands that mask the horizon. Several pole barns located southeast, south, and southwest of the fort intrude upon the fort's viewshed because of their size and color, if not proximity (*Figure 53*). The NHS maintenance facility also is visible from the area between HS-6 and HS-7. A line of power poles marches along the farm road south of the fort. The line continues northeast of the quadrangle across the river to Route 156 (*Figure 54*). Within the fort precinct, the view to the northwest includes intrusions such as the HVAC equipment northwest of HS-1, the handicapped parking area, and the entrance road bridge. Although not visible from the fort itself, the petroleum production equipment northwest of the NHS highway entrance intrudes upon the impression of the fort's setting as an isolated, pre-industrial environment.

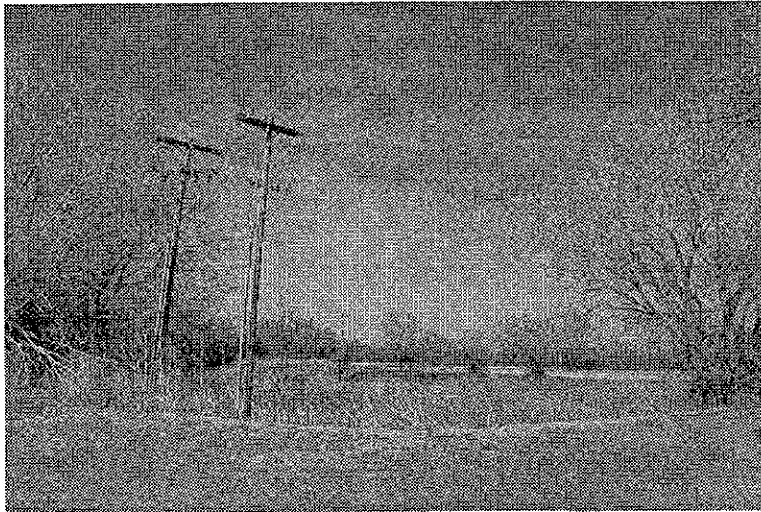
Figure 54. Power poles northeast of HS-2. [LCA, 4/96]

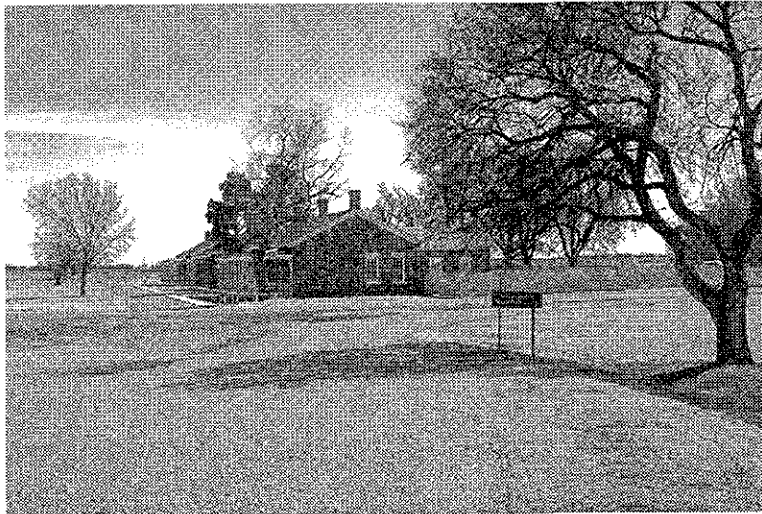
Figure 57. Service road south of entrance bridge. [LCA, 4/96]

The primary vehicular approach to Fort Larned NHS is via Kansas Route 156, a two-lane, asphalt highway connecting Larned and Garden City, Kansas. Route 156 passes through the northern portion of the NHS running east and west. Former Kansas Route 242—a two-lane, tar-and-gravel road acquired from the state in 1985—enters the site from Route 156, providing access to the picnic area with its dirt-and-gravel loop road and to the NHS temporary visitor parking area, also surfaced in tar and gravel. The 0.3-mile entrance road continues south across the Pawnee River on a 350' concrete-and-steel highway bridge, constructed in 1963, to its terminus in a similar but smaller parking area for handicapped visitors at the northwest corner of the fort precinct (*Figures 55, 56*). From this point, a dirt service road for authorized vehicles only continues south, swinging to the west side of Officers' Row and providing access to fenced yards behind each of the officers' quarters (*Figures 57, 58*).

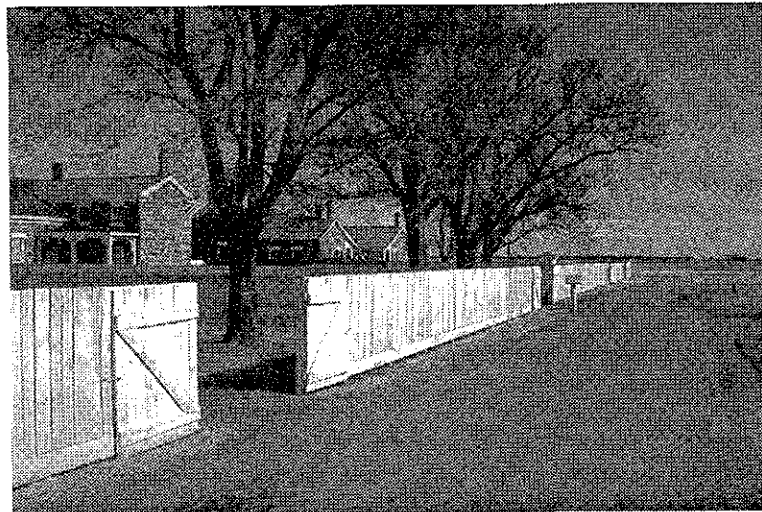
Figure 58. Service road west of Officers' Row. [LCA, 4/96]

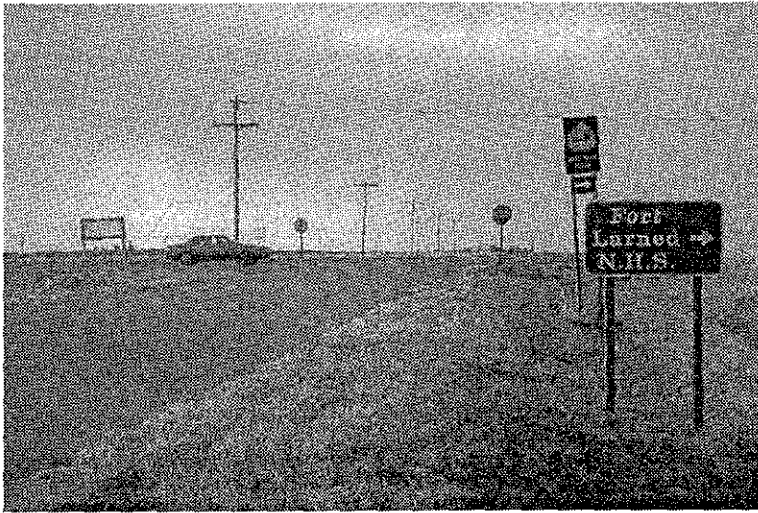
Figure 59. County Road FAS 986, looking north to intersection with Kansas Route 156. [LCA, 4/96]

mile (Figure 59). FAS 986 leads south over the Pawnee River on a concrete-and-steel highway bridge, completed in 1994, to the southern boundary of the NHS, where it continues as a dirt road. West of the county road just north of the river is a one-lane, dirt service road leading to a material storage area. South of the river, a controlled-access, one-lane, dirt-and-gravel service road leads east to intersect with the service road behind Officers' Row. Farther along FAS 986, a dirt-and-gravel entry drive leads west to the fenced, similarly-surfaced, NHS maintenance yard.

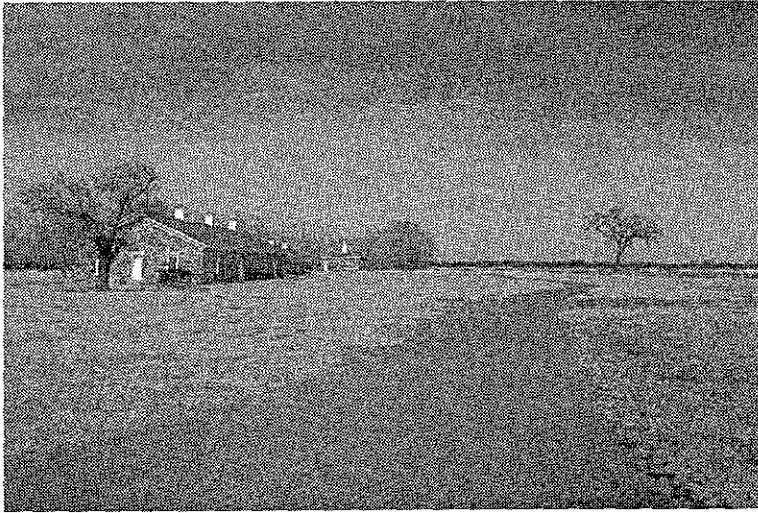
Figure 60. Service road south of quadrangle. [LCA, 4/96]

The two service roads that intersect southwest of Officers' Row continue eastward, south of HS-5 and HS-6 (Figure 60). South of the blockhouse they split again, this time to form a loop which doubles as the pedestrian, history and nature trail. One arm continues north along the east side of HS-4 and HS-3 as a dirt-and-gravel service road, and the other arm continues east as a dirt track along the approximate alignment of the Santa Fe Trail. The former road segment crosses the drainage ditch on an at-grade, wood-plank bridge between the blockhouse and HS-4. Northeast of HS-2 it continues as a dirt track, crossing two embankments at the ends of the oxbow before turning east and south to join the Santa Fe Trail portion. Another dirt track runs south from the fort as a farm road, crossing the reconstructed prairie and agricultural lands toward the community of Frizell. At the Trail Ruts unit, vehicular circulation is limited to a dirt-and-gravel pull-in parking area for two vehicles adjacent to the county road.

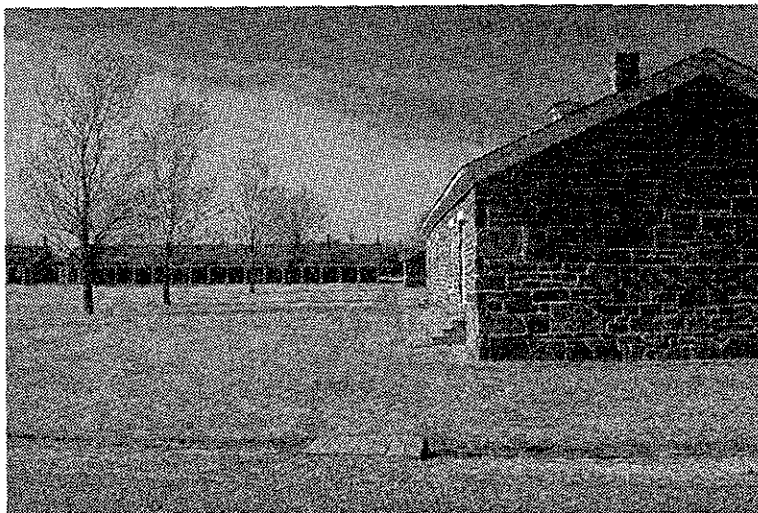
Figure 61. Gravel path and boardwalk in front of HS-4. [LCA, 4/96]

The predominant pedestrian circulation within the NHS is the broad, perimeter walk that surrounds the fort's central parade ground. The gravel walk varies in width from 16' in front of Officers' Row and 14' on the north-northwest and south-southeast sides to 5' in front of HS-3 and HS-4 (Figure 61). The gravel path in front of HS-5 continues east beyond the quadrangle to provide access to the blockhouse. Gravel crosswalks, approximately 5' in width, connect opposite sides of the perimeter walk. A circular gravel area astride the west-southwestern crosswalk, 30' in diameter, marks the center of the parade ground and supports the fort's flagstaff. A reconstructed boardwalk, 4' in width and approximately 440' long, runs in front of the officers' quarters just west of the perimeter gravel walk (Figure 62). The northern and southern ends of the boardwalk are angled to the west for an approximate distance of 25'. Short, entry walks of similar construction lead from the main boardwalk to each of the five sets of porch stairs serving the three residences (Figure 63). An at-grade section of boardwalk also occurs near the eastern corner of the quadrangle where the perimeter gravel path crosses the drainage ditch.

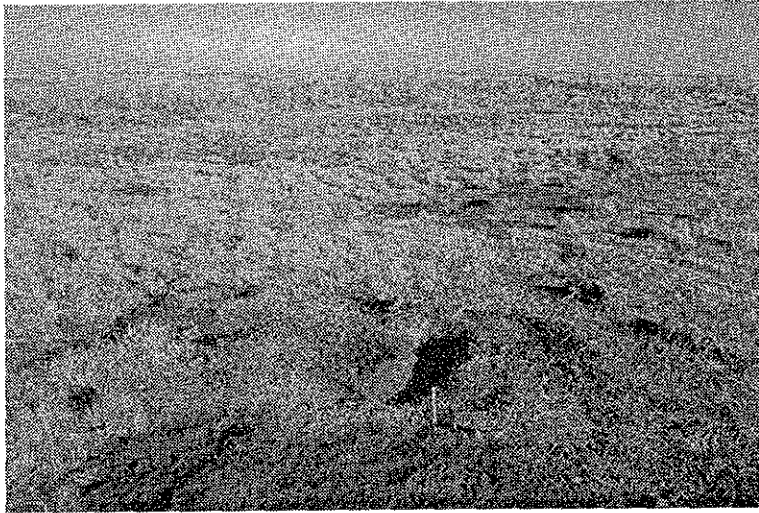
Figure 71. Prairie dog holes at the Trail Ruts unit. [LCA, 4/96]

While prairie restoration efforts appear to be progressing, turf management issues have arisen within the native prairie of the Trail Ruts unit. The prairie dog community in this area appears to be thriving, resulting in heavy grazing and limited growth of prairie grasses, and opening the possibility of damage to the historic trail ruts by the expansion of their burrows (*Figure 71*). Similarly, pocket gophers present a turf management problem within the fort precinct. Networks of gopher holes are present in several areas of the fort, notably north and west of HS-1 and HS-2, between HS-3 and HS-4, in the rear yards of HS-7 and HS-8, northwest of HS-9, and in the south corner of the parade ground (*Figure 72*). These holes damage mowing equipment, subjecting it to expensive repairs, and pose a safety hazard to pedestrians as well as to horses present for special occasions.

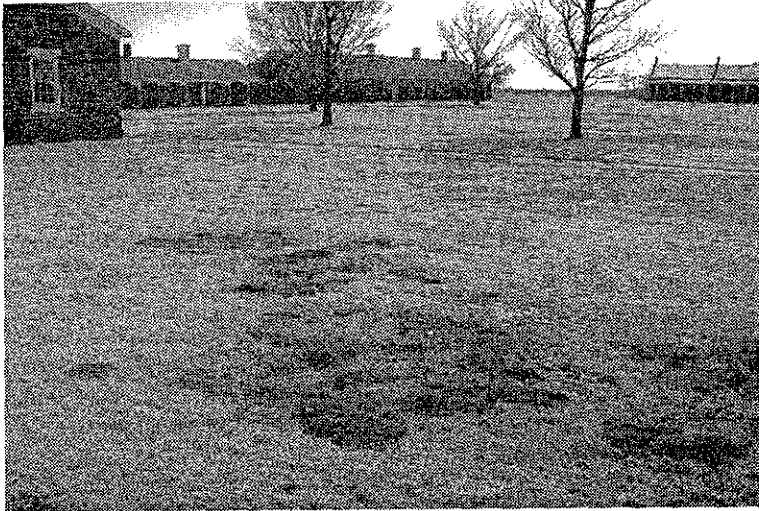
Figure 72. Pocket gopher holes between HS-3 and HS-4. [LCA, 4/96]

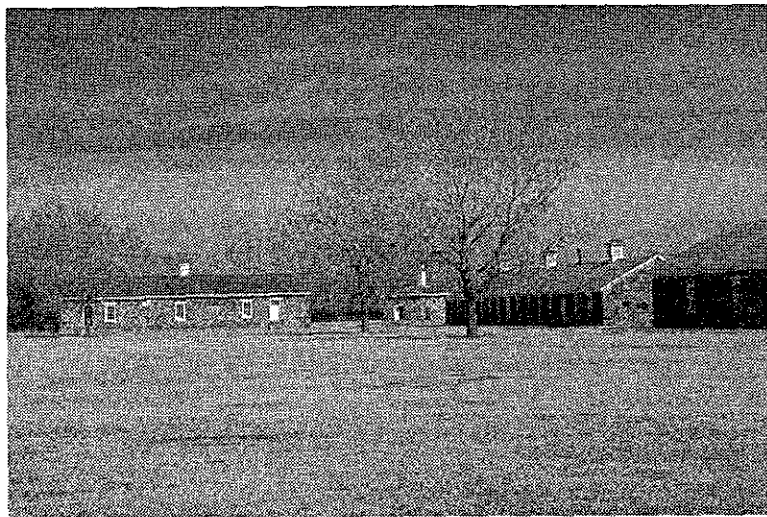
Figure 74. HS-4, HS-10, HS-5,  
and HS-6. [LCA, 4/96]

The historic buildings form the site's dominant cluster arrangement surrounding the fort's central quadrangle. Within this arrangement, several of the buildings and reconstructed structures have close physical, visual or functional relationships. Three one-story sandstone buildings, the Barracks / Visitor Center (HS-1), Barracks / Post Hospital (HS-2), both built 1867-68, and Shops Building (HS-3), built 1867, and the two wood-frame well houses, reconstructed in 1988, form a recognizable, if somewhat extended, cluster at the north side of the parade ground (*Figure 73*). Opposite on the southeast side of the parade ground is a similar extended cluster consisting of the one-story sandstone New Commissary (HS-4) built 1867-68, Old Commissary (HS-5) built 1866, and Quartermaster Storehouse (HS-6) built 1867 (*Figure 74*). At the west end of the parade

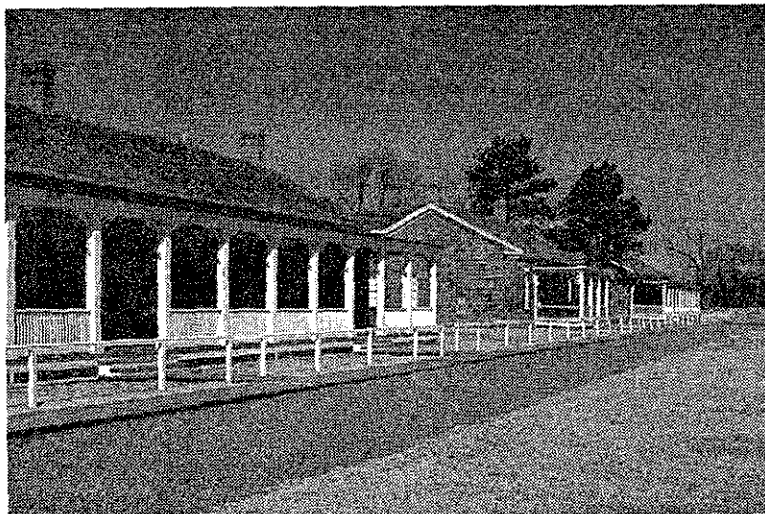
Figure 75. Officers' Row.  
[LCA, 4/96]

ground is the fort's most recognizable building cluster, the three residences and associated outbuildings known as Officers' Row (*Figure 75*). The central element in the row is the sandstone Commanding Officer's Quarters (HS-8), a one-story main block with a two-story rear ell, built in 1867. Flanking this are the two, one-story sandstone Officers' Quarters (HS-7, HS-9) built 1867-68. Each residence has two rear ells that form a courtyard containing a well house, reconstructed in 1988. Farther to the west along a central axis at each residence is a privy, reconstructed in 1988. A non-historic timber and metal carport is located in the rear yard of HS-8. At the center of the parade ground is the fort's 99'-tall reconstructed flagstaff (HS-10). During the site's hours of operation, a 37-star U.S. flag in one of three sizes is flown from the flagstaff depending upon the occasion and weather conditions (*Figure 76*).

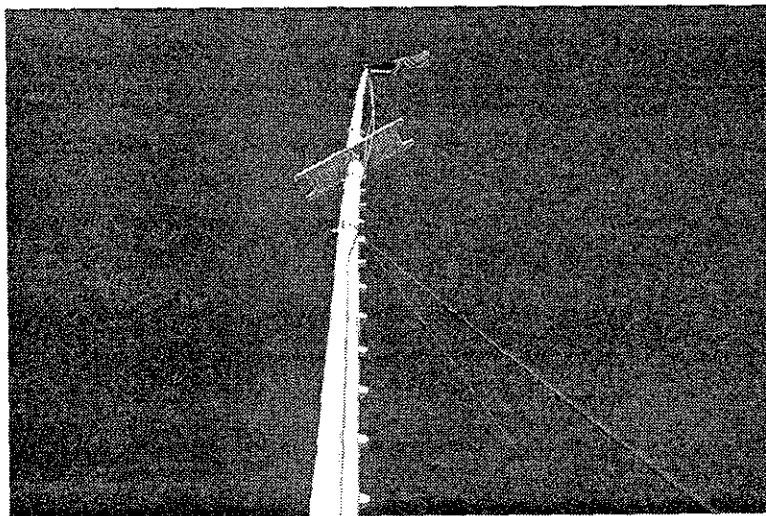
Figure 76. The fort's 99'  
flagstaff. [LCA, 4/96]

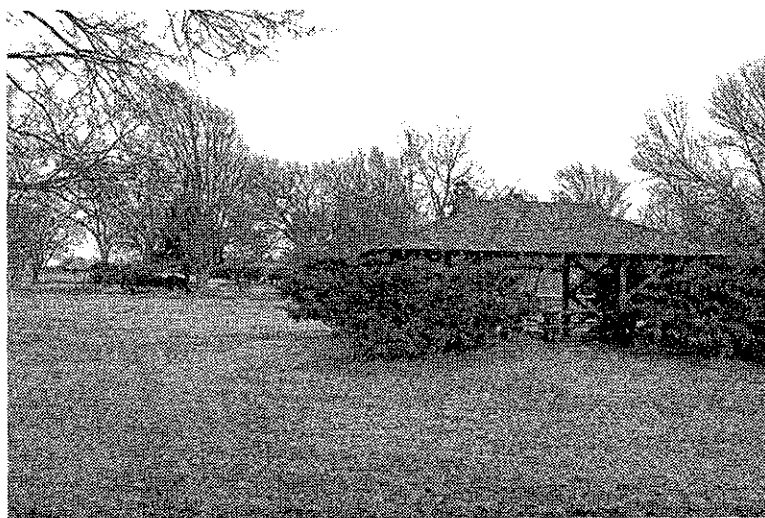
Figure 77. Timber and wood-and-steel shelters at the picnic area. [LCA, 4/96]

The contemporary picnic area also contains an informal cluster of non-historic structures, consisting of two timber and four steel-and-wood-frame picnic shelters, a steel-and-wood-frame exhibit shelter, and a one-story, split-face concrete block restroom building built in 1987 (*Figure 77*).

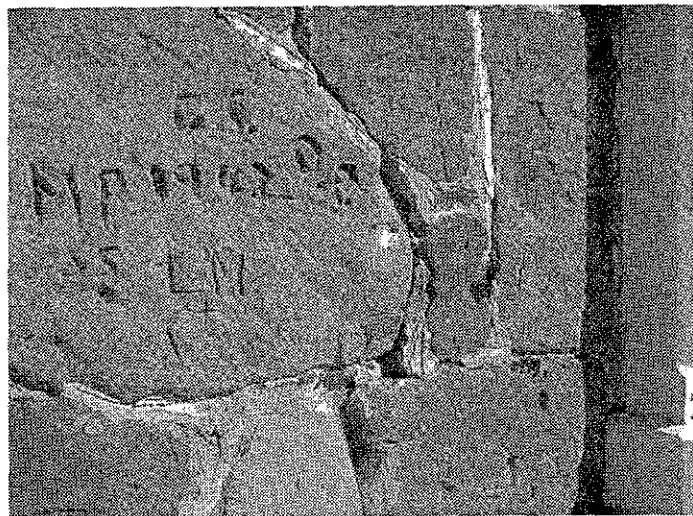
Figure 78. Carved graffiti and boxelder bugs at HS-2. [LCA, 4/96]

In general, most of the historic sandstone buildings appear to be in good condition. Many, however, have extensive areas of carved graffiti, some examples of which date from the fort's historic period. Several buildings also exhibit cracks in the exterior walls due to differential settlement of building foundations and/or moisture penetration and freeze/thaw action. These cracks and other wall openings also provide opportunity for nests of boxelder bugs, wasps, mud-daubers, and sparrows (*Figure 78*). The reconstructed buildings and structures are of recent construction and are in good condition, as are the two concrete block buildings. The remaining structures appear to be in fair condition owing to their age or exposed locations. None of the buildings currently meets the Uniform Federal Accessibility Standards (UFAS) for facility accessibility. Quinn Evans / Architects, the prime consultant for the Midwest Indefinite Quantity Contract, is undertaking concurrent historic structure reports (HSRs) for the NHS.
