FORT LARNED

NATIONAL HISTORIC SITE • KANSAS
NATIONAL PARK SERVICE

Cultural Landscape Report

MAY 1999

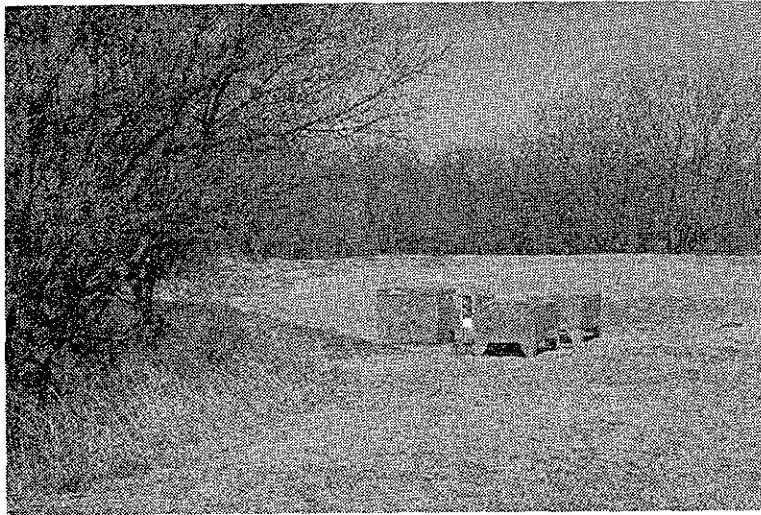
Figure 85. HVAC equipment adjacent to entry walk. [LCA, 4/96]

- concrete pads and HVAC equipment northwest of HS-1 (*Figure 85*) [Good]
- below grade fire hydrant and water shut-off boxes (8) at perimeter of parade ground [Good]

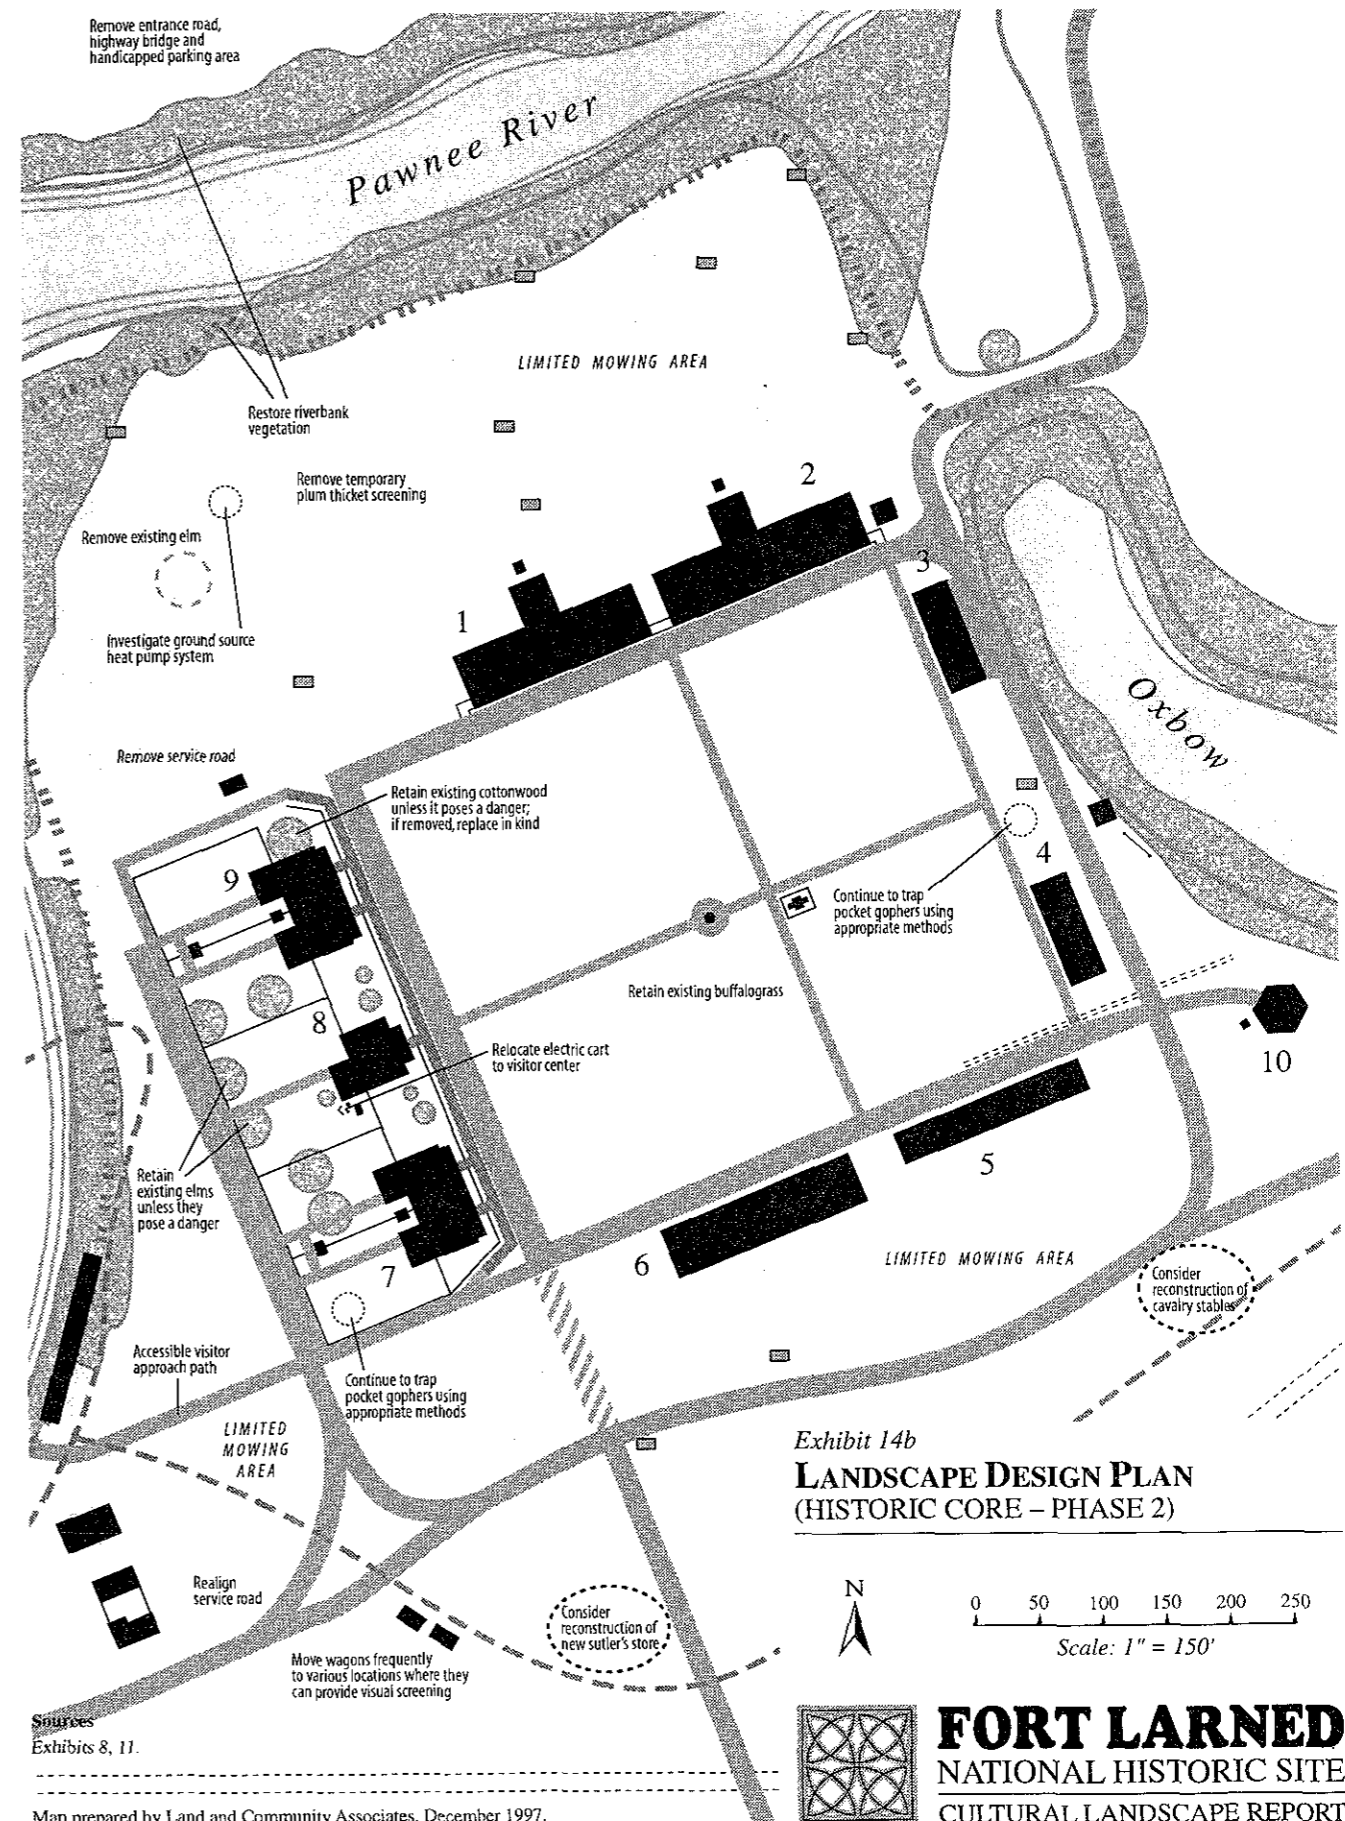
Exhibit 14b  
**LANDSCAPE DESIGN PLAN**  
 (HISTORIC CORE - PHASE 2)

The landscape design plan for Phase 2 focuses on changes to the NHS that can be implemented in conjunction with construction of the visitor center NPS has proposed to locate outside the historic core. The new location provides increased opportunities for removing or relocating existing non-historic circulation, utilities, and vegetation. Relocation of the visitor center to a location outside the core provides an opportunity for removal of non-historic circulation systems that currently provide visitor access to the fort. Similarly new circulation systems are recommended for pedestrian access between the historic core and a new visitor center location; there are also proposals for expanding the trail system to provide pedestrian access to the existing picnic area. Removal of non-historic

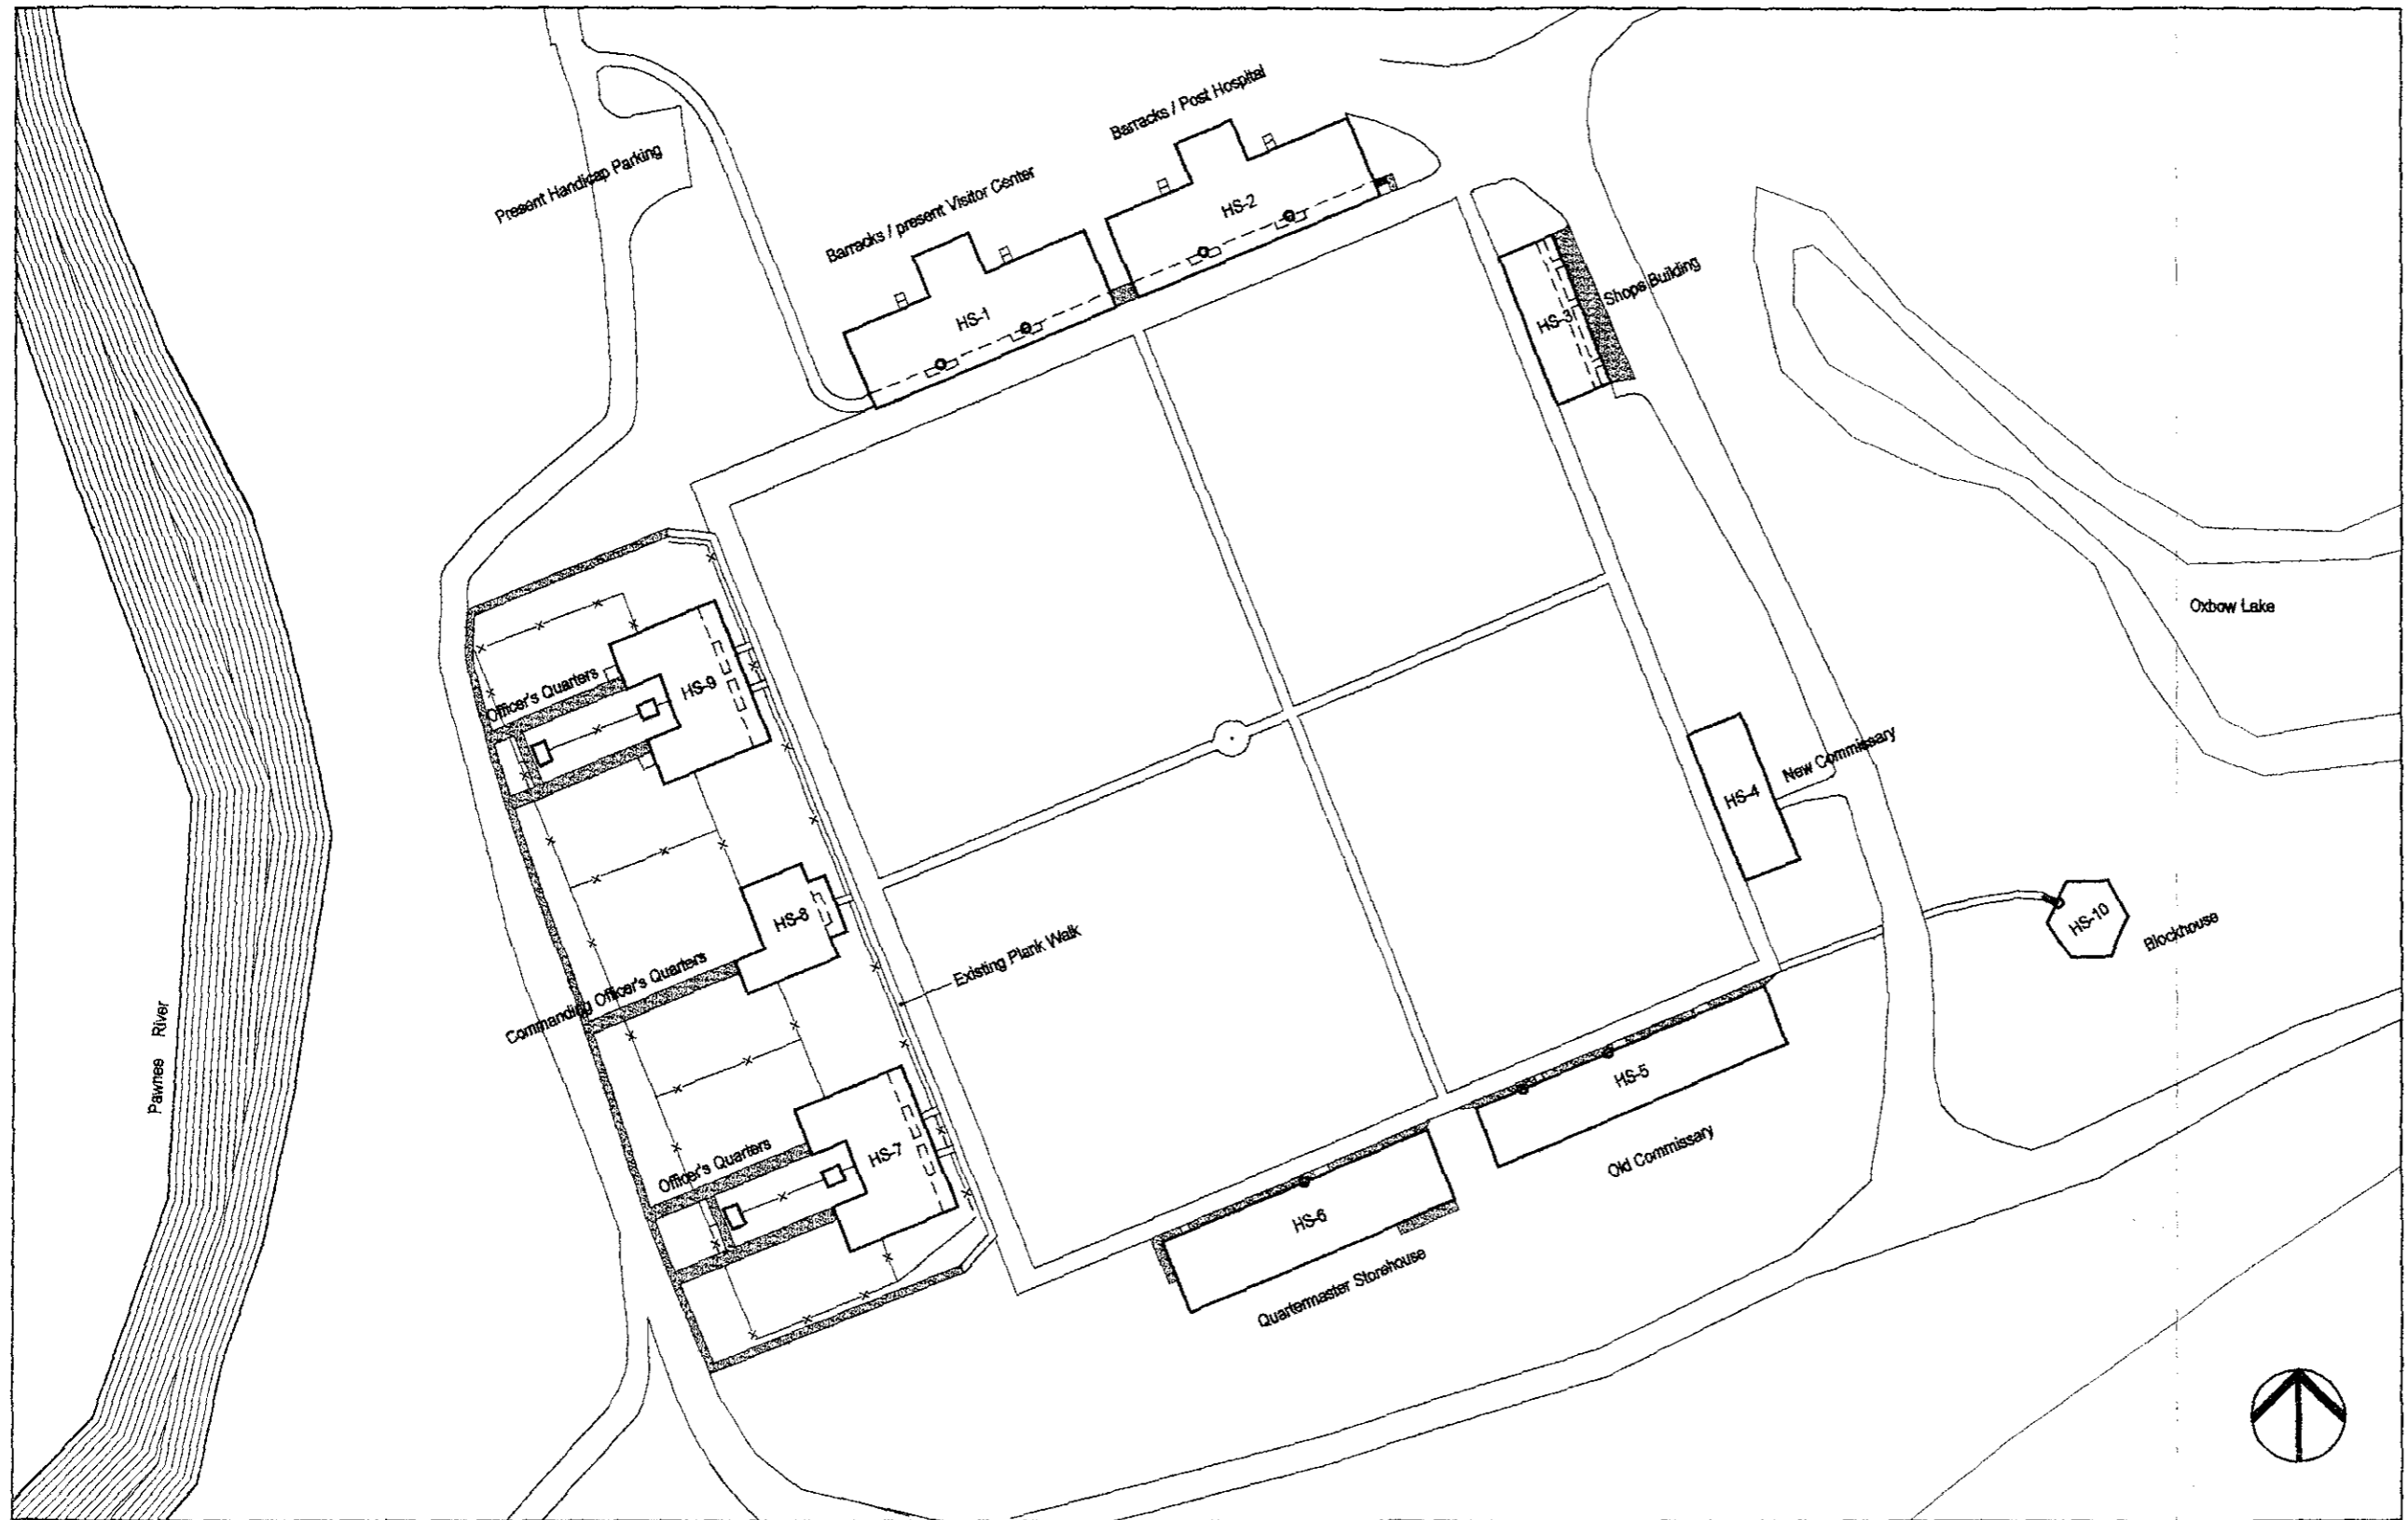
**This Key Map**  
 shows the general location of proposed additions for universal access and  
 is not to scale

**Proposed Ramps**  
 are constructed with dimension lumber. Appearance shall clearly differ from  
 historic plank walks

**Lifts**  
 will have a plank surface to match ramps and retractable guard rails

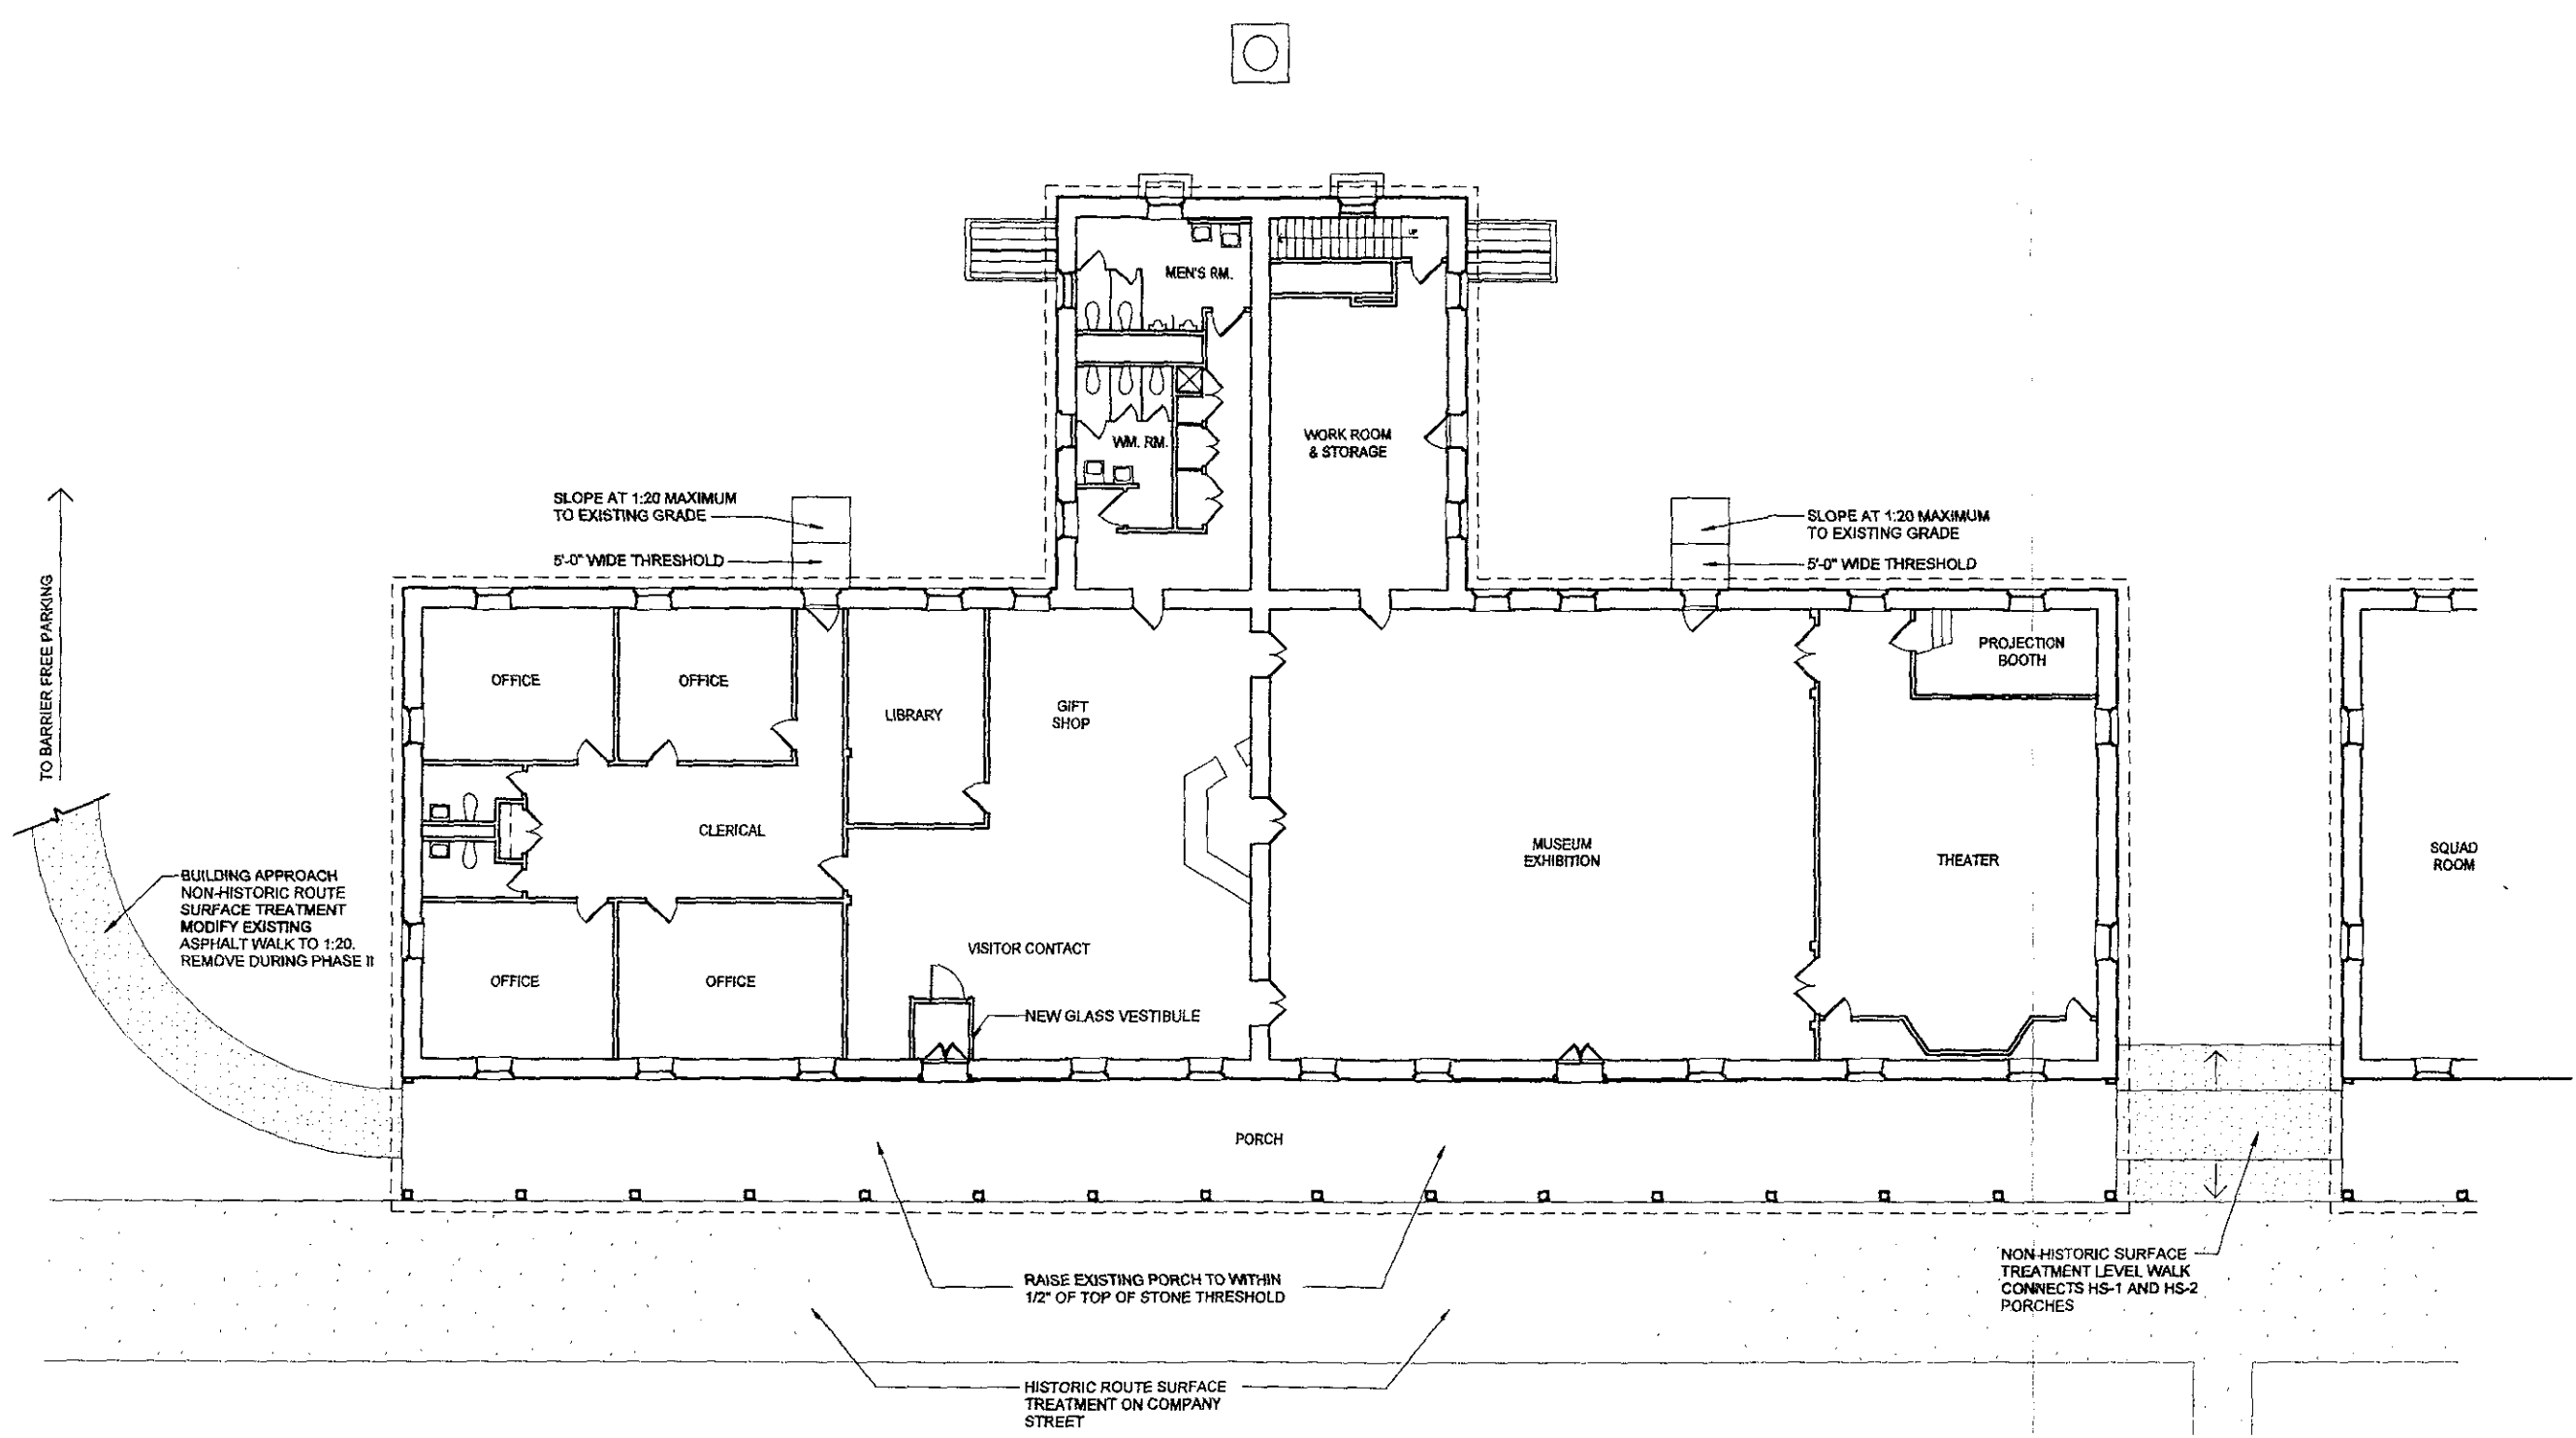
FIRST FLOOR PLAN  
*Exhibit 15b / Recommended Treatment*

DESIGNED: C. H., T. F.	SUB SHEET NO.  <b>A.2</b>	TITLE OF SHEET <b>FIRST FLOOR PLAN BARRACKS / VISITOR CENTER HS-1</b>		DRAWING NO. <b>425</b>
DRAWN: C. H., T. F.		FORT LARNED NATIONAL HISTORIC SITE LARNED, KANSAS		PKG. NO. <b>2</b>
TECH REVIEW: S. J.				SHEET <b>2</b>
DATE: 9/30/97 REV. 12/2/98				OF <b>14</b>

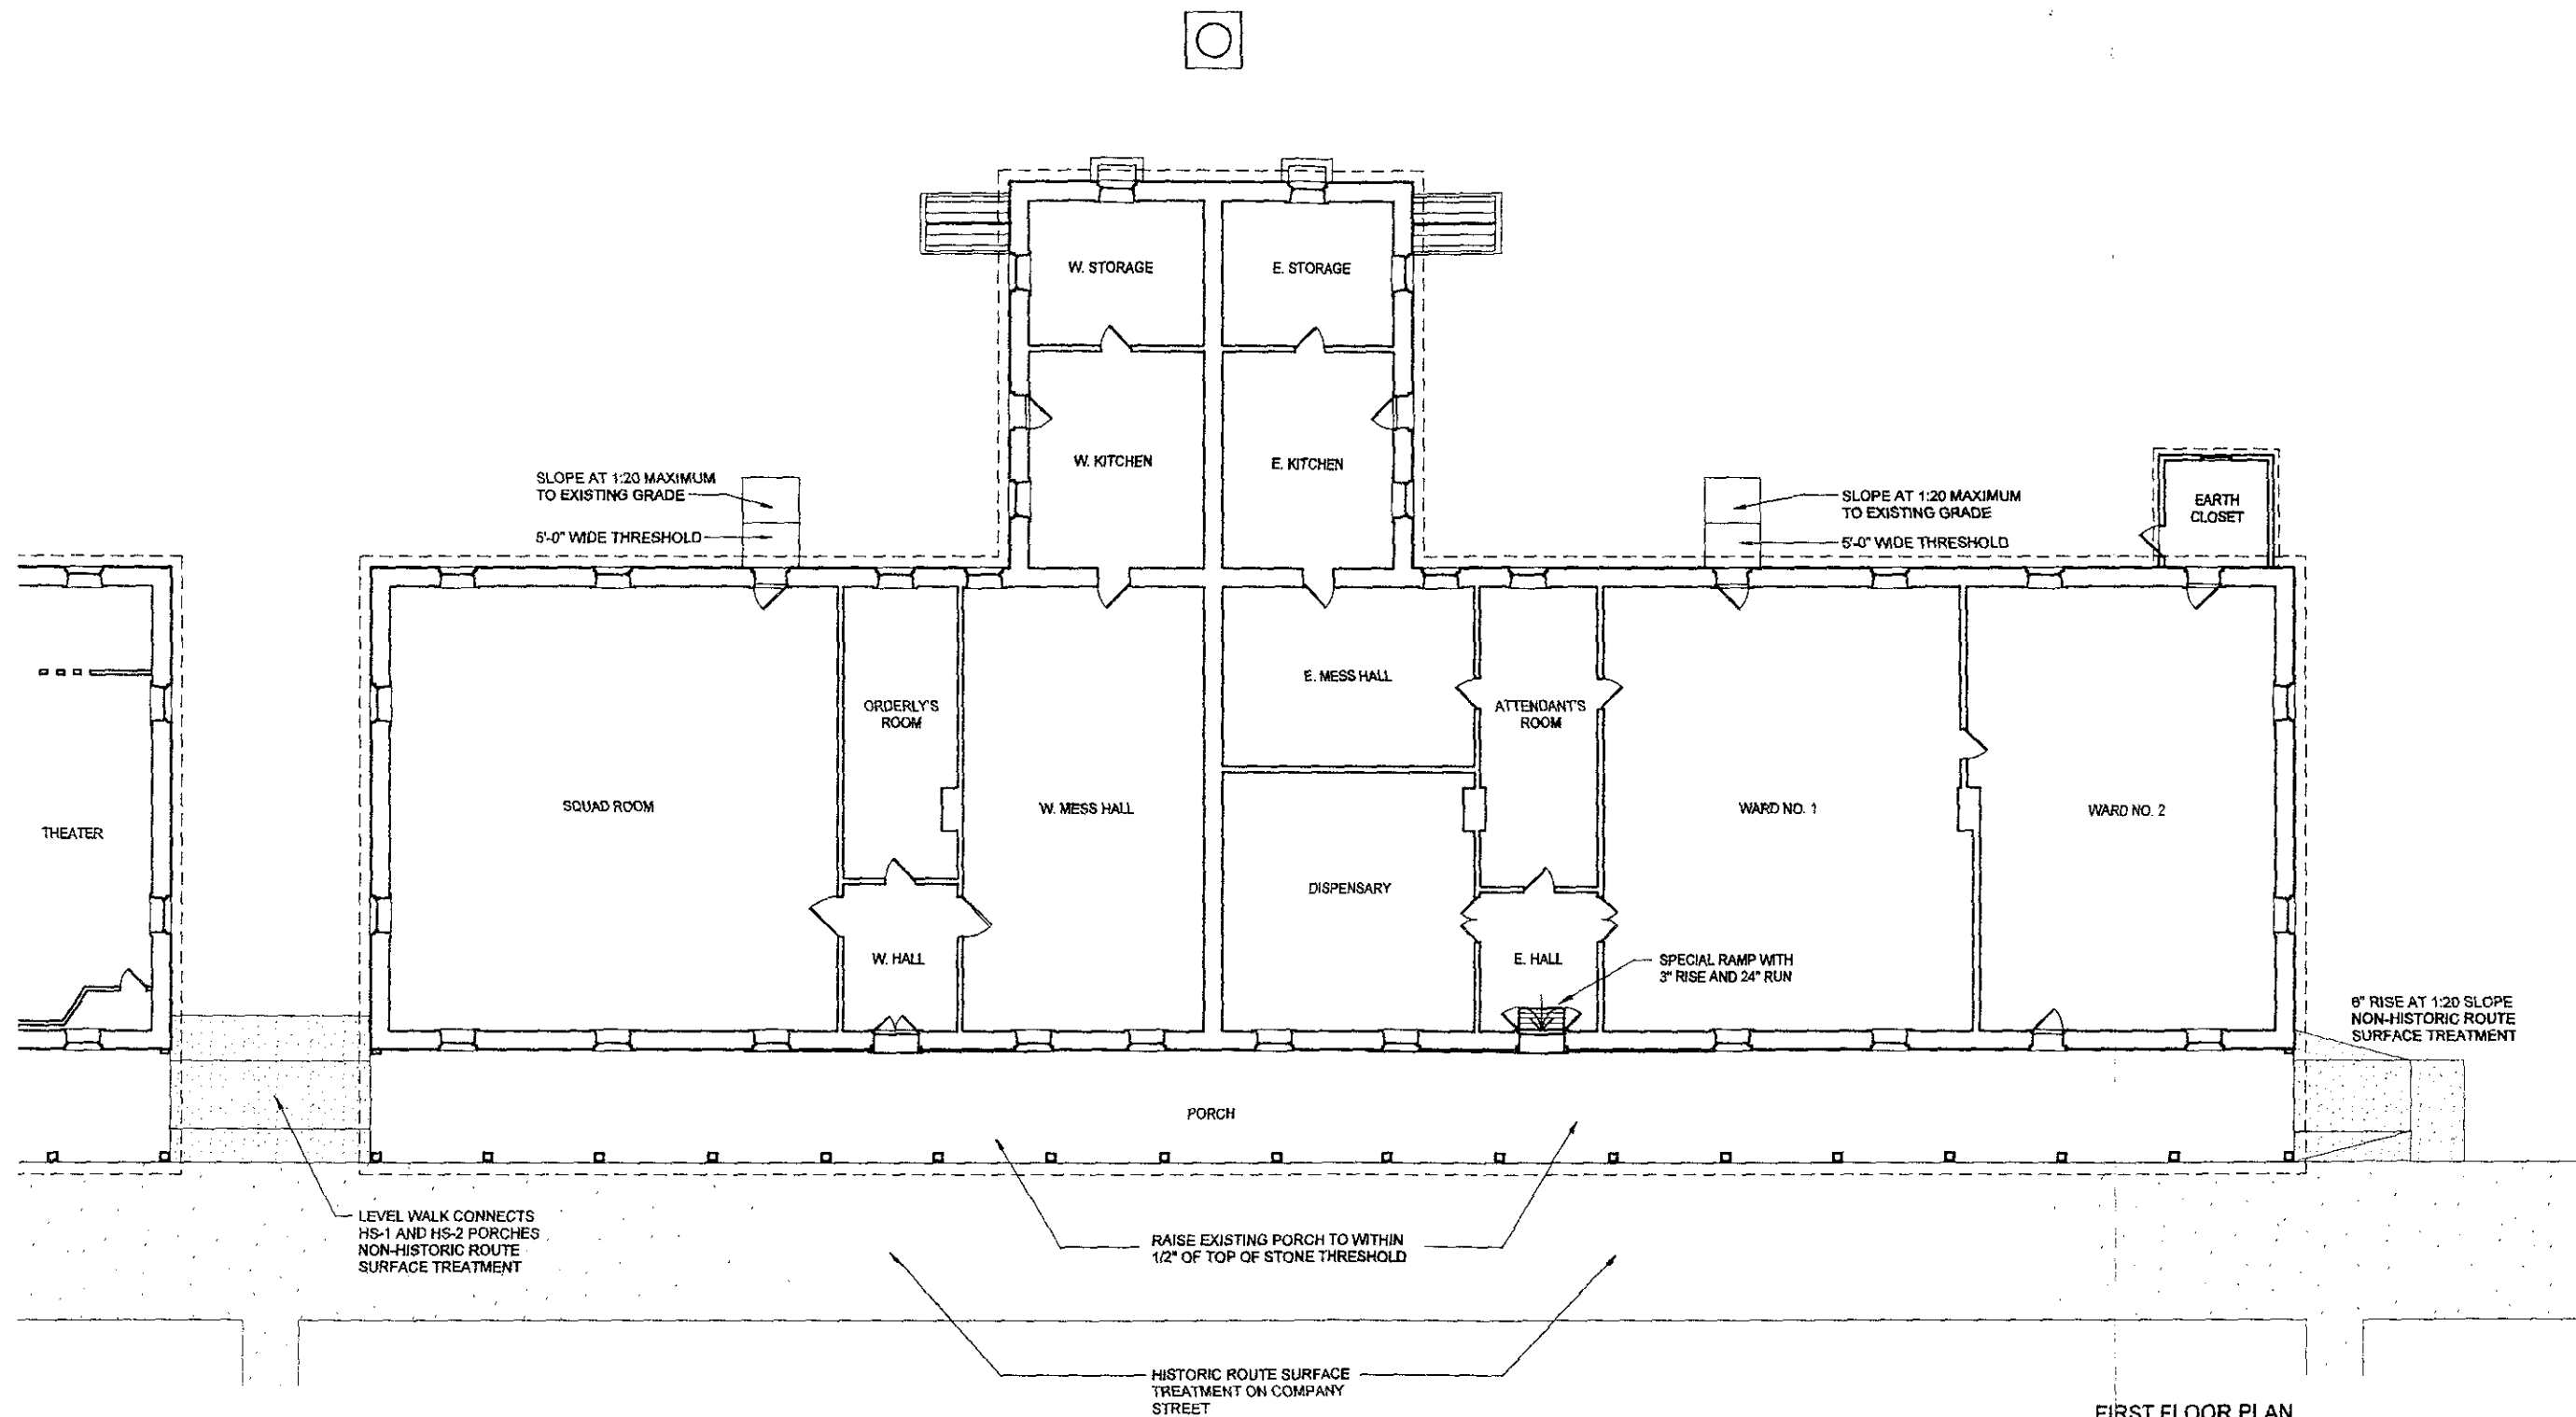
Exhibit 15c / Recommended Treatment

DESIGNED: C. H. T. F.	SUB SHEET NO.  <b>A.3</b>	TITLE OF SHEET  <b>FIRST FLOOR PLAN BARRACKS / POST HOSPITAL HS-2</b>	DRAWING NO. <b>425</b> <b>2007</b>	
DRAWN: C. H. T. F.		PKG. NO.	SHEET	
TECH REVIEW: S. J.			<b>3</b>	
DATE: 5/30/97 REV. 12/2/98				OF <b>14</b>
		FORT LARNED NATIONAL HISTORIC SITE LARNED, KANSAS

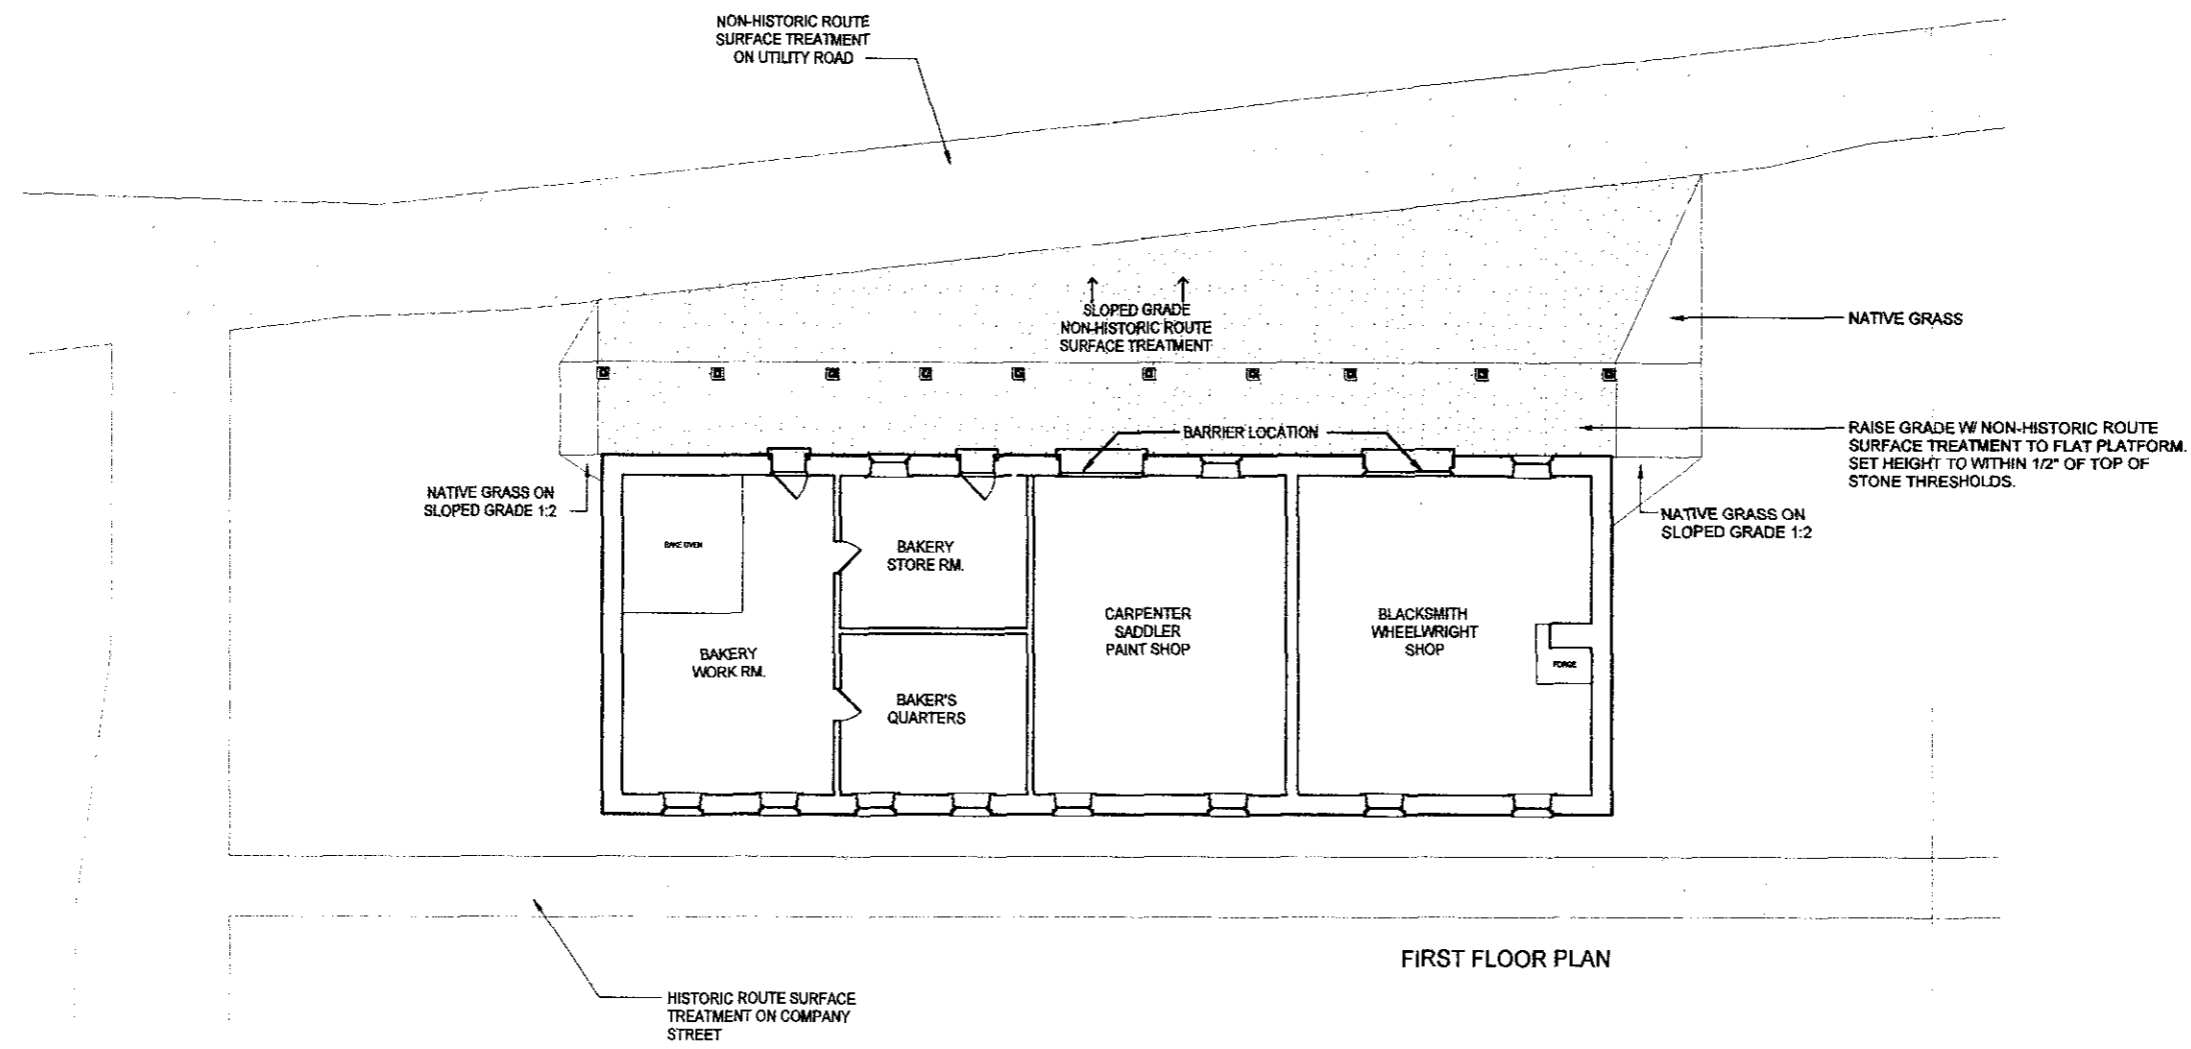
Exhibit 15d / Recommended Treatment

DESIGNED: C. H. T. F.	SUB SHEET NO.  <b>A.4</b>	TITLE OF SHEET  <b>FIRST FLOOR PLAN SHOPS BUILDING HS-3</b>	DRAWING NO. <b>425</b>
DRAWN: C. H. T. F.			20024
TECH REVIEW: S. J.			PKG. NO. <b>4</b>
DATE: 5/30/97 REV. 12/2/98			SHEET OF <b>14</b>
FORT LARNED NATIONAL HISTORIC SITE LARNED, KANSAS

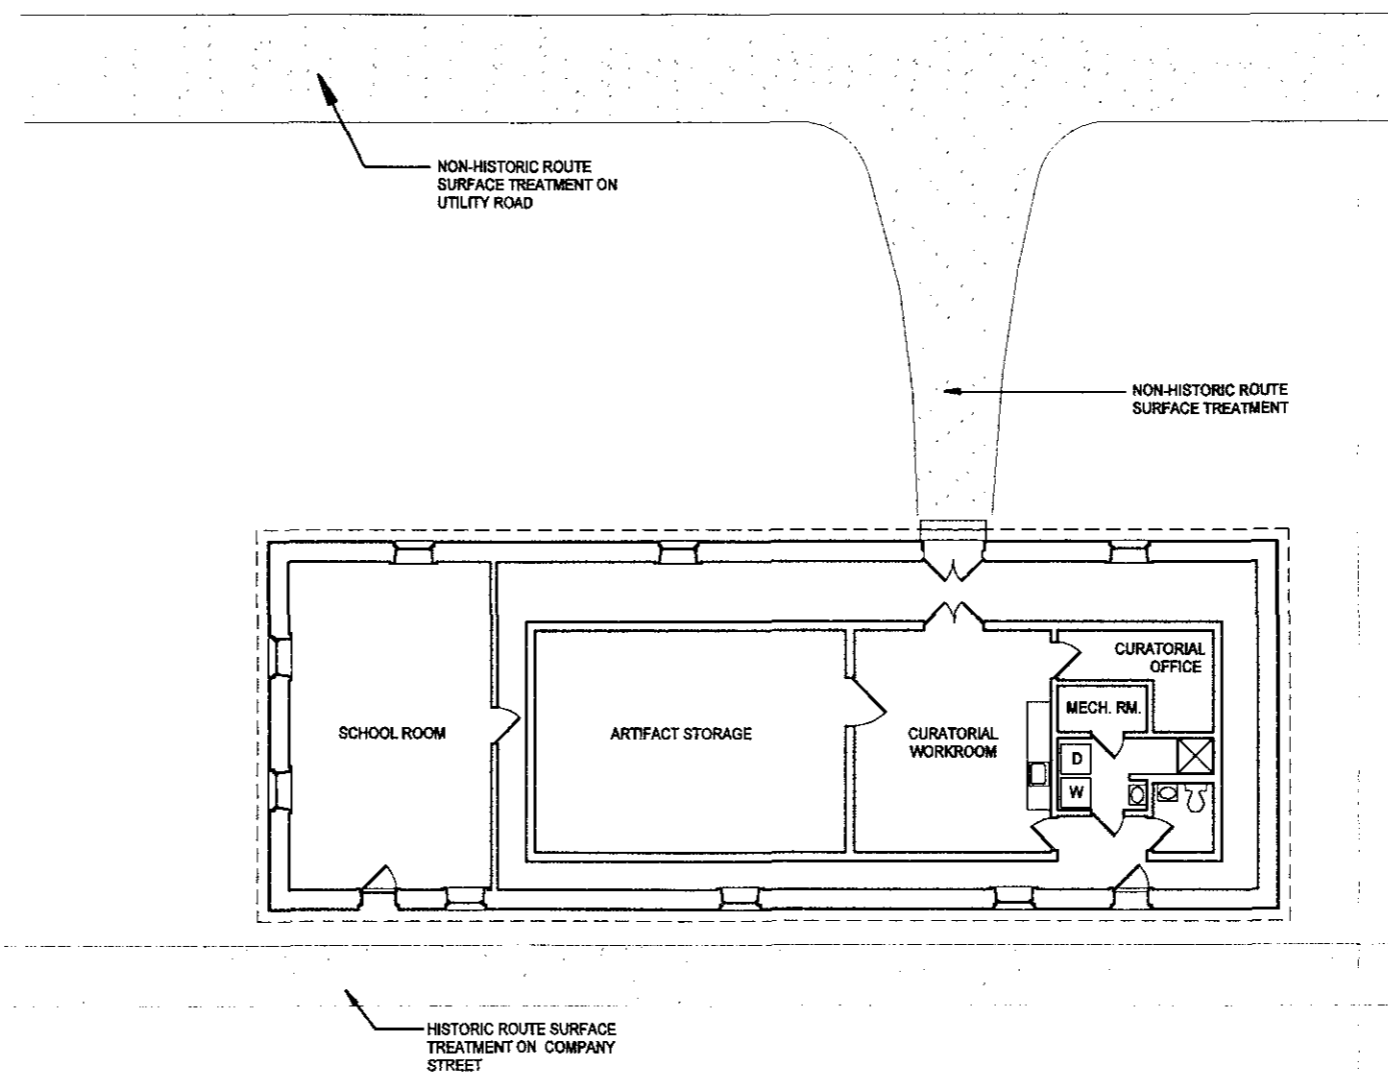
*Exhibit 15e / Recommended Treatment*

DESIGNED: C. H., T. F.	SUB SHEET NO.  <b>A.5</b>	TITLE OF SHEET  <b>FIRST FLOOR PLAN NEW COMMISSARY HS-4</b>	DRAWING NO. <b>425</b> <b>20624</b>
DRAWN: C. H., T. F.		FORT LARNED NATIONAL HISTORIC SITE LARNED, KANSAS	PKG. NO. —
TECH REVIEW: S. J.			SHEET <b>5</b>
DATE: 5/30/97 REV. 12/2/98			OF <b>14</b>

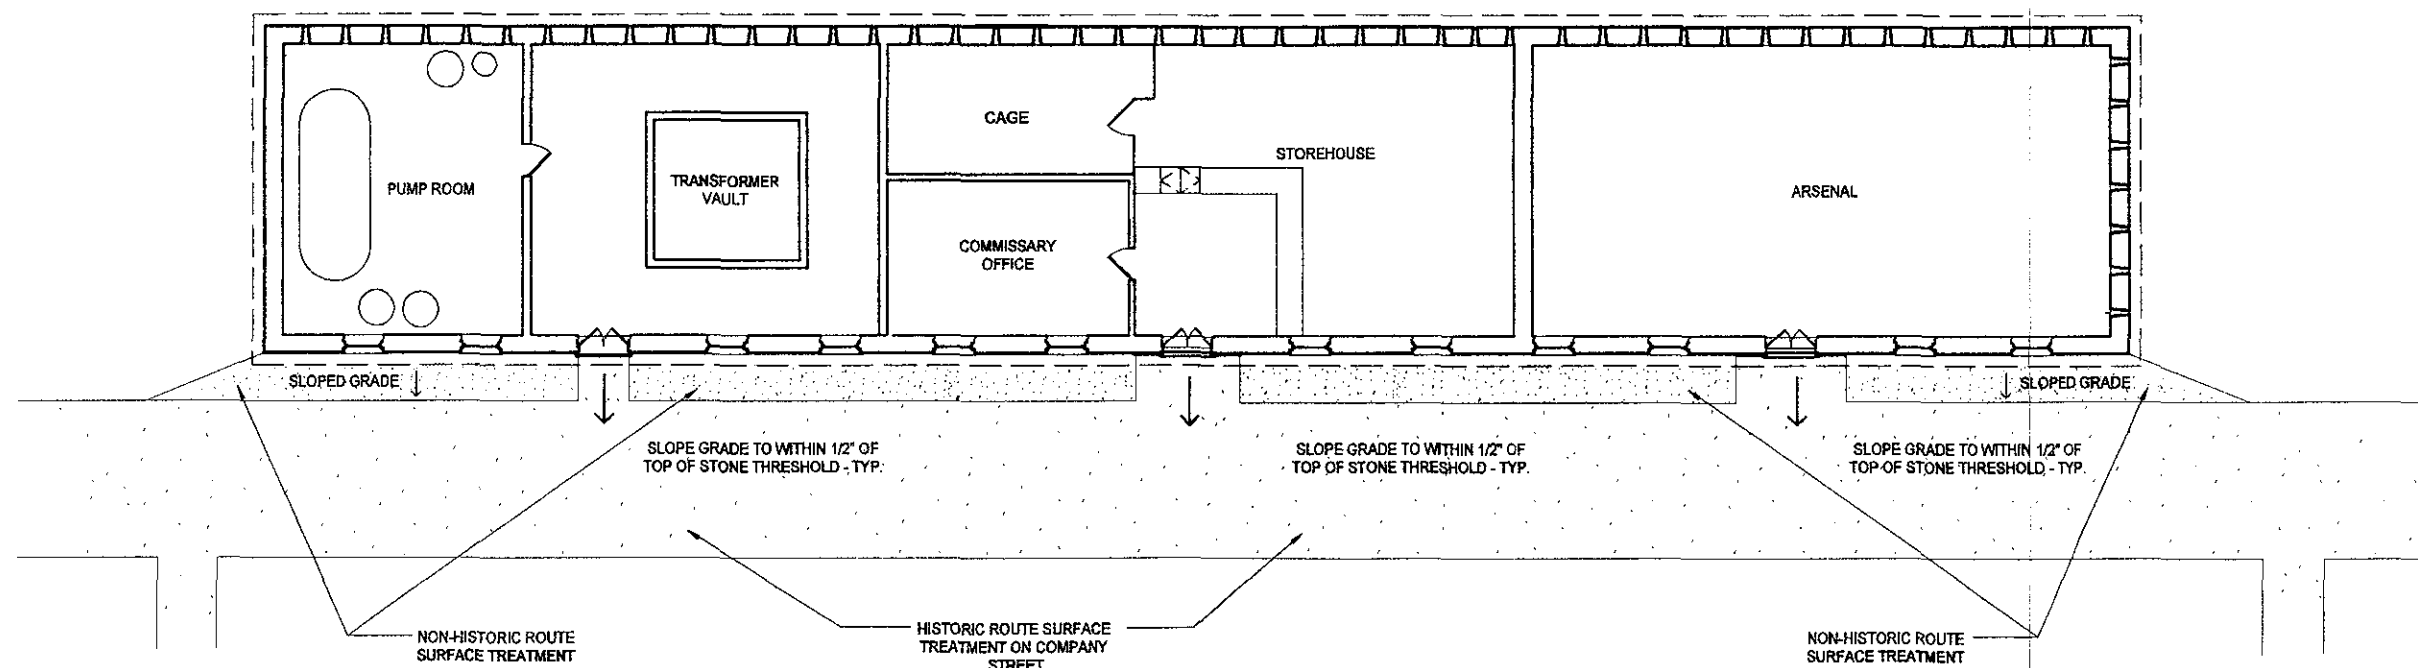
*Exhibit 15f / Recommended Treatment*

DESIGNED: C. H., T. F.	SUB SHEET NO.  <b>A.6</b>	TITLE OF SHEET  <b>FIRST FLOOR PLAN OLD COMMISSARY HS-5</b>	DRAWING NO. <b>425</b> <i>200 24</i>
DRAWN: C. H., T. F.		FORT LARNED NATIONAL HISTORIC SITE LARNED, KANSAS	PKG. NO.
TECH REVIEW: S. J.			SHEET <b>6</b>
DATE: 5/30/97 REV. 12/2/98			OF <b>14</b>

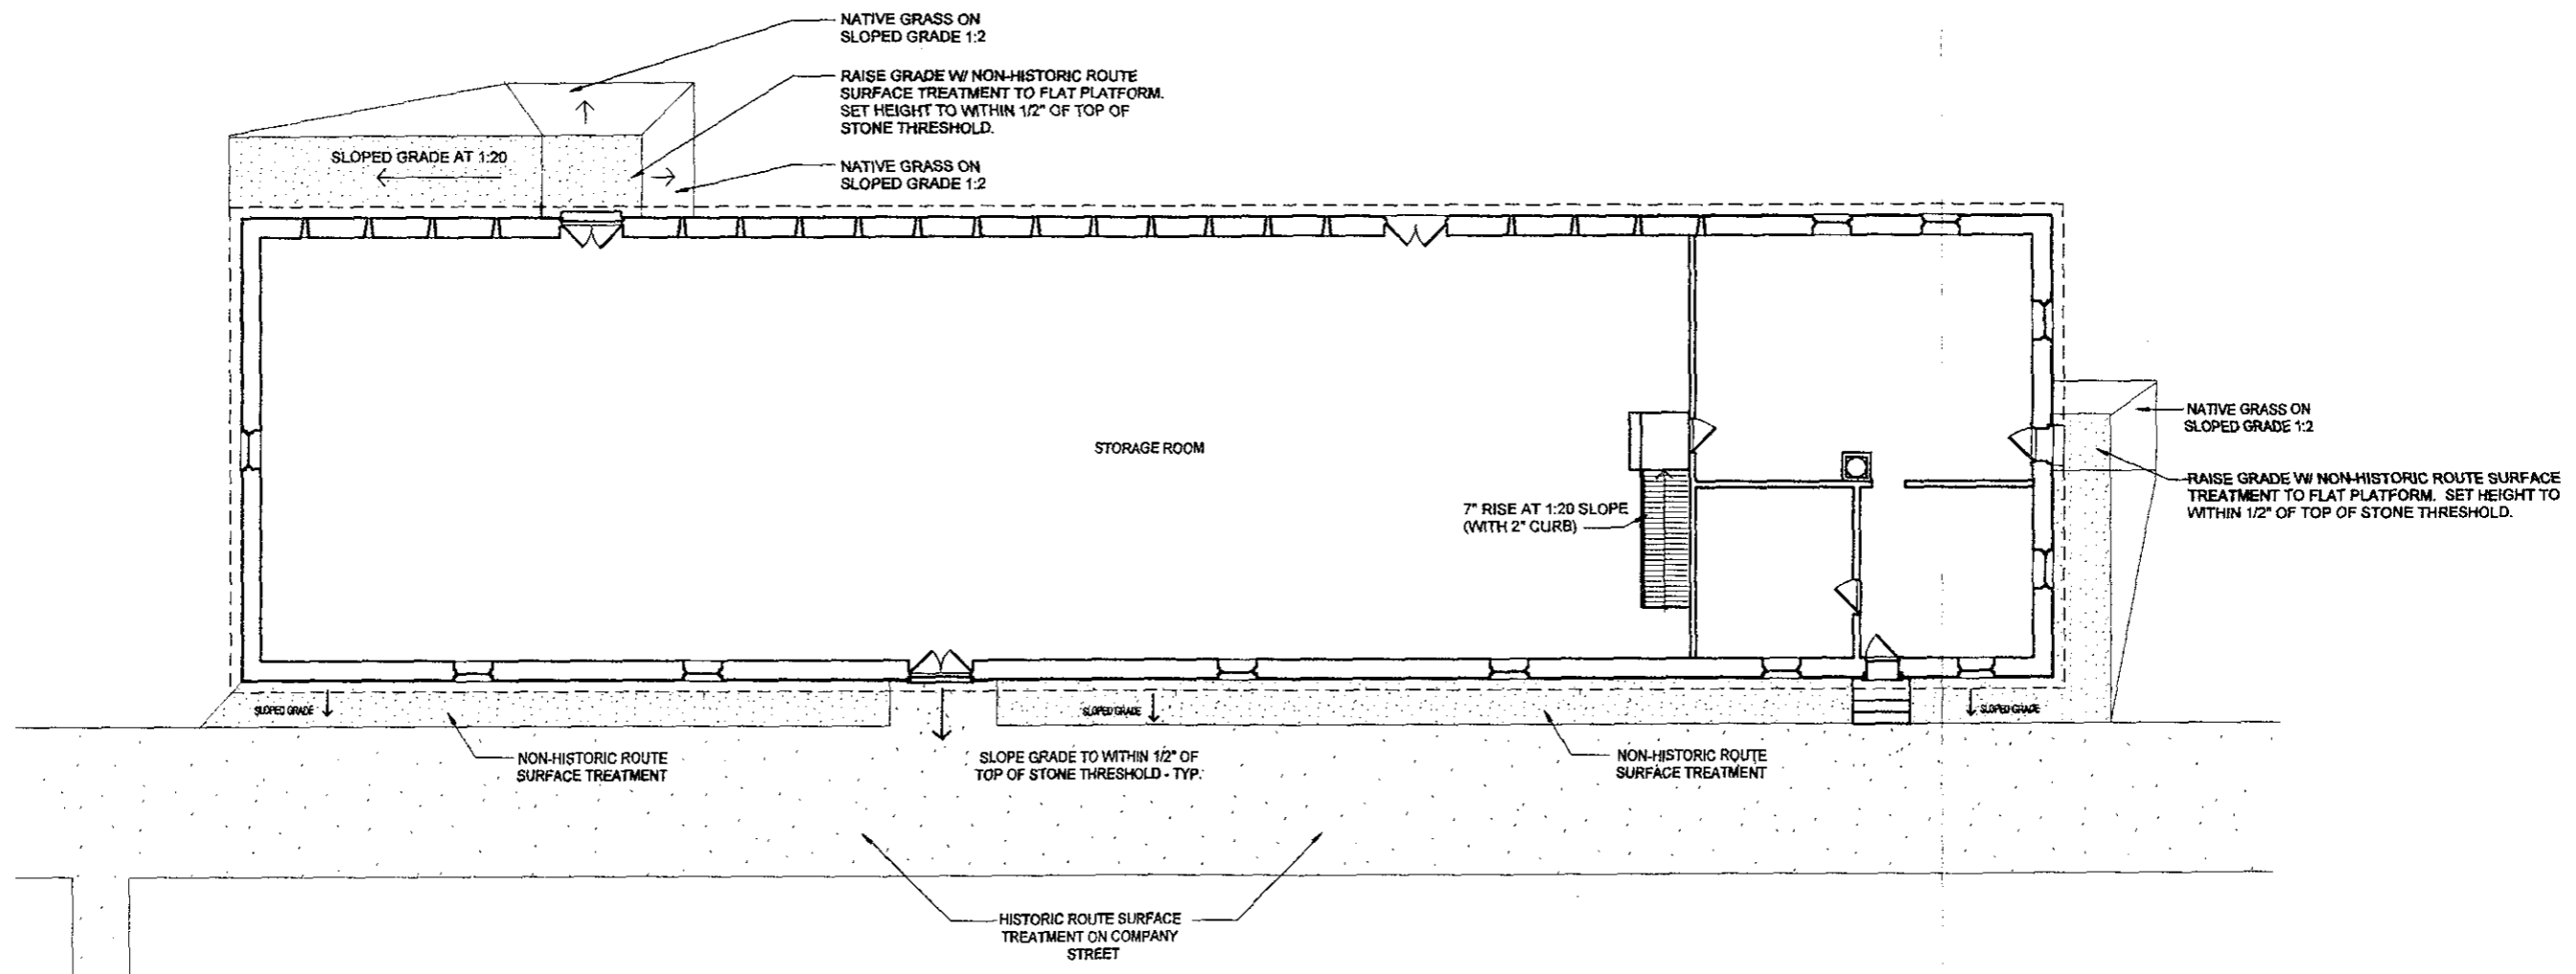
Exhibit 15g / Recommended Treatment

DESIGNED: C. H., T. F.	SUB SHEET NO.  <b>A.7</b>	TITLE OF SHEET  FIRST FLOOR PLAN QUARTERMASTER WAREHOUSE HS-6	DRAWING NO. <b>425</b> <b>20027</b>
DRAWN: C. H., T. F.		FORT LARNED NATIONAL HISTORIC SITE LARNED, KANSAS	PKG. NO.
TECH REVIEW: S. J.			SHEET <b>7</b>
DATE: 5/30/87 REV. 12/2/88			OF <b>14</b>
