FORT LARNED

NATIONAL HISTORIC SITE • KANSAS
NATIONAL PARK SERVICE

Cultural Landscape Report

MAY 1999

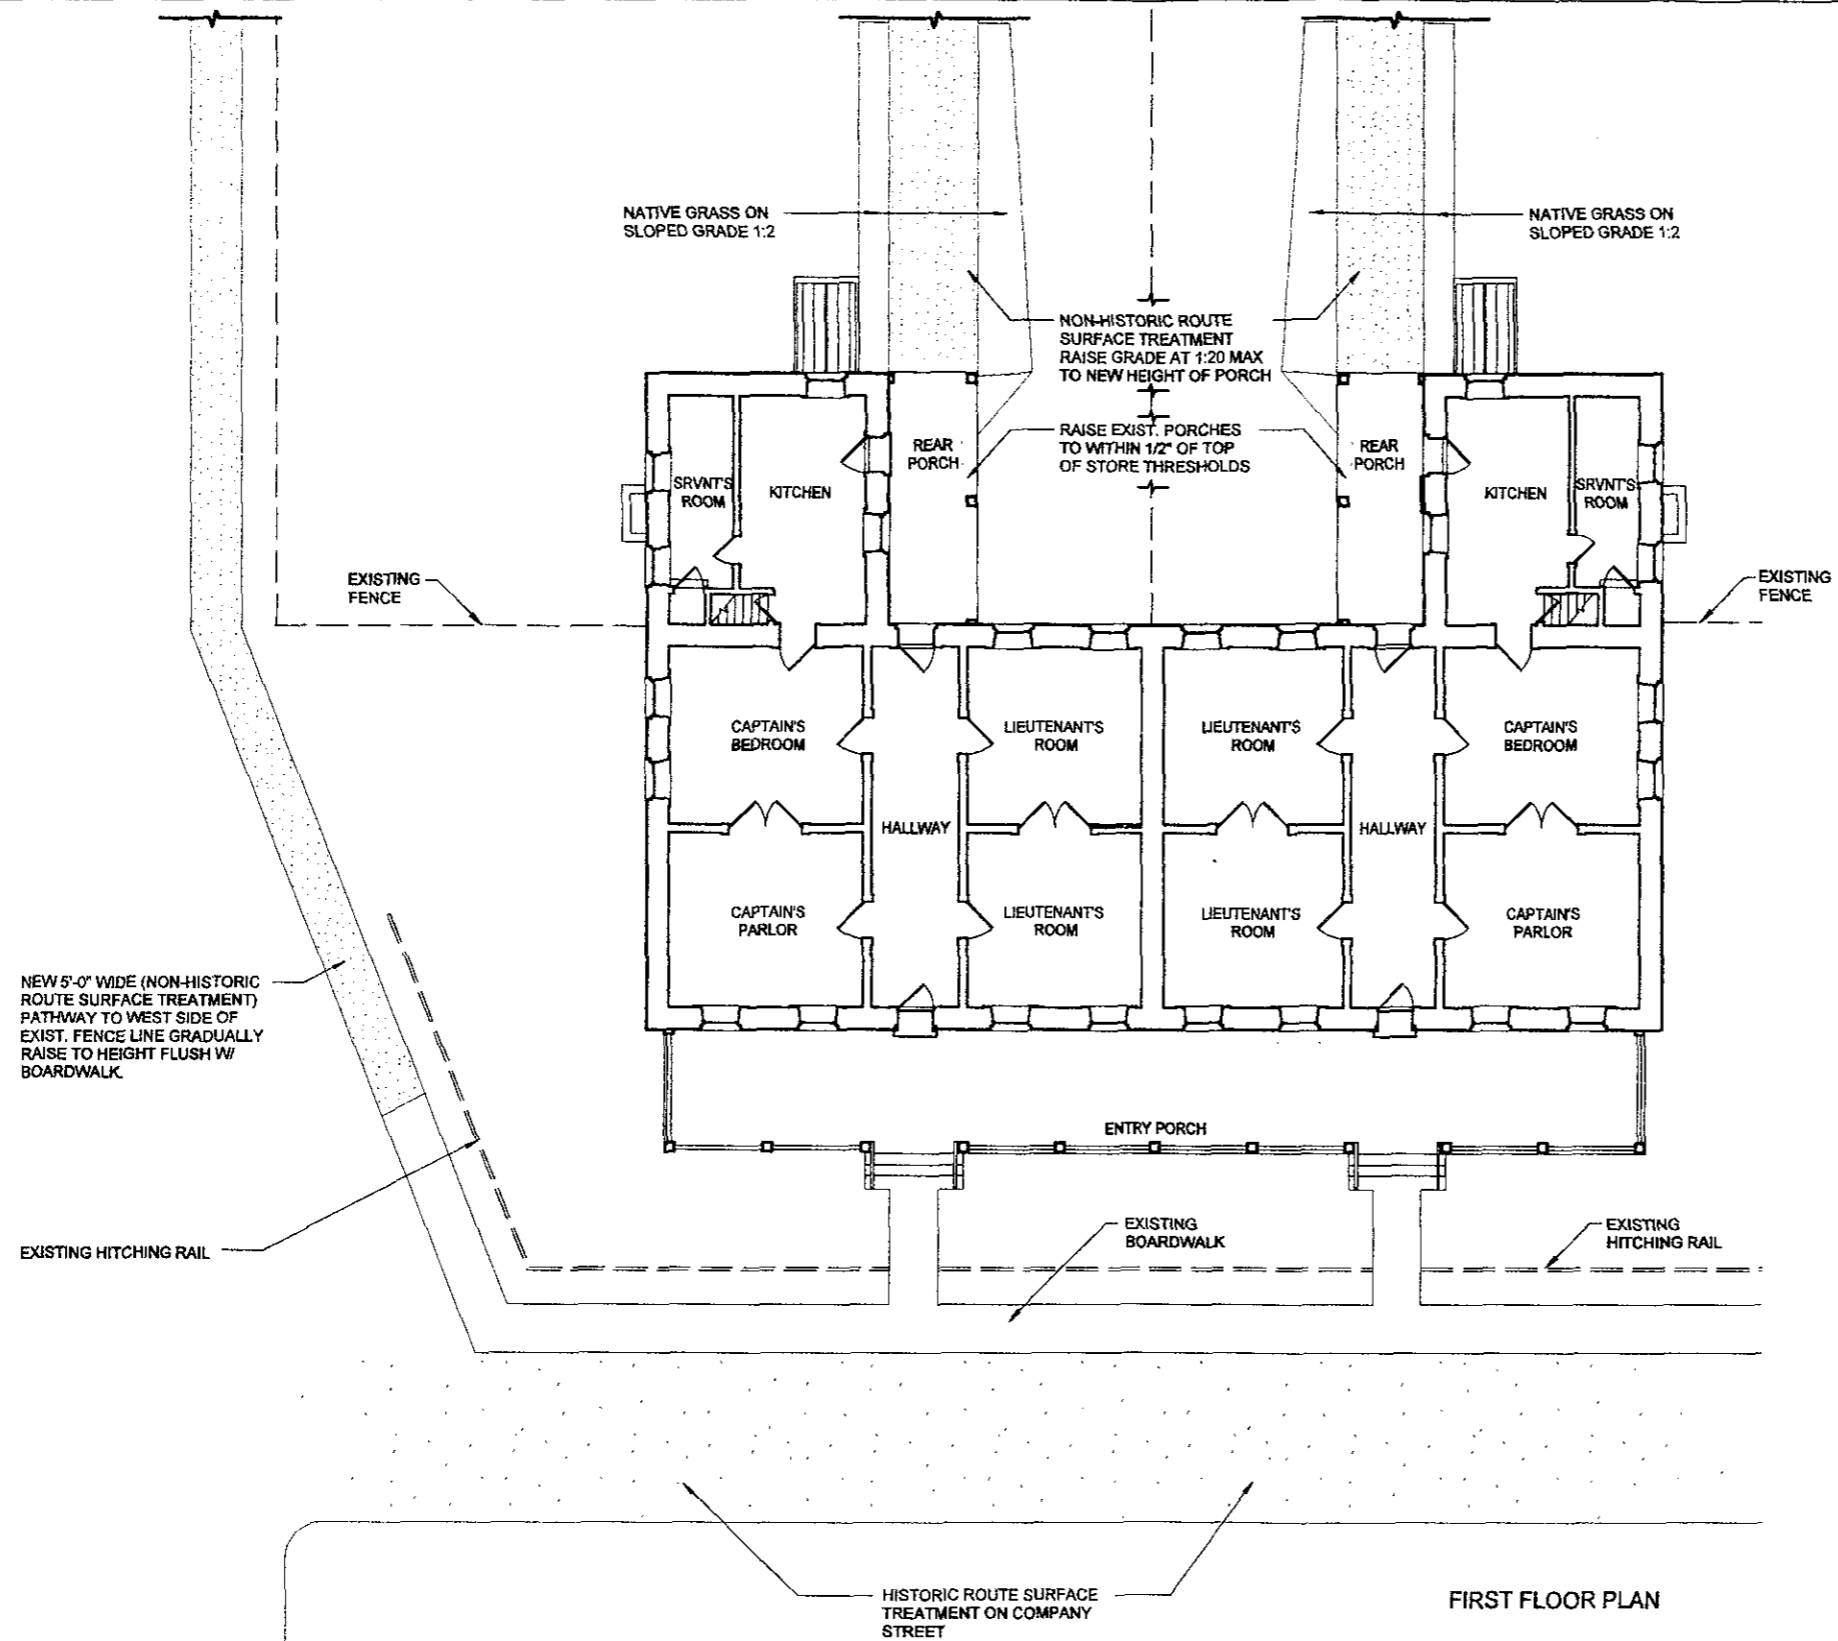
Exhibit 15h / Recommended Treatment

DESIGNED: C. H., T. F.	SUB SHEET NO.  <b>A.8</b>	TITLE OF SHEET <b>FIRST FLOOR PLAN OFFICERS' QUARTERS HS-7</b>	DRAWING NO. <b>425</b>
DRAWN: C. H., T. F.		FORT LARNED NATIONAL HISTORIC SITE LARNED, KANSAS	PKG. NO. —
TECH REVIEW: S. J.			SHEET <b>8</b>
DATE: 9/30/97 REV. 12/2/98			OF <b>14</b>

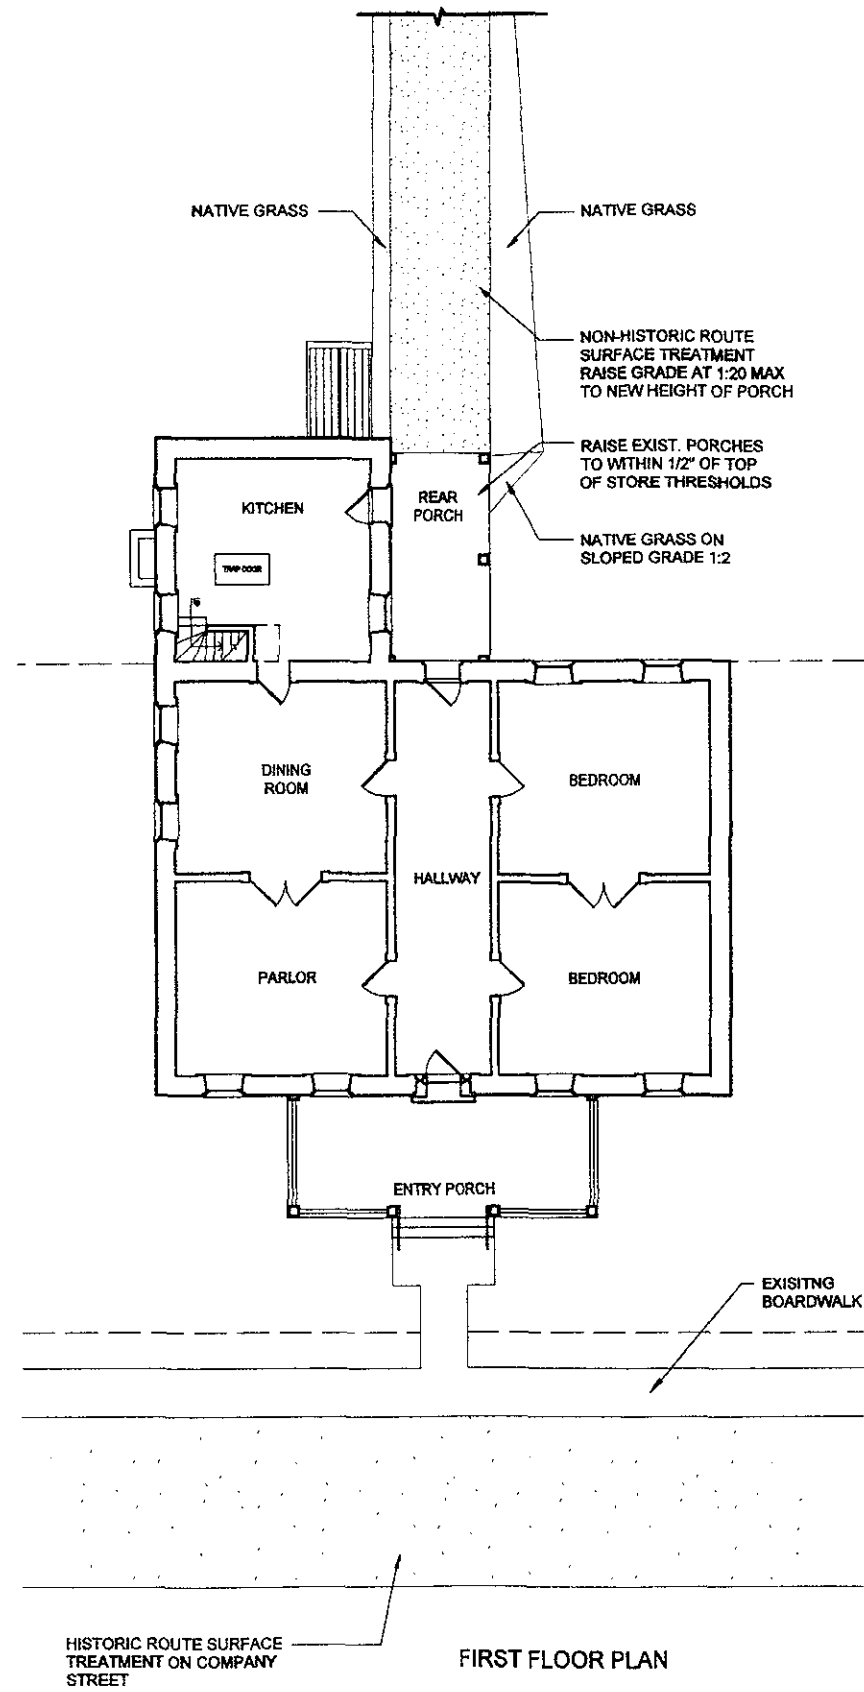
Exhibit 15i / Recommended Treatment

DESIGNED: C. H., T. F.	SUB SHEET NO.  <b>A.9</b>	TITLE OF SHEET <b>FIRST and SECOND FLOOR PLANS COMMANDING OFFICER'S QUARTERS HS-8</b>	DRAWING NO. <i>425</i>
DRAWN: C. H., T. F.		FORT LARNED NATIONAL HISTORIC SITE LARNED, KANSAS	PKG. NO. —
TECH REVIEW: S. J.			SHEET <b>9</b>
DATE: 5/30/87 REV. 12/2/98			OF <b>14</b>

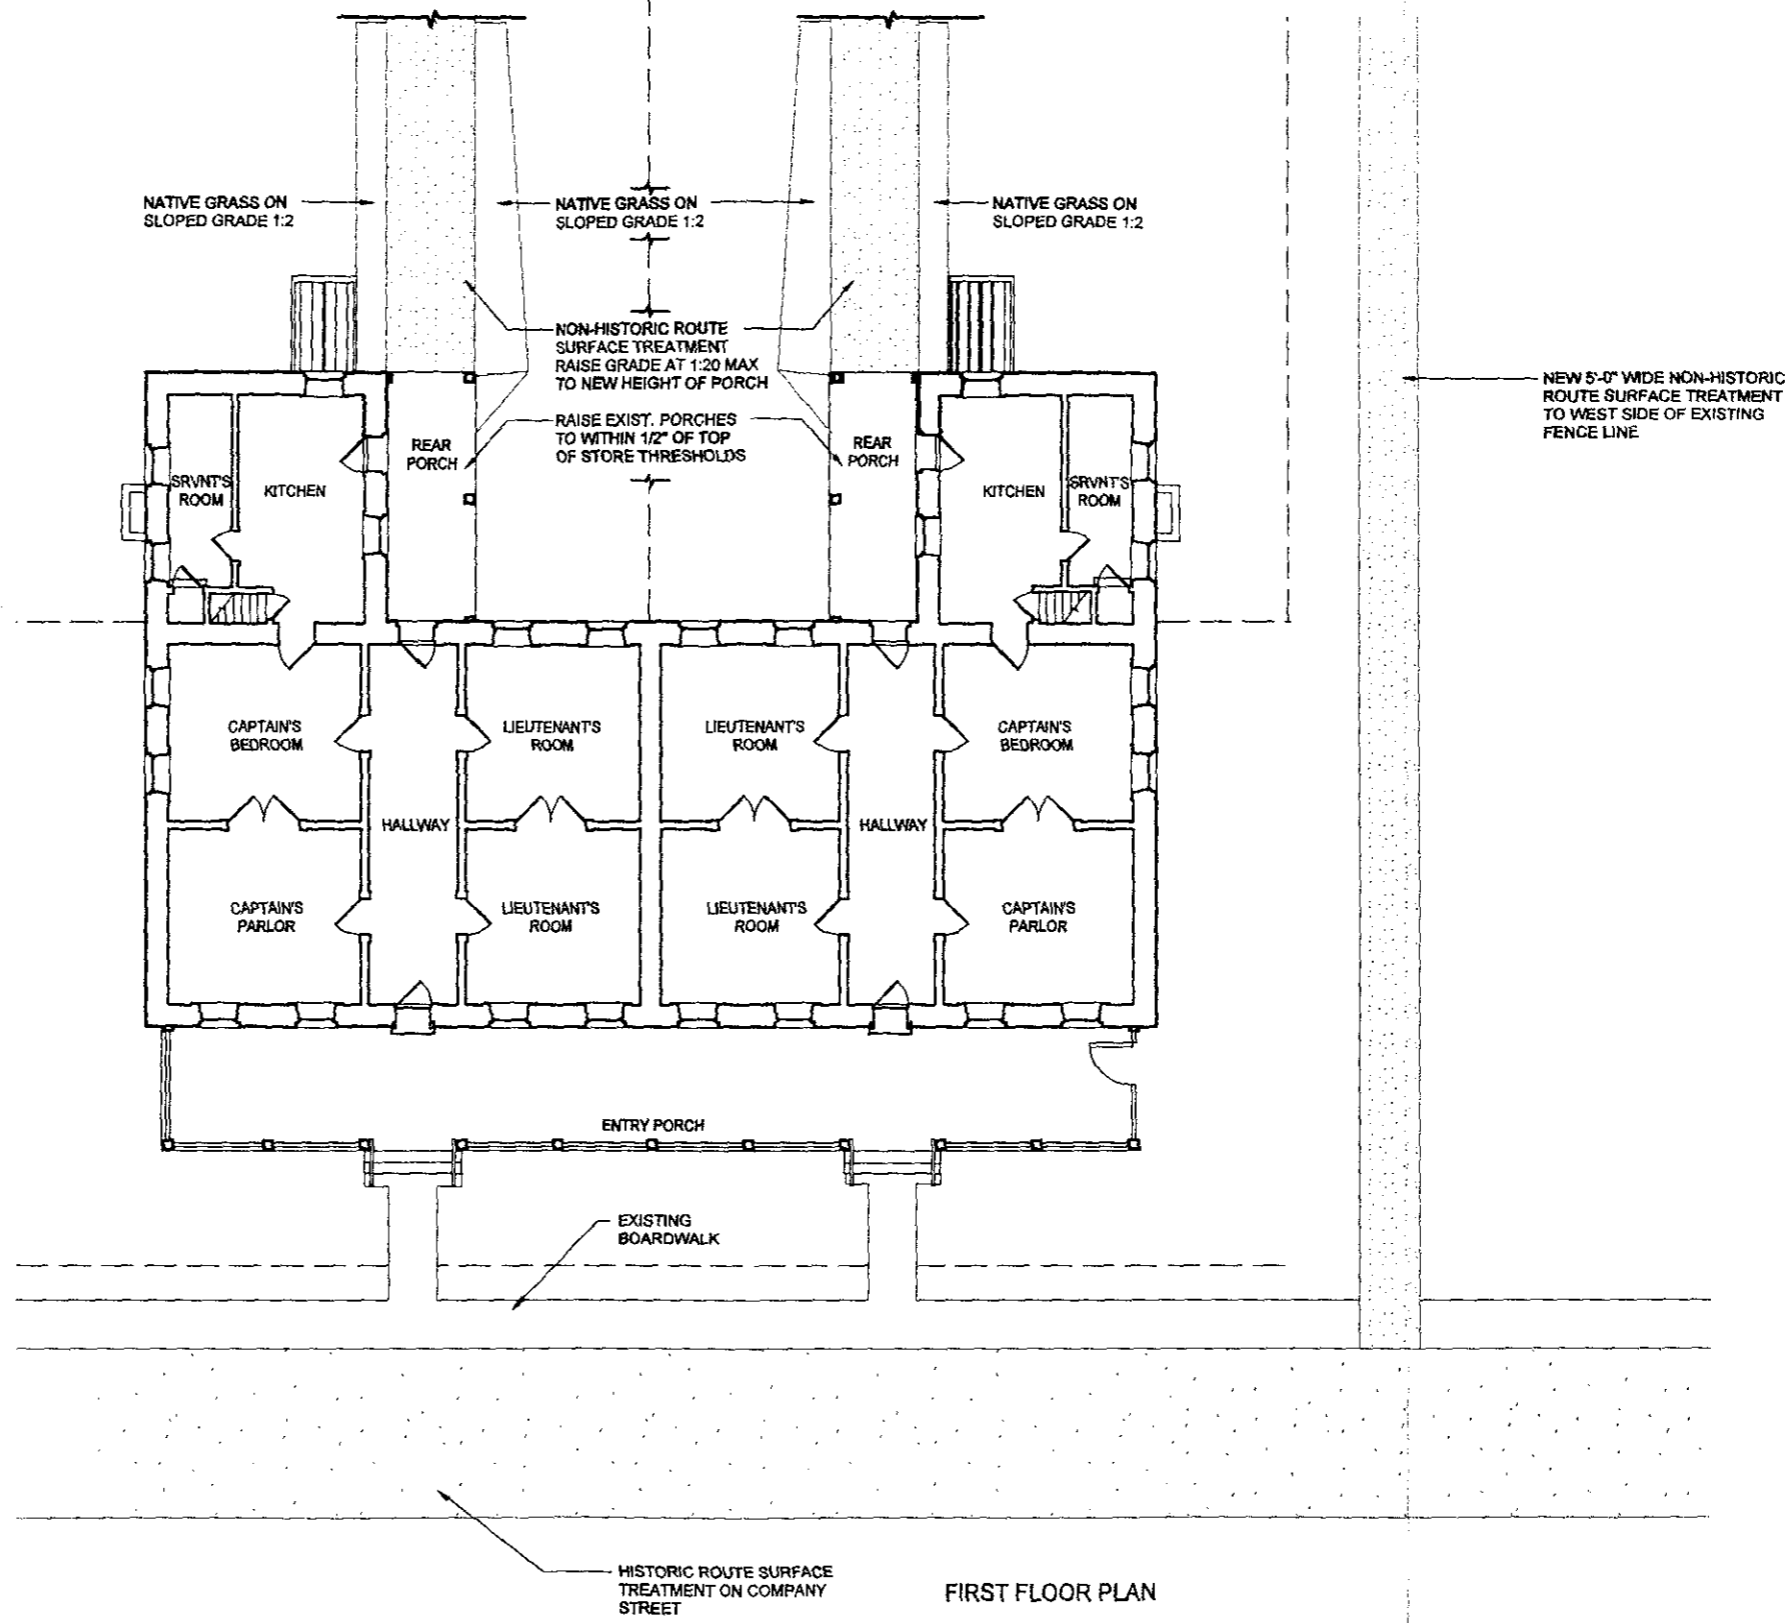
Exhibit 15j / Recommended Treatment

DESIGNED: C. H. T. F.	SUB SHEET NO.  <b>A.10</b>	TITLE OF SHEET <b>FIRST FLOOR PLAN OFFICERS' QUARTERS HS-9</b>	DRAWING NO. 425 20024
DRAWN: C. H. T. F.		FORT LARNED NATIONAL HISTORIC SITE LARNED, KANSAS	PKG. NO.
TECH REVIEW: S. J.			SHEET <b>10</b>
DATE: 5/30/97 REV. 12/2/98			OF <b>14</b>

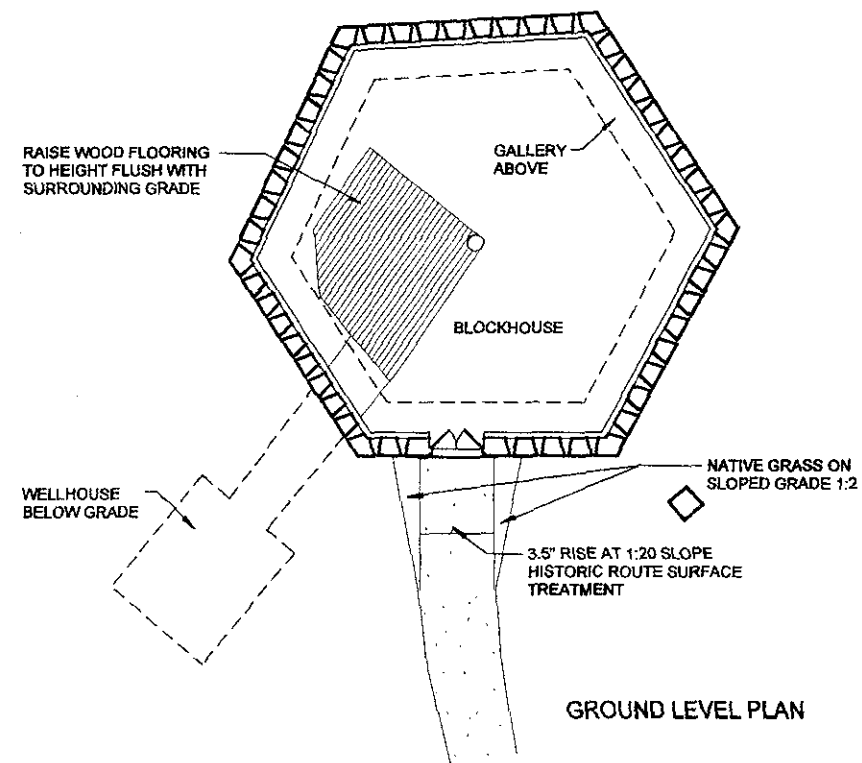
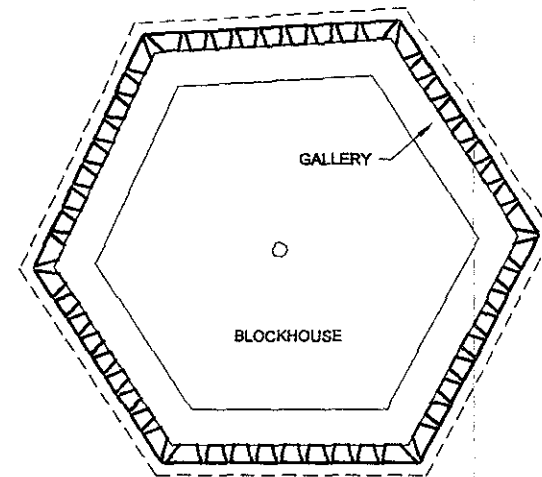
Exhibit 15k / Recommended Treatment

GROUND LEVEL PLAN

GALLERY LEVEL PLAN

DESIGNED: C. H., T. F.	SUB SHEET NO.  <b>A.11</b>	TITLE OF SHEET	DRAWING NO. 425 20624	
DRAWN: C. H., T. F.		GROUND and GALLERY LEVEL PLANS BLOCKHOUSE HS-10	PKG. NO.	
TECH REVIEW: S. J.			SHEET 11	
DATE: 5/30/97 REV. 12/2/98			FORT LARNED NATIONAL HISTORIC SITE LARNED, KANSAS	OF 14

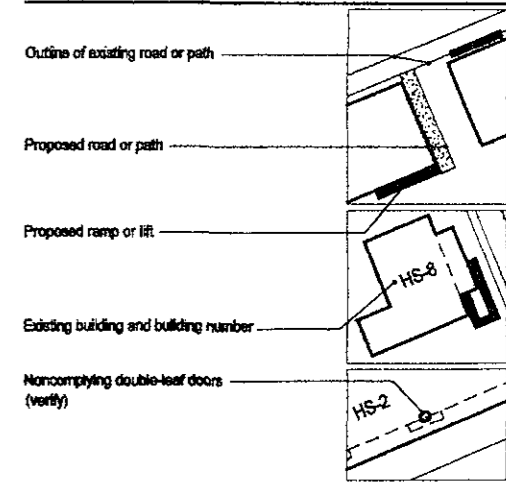
**Key to Drawing**

**This Key Map**  
 shows the general location of proposed additions for universal access and is not to scale

**Proposed Ramps**  
 are constructed with dimension lumber. Appearance shall clearly differ from historic plank walks

**Lifts**  
 will have a plank surface to match ramps and retractable guard rails

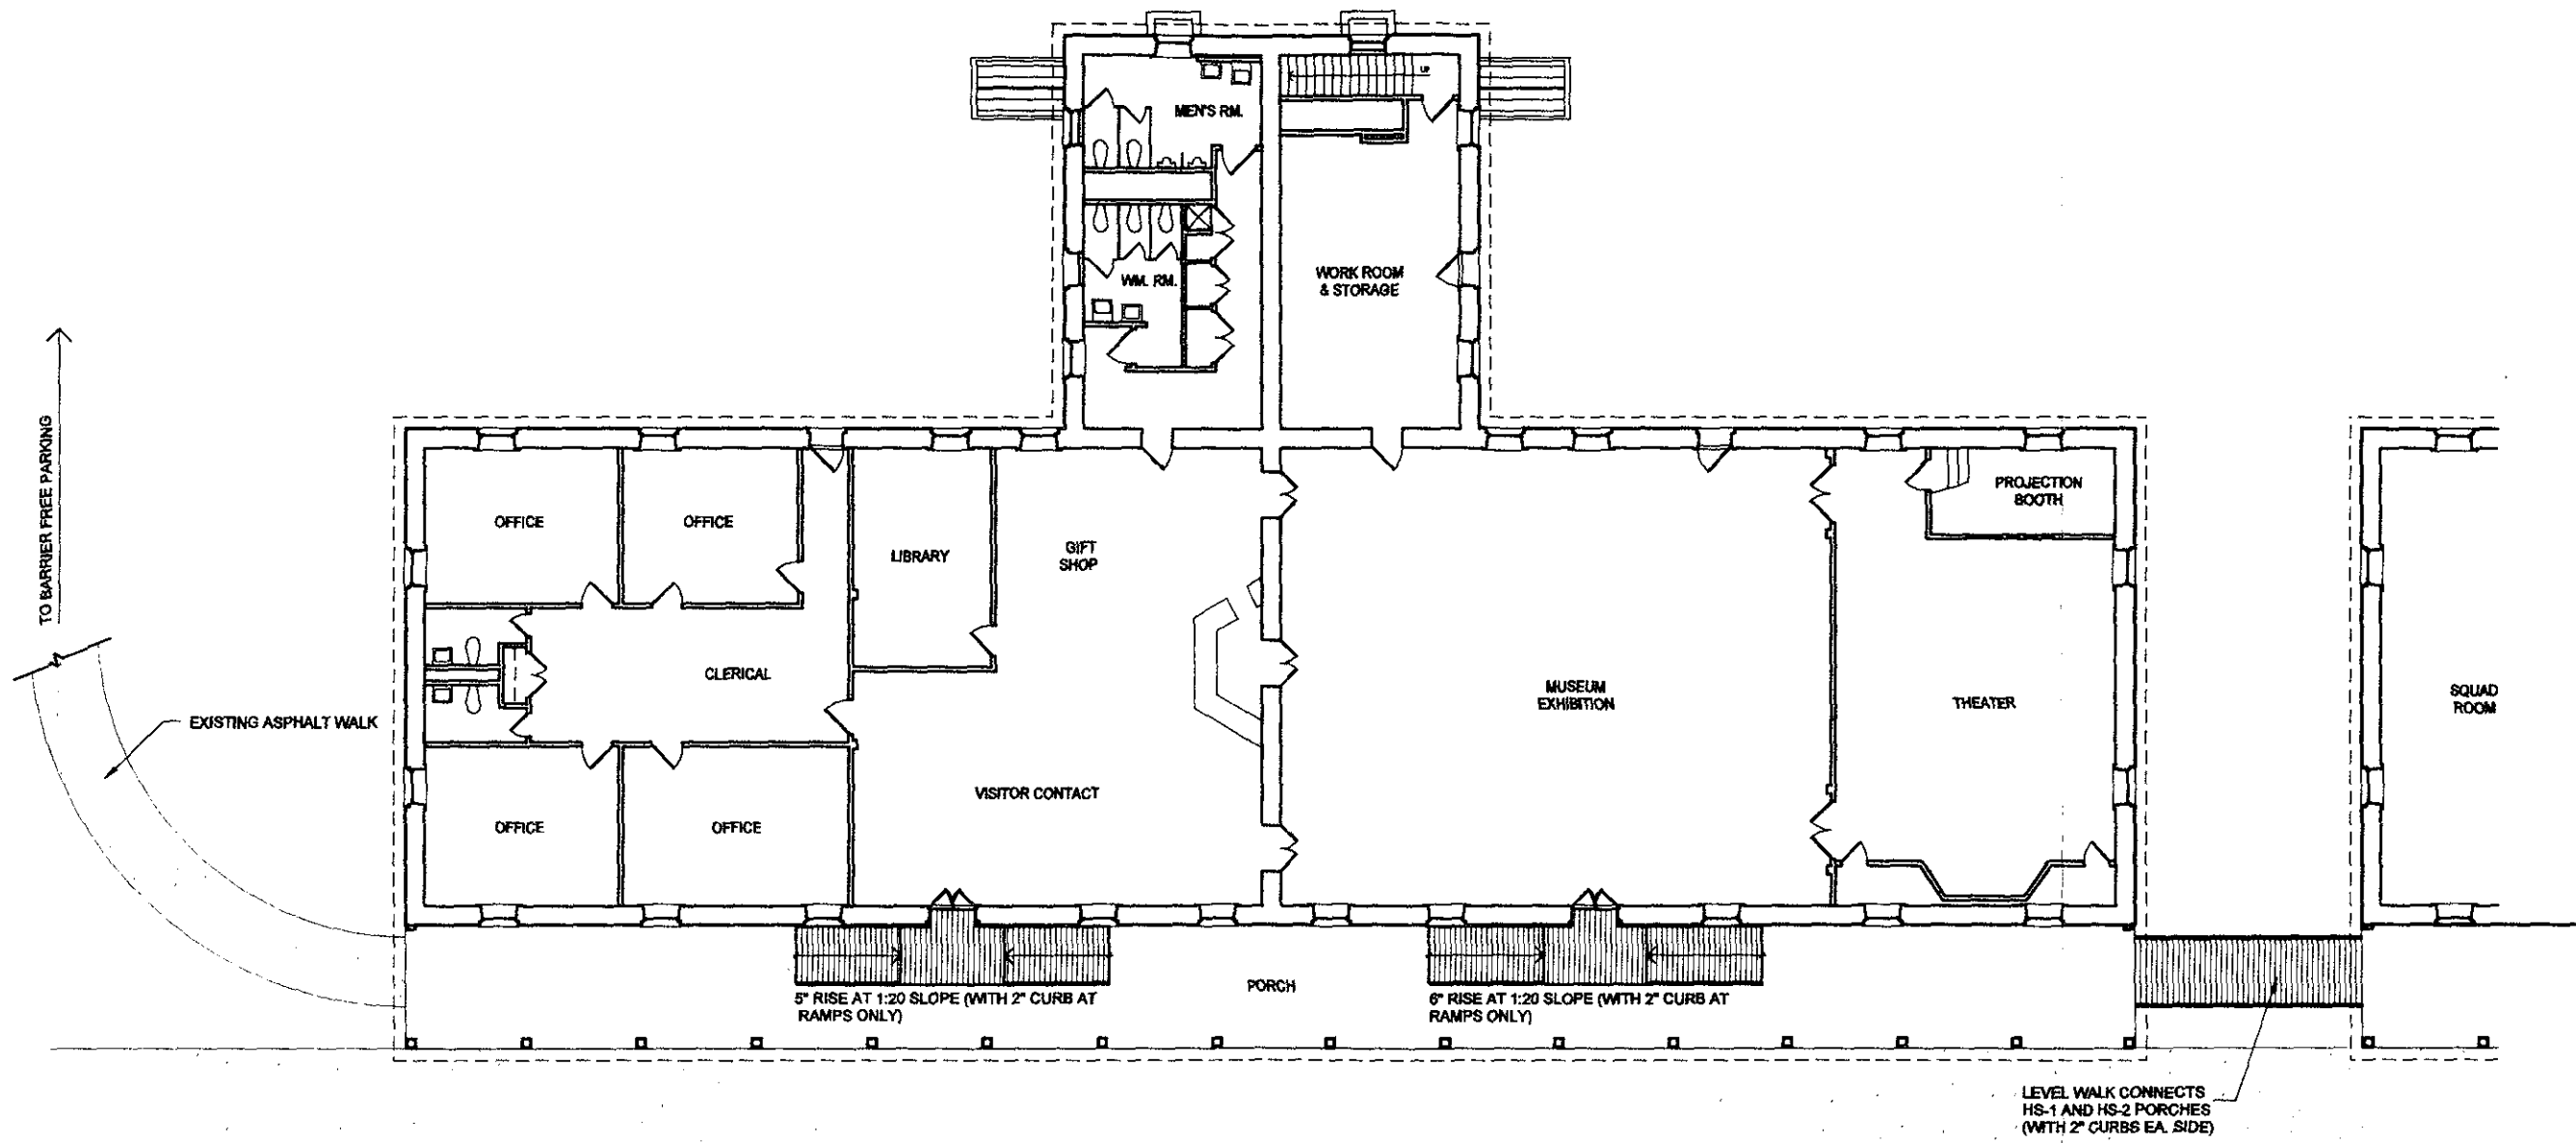
FIRST FLOOR PLAN *Exhibit 16b / Treatment Option 2*

DESIGNED: C. H. T. F.	SUB SHEET NO.  <b>A.2</b>	TITLE OF SHEET  <b>FIRST FLOOR PLAN BARRACKS / VISITOR CENTER HS-1</b>	DRAWING NO. <i>425</i> <i>20023</i>
DRAWN: C. H. T. F.		PKG. NO. — SHEET NO. <b>2</b> OF <b>14</b>	
TECH REVIEW: S. J.			
DATE: 5/30/97			
FORT LARNED NATIONAL HISTORIC SITE LARNED, KANSAS

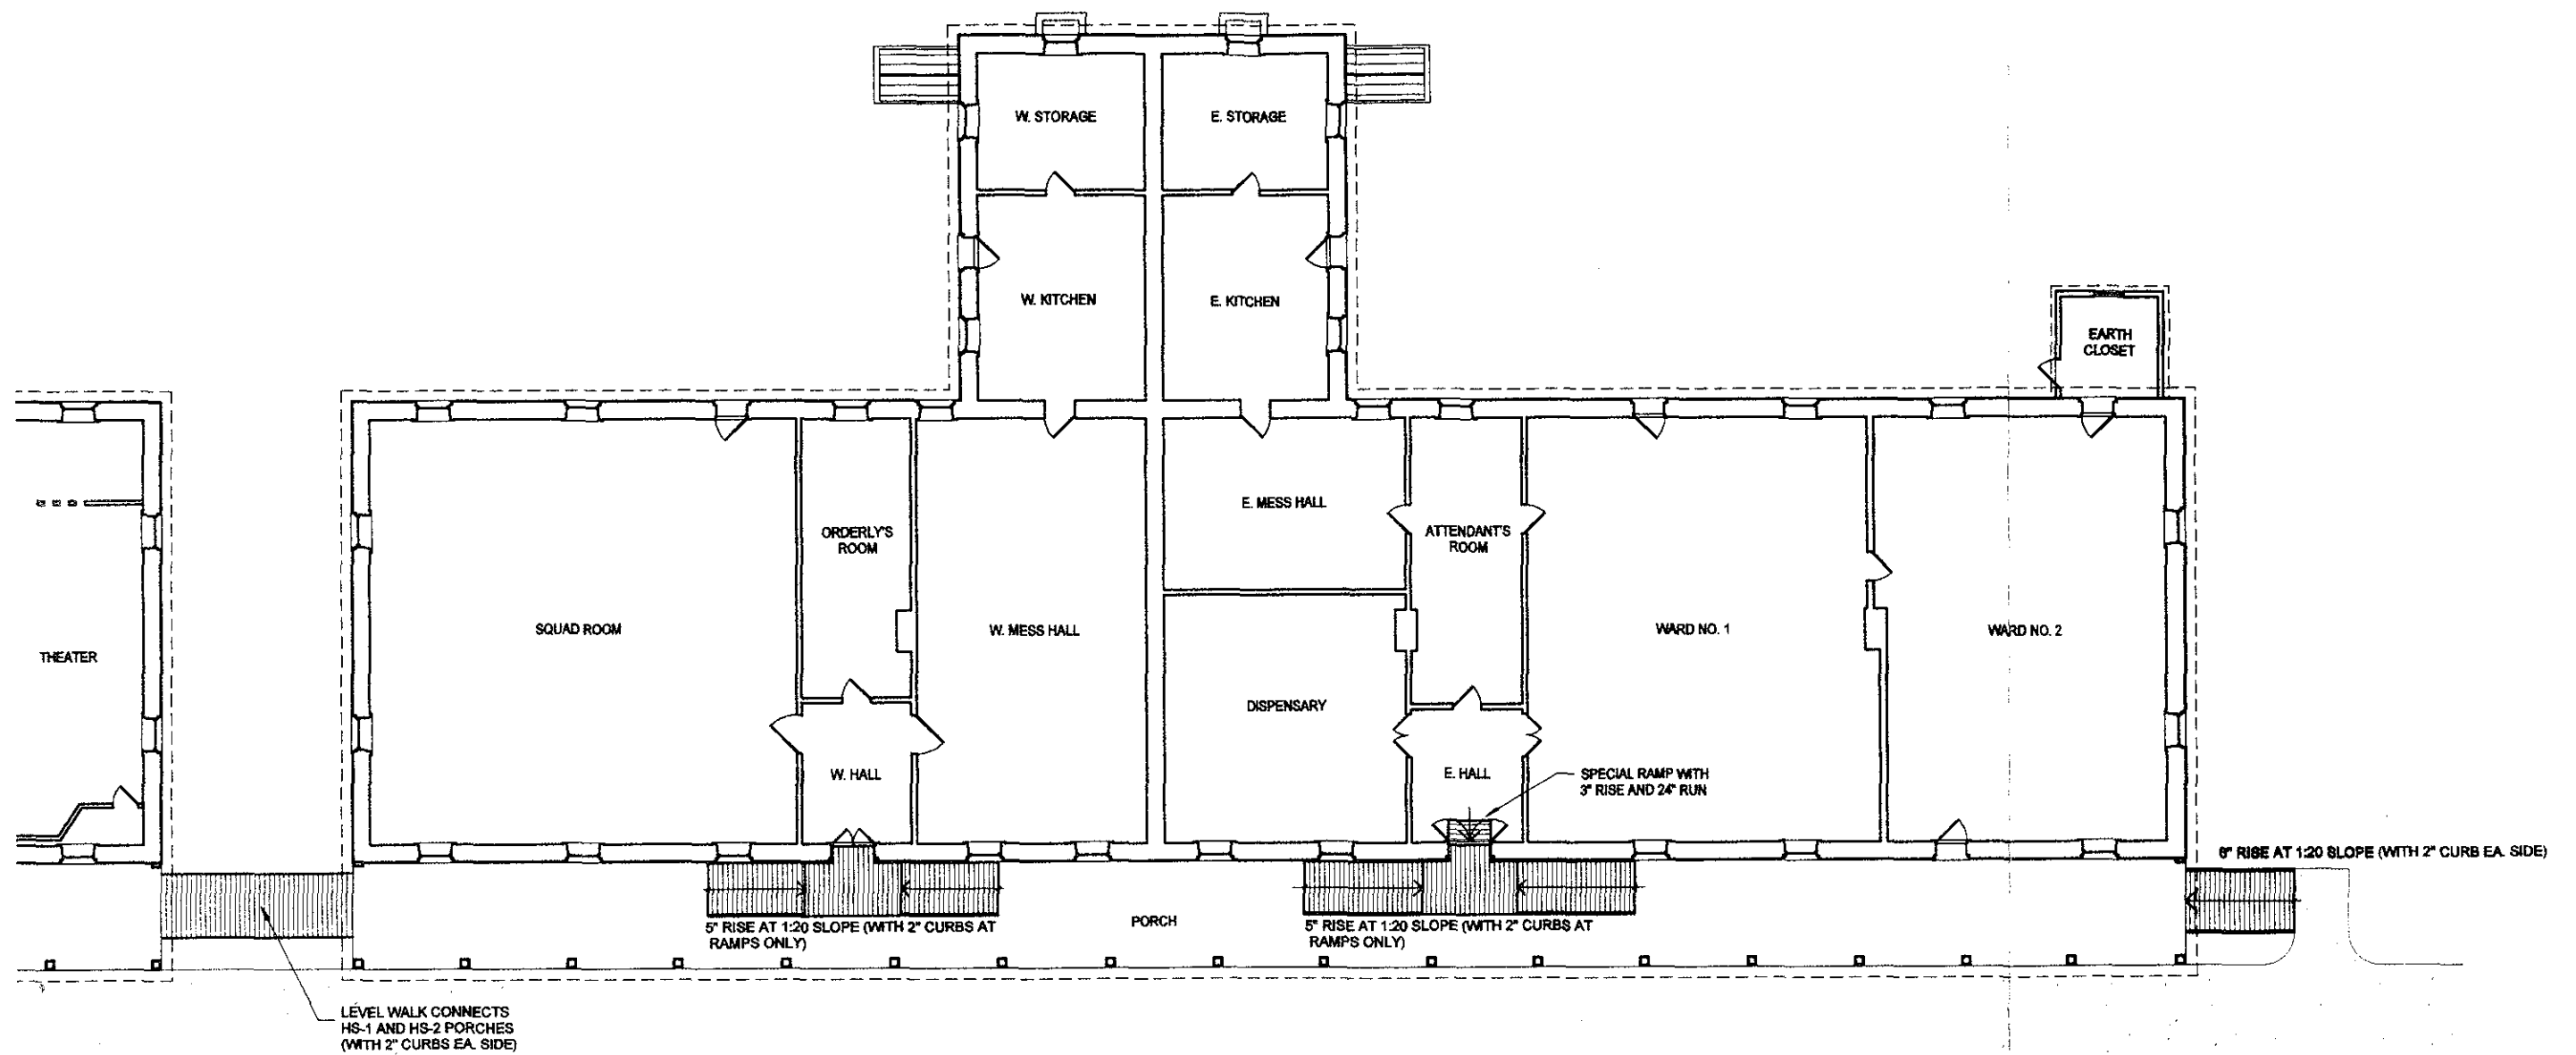
FIRST FLOOR PLAN *Exhibit 16c / Treatment Option 2*

DESIGNED: C. H. F. F.	SUB SHEET NO. <b>A.3</b>	TITLE OF SHEET <b>FIRST FLOOR PLAN BARRACKS / POST HOSPITAL HS-2</b>	DRAWING NO. <i>425</i>
DRAWN: C. H. F. F.			<i>20025</i>
TECH REVIEW: S. J.			PKG. NO. <b>3</b>
DATE: 5/30/87		FORT LARNED NATIONAL HISTORIC SITE LARNED, KANSAS	SHEET OF <b>14</b>

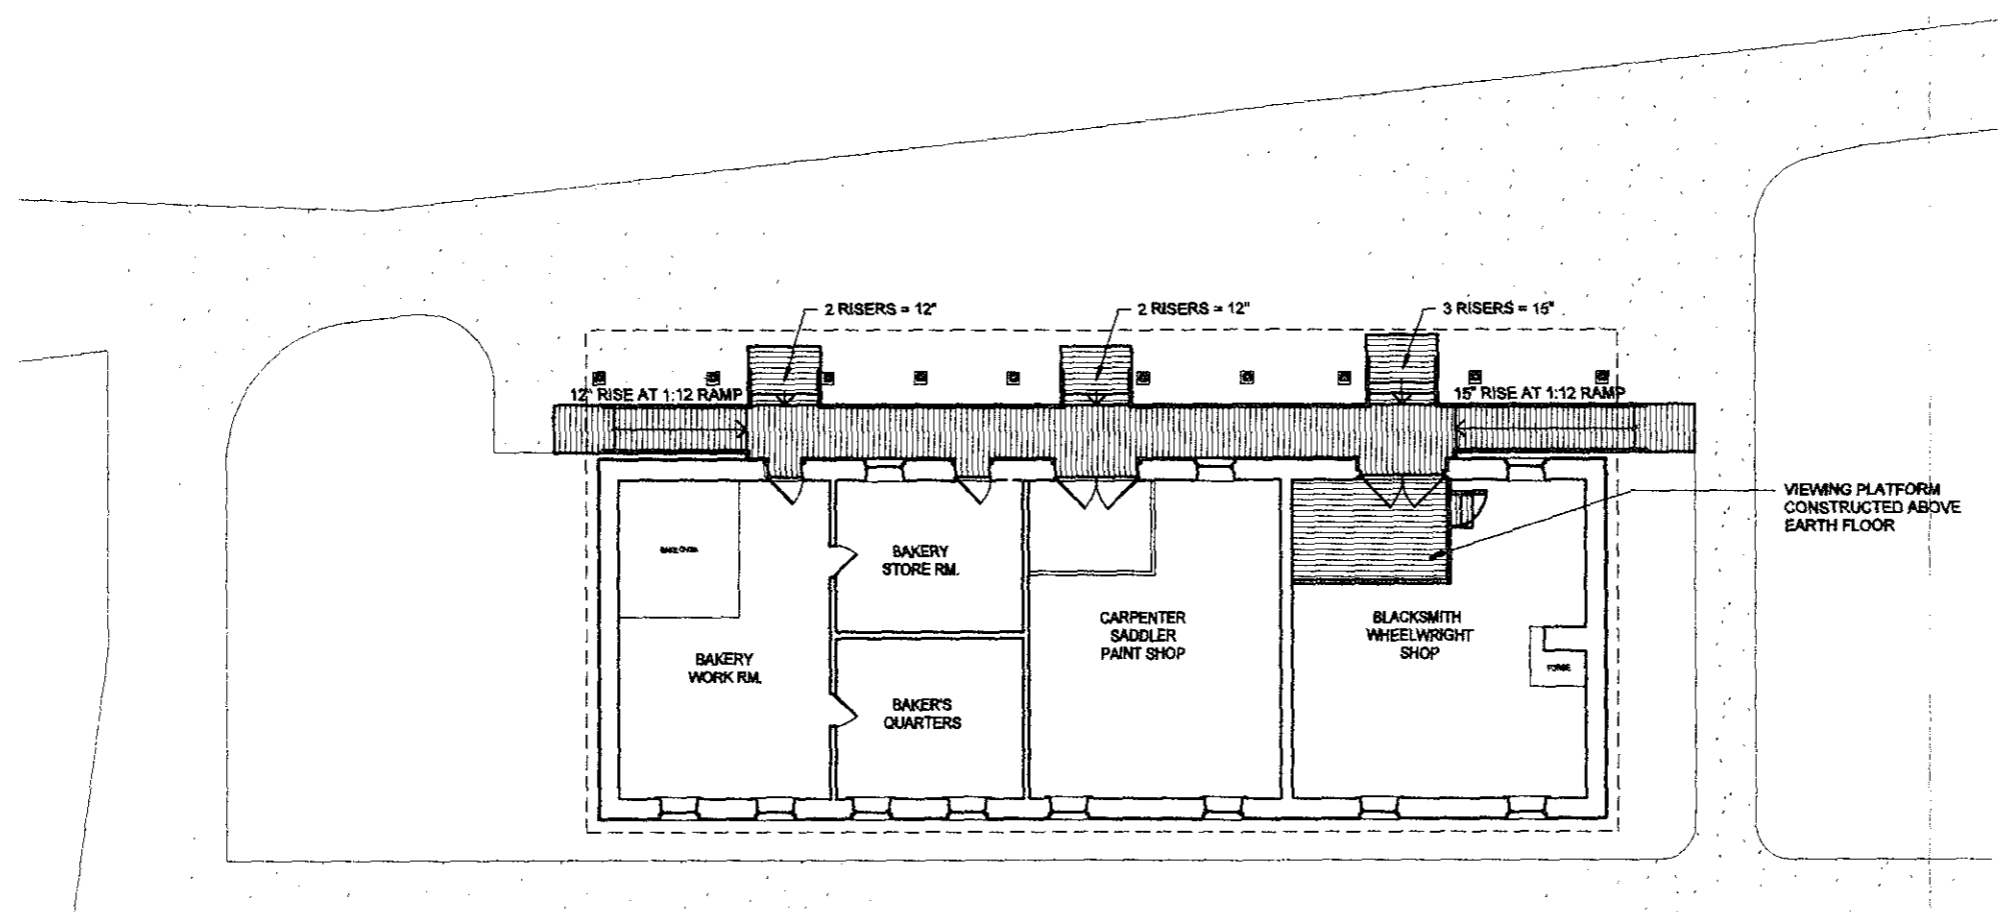
FIRST FLOOR PLAN

DESIGNED: C. H., T. F.	SUB SHEET NO.  <b>A.4</b>	TITLE OF SHEET <b>FIRST FLOOR PLAN SHOPS BUILDING HS-3</b>	DRAWING NO. <b>425</b> <b>2825</b>
DRAWN: C. H., T. F.			PKG. NO.
TECH REVIEW: S. J.			SHEET <b>4</b>
DATE: 5/30/97			OF <b>14</b>
			FORT LARNED NATIONAL HISTORIC SITE LARNED, KANSAS

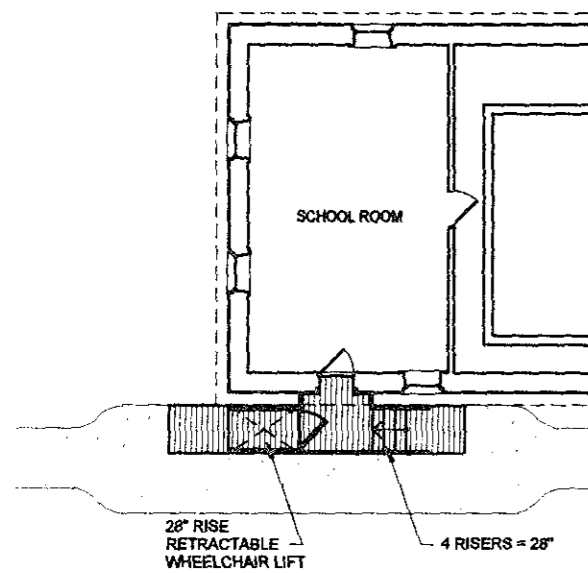
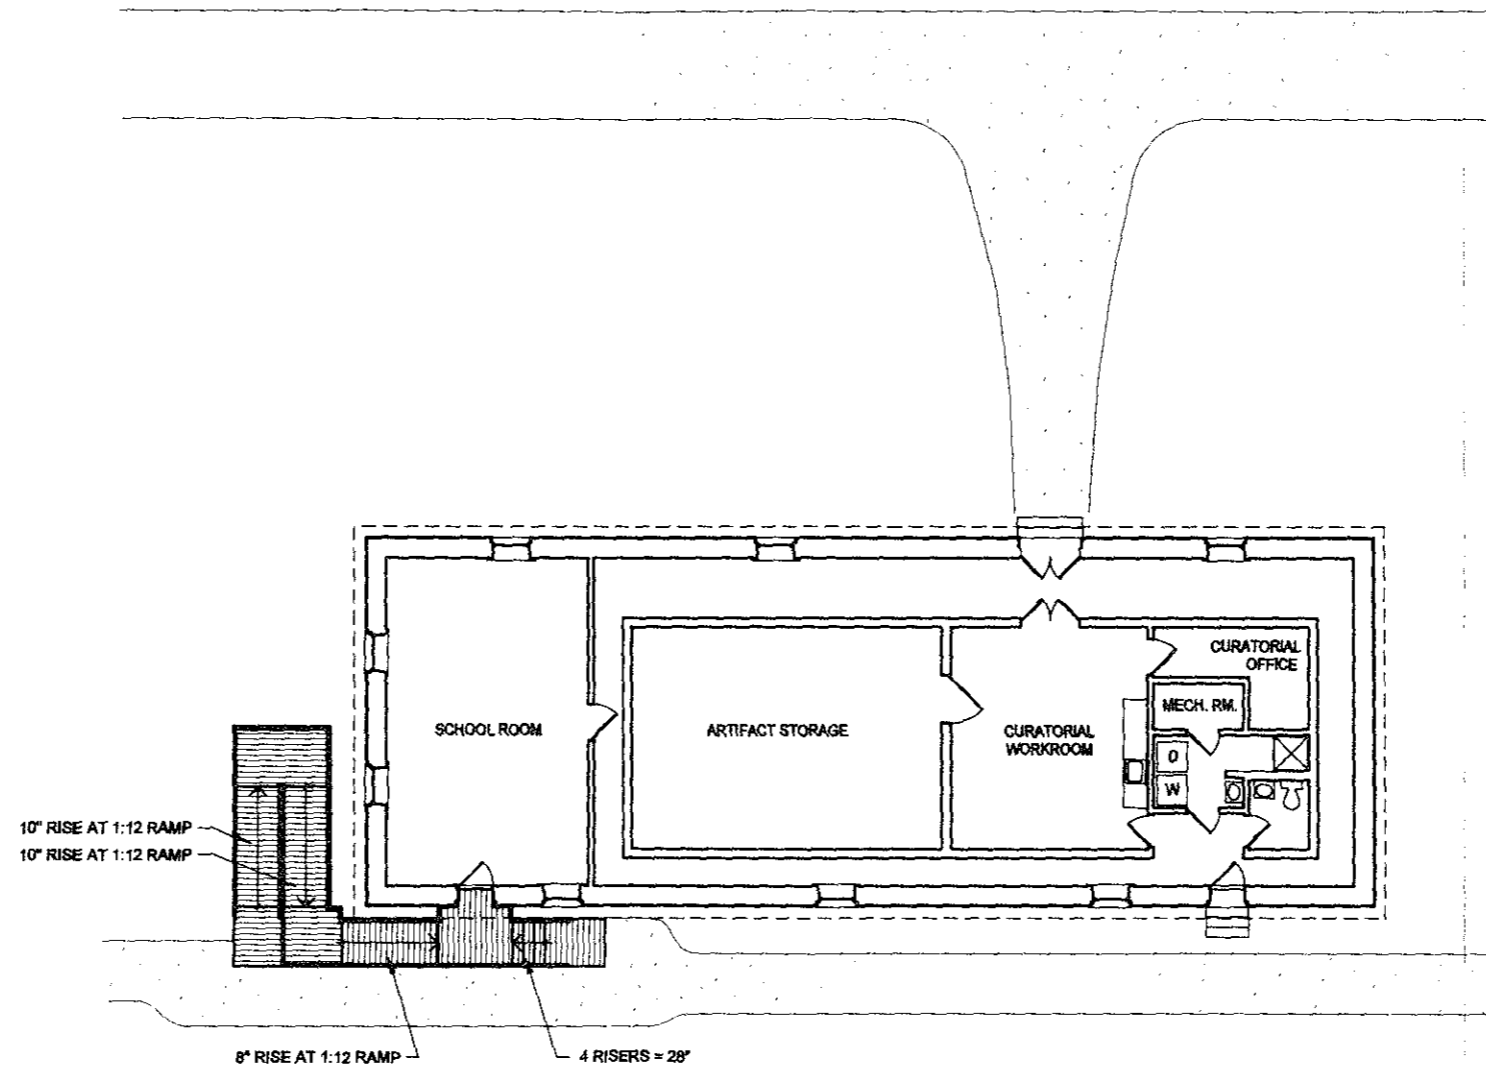
Exhibit 16e / Treatment Option 3

OPTION 3a - FIRST FLOOR PLAN

OPTION 3b - FIRST FLOOR PLAN

DESIGNED: C. H., T. F.	SUB SHEET NO.  <b>A.5</b>	TITLE OF SHEET	DRAWING NO. 425 20025
DRAWN: C. H., T. F.		FIRST FLOOR PLAN NEW COMMISSARY HS-4	PKG. NO.
TECH REVIEW: S. J.			SHEET 5
DATE: 5/30/97			OF 14
			FORT LARNED NATIONAL HISTORIC SITE LARNED, KANSAS

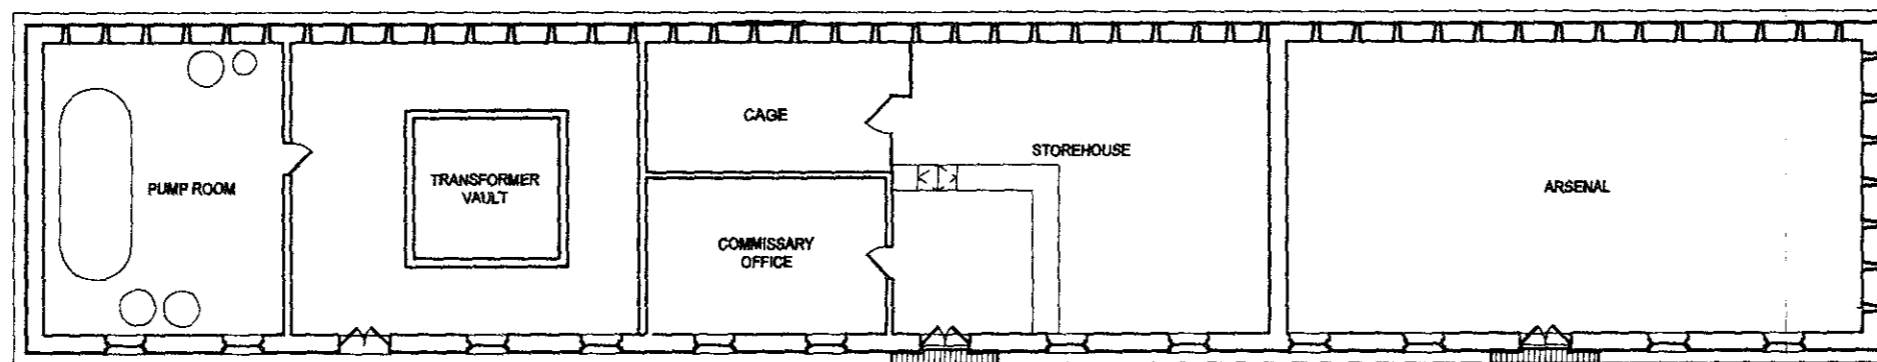
6" RISE AT 1:20 SLOPE (WITH 2" CURB AT RAMPS ONLY)

DESIGNED: C. H., T. F.	SUB SHEET NO.  <b>A.6</b>	TITLE OF SHEET  <b>FIRST FLOOR PLAN OLD COMMISSARY HS-5</b>	DRAWING NO. <i>425</i>
DRAWN: C. H., T. F.		FORT LARNED NATIONAL HISTORIC SITE LARNED, KANSAS	<i>30023</i>
TECH REVIEW: S. J.			PKG. NO.
DATE: 5/30/67			SHEET
			<b>6</b>
		OF	<b>14</b>

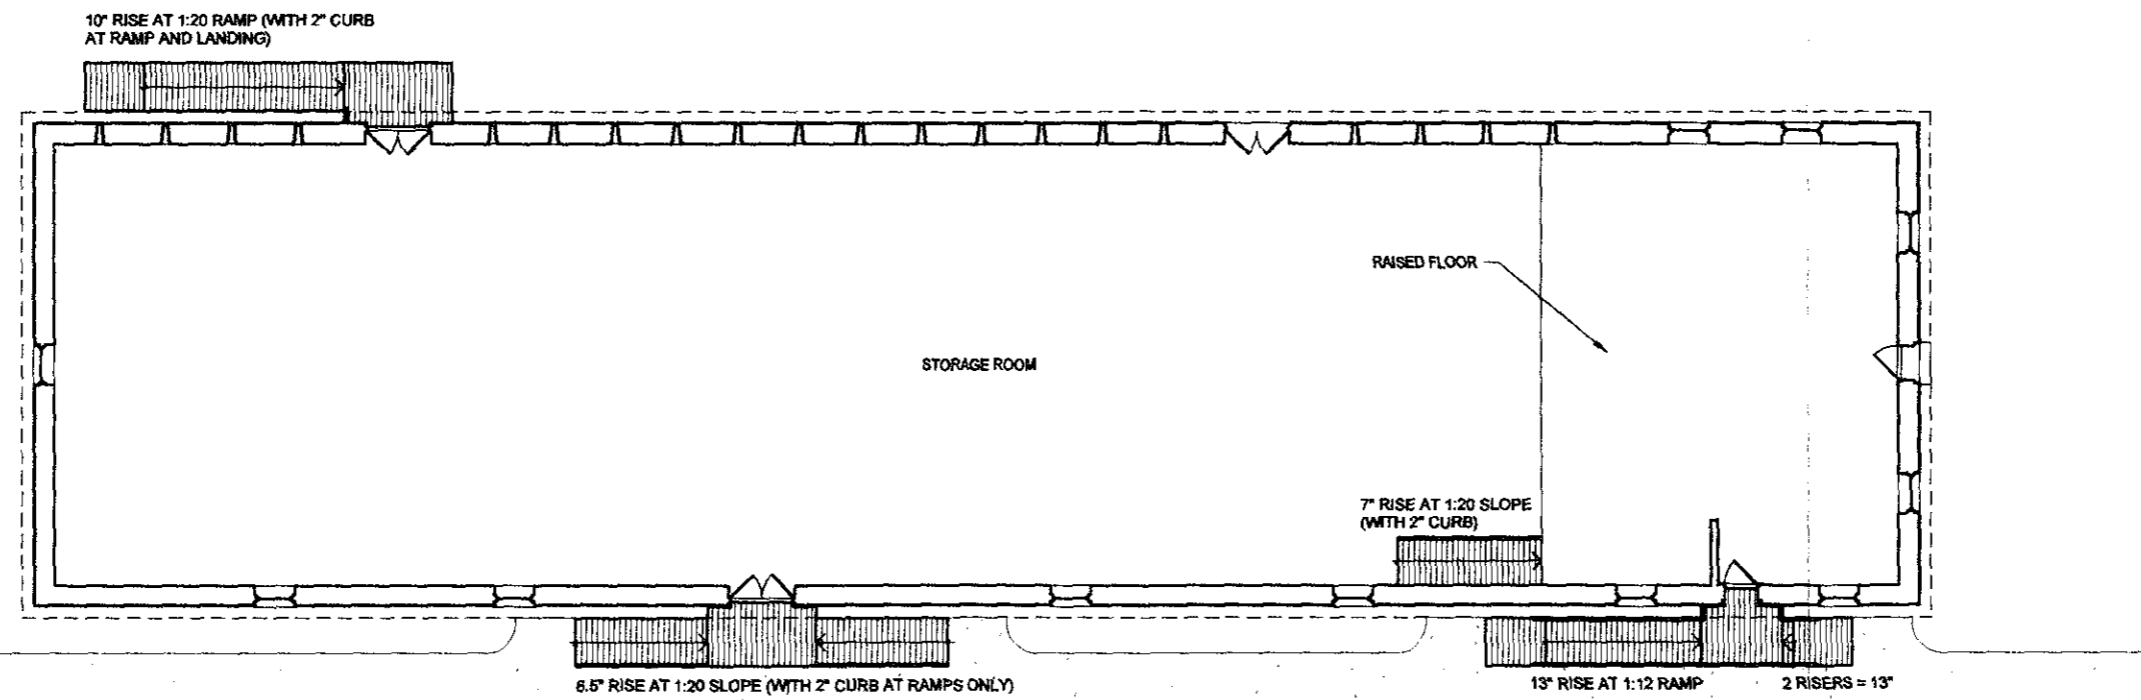
FIRST FLOOR PLAN

DESIGNED: C. H., T. F.	SUB SHEET NO.  <b>A.7</b>	TITLE OF SHEET <b>FIRST FLOOR PLAN QUARTERMASTER WAREHOUSE HS-6</b>	DRAWING NO. <b>425</b>	
DRAWN: C. H., T. F.		PKG. NO. —	SHEET <b>7</b>	
TECH REVIEW: S. J.		FORT LARNED NATIONAL HISTORIC SITE LARNED, KANSAS		OF <b>14</b>
DATE: 5/30/87

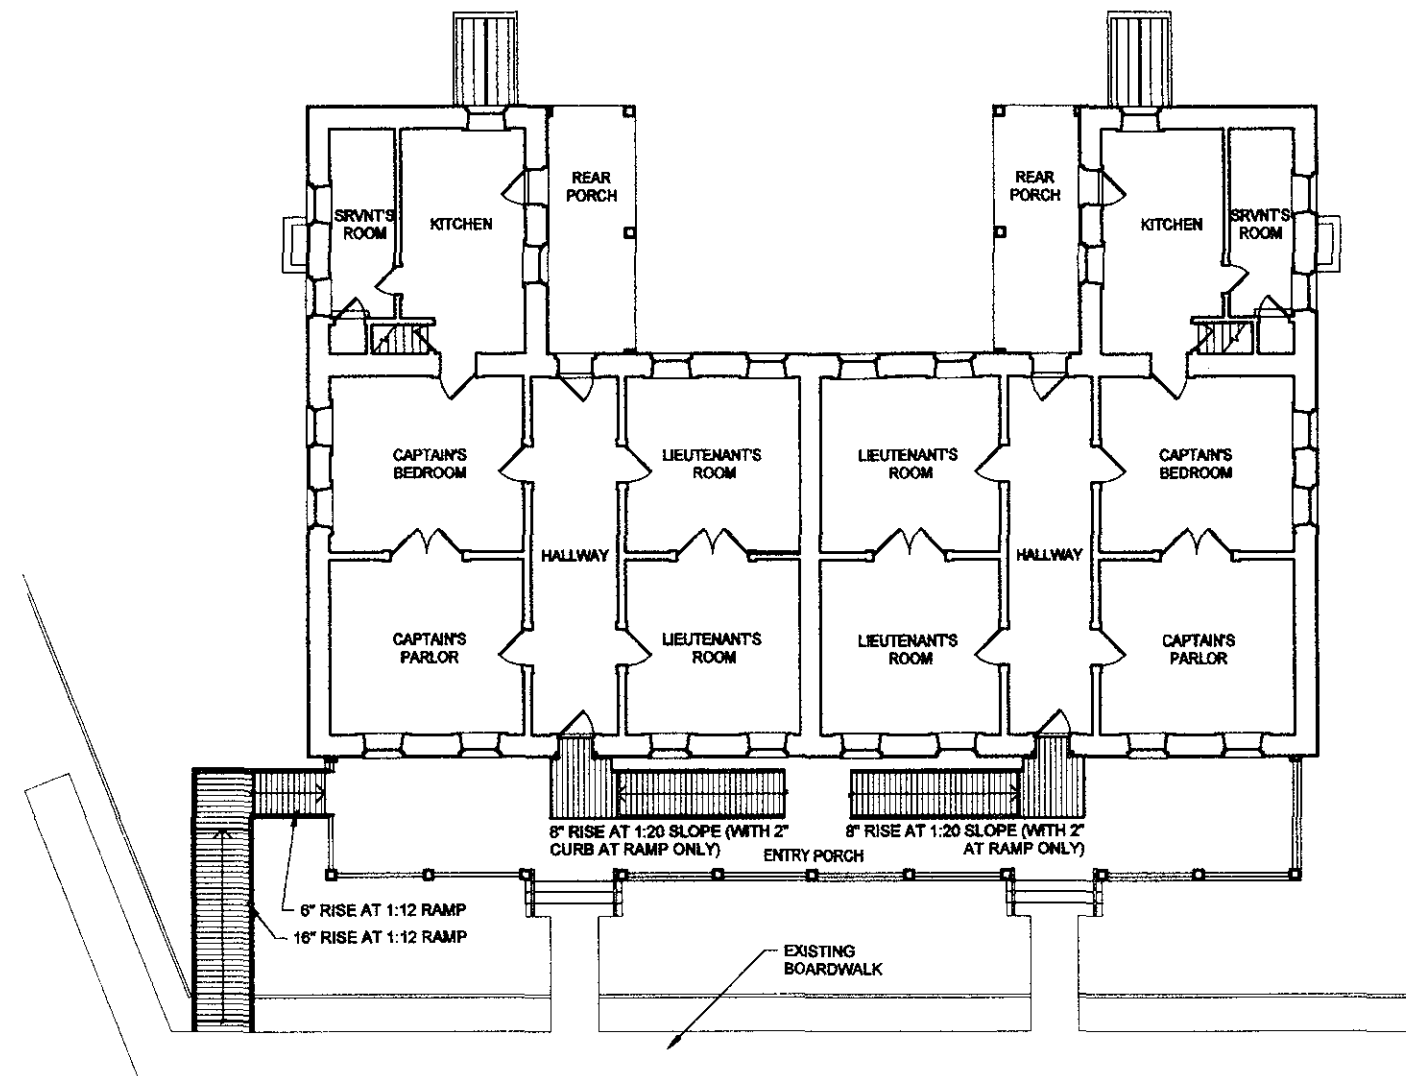
FIRST FLOOR PLAN

DESIGNED: C. H., T. F.	SUB SHEET NO.  <b>A.8</b>	TITLE OF SHEET  <b>FIRST FLOOR PLAN OFFICERS' QUARTERS HS-7</b>	DRAWING NO. 425
DRAWN: C. H., T. F.		20025	
TECH REVIEW: S. J.		PKG. NO.	SHEET <b>8</b>
DATE: 5/30/67			OF <b>14</b>
		FORT LARNED NATIONAL HISTORIC SITE LARNED, KANSAS
