FORT LARNED

NATIONAL HISTORIC SITE • KANSAS
NATIONAL PARK SERVICE

Cultural Landscape Report

MAY 1999

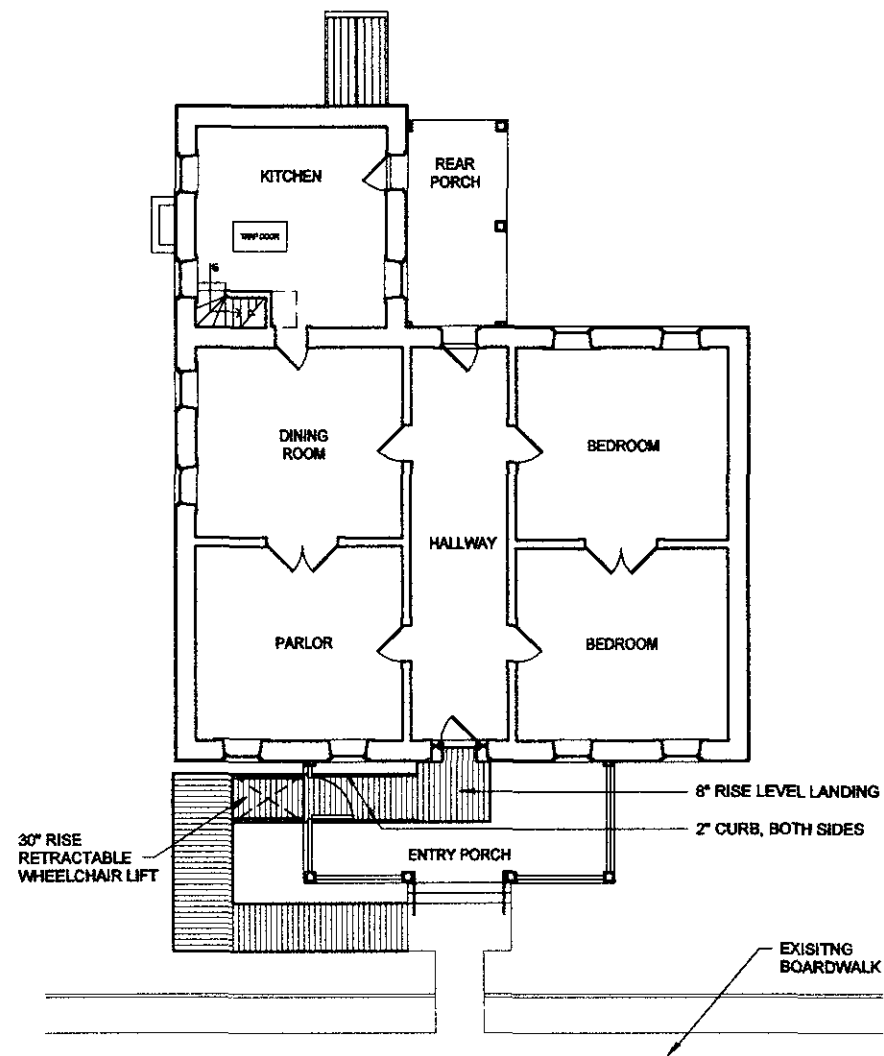
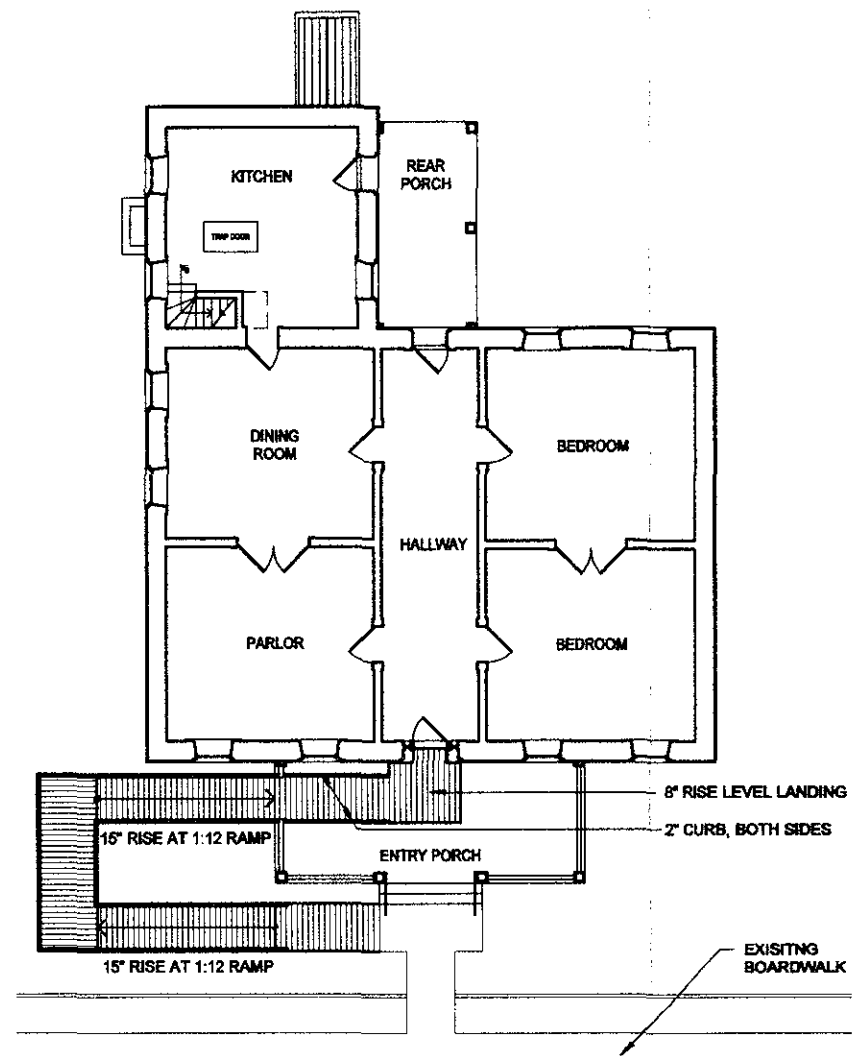
Exhibit 16i / Treatment Option 2

OPTION 'A' - FIRST FLOOR PLAN

OPTION 'B' - FIRST FLOOR PLAN

DESIGNED: C. H., T. F.	SUB SHEET NO.  <b>A.9</b>	TITLE OF SHEET <b>FIRST and SECOND FLOOR PLANS COMMANDING OFFICER'S QUARTERS HS-8</b>	DRAWING NO. 425
DRAWN: C. H., T. F.		PKG. NO.	20625
TECH REVIEW: S. J.		SHEET NO.	<b>9</b>
DATE: 5/30/97		OF	<b>14</b>
		FORT LARNED NATIONAL HISTORIC SITE LARNED, KANSAS

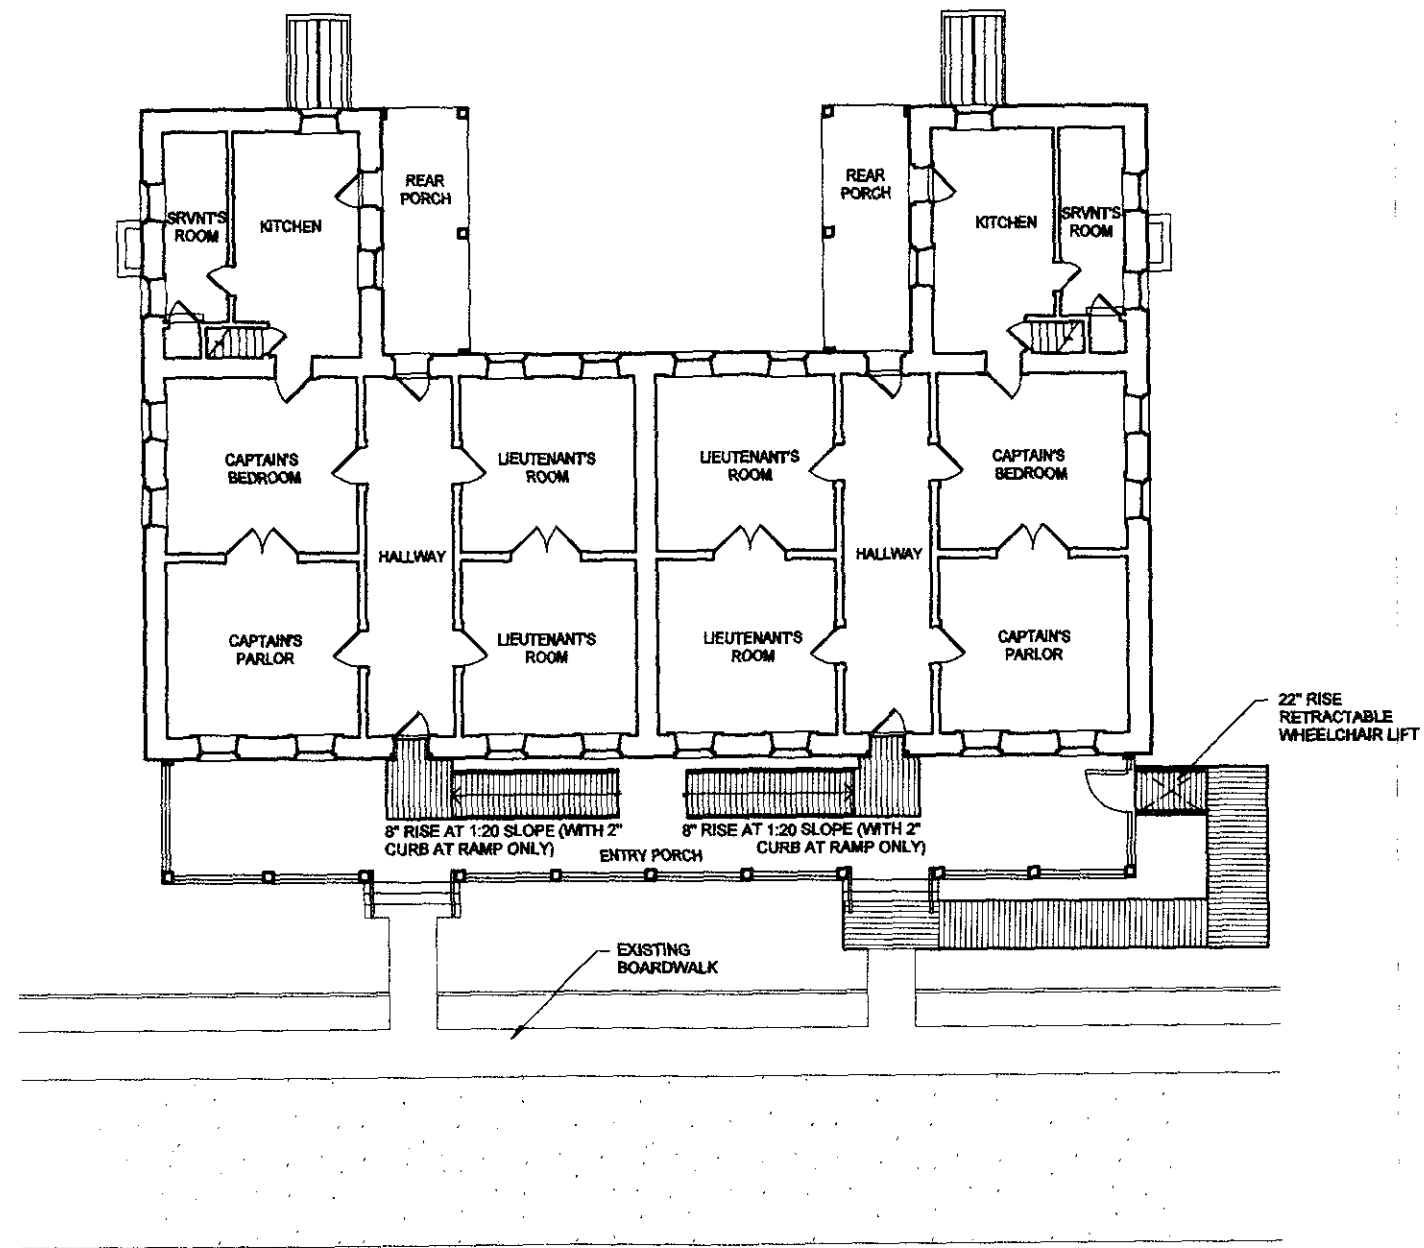
FIRST FLOOR PLAN

DESIGNED: C. H., T. F.	SUB SHEET NO.  <b>A.10</b>	TITLE OF SHEET <b>FIRST FLOOR PLAN OFFICERS' QUARTERS HS-9</b>	DRAWING NO. <i>425</i> <i>20025</i>
DRAWN: C. H., T. F.		FORT LARNED NATIONAL HISTORIC SITE LARNED, KANSAS	PKG. NO. —
TECH. REVIEW: S. J.			SHEET <b>10</b>
DATE: 5/30/07			OF <b>14</b>

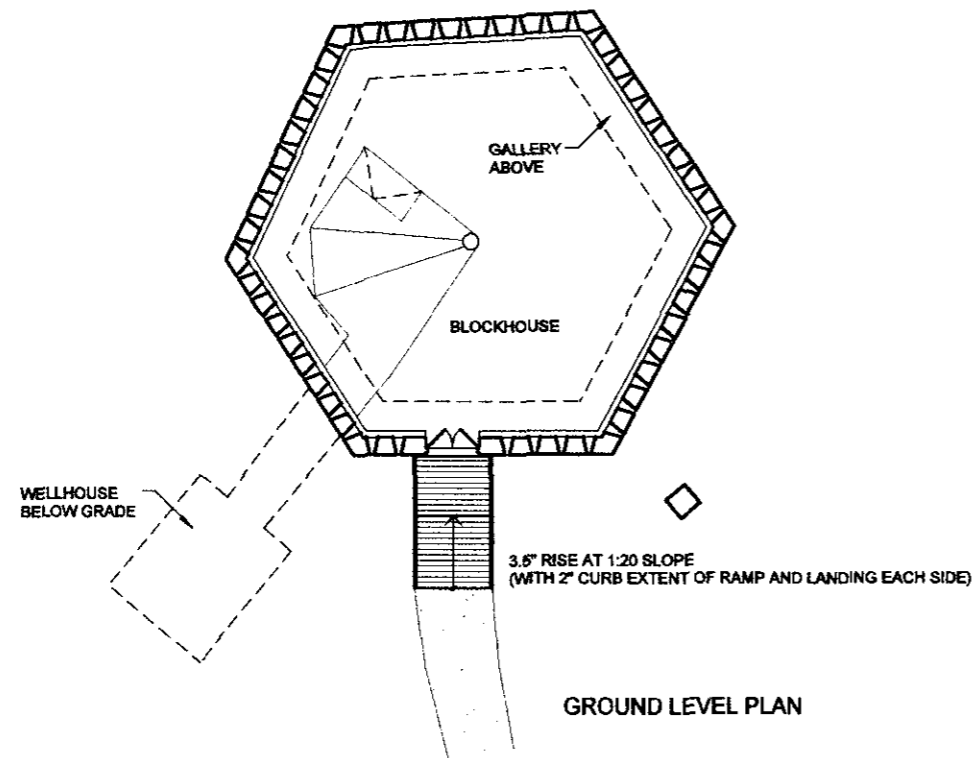
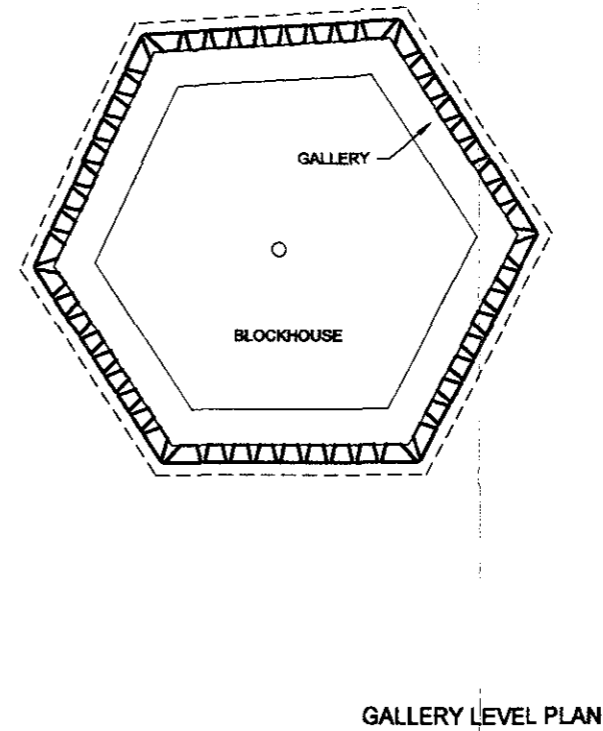
Exhibit 16k / Treatment Option 2

DESIGNED: C. H. T. F.	SUB SHEET NO.  <b>A.11</b>	TITLE OF SHEET	DRAWING NO. 425
DRAWN: C. H. T. F.		GROUND and GALLERY LEVEL PLANS BLOCKHOUSE HS-10	2025
TECH REVIEW: S. J.			PKG. NO.
DATE: 5/30/87			SHEET
			11
		OF	14
		FORT LARNED NATIONAL HISTORIC SITE LARNED, KANSAS

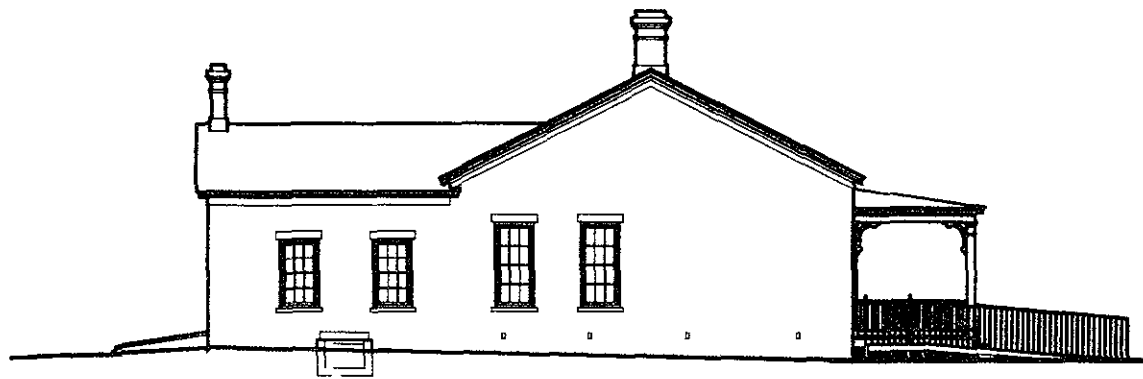
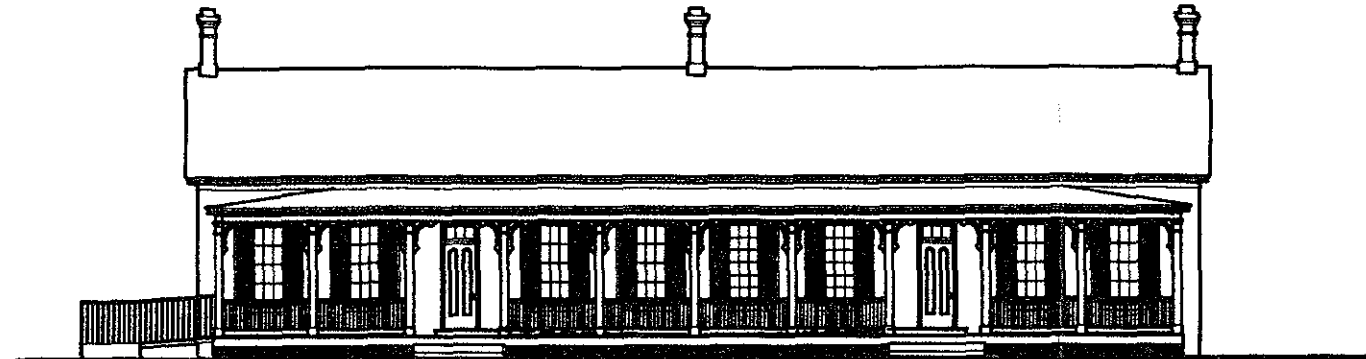
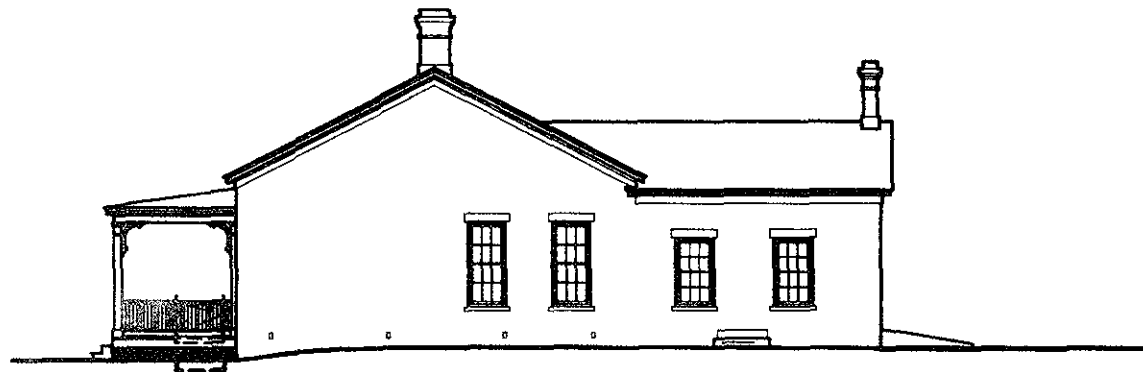
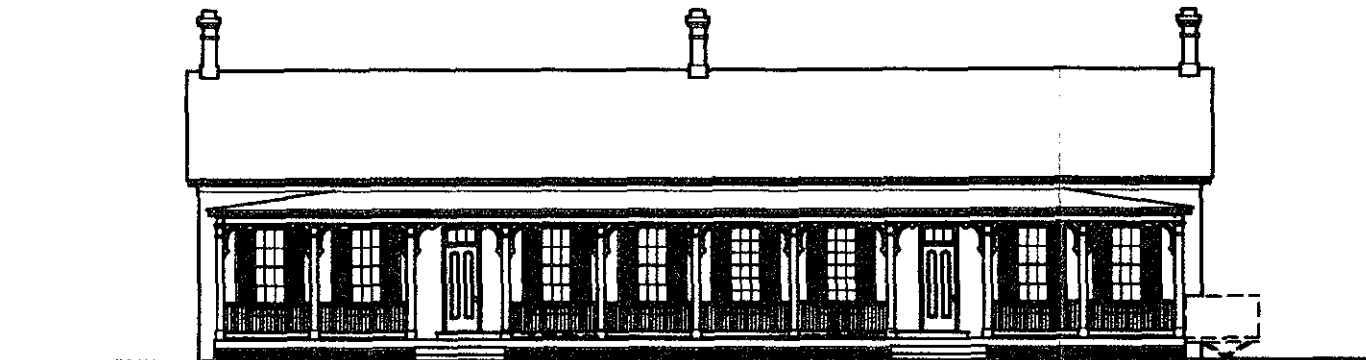
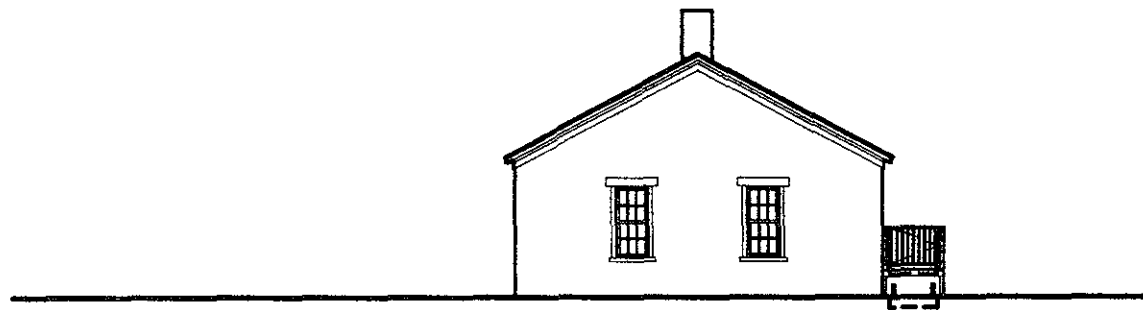
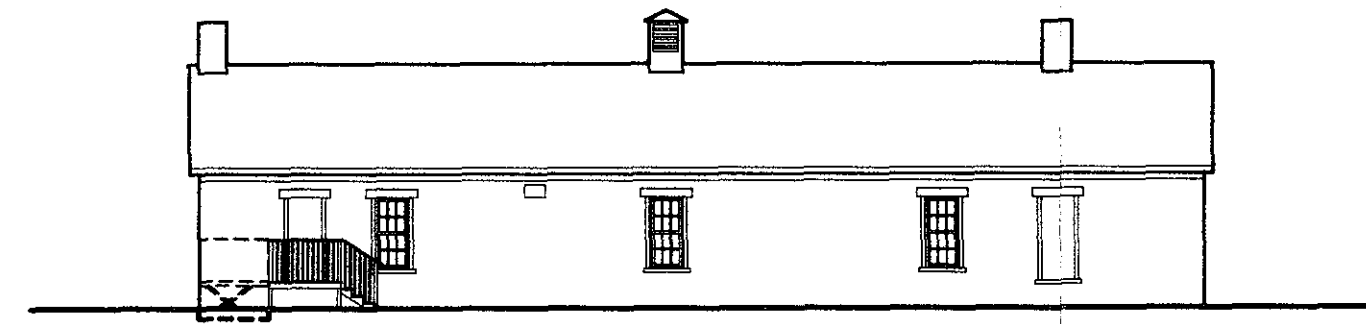
Exhibit 161 / Treatment Option 2

HS-7 AND HS-9, SOUTH ELEVATION, OPTION 'A'

WITH RAMP

HS-7 AND HS-9, EAST ELEVATION, OPTION 'A'

HS-7 AND HS-9, NORTH ELEVATION, OPTION 'B'

WITH LIFT

HS-7 AND HS-9, EAST ELEVATION, OPTION 'B'

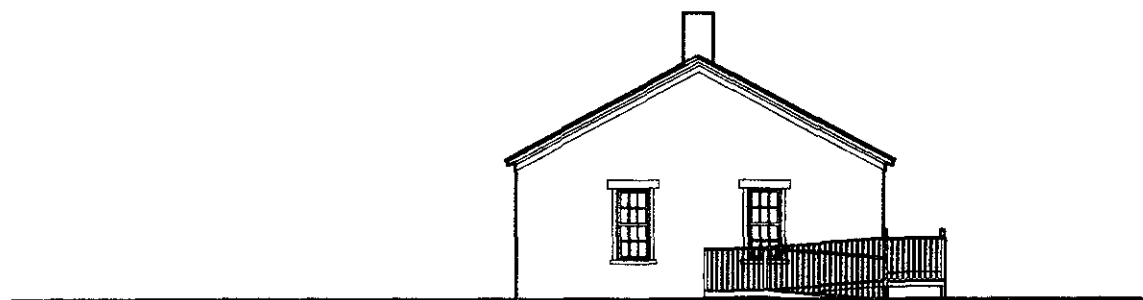
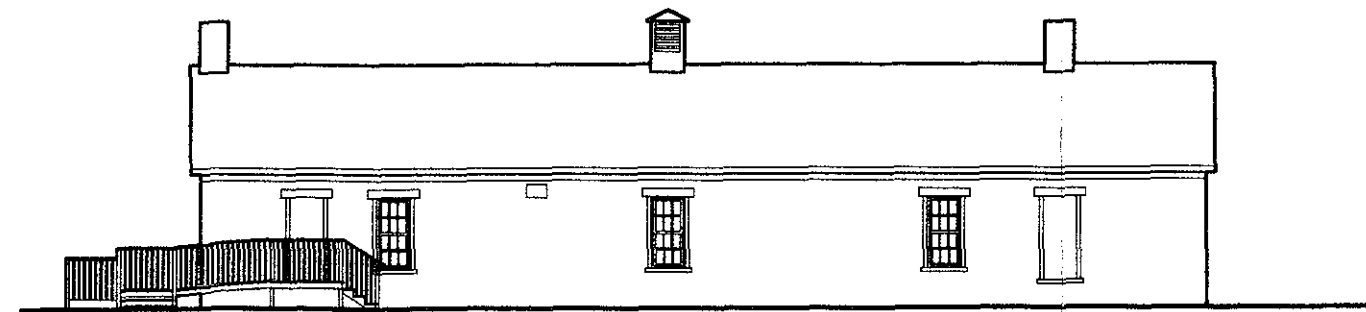
HS-4, NORTH ELEVATION, OPTION 'B'

WITH RAMP AND STAIR

HS-4, WEST ELEVATION, OPTION 'B'

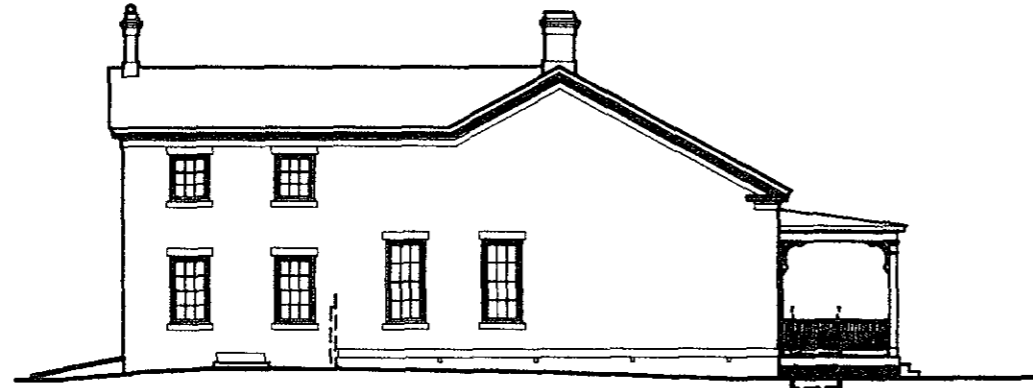
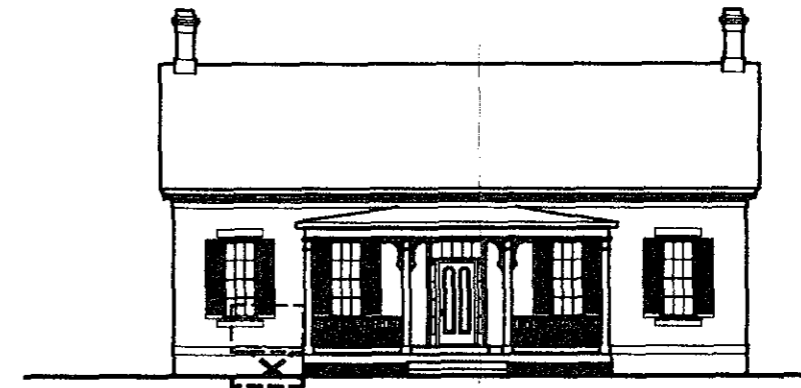
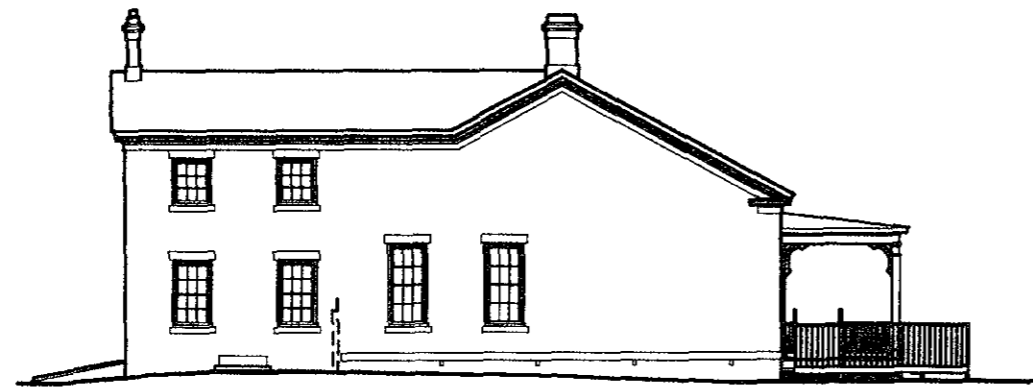
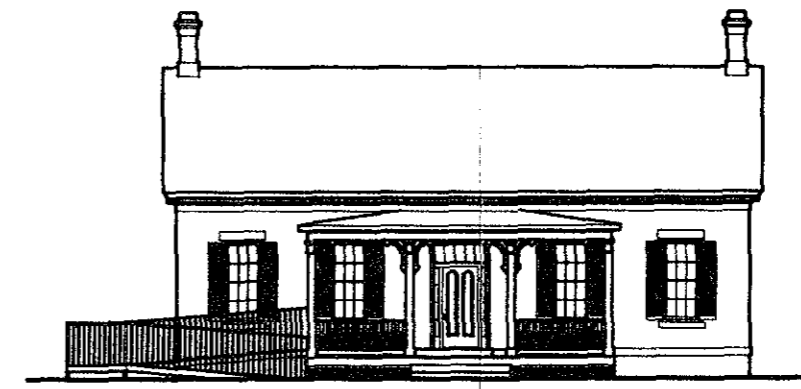
Exhibit 16m / Treatment Option 2

HS-8, SOUTH ELEVATION, OPTION 'A'

WITH LIFT

HS-8, EAST ELEVATION, OPTION 'A'

HS-8, SOUTH ELEVATION, OPTION 'B'

WITH RAMP

HS-8, EAST ELEVATION, OPTION 'B'

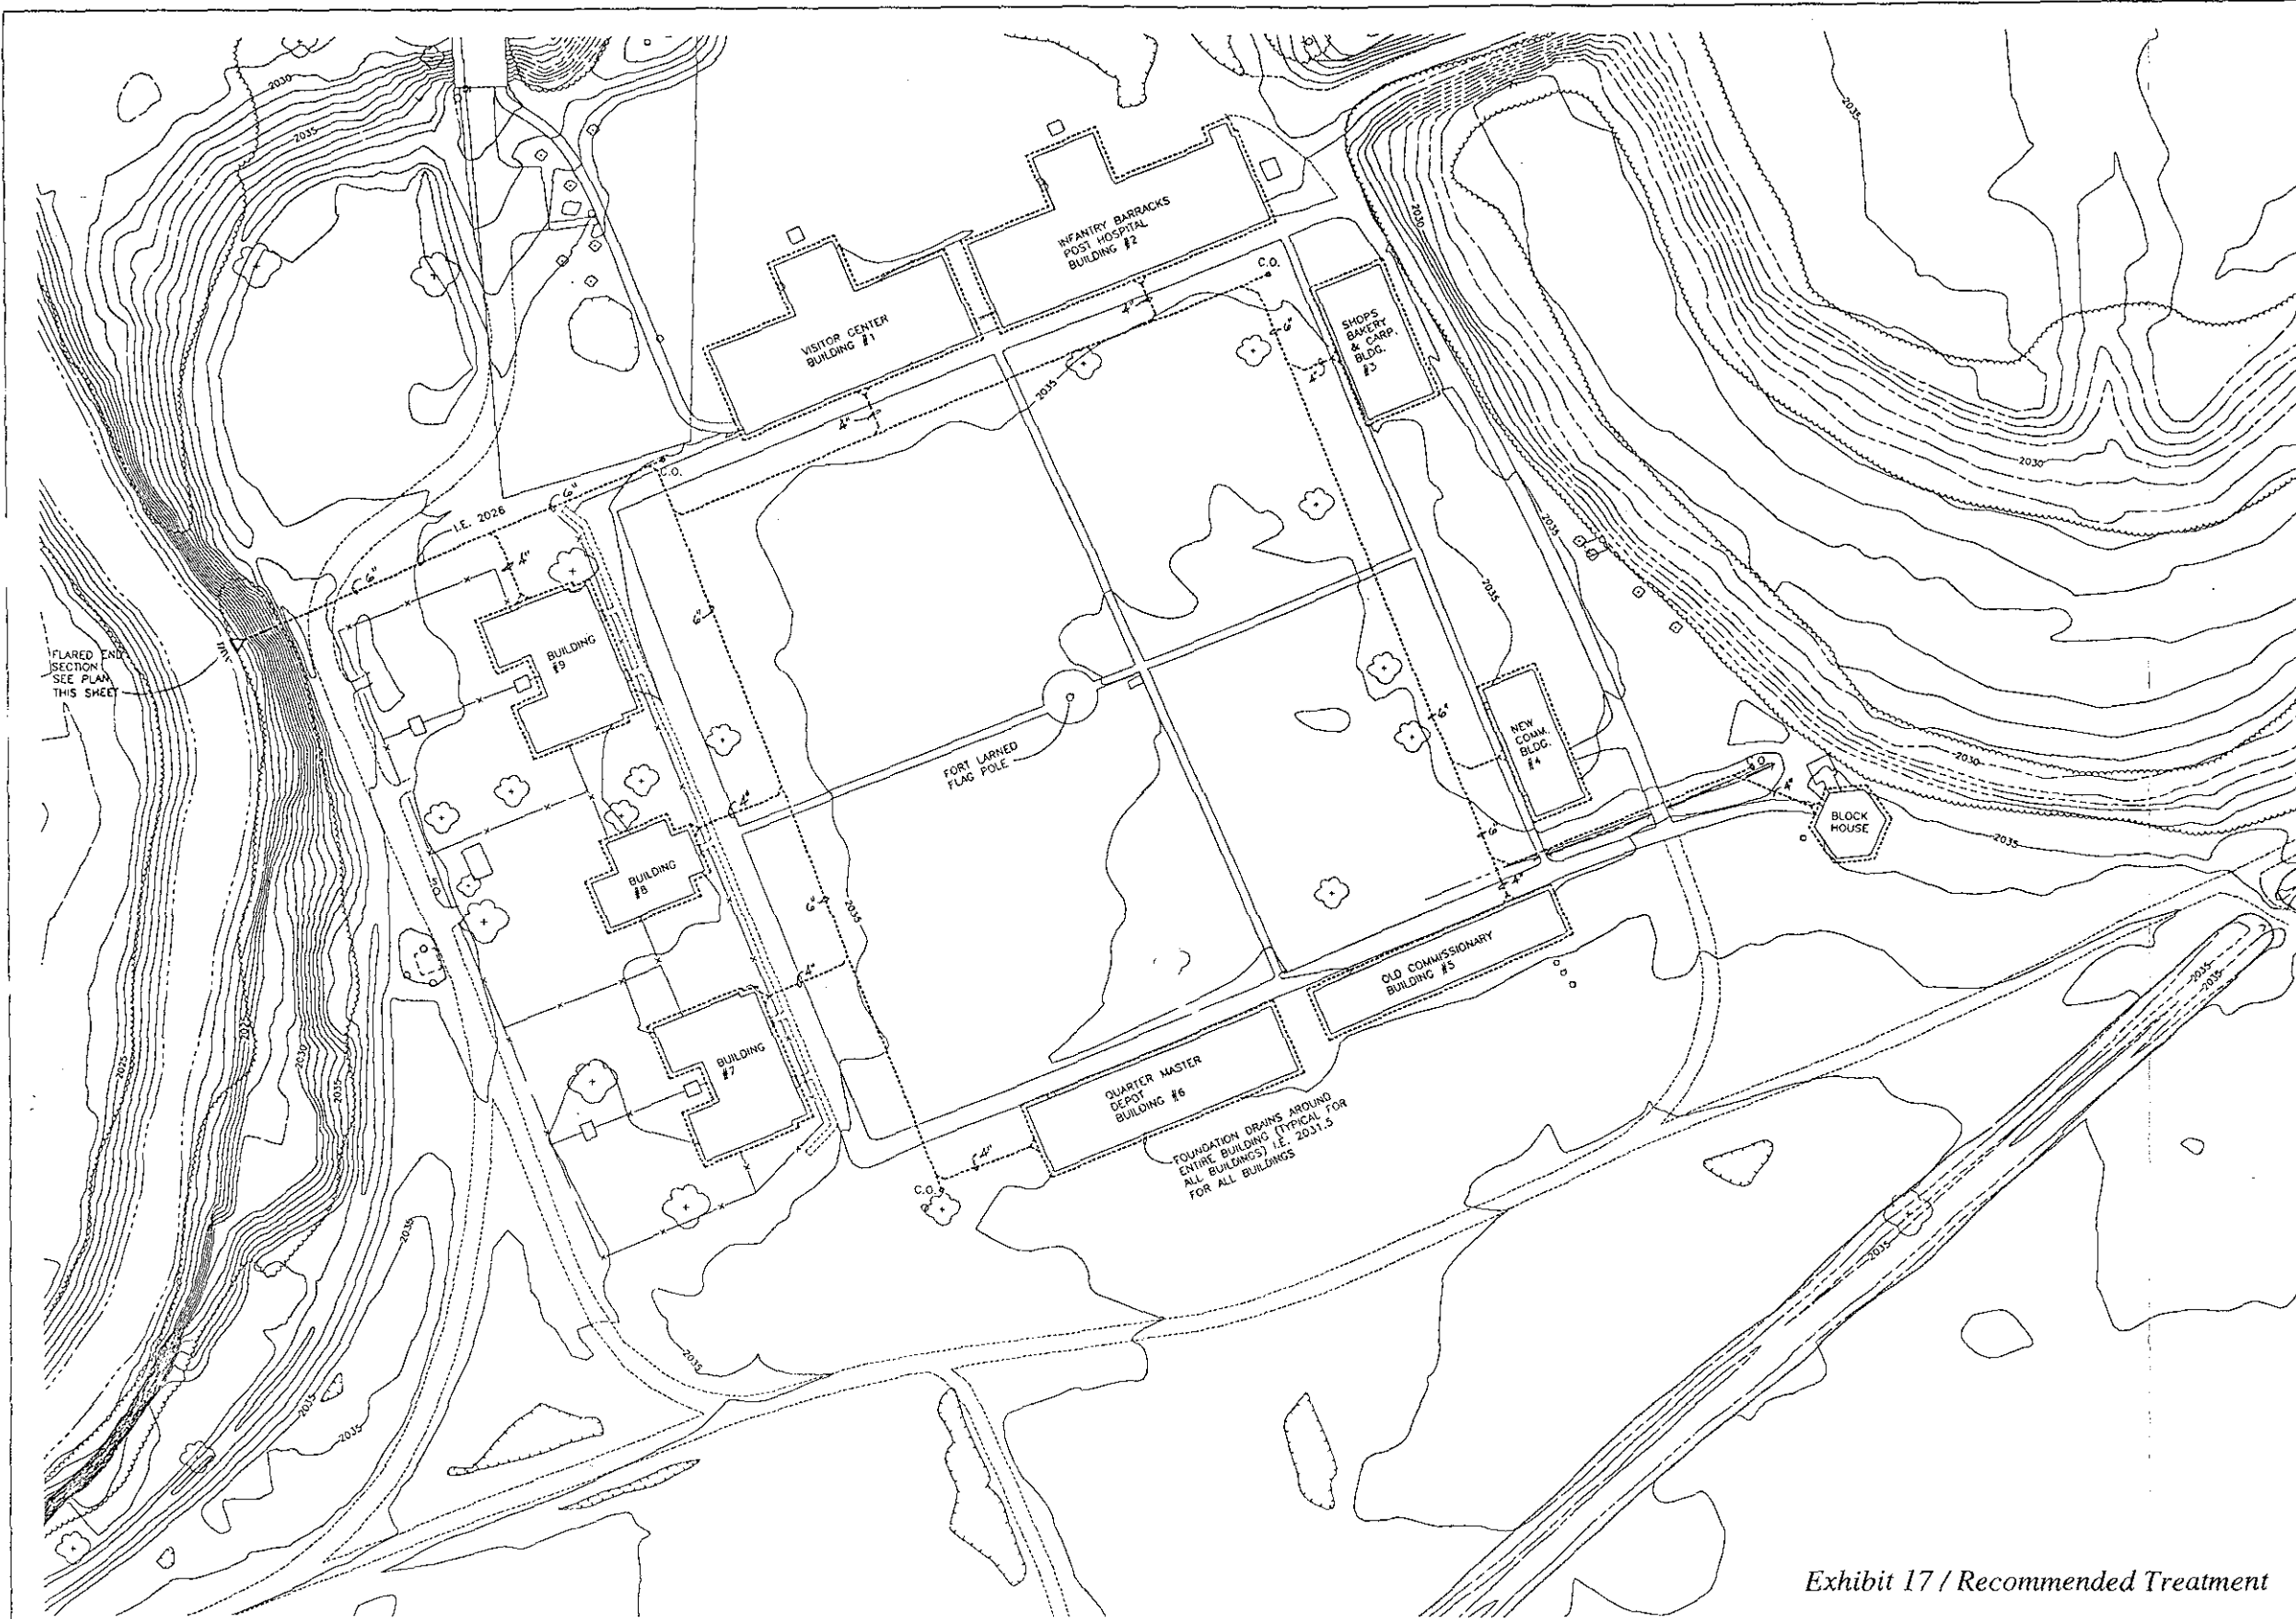
FLARED END SECTION  
NO SCALE

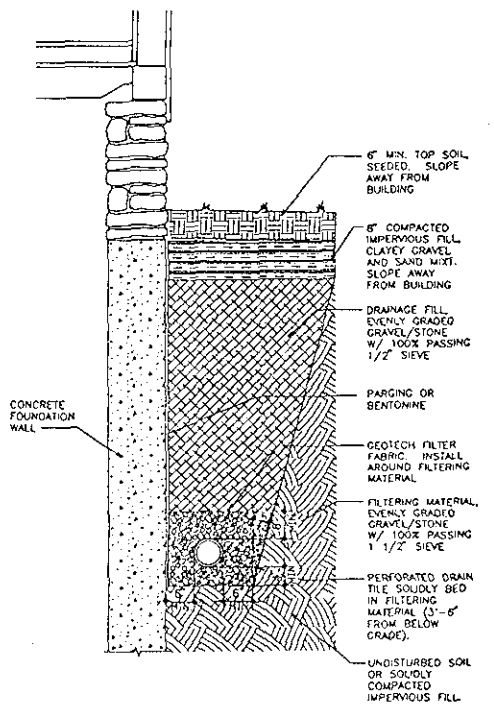
FOUNDATION DRAIN DETAIL @ CONCRETE WALLS  
NO SCALE

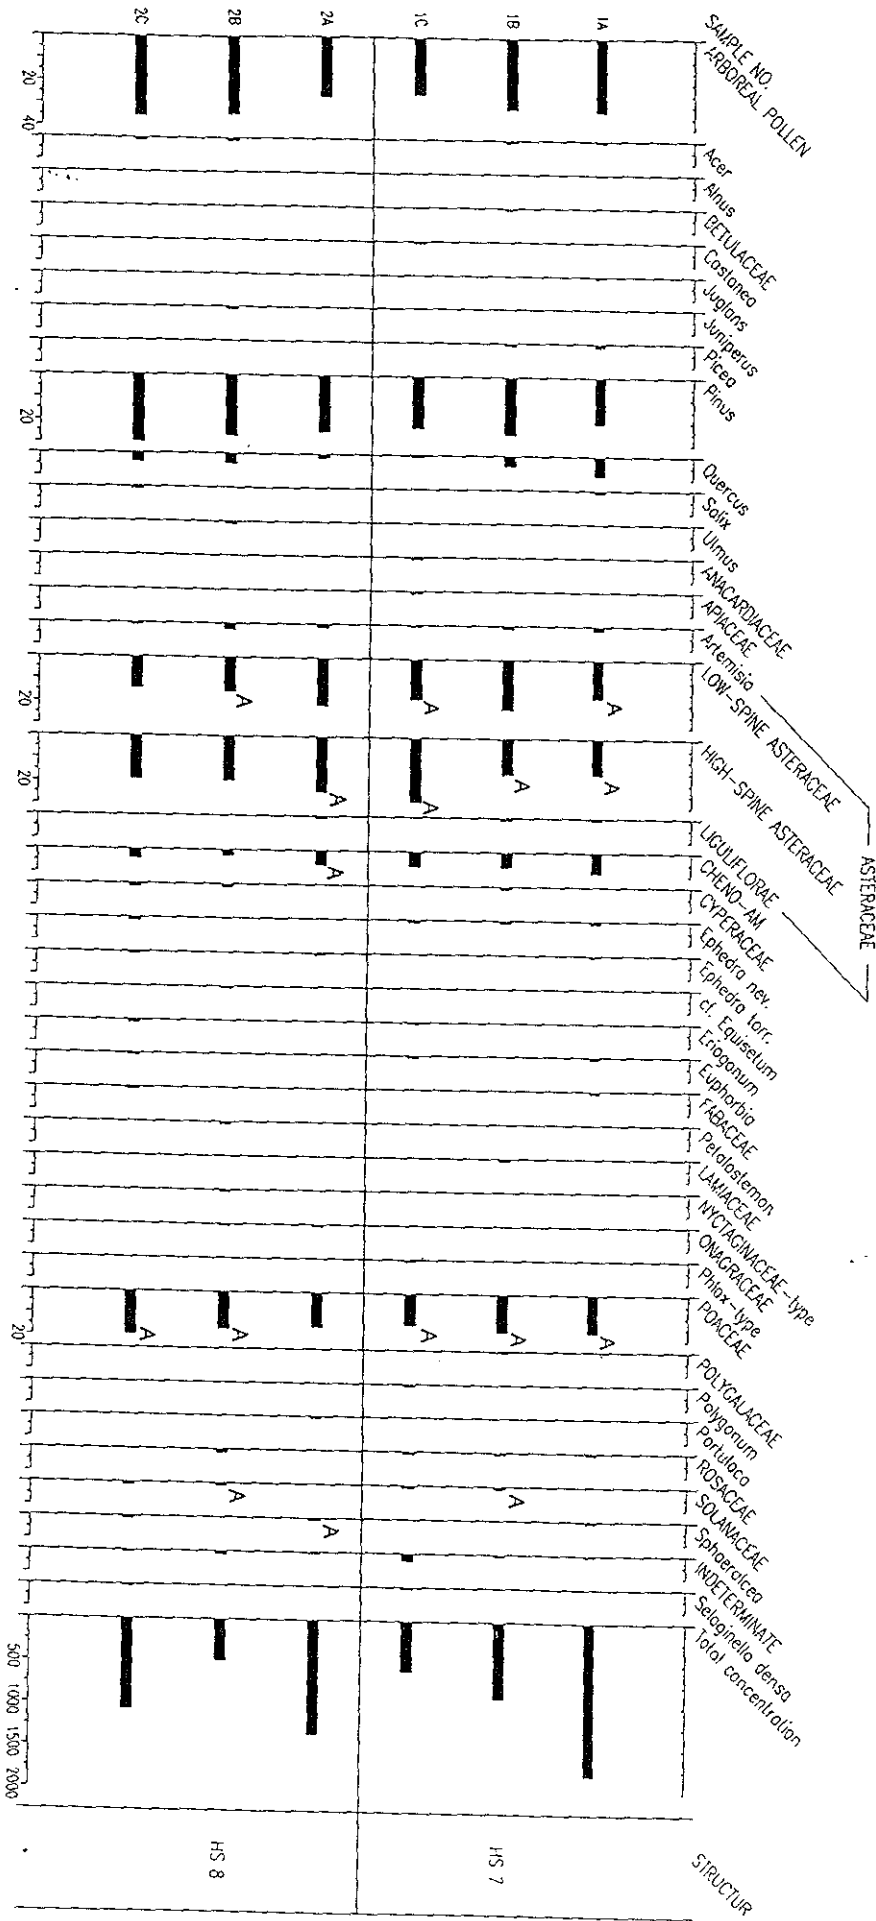
FIGURE 1. POLLEN DIAGRAM FOR FORT LARNED, KANSAS

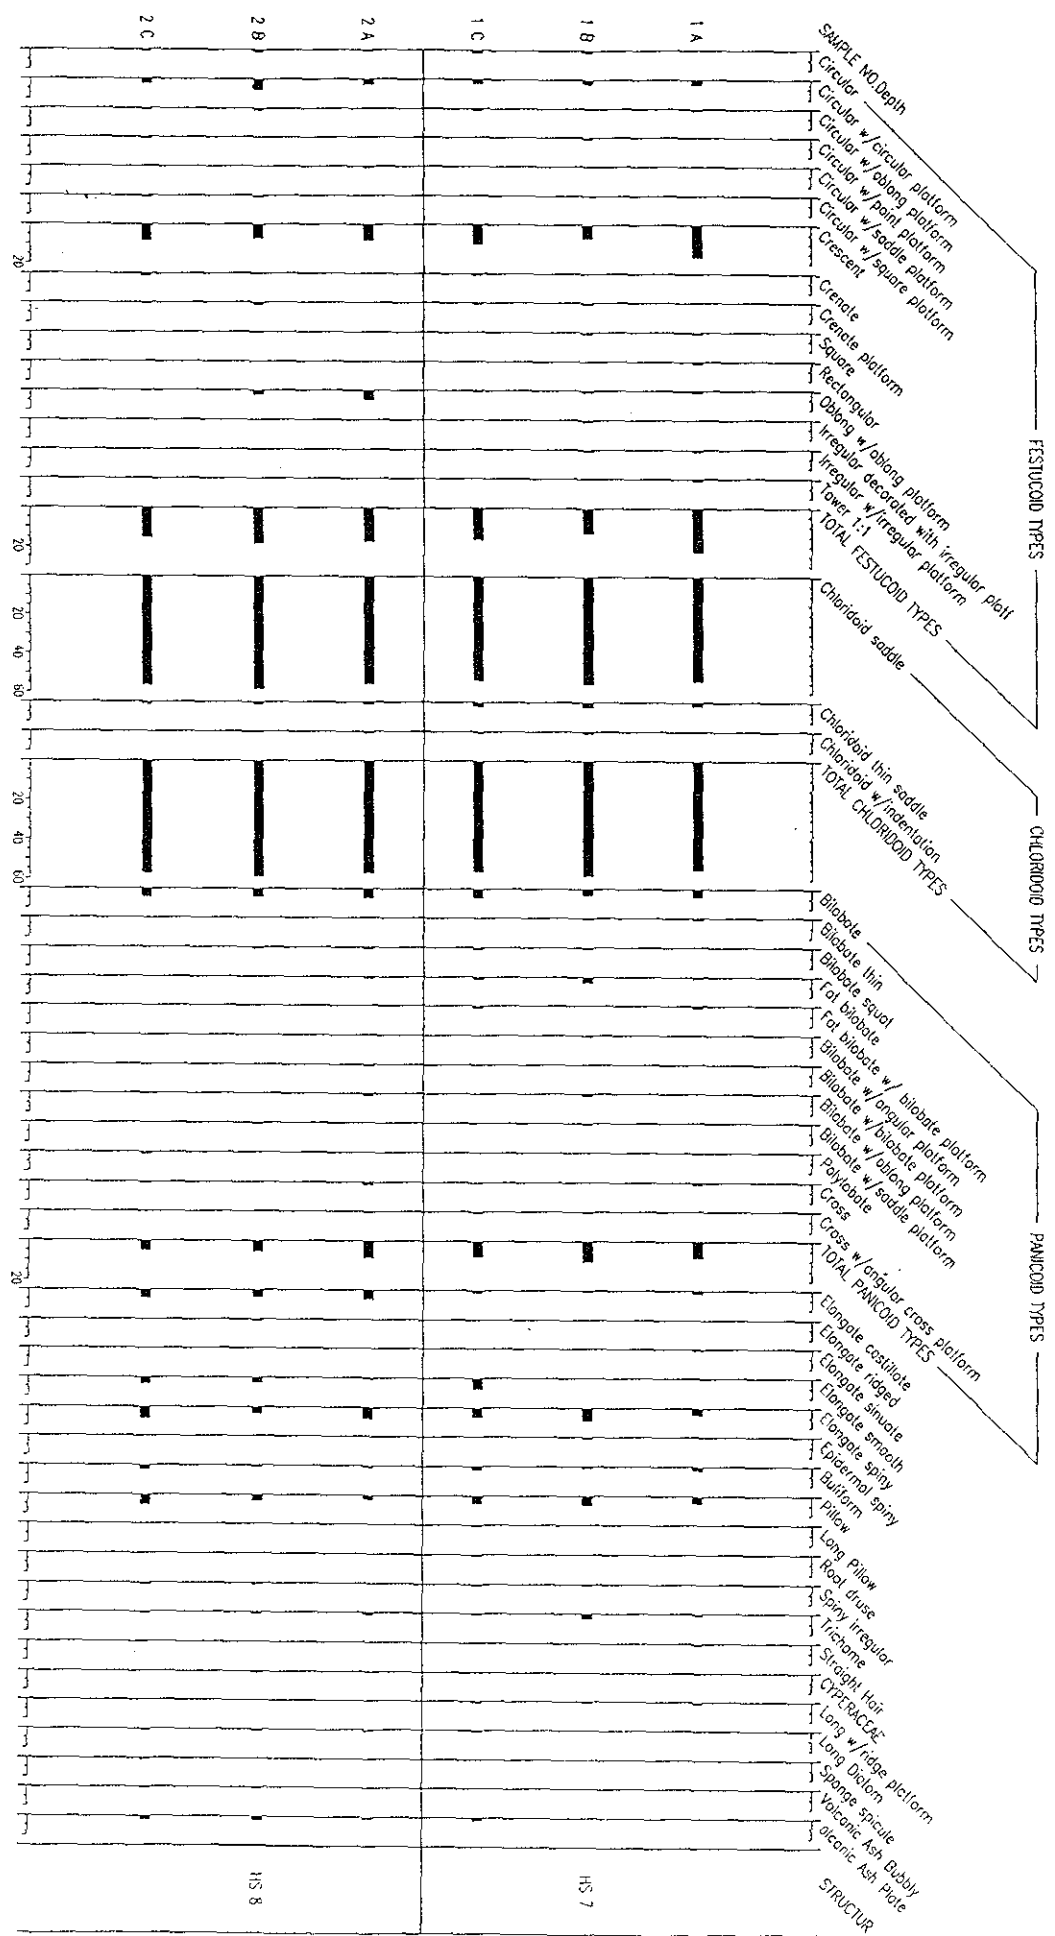
FIGURE 2. PHYTOLITH DIAGRAM FOR FORT LARNED, KANSAS.

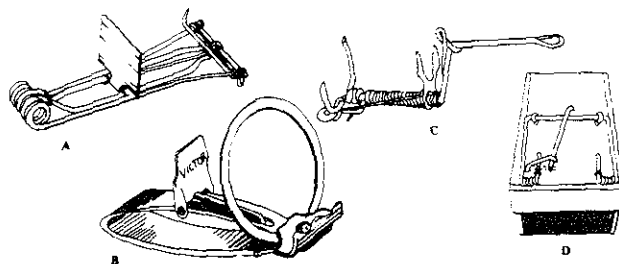
Figure 2. Typical gopher traps: (A) Macabee; (B) Victor Gopher Getter; (C) Death-Klutch 1; and (D) Guardian (California Box-Type).

Trapping is one of the best methods for reducing pocket gopher numbers on small to moderate sized fields (less than 50 acres) and to remove remaining animals after a poison control program. Body gripping traps (Death Clutch 1, Macabee, Victor, Guardian Gopher Trap), available from hardware and trapping supply stores, work exceptionally well for capturing gophers (Figure 2). Traps

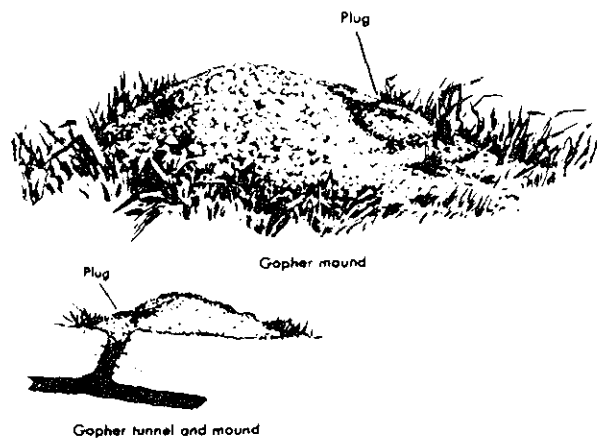
Figure 3. Pocket gopher mound and its relation to tunnel system.

can be set in the main tunnel or in a lateral, preferably near the freshest mounds. The lateral tunnel usually can be located by a circular plug (sometimes a depression) in the fan shaped mound (Figure 3). Probe into the depression, usually in the direction away from the mound, until the direction of the tunnel is determined. Remove the several-inch plug of soil with a garden trowel or a spade. A trap, secured to a wire and marker stake, can be inserted with the body gripping jaws about 6 to 8 inches into the tunnel (Figure 4). Traps also can be set in the main tunnel located about 12 to 18 inches from the mound. After uncovering the main tunnel with a shovel, set 2 traps as shown in Figure 4. The tunnels either can be left open or covered after setting traps. Traps can be checked twice daily since gophers often visit the traps within a few hours. If a trap is not visited within 48 hours, move it to a new location. Trapping usually is most successful in the spring and fall when gophers are actively building mounds.

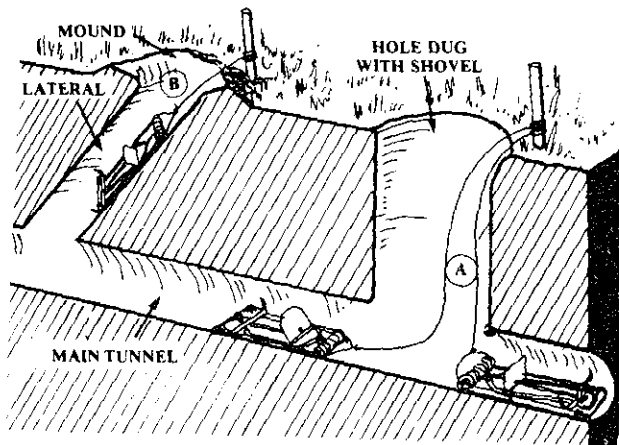
**Figure 4. Methods of placing gopher traps into burrow systems:** (A) Place two traps set in opposite directions in main tunnel; (B) set single trap in lateral tunnel from which soil plug has been removed. Wire each trap to a stake.

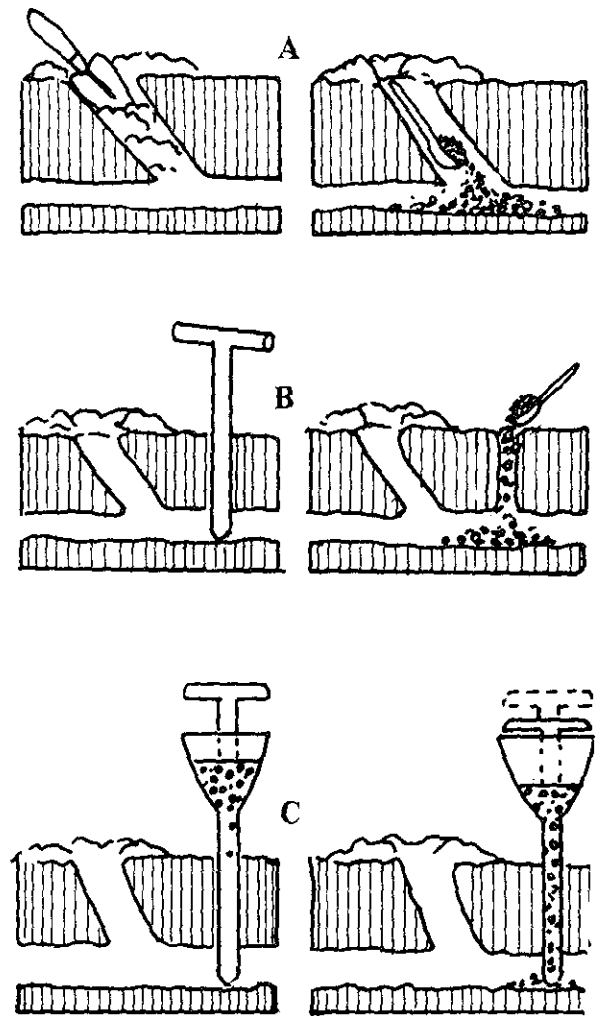
**Figure 5. Methods of applying gopher bait by hand or with a probe.**

Bait can be placed through the probe hole into the tunnel. A reservoir-type bait probe dispenser is also available for poisoning gophers (Figure 5). A button is pushed on the bait probe when it is pushed in the burrow and a metered dose of bait drops into the burrow. Place the recommended amount of bait down each of 2 or 3 probe openings and then cover the probe holes with sod.

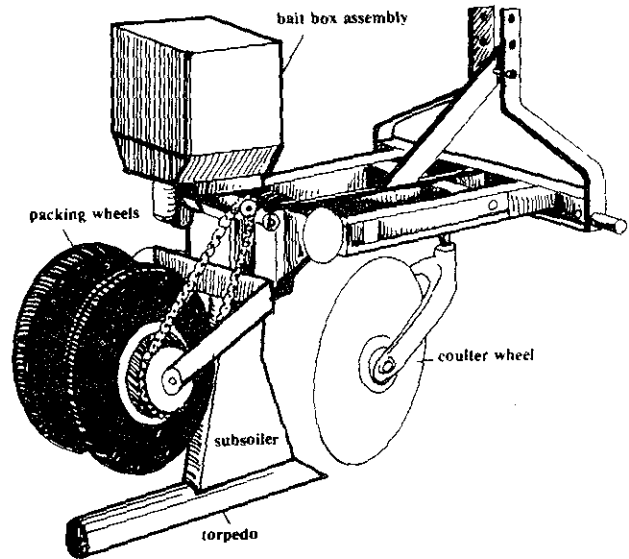
Figure 6. The "burrow-builder" machine may be used to control pocket gophers on large acreages.

The burrow builder (Figure 6) mechanically delivers bait underground so large acreages can be economically treated for pocket gopher control. Burrow builders are available in a standard hydraulically operated unit or a three-point hitch model. The device consists of a knife and torpedo assembly which makes the artificial burrow at desired soil depths, a coultter blade which cuts roots of plants ahead of the knife, a seeder assembly for bait dispensing, and the packer wheel assembly to close the furrow behind the knife. The seeder box has a metering device for dispensing various poison baits at desired rates.
