CULTURAL LANDSCAPE REPORT

Chellberg Farm

Indiana Dunes National Lakeshore

May 2000

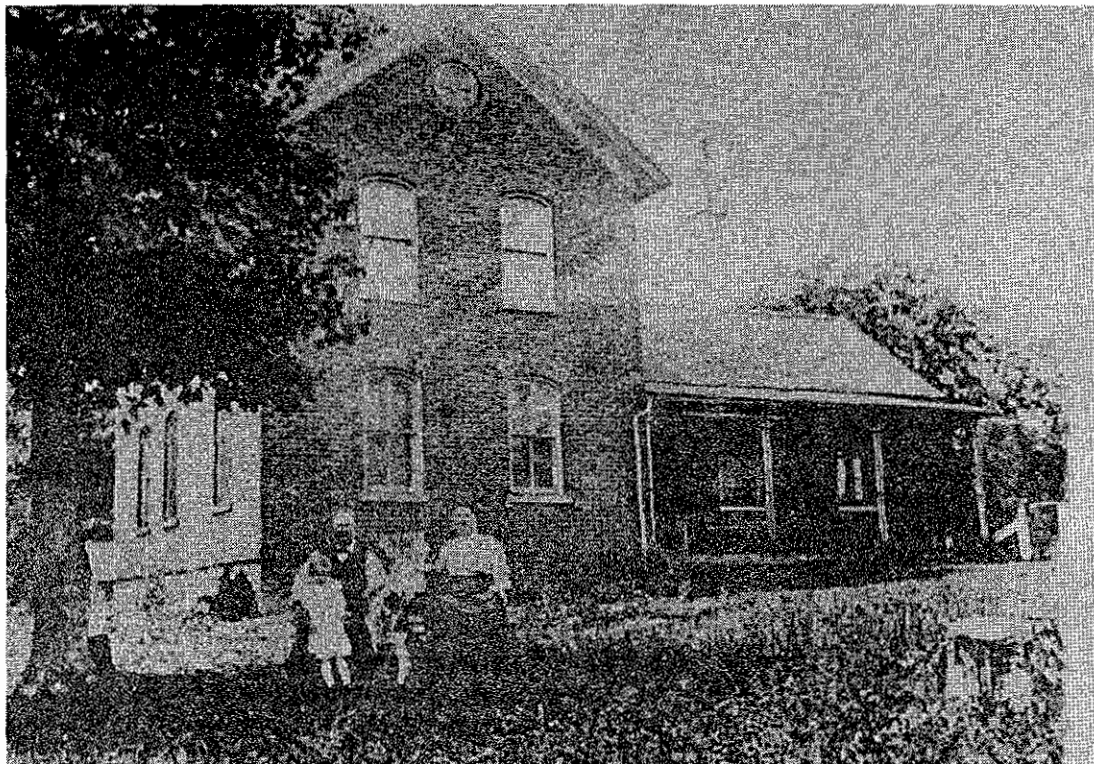
Figure II-15: The south and east sides of the house, with the windmill visible in back, circa 1908. (H2-0002)

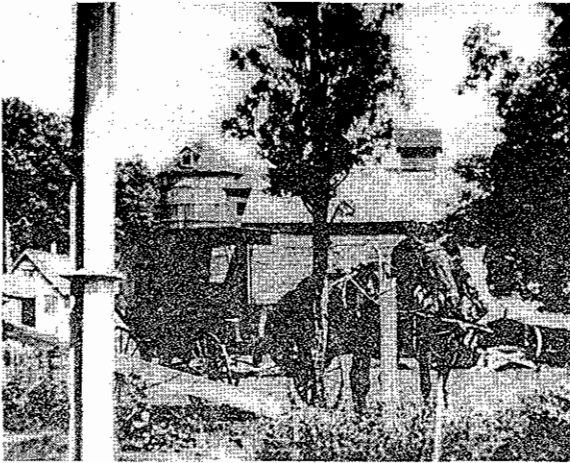
Figure II-23: Circa 1921 photo showing the wire fence with wood post at the yard and the light post south of the chicken coop. (HS0043)

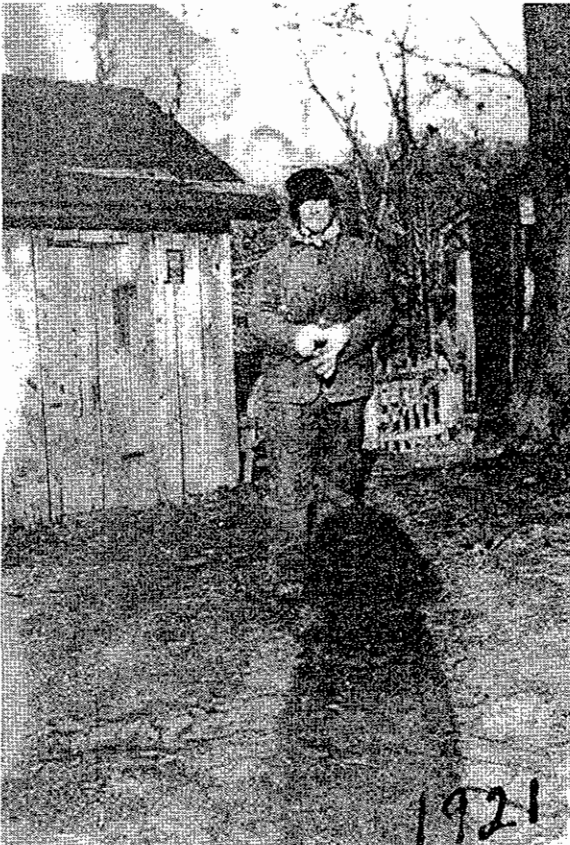
Figure II-24. A 1921 photograph showing the woodshed area and the gate. The outhouse is on the right behind the tree. (H20018)

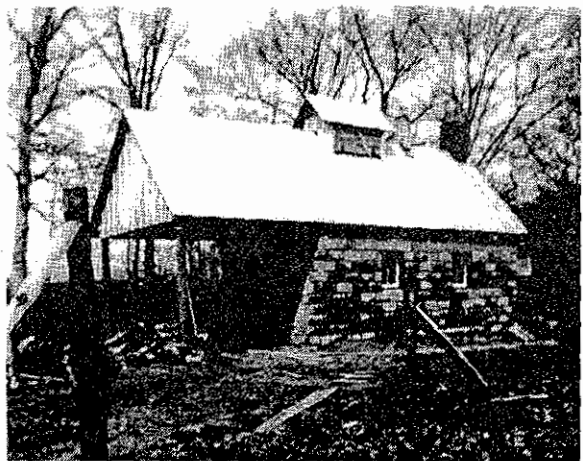
Figure II-32: The sugar camp with a fence running along the ravine. Early 1935 or 1936--the pump house addition has not yet been built. (INDU8138)

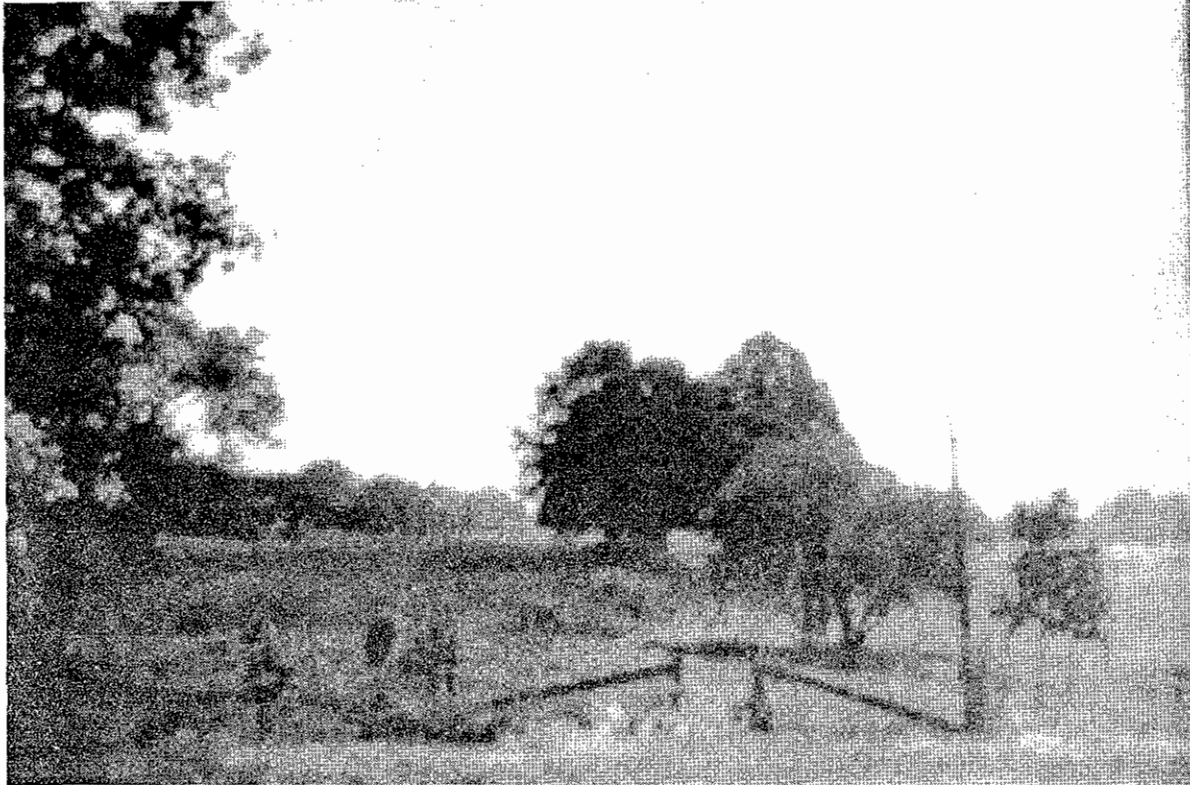
Figure II-38: Gate at eastern edge of yard, circa 1922. Note the tree-lined lane, fruit tree, and ornamental plants near the fence. (lane.tif)

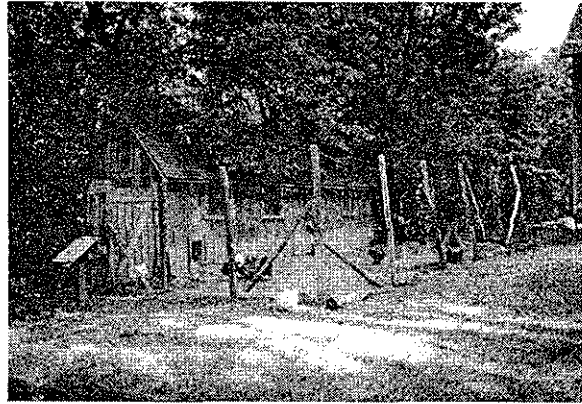
Figure III-20: Chicken house, south and east elevations, 8/11/98.

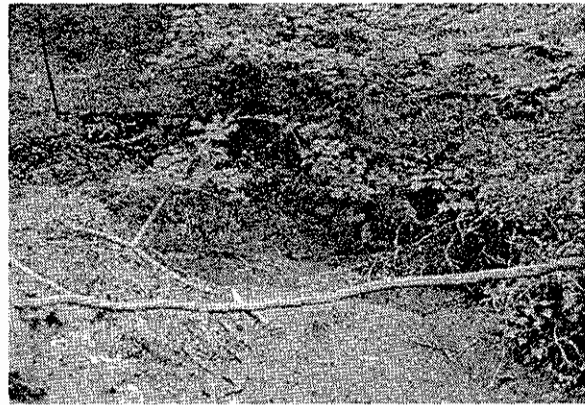
Figure III-31: Erosion west of Sugar camp, 8/11/98.

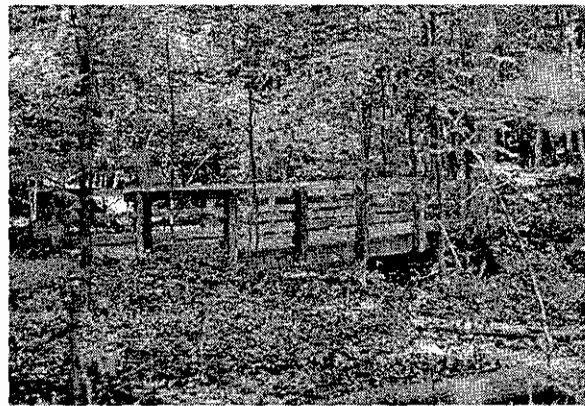
Figure III-32: Bridge over washout area west of Sugar camp, 8/11/98.

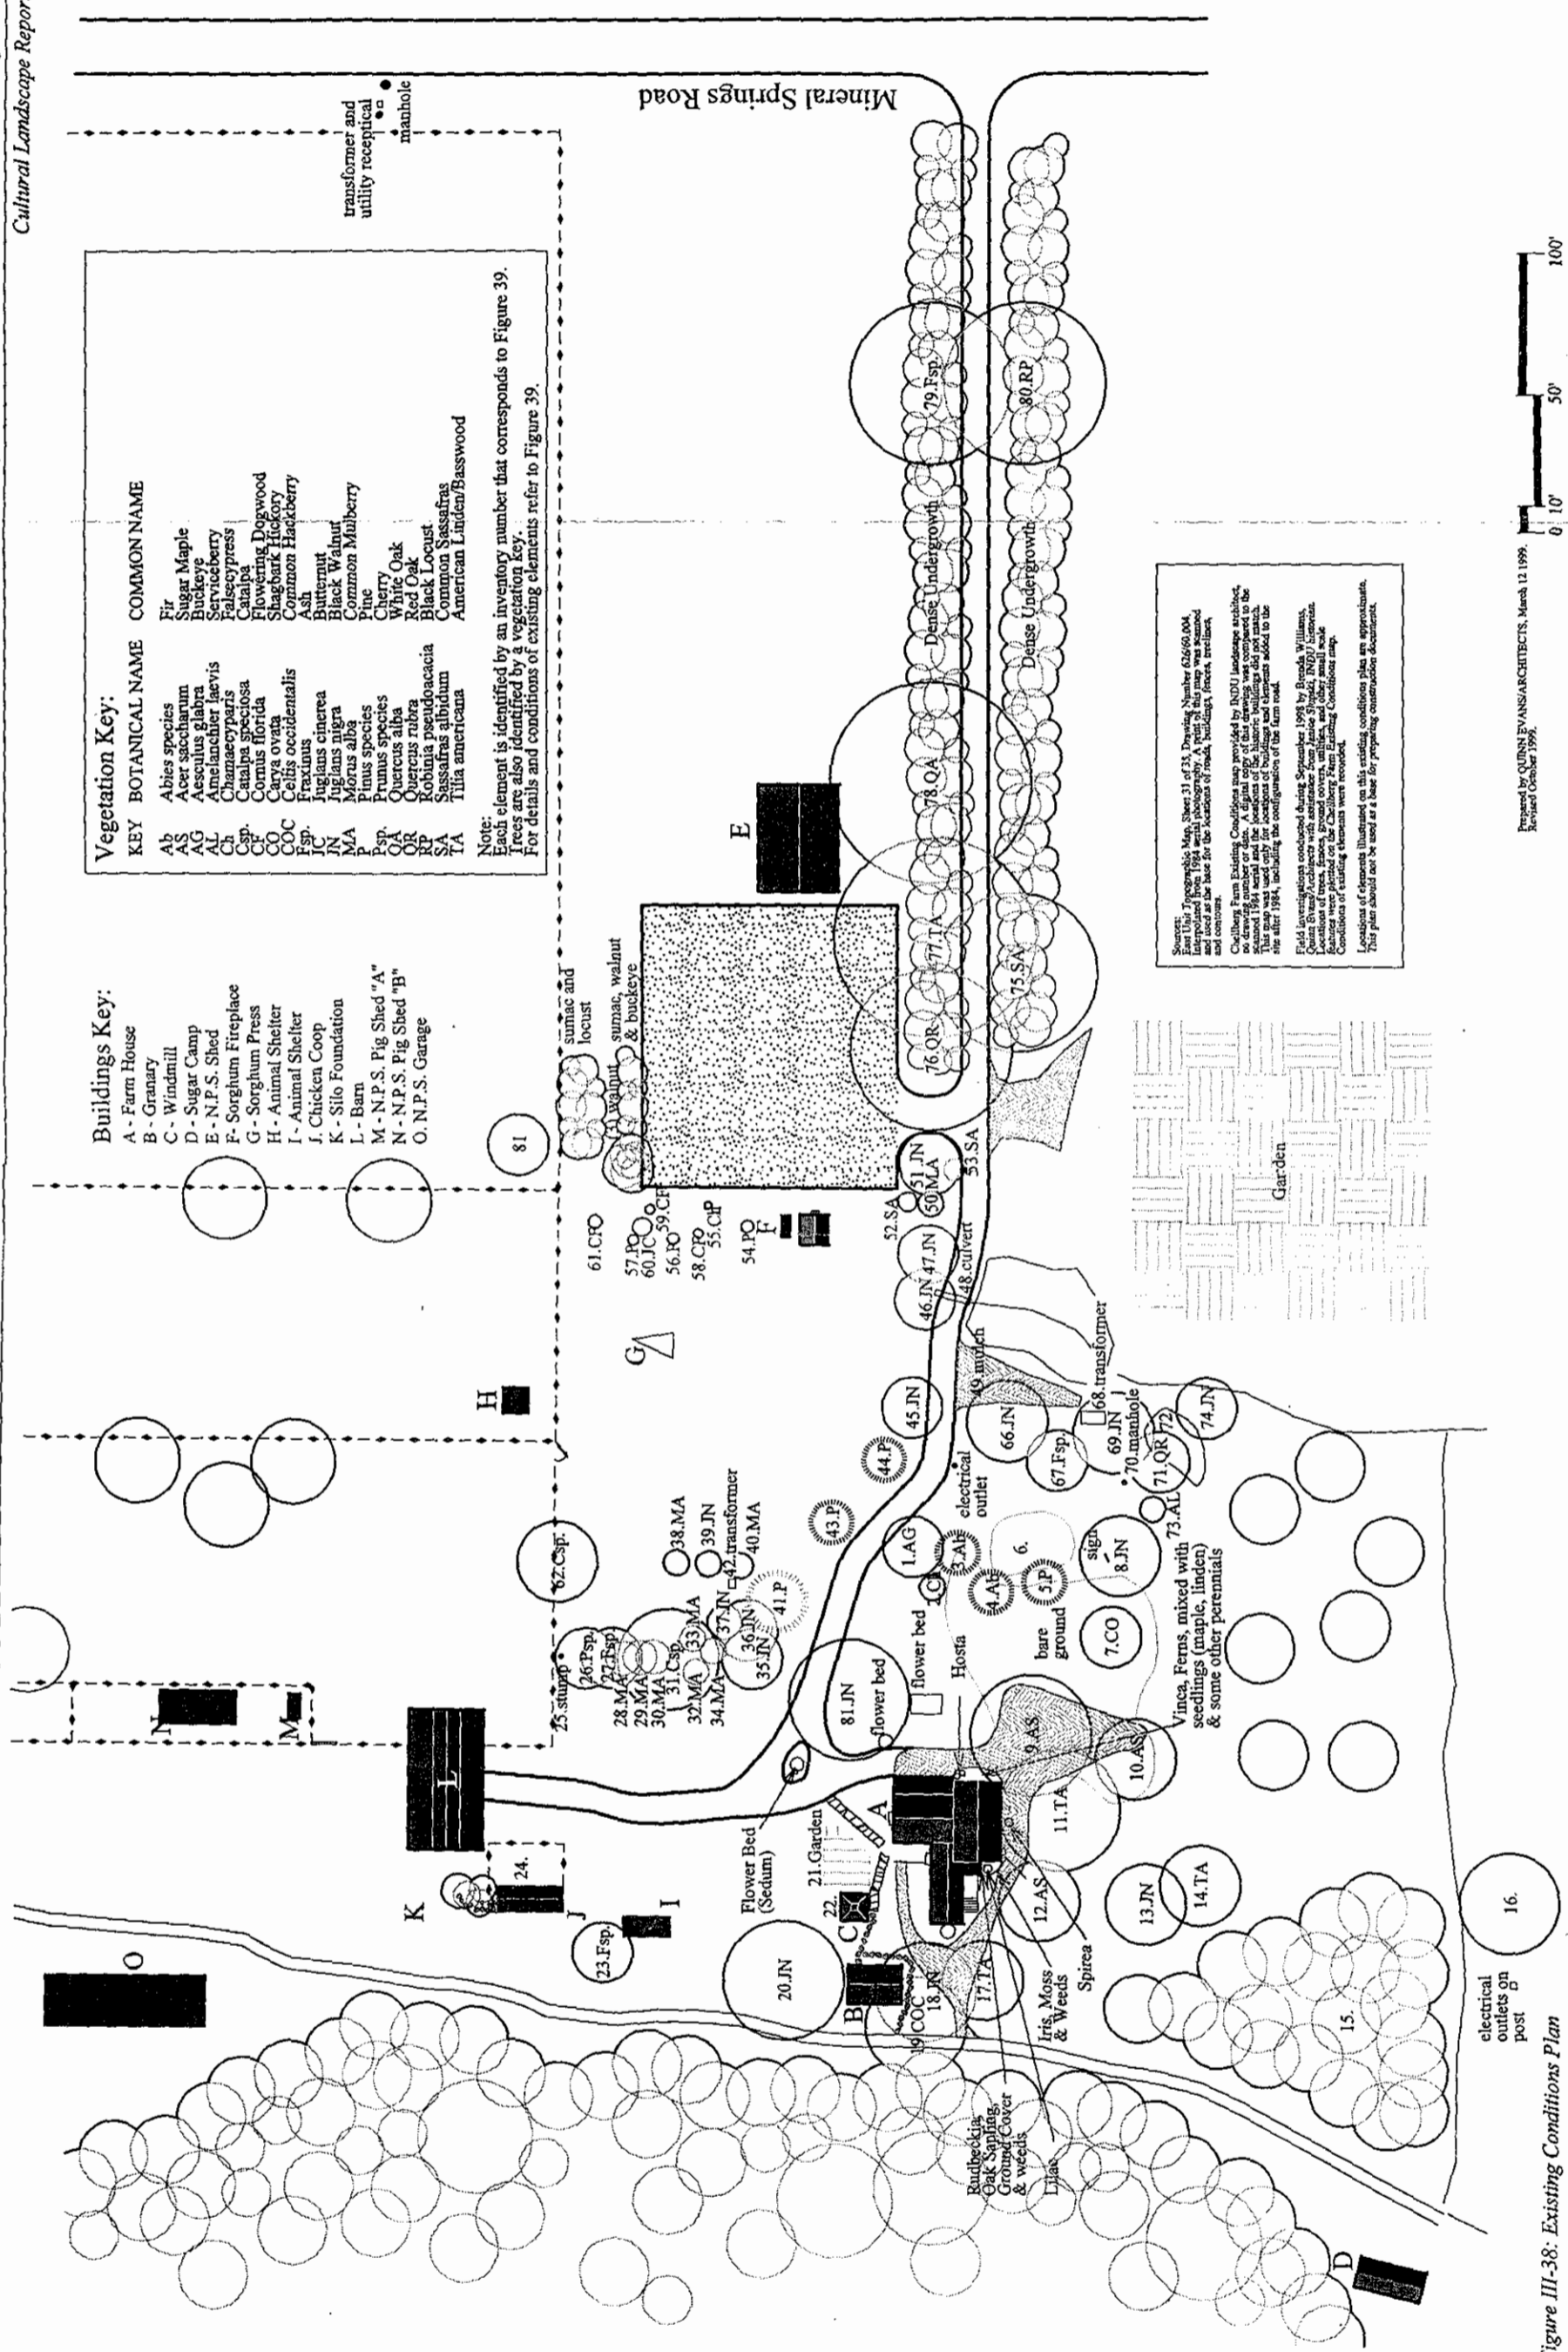
- Buildings Key:**
- A - Farm House
 - B - Granary
 - C - Windmill
 - D - Sugar Camp
 - E - N.P.S. Shed
 - F - Sorghum Fireplace
 - G - Sorghum Press
 - H - Animal Shelter
 - I - Animal Shelter
 - J - Chicken Coop
 - K - Silo Foundation
 - L - Barn
 - M - N.P.S. Pig Shed "A"
 - N - N.P.S. Pig Shed "B"
 - O - N.P.S. Garage

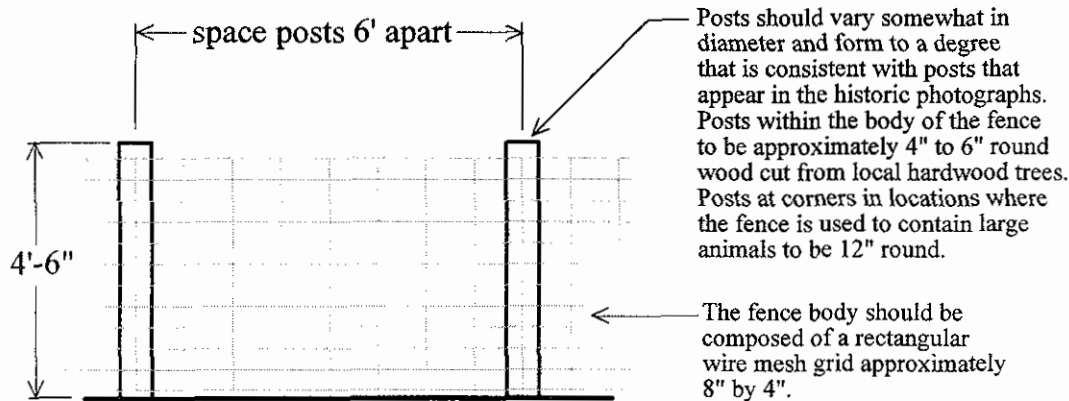
Figure VI-6: Recommended Fence Elevation

Note: This design will result in buckles and sways in the fence body which are desirable to be consistent with the historic fence.

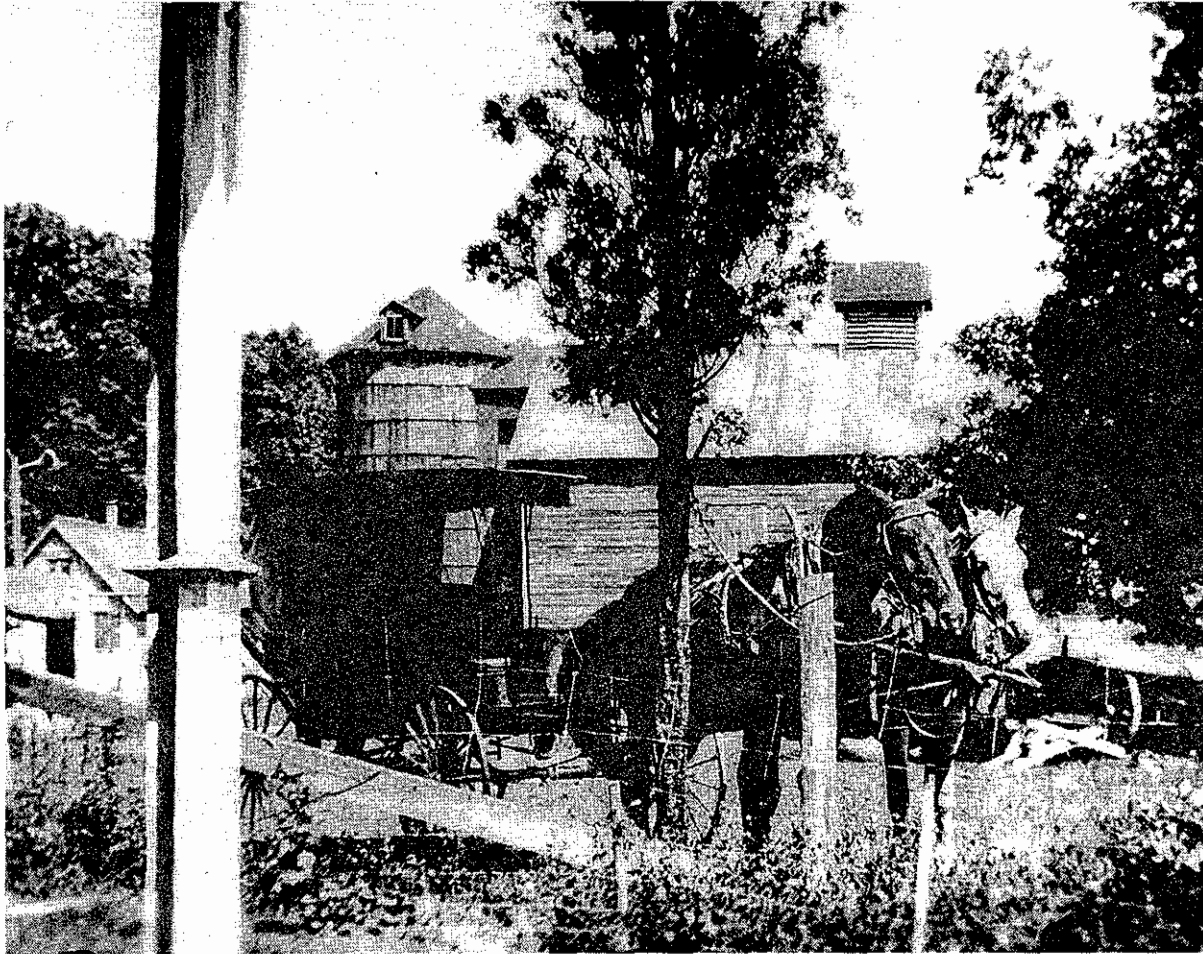
Figure VI-9: Historic Photograph of Fence Details
