CULTURAL LANDSCAPE REPORT FOR
NATIONAL CENTER FOR PRESERVATION
TECHNOLOGY AND TRAINING

NORTHWESTERN STATE UNIVERSITY
NATCHITOCHES, LOUISIANA

Prepared by
Christopher Stevens, Olmsted Center for Landscape Preservation

National Park Service, Boston, Massachusetts, 2006

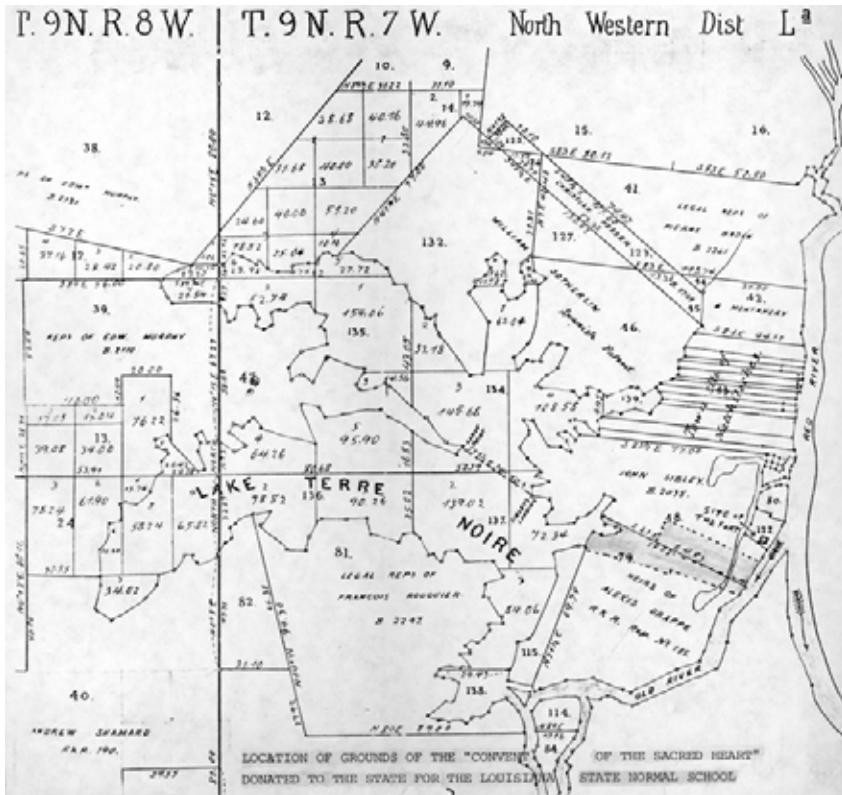
Figure 1. Undated plat map showing the location of the Academy of the Sacred Heart in Natchitoches, Louisiana (shaded in gray, lower right) (Northwestern State University, Watson Memorial Library, Cammie G. Henry Research Center).

On April 23, 1856, Madam Antoinette Bullion, Superior of the Academy of the Sacred Heart, bought the Bullard property and buildings from the Reverend Martin (Figure 1). The Natchitoches Academy of the Sacred Heart had been established to provide the first catholic school north of Baton Rouge. The nuns assigned to the school were known as the Religious of the Sacred Heart or the Ladies of the Sacred Heart.¹⁸ Behind the new school, a pine and cedar avenue led to a Virgin Mary statue known as “Our Lady of the Piney Woods.”¹⁹

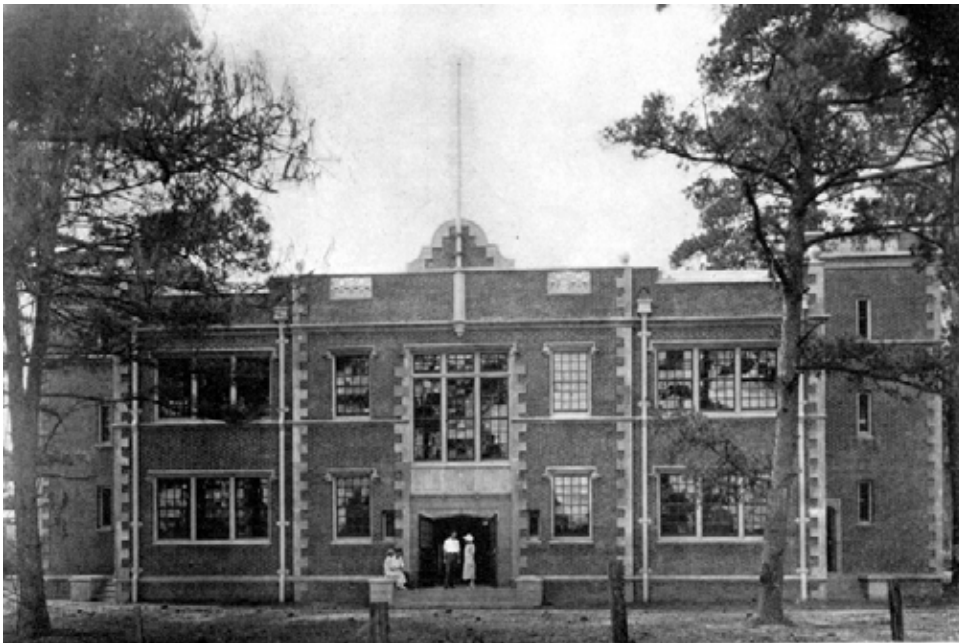
Figure 8. Front (north) façade of Women's Gymnasium showing pine trees, 1924 (Northwestern State University, Watson Memorial Library, Cammie G. Henry Research Center (Potpourri Yearbook)).

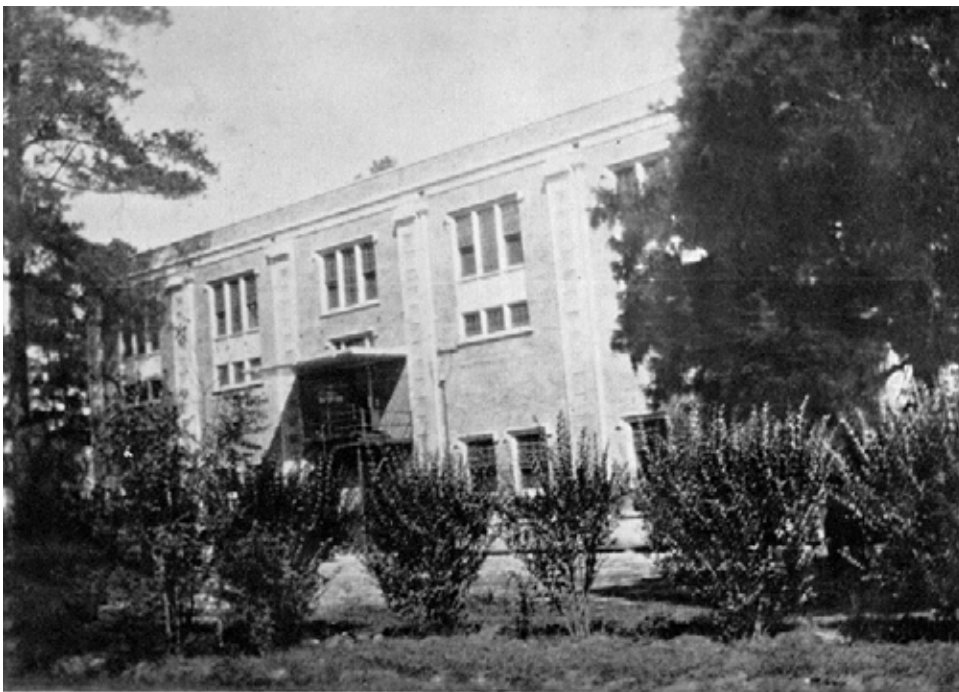
REAR VIEW OF THE GYMNASIUM

Figure 9. Rear (south) façade of Women's Gymnasium showing pine trees and hedge, 1924 (Northwestern State University, Watson Memorial Library, Cammie G. Henry Research Center (Potpourri Yearbook)).

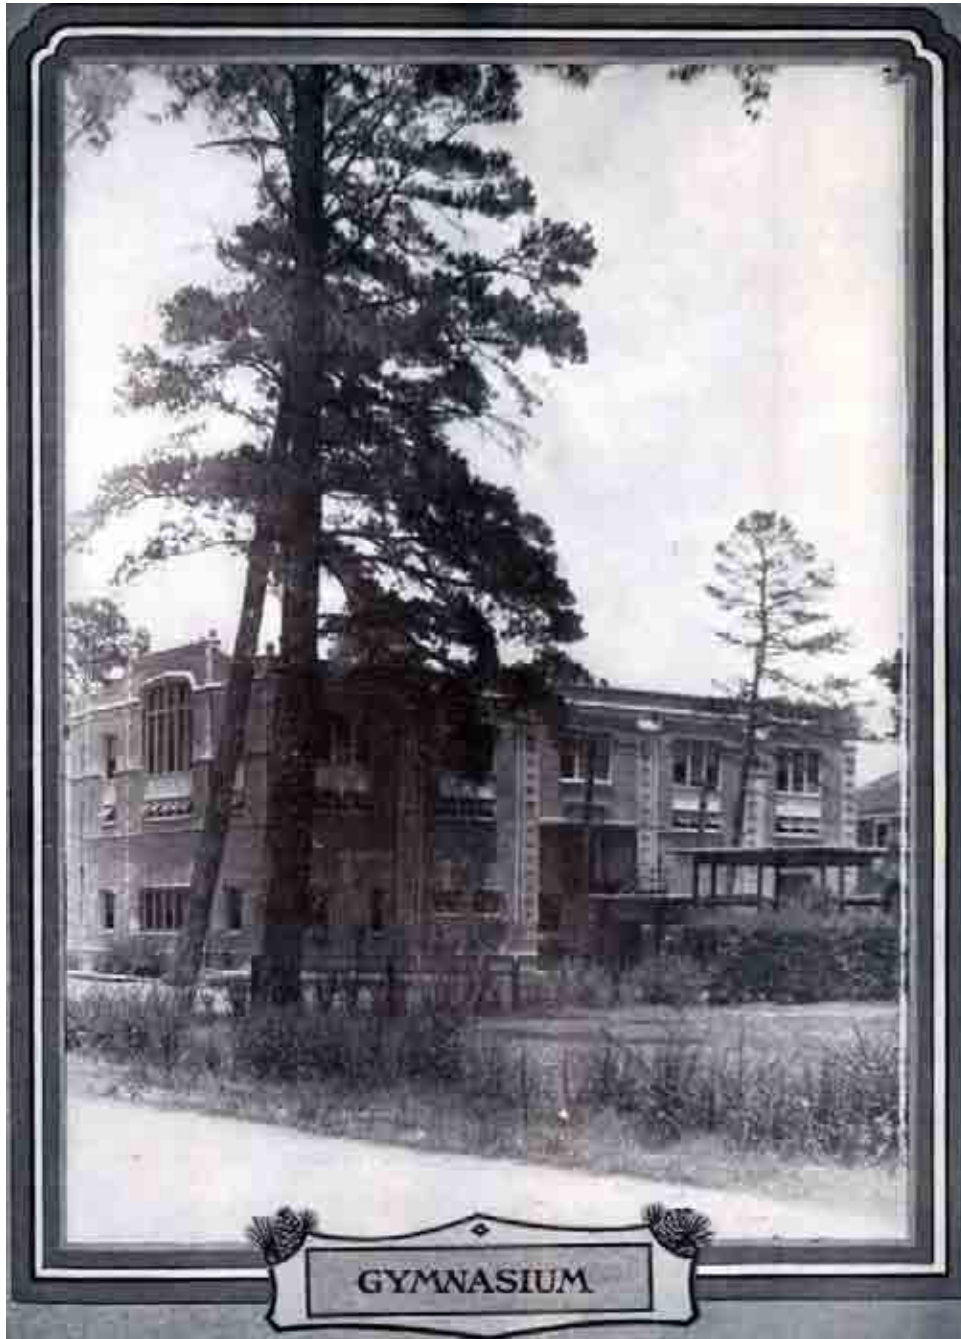
Figure 10. Southwest corner of Women's Gymnasium showing pine trees, hedges, and pergola-covered central walk to rear entrance, 1926 (Northwestern State University, Watson Memorial Library, Cammie G. Henry Research Center (Potpourri Yearbook)).

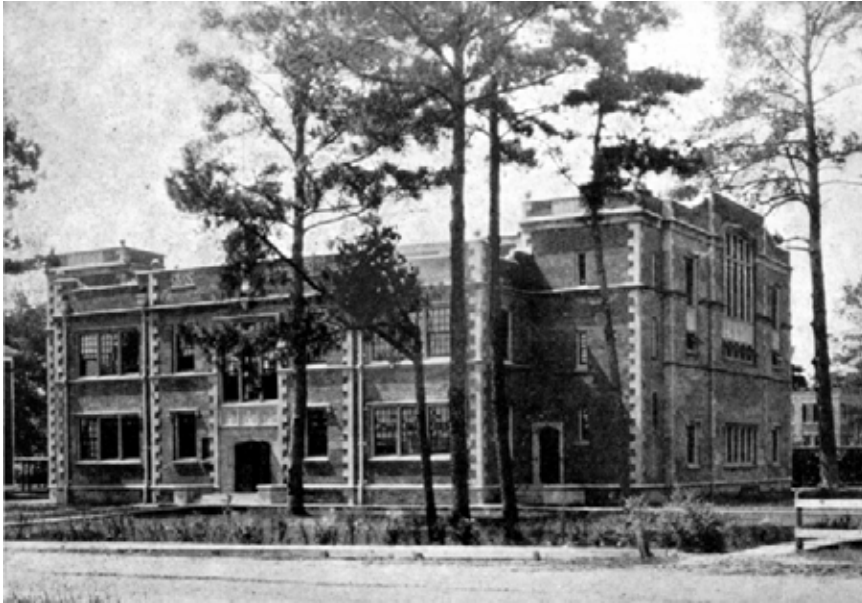
Figure 11. Front (north) façade of Women's Gymnasium showing pine trees and hedges and walkways along College Avenue, 1927. Note the former neighboring building at the far left.(Northwestern State University, Watson Memorial Library, Cammie G. Henry Research Center (Potpourri Yearbook)).

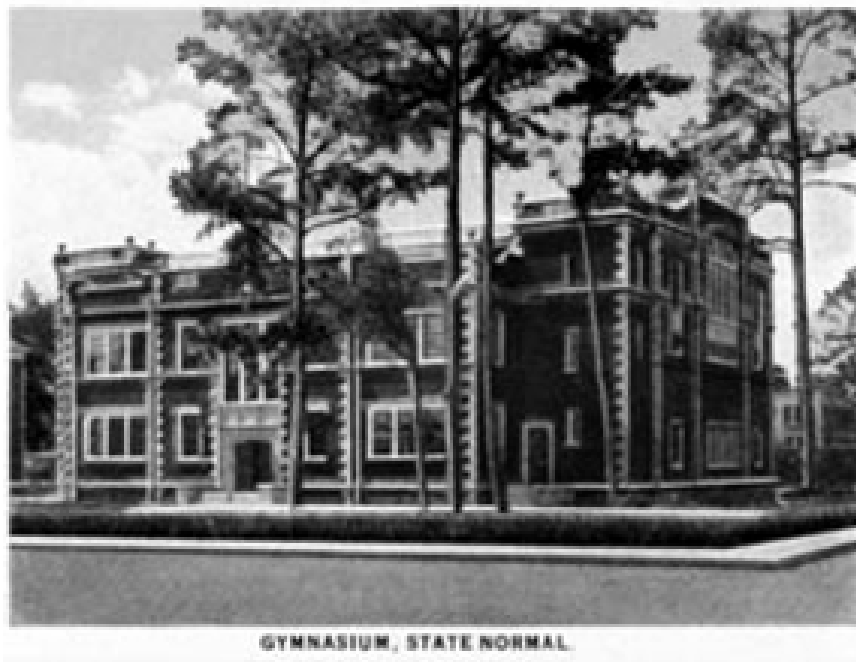
Figure 12. Front (north) façade of Women's Gymnasium showing pine trees and hedges and walkways along College Avenue, ca. 1927. Note the former neighboring building at the far left.(Northwestern State University, Watson Memorial Library, Cammie G. Henry Research Center (Postcard)).

⁶¹ See Figures 12, 13, 15, 17, 20, 21, 25, 29, 30, & 31 for historic photos of NSU pergolas.

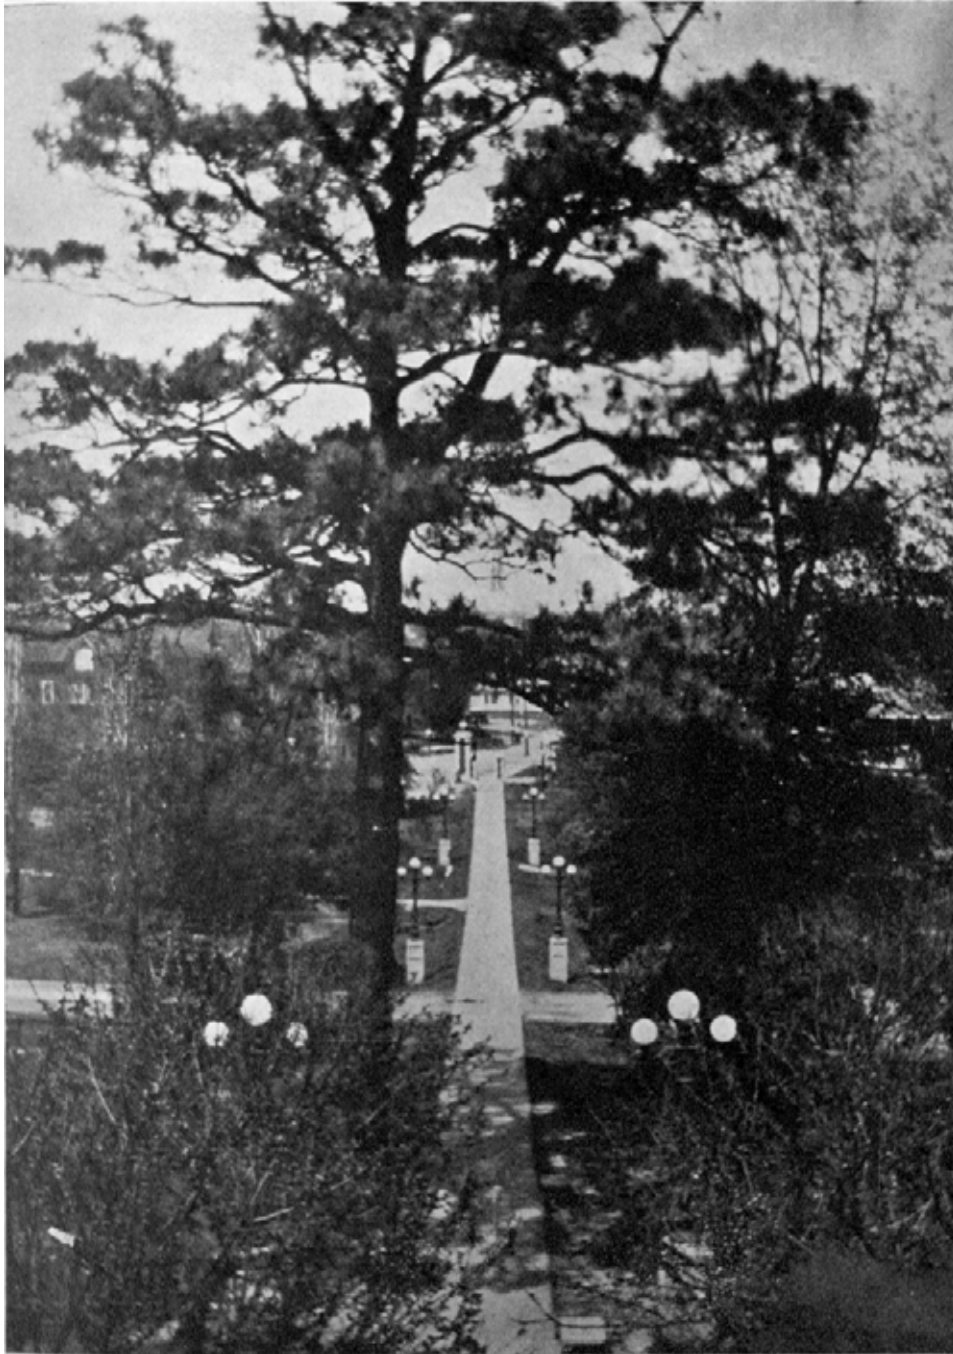
THE ROAD TO KNOWLEDGE

Figure 13. Walkway from Normal Hill to Main Gate lined by electroliers and ornamental vegetation including the "Sentinel Pine" (upper left), 1924 (Northwestern State University, Watson Memorial Library, Cammie G. Henry Research Center (Potpourri Yearbook)).

⁶² See Figures 13, 14, 16, 17, 18, 19, 29 & 24 for historic photos of NSU electroliers.

⁶³ See figures 13, 14, 17 & 18 for historic photos of NSU “Sentinel Pine” tree.

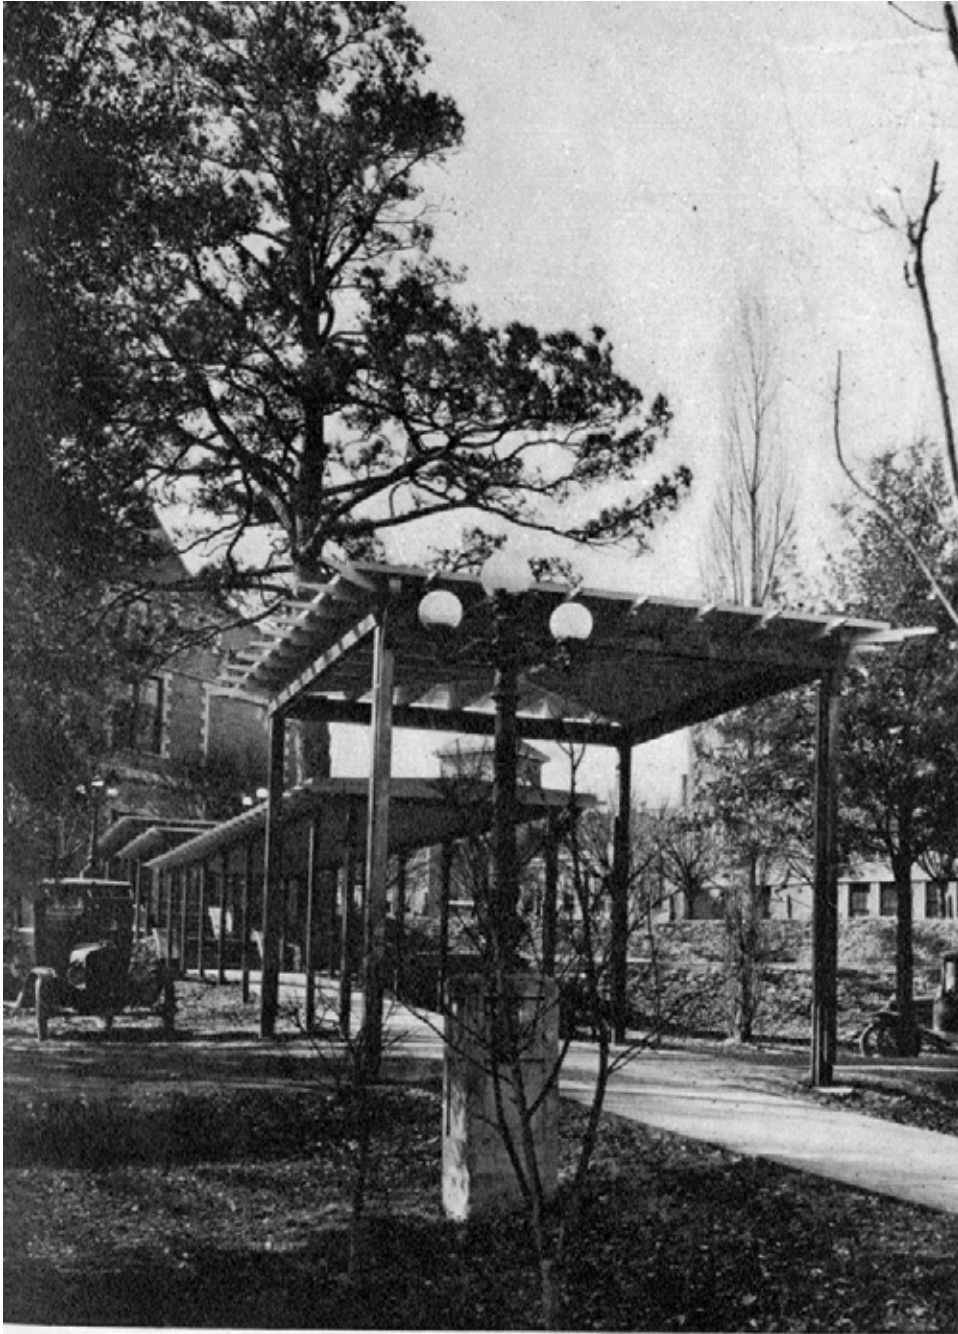
Figure 14. Walkway from Main Gate to Normal Hill lined with electroliers, and ornamental vegetation including the "Sentinel Pine" (top center) and sheltered with pergolas, 1924 (Northwestern State University, Watson Memorial Library, Cammie G. Henry Research Center (Potpourri Yearbook)).

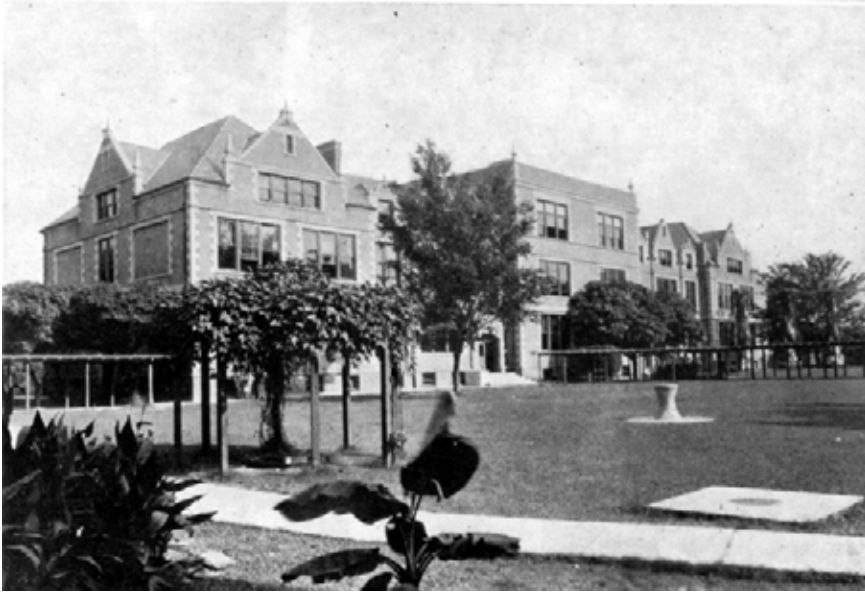
Figure 15. Planted and unplanted pergolas covering several of the college's walkways, 1927 (Northwestern State University, Watson Memorial Library, Cammie G. Henry Research Center (Potpourri Yearbook)).

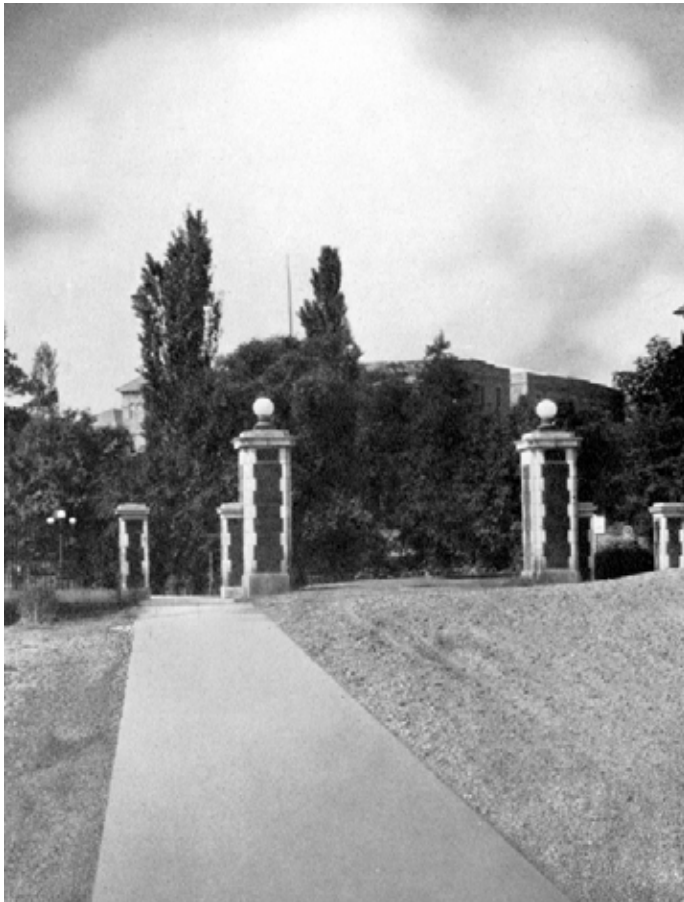
Figure 16. Main Gates along College Avenue, 1928 (Northwestern State University, Watson Memorial Library, Cammie G. Henry Research Center (Potpourri Yearbook)).

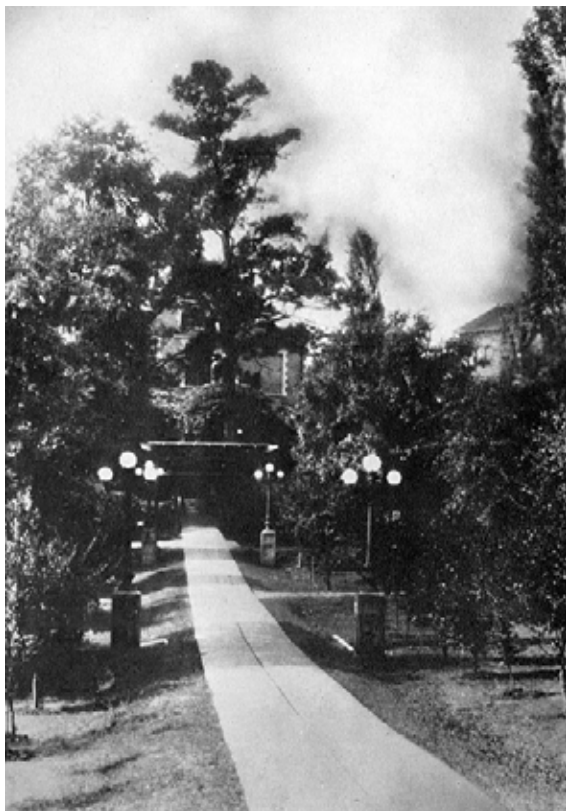
Figure 17. Walkway from Main Gate to Normal Hill lined by electroliers and ornamental vegetation and shaded with pergolas, 1928. Note the "Sentinel Pine" top center (Northwestern State University, Watson Memorial Library, Cammie G. Henry Research Center (Potpourri Yearbook)).

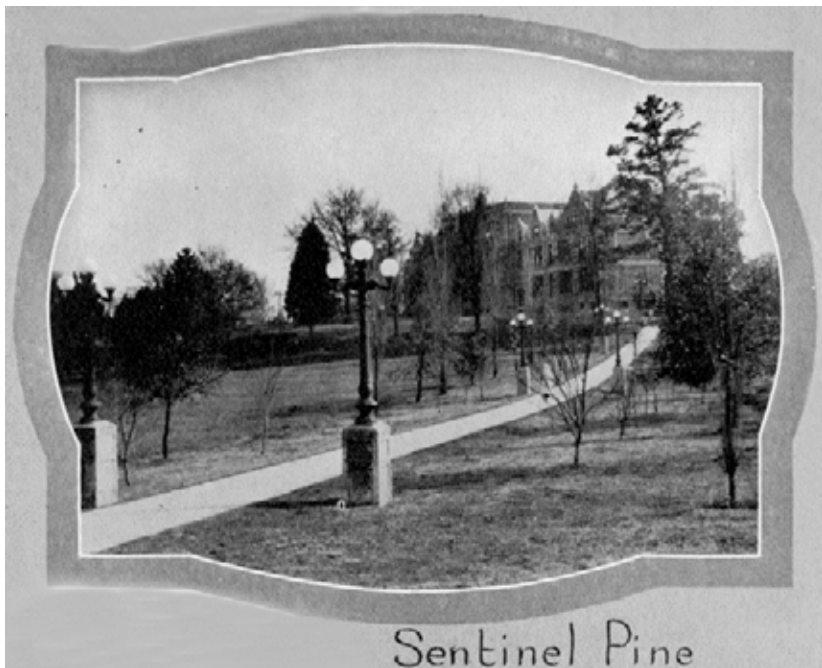
Figure 18. Walkway from Main Gate to Normal Hill lined by electroliers and ornamental vegetation with the "Sentinel Pine" at the top, 1928 (Northwestern State University, Watson Memorial Library, Cammie G. Henry Research Center (Potpourri Yearbook)).

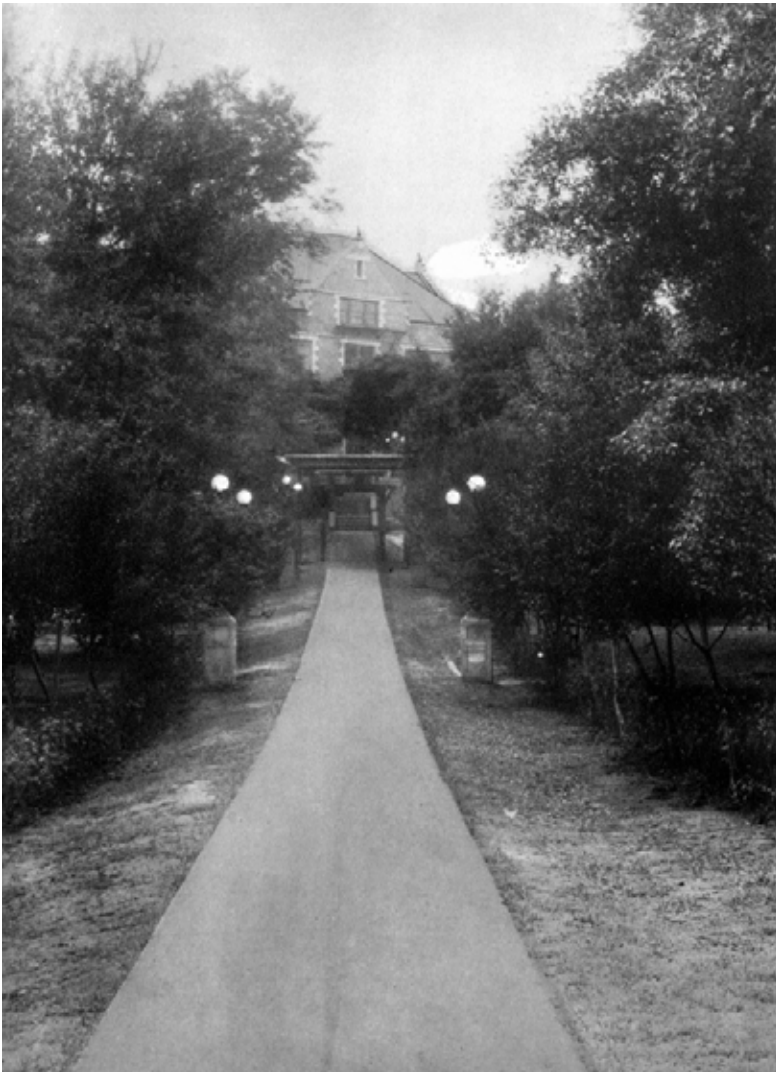
Figure 20. Walkway from Main Gate to Normal Hill lined with electroliers and ornamental vegetation and shaded with pergolas, 1931 (Northwestern State University, Watson Memorial Library, Cammie G. Henry Research Center (Potpourri Yearbook)).

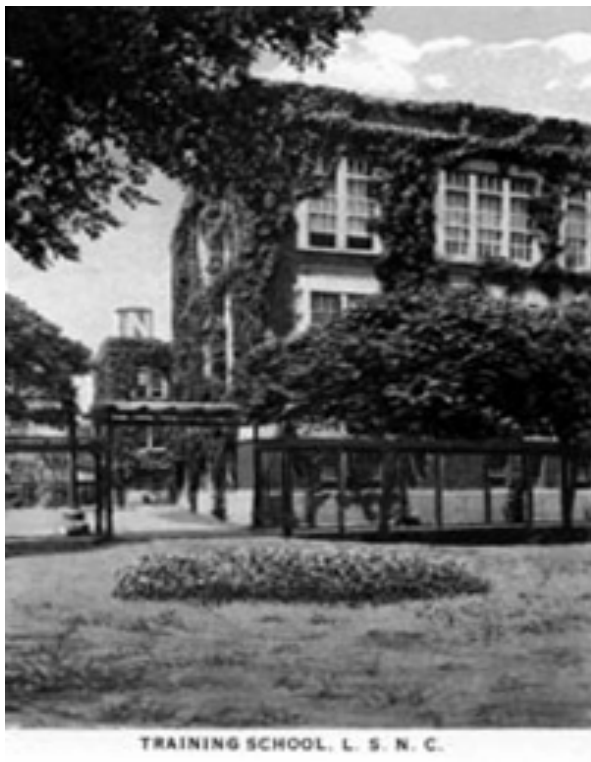
Figure 21. Louisiana State Normal College's Training School connected to greater campus with pergola covered walkway, ca. 1930. Note the round flowerbed in the lawn (Northwestern State University, Watson Memorial Library, Cammie G. Henry Research Center (Postcard)).

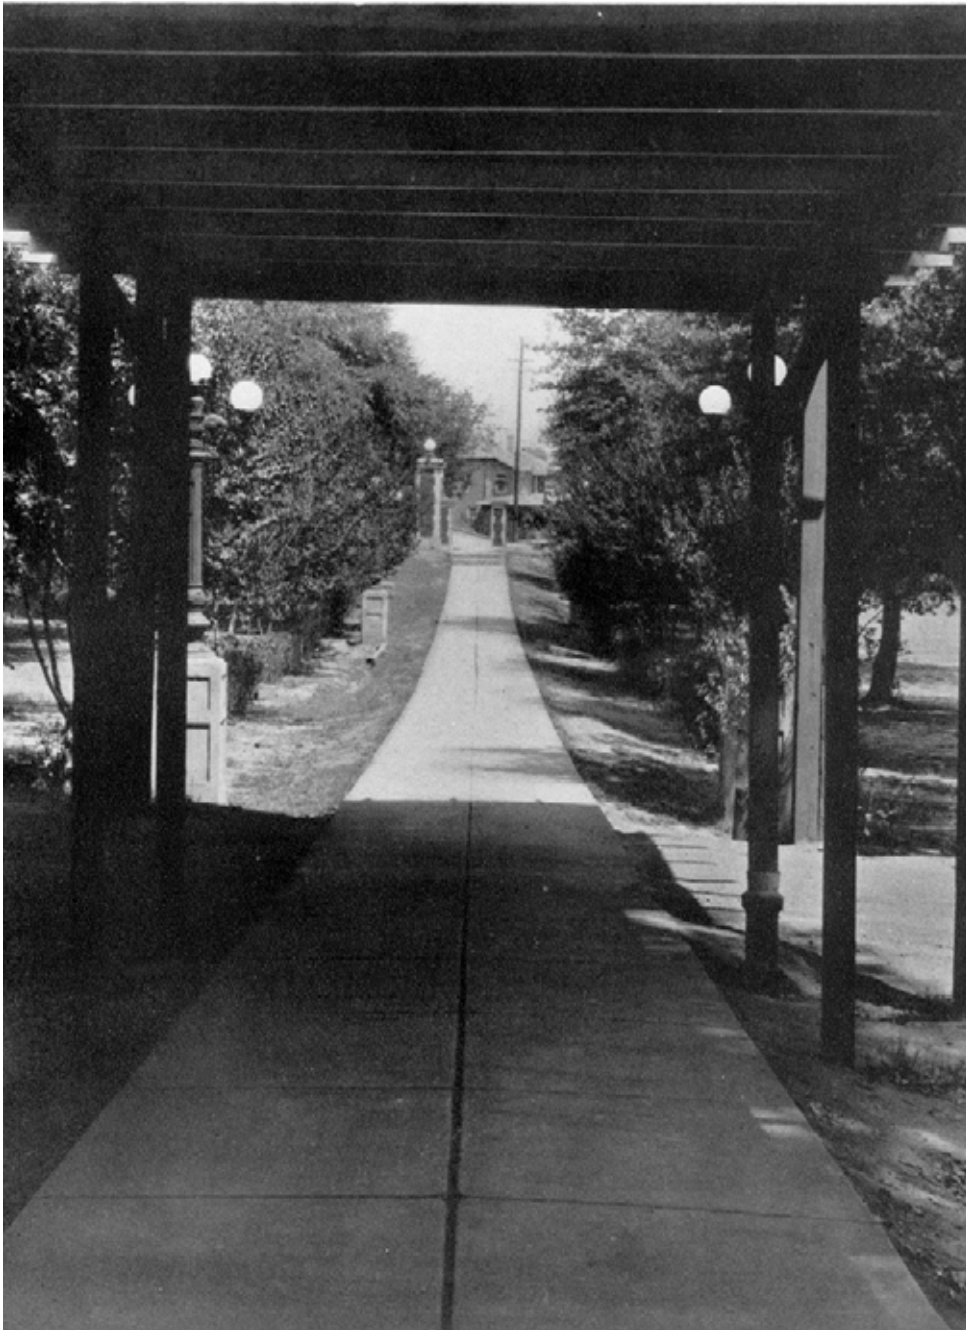
Figure 25. Shaded view from inside one of the pergolas along the walkway from Normal Hill to the Main Gate, 1932 (Northwestern State University, Watson Memorial Library, Cammie G. Henry Research Center (Potpourri Yearbook)).

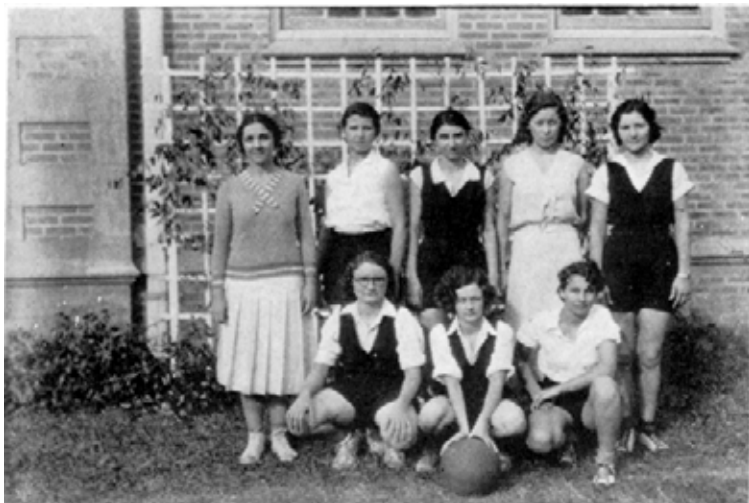
Figure 26. Trellis at Women's Gymnasium with ornamental vine, 1932 (Northwestern State University, Watson Memorial Library, Cammie G. Henry Research Center (Potpourri Yearbook)).

By the end of the 1930s, wooden trellises supported vines along the south façade of the Women's Gymnasium (Figures 26-27). Female students utilized the landscape, exercising beneath the pine trees (Figure 28).

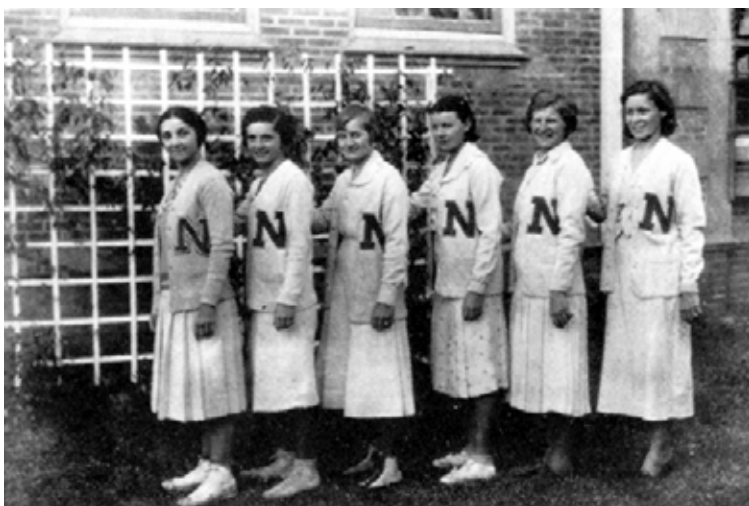
Figure 27. Trellis at Women's Gymnasium with ornamental vine, 1932 (Northwestern State University, Watson Memorial Library, Cammie G. Henry Research Center (Potpourri Yearbook)).

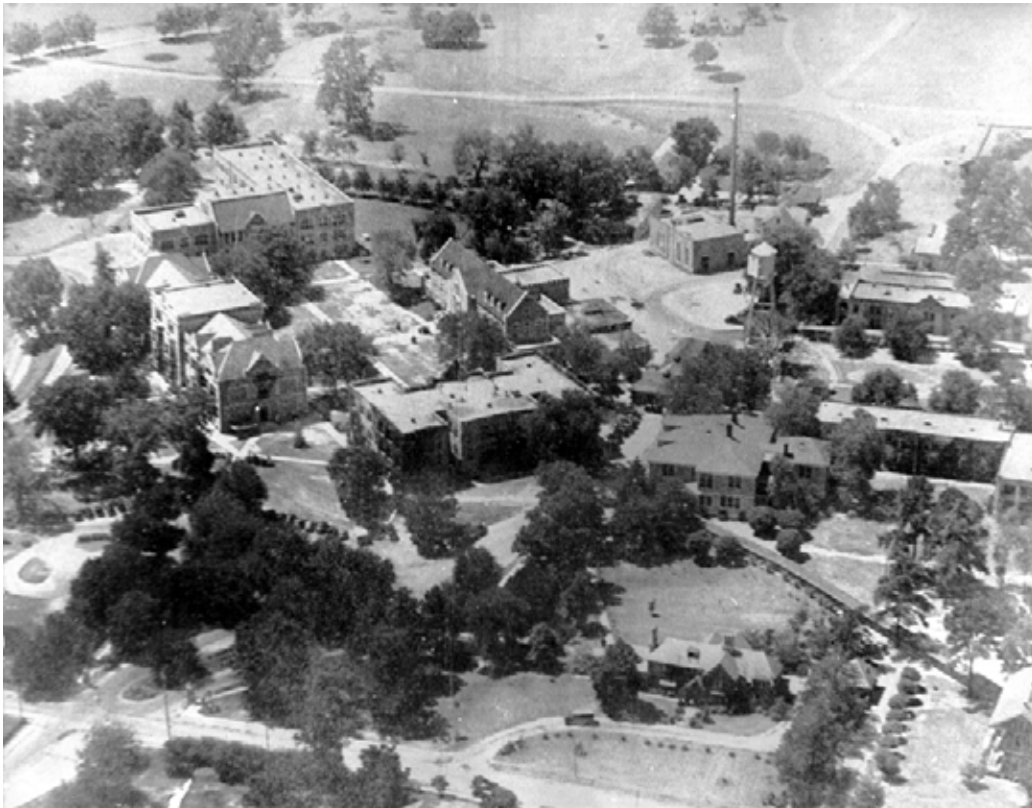
Figure 29. Normal Hill Quadrangle with pergola-covered walkway running from former Guardia Hall to the old Fine Arts building (lower right, current site of Horseshoe Drive east of the Women's Gymnasium), c.1939 (Northwestern State University, Watson Memorial Library, Cammie G. Henry Research Center).

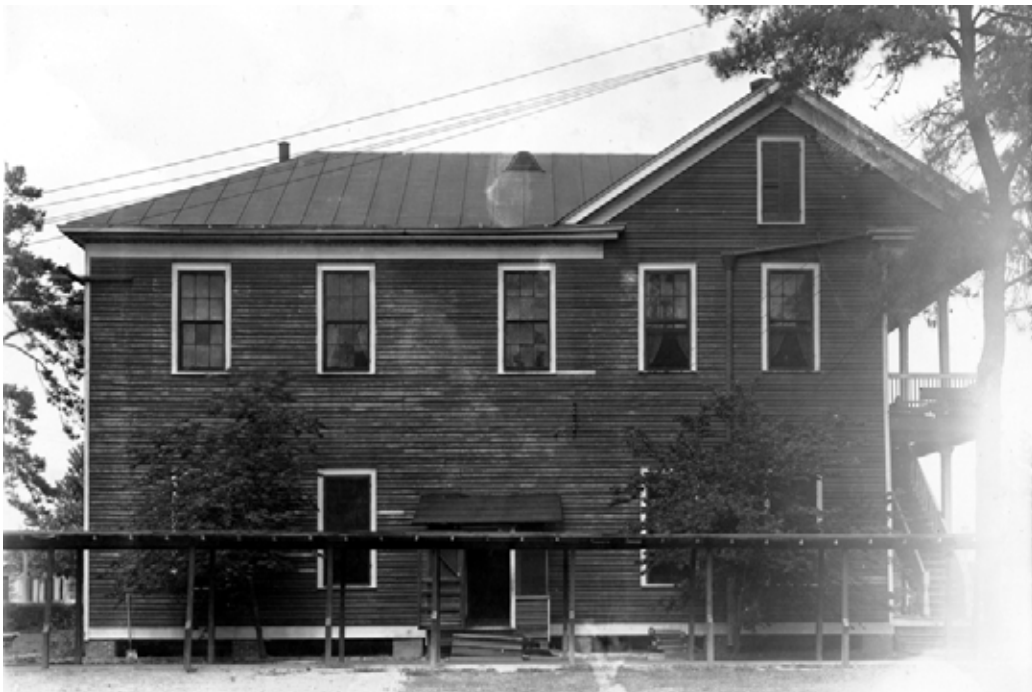
Figure 30. The old Fine Arts building formerly located in the vicinity of Horseshoe Drive east of the Women's Gymnasium, c. 1939 (year of demolition). The pergola-covered walkway in the foreground lead to Normal Hill (Northwestern State University, Watson Memorial Library, Cammie G. Henry Research Center (Potpourri Yearbook)).

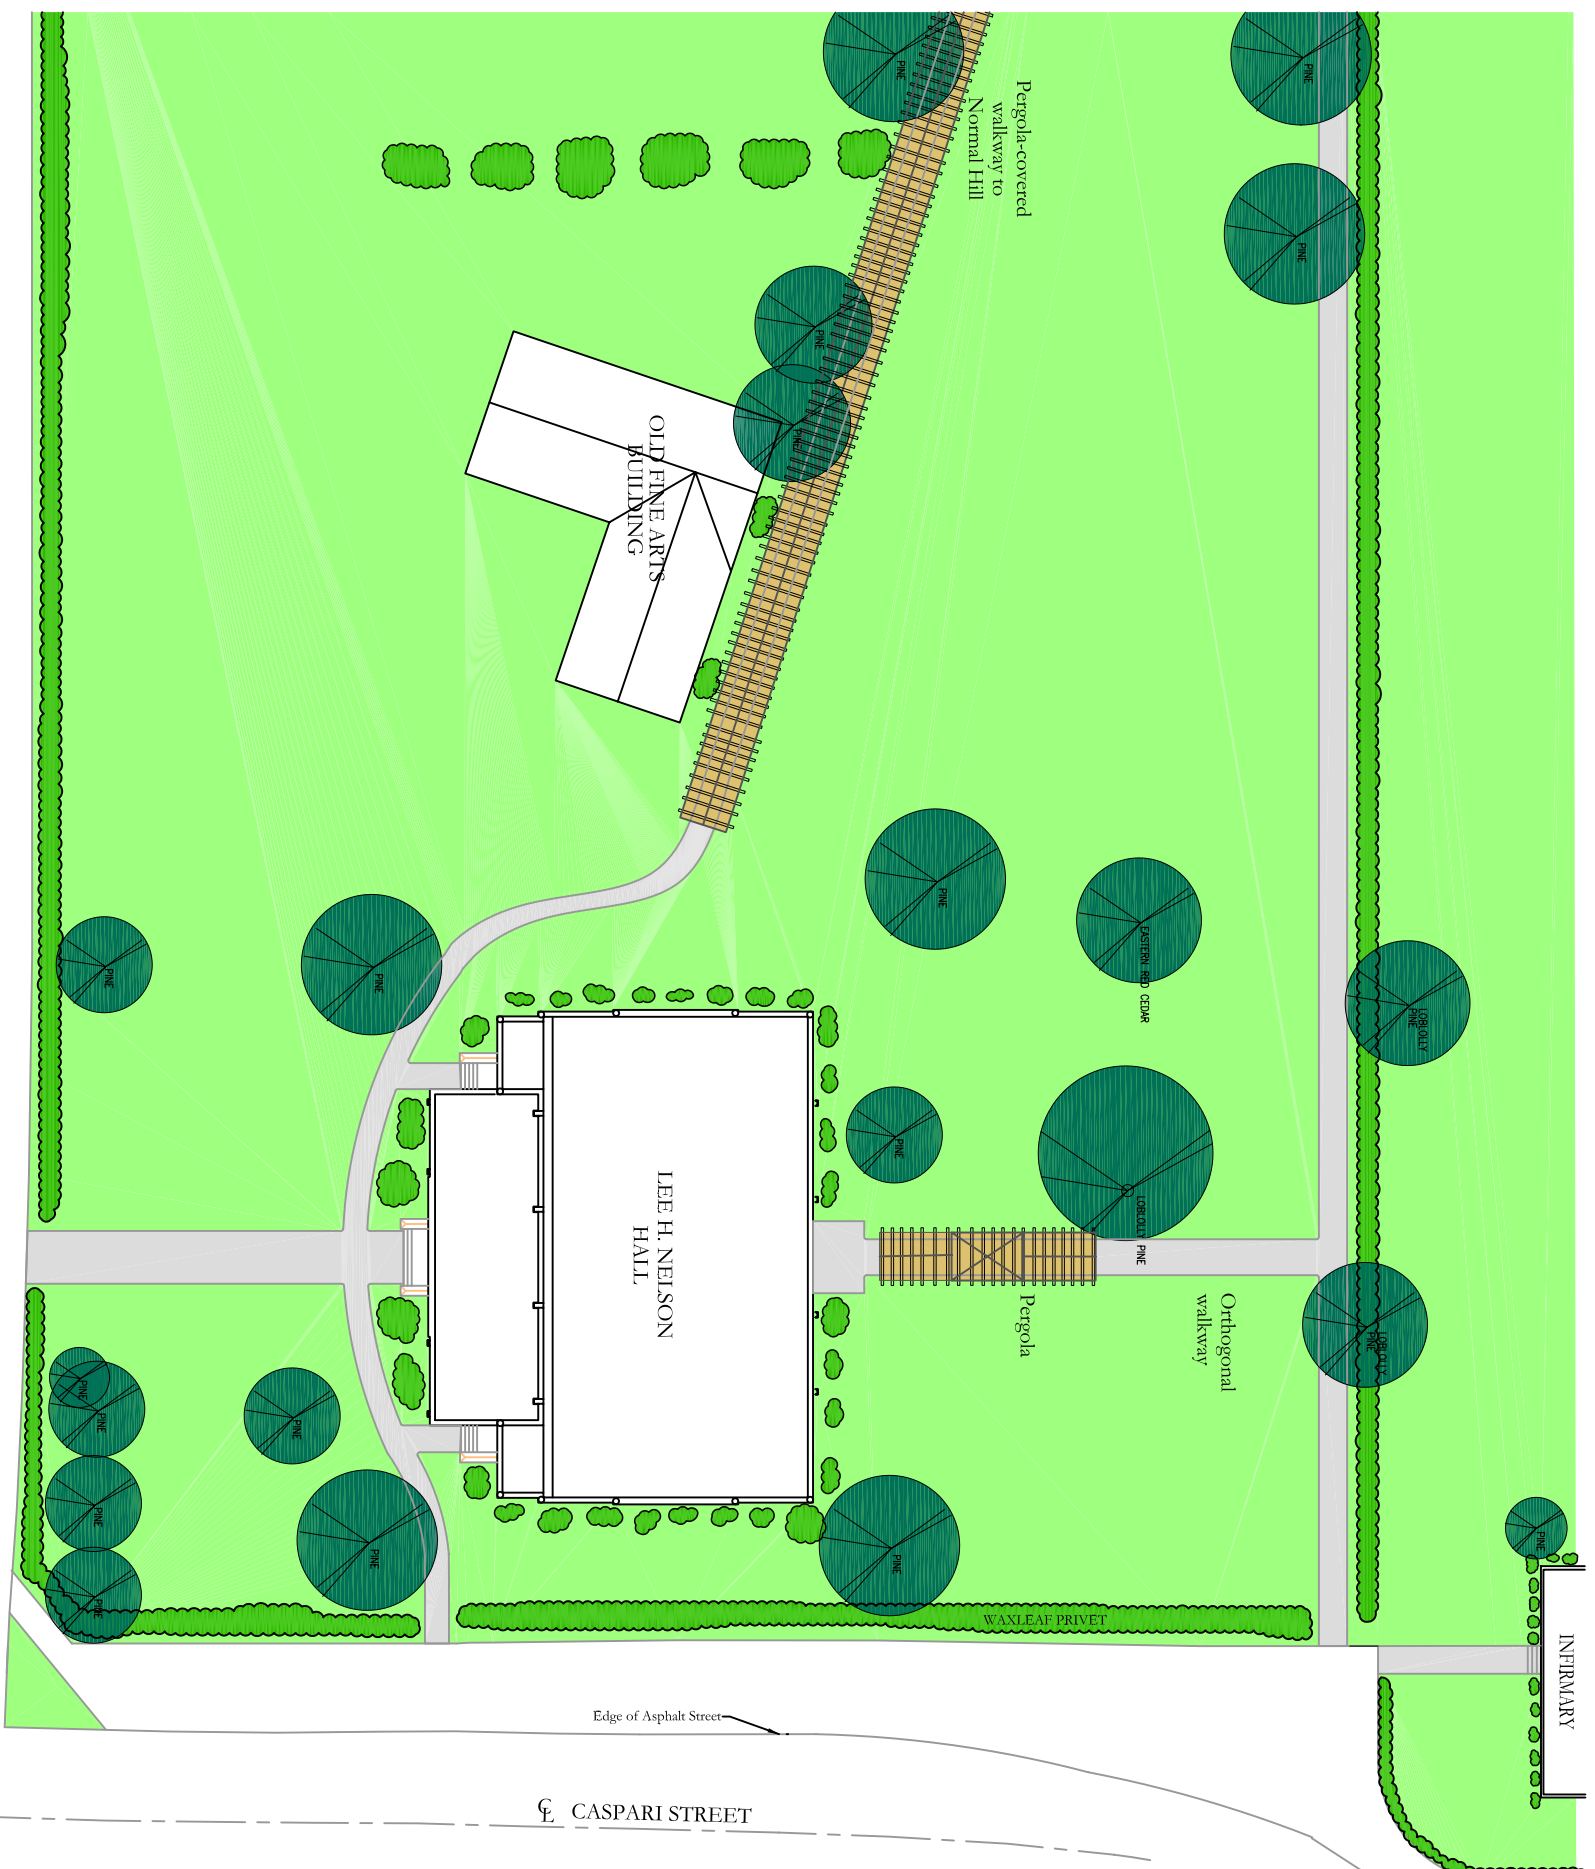
Figure 31.

- CONCRETE CIRCULATION
- TREE
- SHRUBS
- HEDGE
- LAWN

A 1939 period plan (Figure 31) depicts the Women's Gymnasium landscape and its surroundings immediately prior to the construction of Varnado Hall and Horseshoe Drive. With the completion of these projects, the Women's Gymnasium landscape changed (Figures 32-38). The college realigned the walkways south of the Women's Gymnasium. The college removed the orthogonal walkway and pergola from the rear entrance of the gymnasium, and replaced it with a diagonal walkway that headed southwest to connect with Caspari Street and a new campus walkway along the front of Varnado Hall. By the 1940s, hedges still bordered College Avenue and Caspari Street, and the college had planted shrubs along the foundation of the gymnasium. The pine trees at the southwest corner of the gymnasium had disappeared. By 1941, the college had installed the lamp standards with concrete poles that still illuminate much of the campus today.

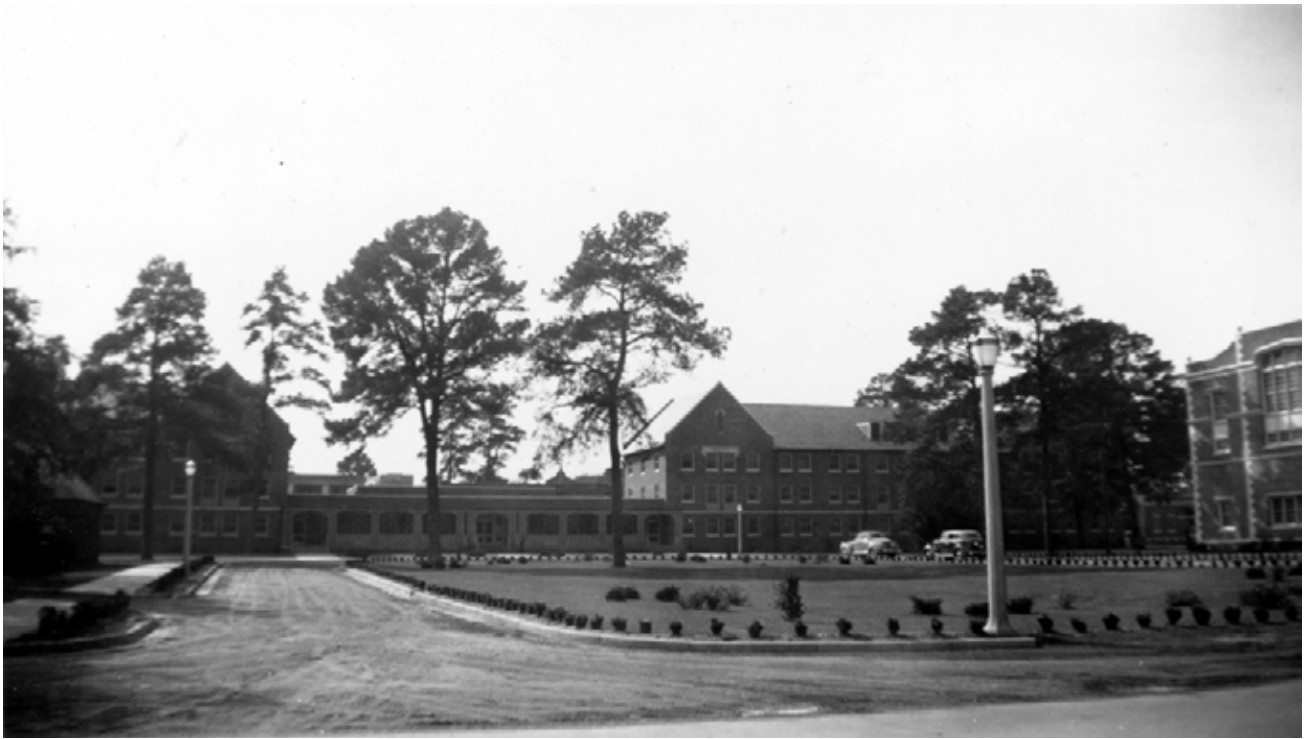
Figure 33. The newly constructed Varnado Hall and Horseshoe Drive (site of former fine arts building) with the Women's Gymnasium to the west, 1941. Note the newly planted hedge and shrub clusters (Northwestern State University, Watson Memorial Library, Cammie G. Henry Research Center (1941 Booklet-Insurance of Campus Buildings)).

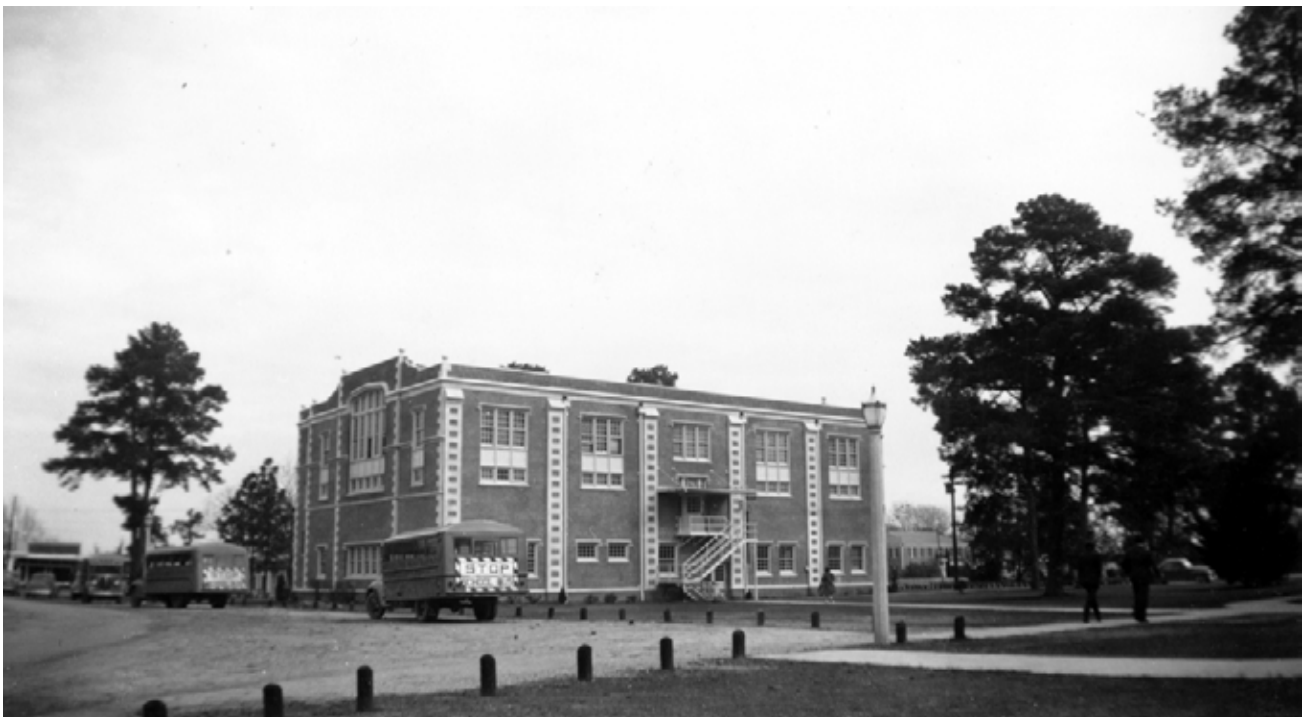
Figure 34. South lawn of the Women's Gymnasium, 1941 (Northwestern State University, Watson Memorial Library, Cammie G. Henry Research Center (1941 Booklet-Insurance of Campus Buildings)).

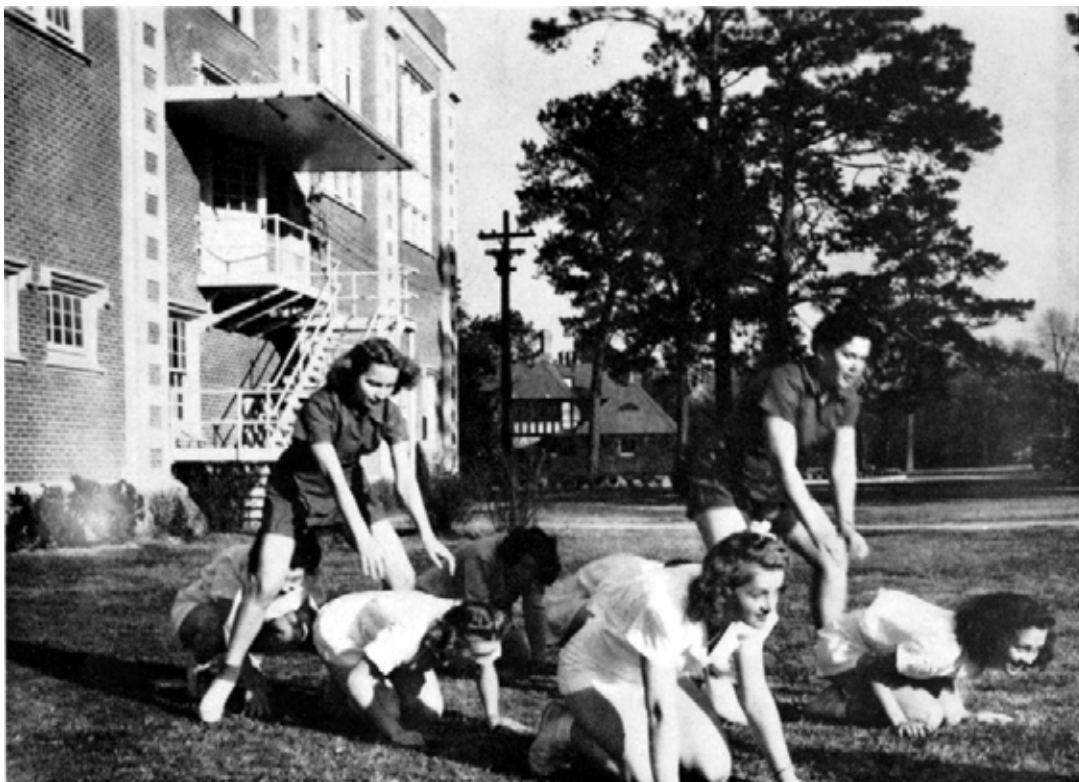
Figure 36. Leap frog on the south lawn of the Women's Gymnasium, 1943. Note the diagonal walkway coming from the rear entrance, the foundation shrubs, the large pine trees at the southeast corner, and the young hedge along Horseshoe Drive (background) (Northwestern State University, Watson Memorial Library, Cammie G. Henry Research Center (Potpourri Yearbook)).

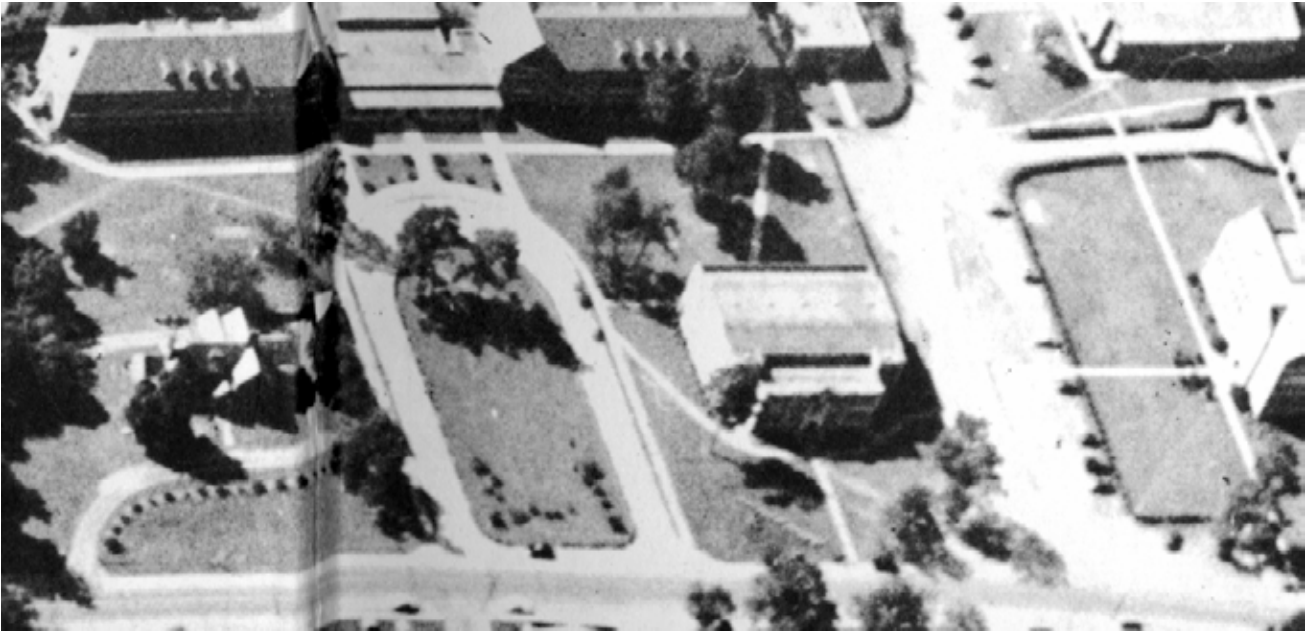
Figure 37. Aerial photograph showing from left to right, the President's Home, Horseshoe Drive, and the Women's Gymnasium, 1948. Note the extensive use of hedges on the campus including between Caspari Drive and the gym. All of the trees at the gym were pines. Varnado Hall is at the top of the image (Northwestern State University, Watson Memorial Library, Cammie G. Henry Research Center (Potpourri Yearbook)).
